Aznalcóllar dam failure. Part 1: Field observations and material properties

E. E. ALONSO* and A. GENS*

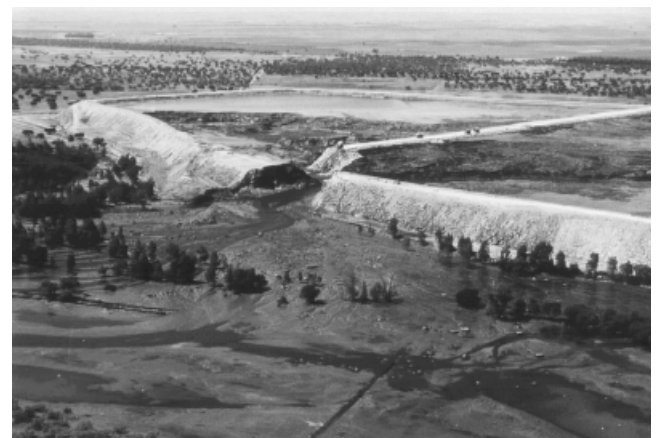
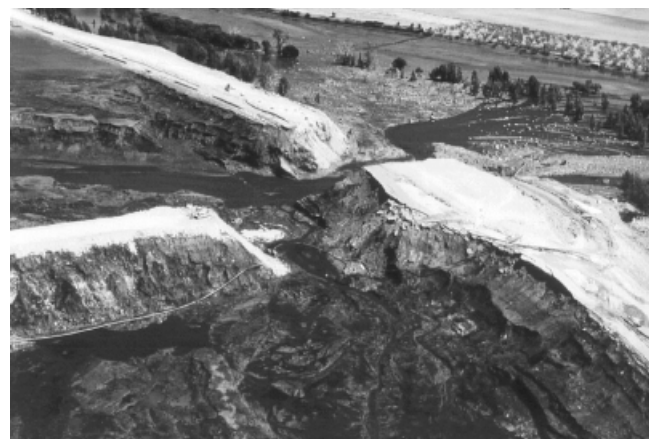
Fig. 4. Two aerial views of the breached dam a few hours after the failure: (a) view from the east; (b) detail of the breach

The orientation of the initial outflow is indicated by the depositional fans observed outside the breached embankment (Fig. 4(b)). The flow of tailings was directed initially in a NE direction, against the natural slope of the Agrío valley. Later, the progressive erosion of the breach allowed the outflow to change direction towards the east.

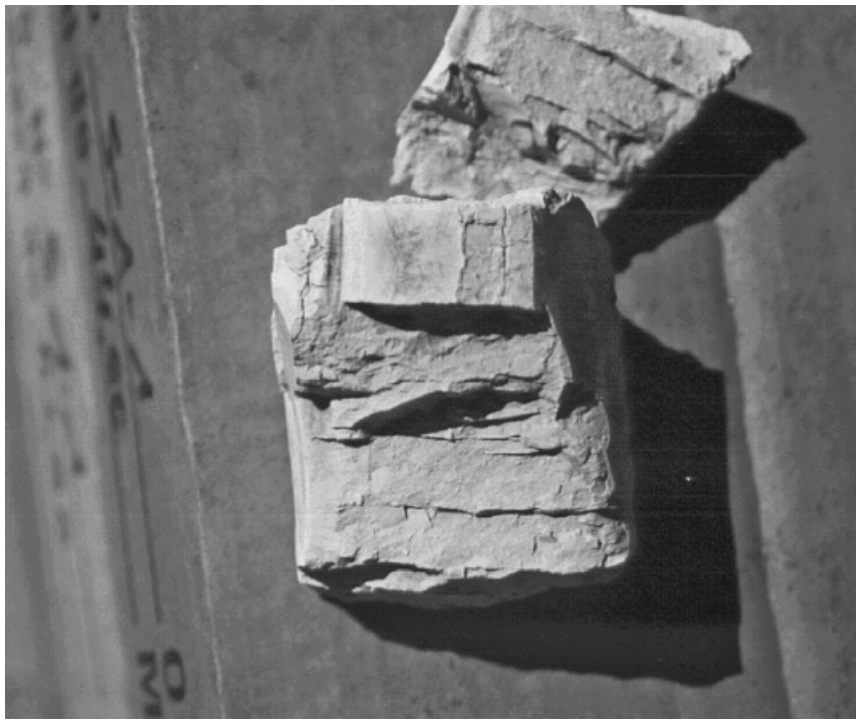
are exposed to the atmosphere and partially dried, some laminations and the alignments of pyrite micronodules reveal the bedding planes (Fig. 7). In exposed outcrops outside the slide area (Fig. 8) the weathered clay exhibits the bedding planes more clearly. A dip of $2\text{--}4^\circ$ towards the SSE was measured in outcrops and trenches. Observations in bedding planes, both in outcrops and in cores, revealed some shear striations and some shear zones similar to those described in Chandler *et al.* (1998). Two examples of shear striations are shown in Figs 9 and 10. However, these phenomena were not general, and in other cases the bedding planes appeared

Fig. 7. Stratification of clay as observed in a partially dried core (borehole S1-3; depth 19 m)

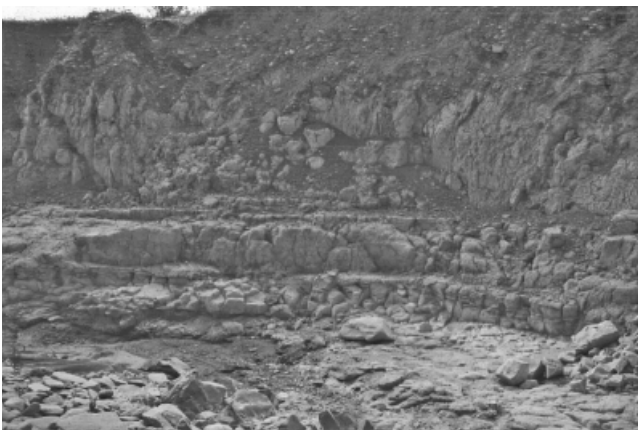
Fig. 8. Exposed outcrops of Guadalquivir clay showing horizontal bedding planes: river banks of Agrio river

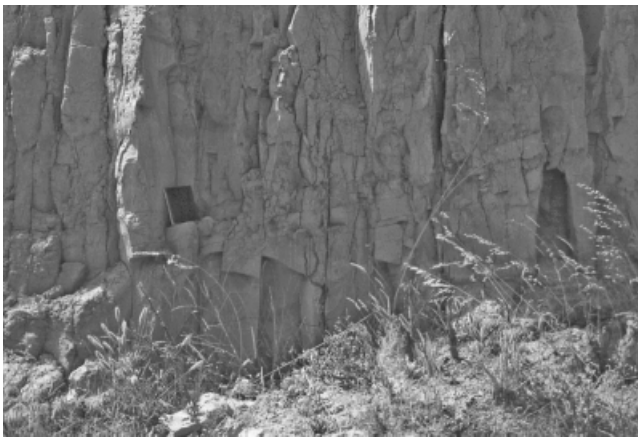
Fig. 11. Vertical jointing: outcrops in Agrio river

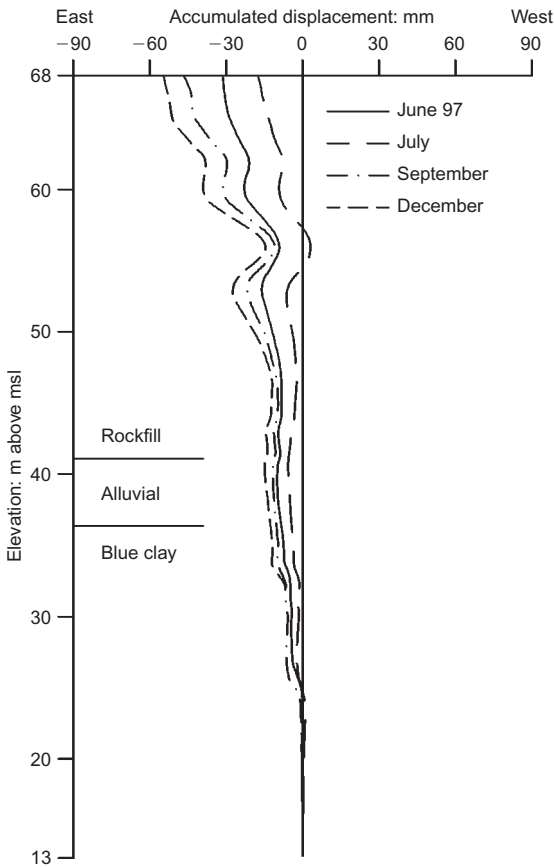
Inclinometer I-3 was located approximately at the centre of the section of the embankment that slid towards the river at the time of failure. A few readings were made during December 1996–December 1997. They are shown in Fig. 14. The locations of the rockfill/alluvial and alluvial/clay interfaces are shown in the figure. Unfortunately, the upper part of the inclinometer was damaged in January 1998, and no data for the months immediately preceding the failure are available. The displacements shown in Fig. 14 were not

interpreted, at the time of readings, as a sign of a possible deep sliding. It was later established, after the failure, that a sliding surface developed at elevation 26 m. Six millimetres of displacements accumulated at this elevation during the year 1997. Most of the observed displacements were recorded within the rockfill embankment, which was under construction.

Fig. 14. Readings in inclinometer I-3 in direction perpendicular to dam axis (towards the east)

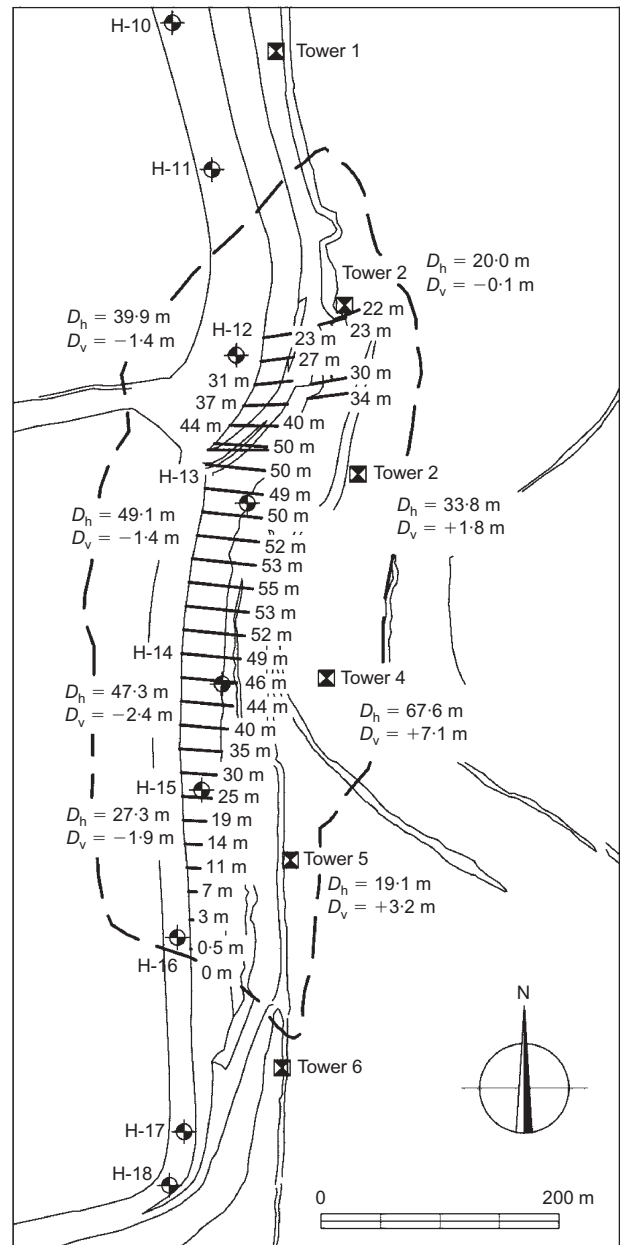
Fig. 16. Limits of the slide area and vectors indicating the displacement. Displacements were measured in topographic marks and electrical towers. D_h , horizontal displacement; D_v , vertical displacement (negative numbers indicate a drop in elevation)

The inclination ($1.5\text{--}2^\circ$) and planar nature of the basal sliding surface are a strong indication that it followed a bedding plane. The position of settlement plates, precisely located on the crest of the embankment before the slide, could be used also to determine the horizontal (D_h) and vertical (D_v) displacements experienced by those plates. The measured values are indicated in Fig. 16. The slope ($\arctan D_v/D_h$) is also consistent with a sliding surface dipping $2\text{--}3^\circ$ towards the east. A comparison of the topography before and after the failure also provides a good indication of the magnitude of horizontal displacements (Fig. 16).

The central part of the embankment moved 40–55 m towards the east (directions varied between 93° and 100° with respect to north). The magnitude of the displacement decreased to 20–22 m at the northern limit of the slide, at the position of the open breach. Towards the south, a more gradual decrease of displacements was observed. In total, a 600 m long portion of the south-eastern embankment of the lagoon was affected by the slide. North of the breach, no displacements of the embankment were detected.

The shape of the northern limit of the slide (Fig. 16) suggests that the failure surface crossing the embankment was controlled by the dominant orientation (NE–SW) of the vertical joints of the foundation clay. An interpretation of the original rupture breach is given in Fig. 23. The orientation of the embankment, its size, the direction and intensity of the sliding motion and the orientation of the rupture plane led to an initial breach width of 14 m. Note also that the two lips of the breach separated immediately, and therefore

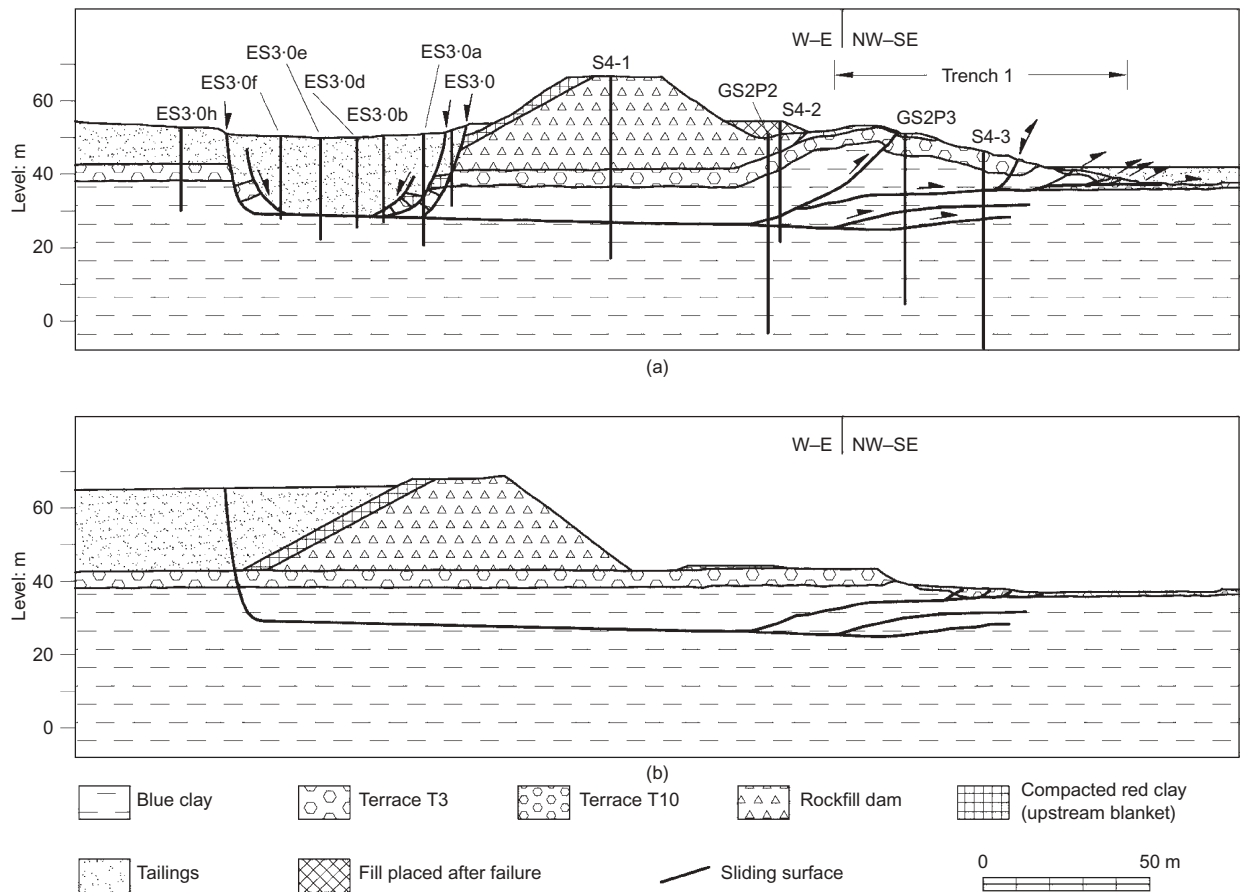
Fig. 17. Cross-section of slide at position of Profile 4: (a) geometry after the slide, as interpreted from borehole results and surface topography; (b) reconstruction of position of sliding surfaces before failure

found in direct contact with the clay in some of them (e.g. Boring ES3-0e in Fig. 17). In several boreholes it was also possible to identify the position of the sliding surface where a highly polished surface could be found. This is the case for the plane shown in Fig. 18.

Also indicated in Fig. 17(a) are the folded structures found at the foot of the downstream slope of the embankment. The interpretation given is based on zones of intense shearing found in boreholes and trenches. Upward displacements of the ground, close to 8 m, were measured at the position of the folded strata. Fig. 17(b) provides a reconstruction of the original position of the sliding surface before failure displacements. An interesting finding of this reconstruction is that the head scar of the slide was a near-vertical surface located at the original upstream toe of the embankment. This vertical scar was fairly well preserved even after the intense erosion of the tailings deposits that followed the uncontrolled flow out of the lagoon. This is shown in Fig. 19.

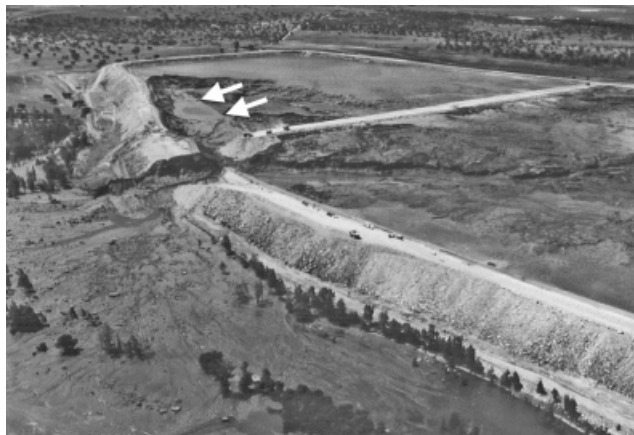
Fig. 19. The straight line, indicated by arrows, shows the position of the upstream scar of the slide

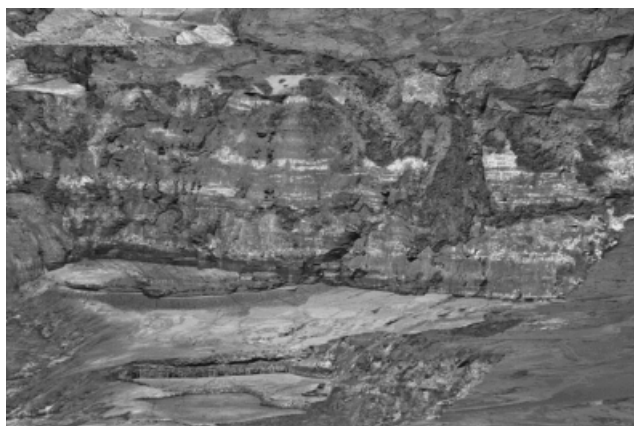
It was also observed that the tailings could maintain stable vertical cliffs 15–20 m high (Fig. 20). The position of the initial upstream vertical scar, as given by the reconstruction of the original profiles, is shown in Fig. 21. Also shown in this figure is the position of the scar, some months after the failure. It shows a small retrogression towards the lagoon as a consequence of (limited) sliding and erosion. The vertical jointing on the clay foundation is consistent with this interpretation of field observations as it explains the existence of a nearly vertical upstream limit of the slide, within the blue clay, which continued upwards within the tailings deposit.

Fig. 20. Vertical cliffs inside lagoon as observed a few weeks after failure

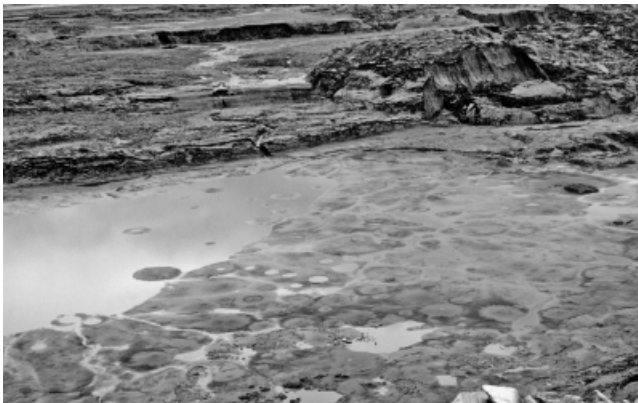
Observations made a few hours after the failure showed small mud volcanoes on the solidified tailings upstream of

the dam (Fig. 22). This was a clear indication of tailings liquefaction during the failure process.

Fig. 22. Mud volcanoes observed a few hours after failure on surface of depressed basin upstream of slid dam
