Aznalcóllar dam failure. Part 2: Stability conditions and failure mechanism

A. GENS* and E. E. ALONSO*

An analysis of the conditions that led to the failure of the Aznalcóllar dam is made in the paper. Pore water pressures prevailing in the foundation clay at the time of the failure have been established on the basis of piezometric observations made after the failure. A simplified consolidation analysis is first presented to interpret pore water pressure generation and dissipation and to evaluate the evolution of shear stresses along the potential failure plane. Both limit equilibrium and finite element analysis are used to back-analyse the failure and to derive representative strength parameters along the failure surface. Three-dimensional effects introduced by the layered nature of the foundation clay are then described. They provide an explanation for the location of the slide, which affected only the south-eastern portion of the embankment. The failure is examined in the final part of the paper from the perspective offered by the current knowledge of the strength behaviour of brittle clays. The significance of progressive failure is discussed, together with other factors that

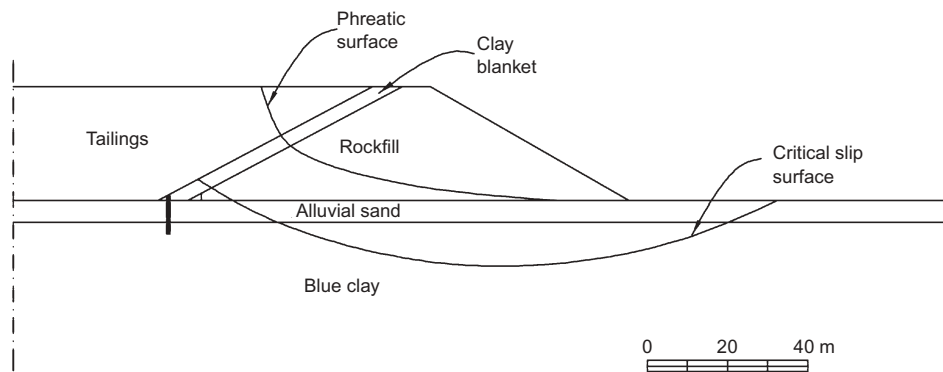
Fig. 2. Estimation of stability conditions at design stage

The critical failure circle was found to be a deep circle, shown in Fig. 2. A safety factor $F = 1.30$ computed for this circle was deemed to be acceptable because it was higher than the recommendation ($F = 1.2$) of the seismic code applied.

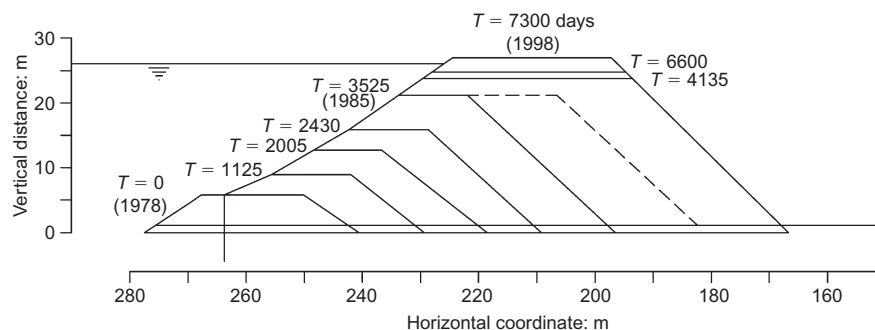
Fig. 3. Evolution of representative cross-section of the dam actually built (east side)

The dam actually built did not follow all the design specifications. A representative cross-section of the failed dam is shown in Fig. 3. A significant change was introduced in 1985, when the downstream slope increased from the projected value of 30° (1V:1.75H) to 39° (1V:1.24H). The downstream slope was maintained unchanged thereafter. A second significant change took place in 1990: the width of the crest of the dam increased from the planned value of 14 m to 36.50 m. At that time, the height of the cross-section was 21 m over foundations. Other changes, which may be identified by comparing Figs 1 and 3, are of minor significance. In 1990 the width of the base of the dam reached a maximum value of 130 m. Subsequent changes in dam height did not modify this base width.

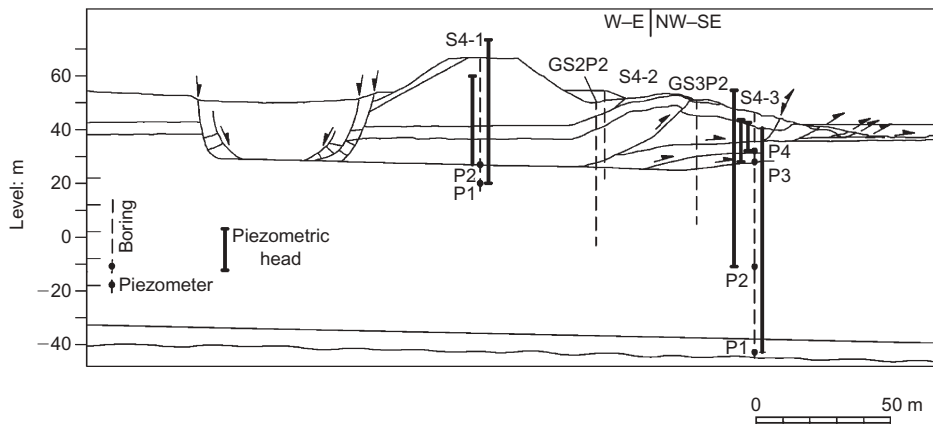
Fig. 5. Pore water pressure measured in piezometers located in Profile 4 (in borings S4-1 and S4-3). Other borings indicated helped to identify the position of sliding surfaces, shown in the plot. The graph also shows the soil profile and the geometry of the displaced dam after failure

On 25 April 1998 the embankment moved to its new position, raising the load of foundation points such as P1 in Borehole S-4-1 (Fig. 5). The point, therefore, experienced an undrained loading followed by a period of dissipation under newly formed boundary conditions. Other points, such as P2 in the same borehole, probably travelled with the moving dam, but were affected by the rapid unloading associated with the sudden decrease of the tailings level in the lagoon. This sequence of events makes any prediction exercise somewhat uncertain. Perhaps the major difficulty is the correct interpretation of the drainage boundaries after the

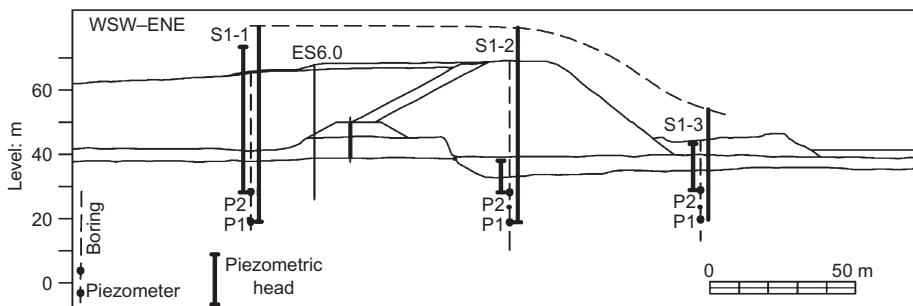
Fig. 6. Pore water pressures measured in piezometers located in borings S1-1, S1-2 and S1-3 in Profile 1 (not affected by the failure). The graph shows also the level of tailings after the failure and the soil profile

It is interesting to note in Fig. 6 that the readings in the piezometers P2, located in a shallower position within the clay, detect the boundary water pressure upstream and downstream of the cut-off wall. Water pressures in the alluvial granular soil downstream of the embankment appear to have a low value, close to the original ground surface, similar to that measured in open tube piezometers. Upstream of the cut-off, the water level in the alluvium is given by the water level in the lagoon, and this explains the reading in piezometer P2 in borehole S1-1. It is also clear that strong vertical pressure gradients exist below the embankment in the vicinity of the position of the sliding surface (in the failed embankment) as a result of the consolidation process

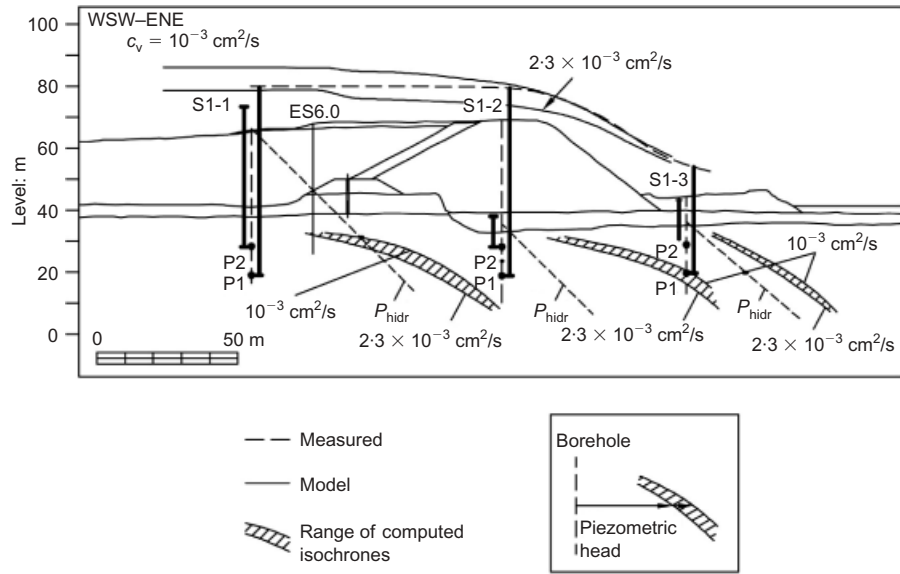
Fig. 8. Calculated and measured distributions of pore water pressures under Profile 1

A comparison of the calculated and measured pore water pressures under the embankment and the lagoon, for Profile 1, is shown in Fig. 8. The calculation simulated the construction process defined in Figs 3 and 7, as well as the reduction in tailings level due to erosion immediately after the failure, the change in boundary condition upstream of the cut-off wall, and the subsequent dissipation time prior to the pore water pressure measurements being performed.

The level of tailings after failure is shown in Fig. 8. It implies an unloading (which was assumed to be undrained) with respect to the tailings level immediately before failure. Fig. 8 shows the calculated pore pressures along the failure plane for two values of c_v ($10^{-3} \text{ cm}^2/\text{s}$ and $2.3 \times 10^{-3} \text{ cm}^2/\text{s}$) and a comparison with measurements in piezometers P1. Also shown in the figure are the calculated and measured vertical profiles of water pressure at the location of boreholes S1-1, S1-2 and S1-3. They show a strong pore pressure gradient in the upper part of the clay deposit. The agreement between calculated and measured pore pressures is very good for a value of c_v close to $10^{-3} \text{ cm}^2/\text{s}$. Remarkably, this back-calculated value is very close to the c_v values derived from consolidation tests on specimens of blue clay (Alonso & Gens, 2006). This agreement is a further indication of the massive and homogeneous nature of the foundation clay. The back-calculated values are of the same order of magnitude as those derived by Vaughan & Walbancke (1973) from observation of cutting slopes in London clay.

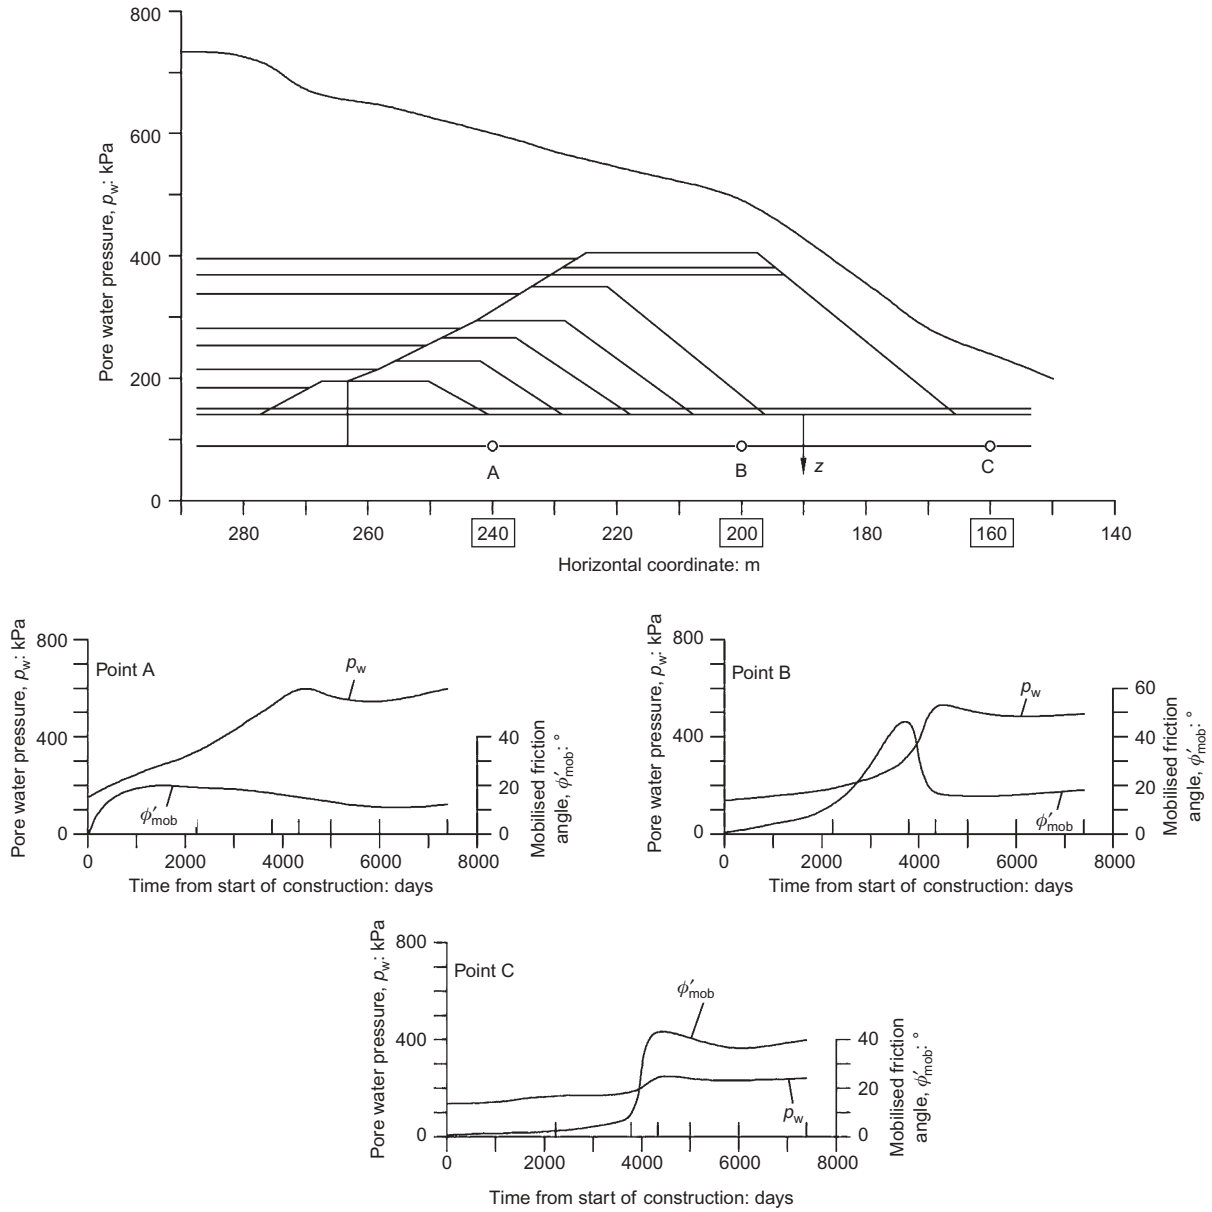
Fig. 9. Calculated water pressures and stress ratios under dam and lagoon at points A, B and C in representative profile of failed southern part of east embankment

The next step in the calculations was the estimation of pore water pressures under the embankment and lagoon for a representative profile of the southern part of the east embankment. A change in the vertical density of the deposited tailings was considered. The evolution of pore water pressures at three points under the embankment, in a horizontal plane, 14 m below the ground surface, is shown in Fig. 9. Also shown in the figure is the estimated cross-profile of pore water pressure immediately before failure for the indicated horizontal plane (which is very close to the position of the actual basal sliding plane). This calculation shows that the pore pressures on the failure plane prior to failure were high, certainly much higher than the values assumed in design.

The plots in Fig. 9 also indicate that pore pressures reached a peak at $t = 4500$ days, around 1990, at the end of a relatively rapid increase in embankment height (Figs 3 and

7). The subsequent slowdown in construction rate resulted in a reduction in pore water pressures followed by a final increase associated with the final and faster stages of embankment construction.

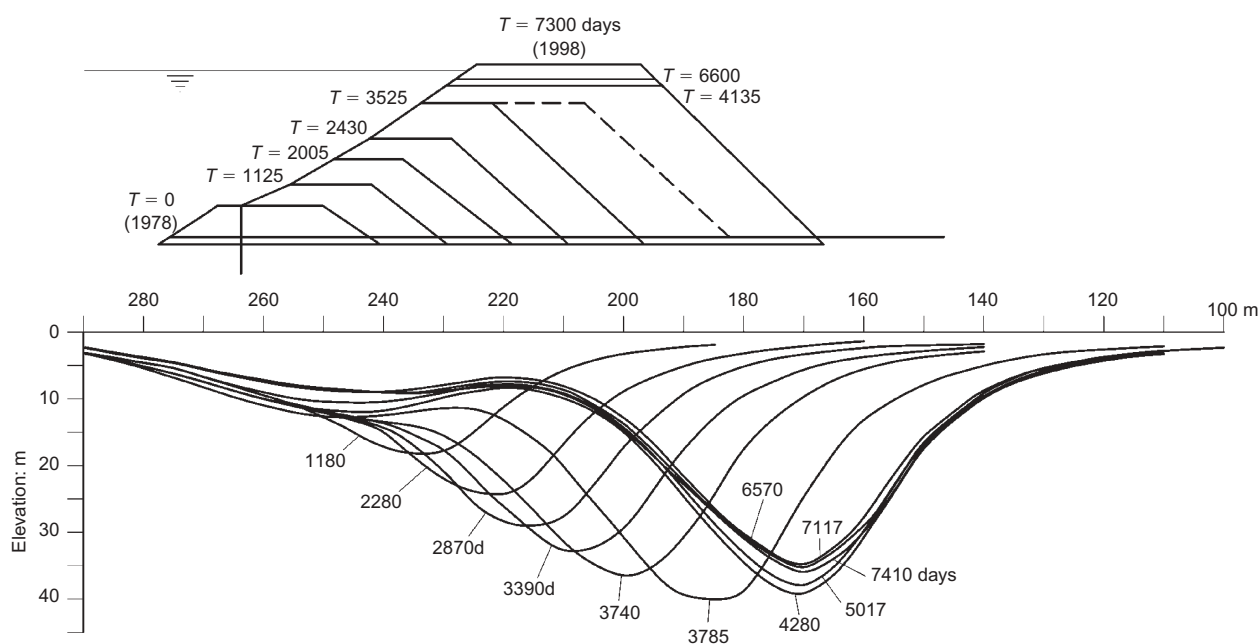
Fig. 10. Variation of mobilised friction in a horizontal plane located at depth $z = 14$ m within clay foundation. Numbers indicate time elapsed (days) since start of dam construction (January, 1978)

Note that the maximum values are high ($35\text{--}45^\circ$). If the subhorizontal bedding planes do not have an effective cohesion, the advancing embankment has certainly induced some damage on the bedding planes, which are unable to resist those high stress ratios. Note also that a maximum stress ratio was reached at a time $t \cong 3800\text{--}4000$ days (around 1988–1989), 10 years before the failure. Later, the dissipation of pore pressures, associated with slower construction rate, led to an increase in normal effective stresses and to a reduction of the stress ratio.

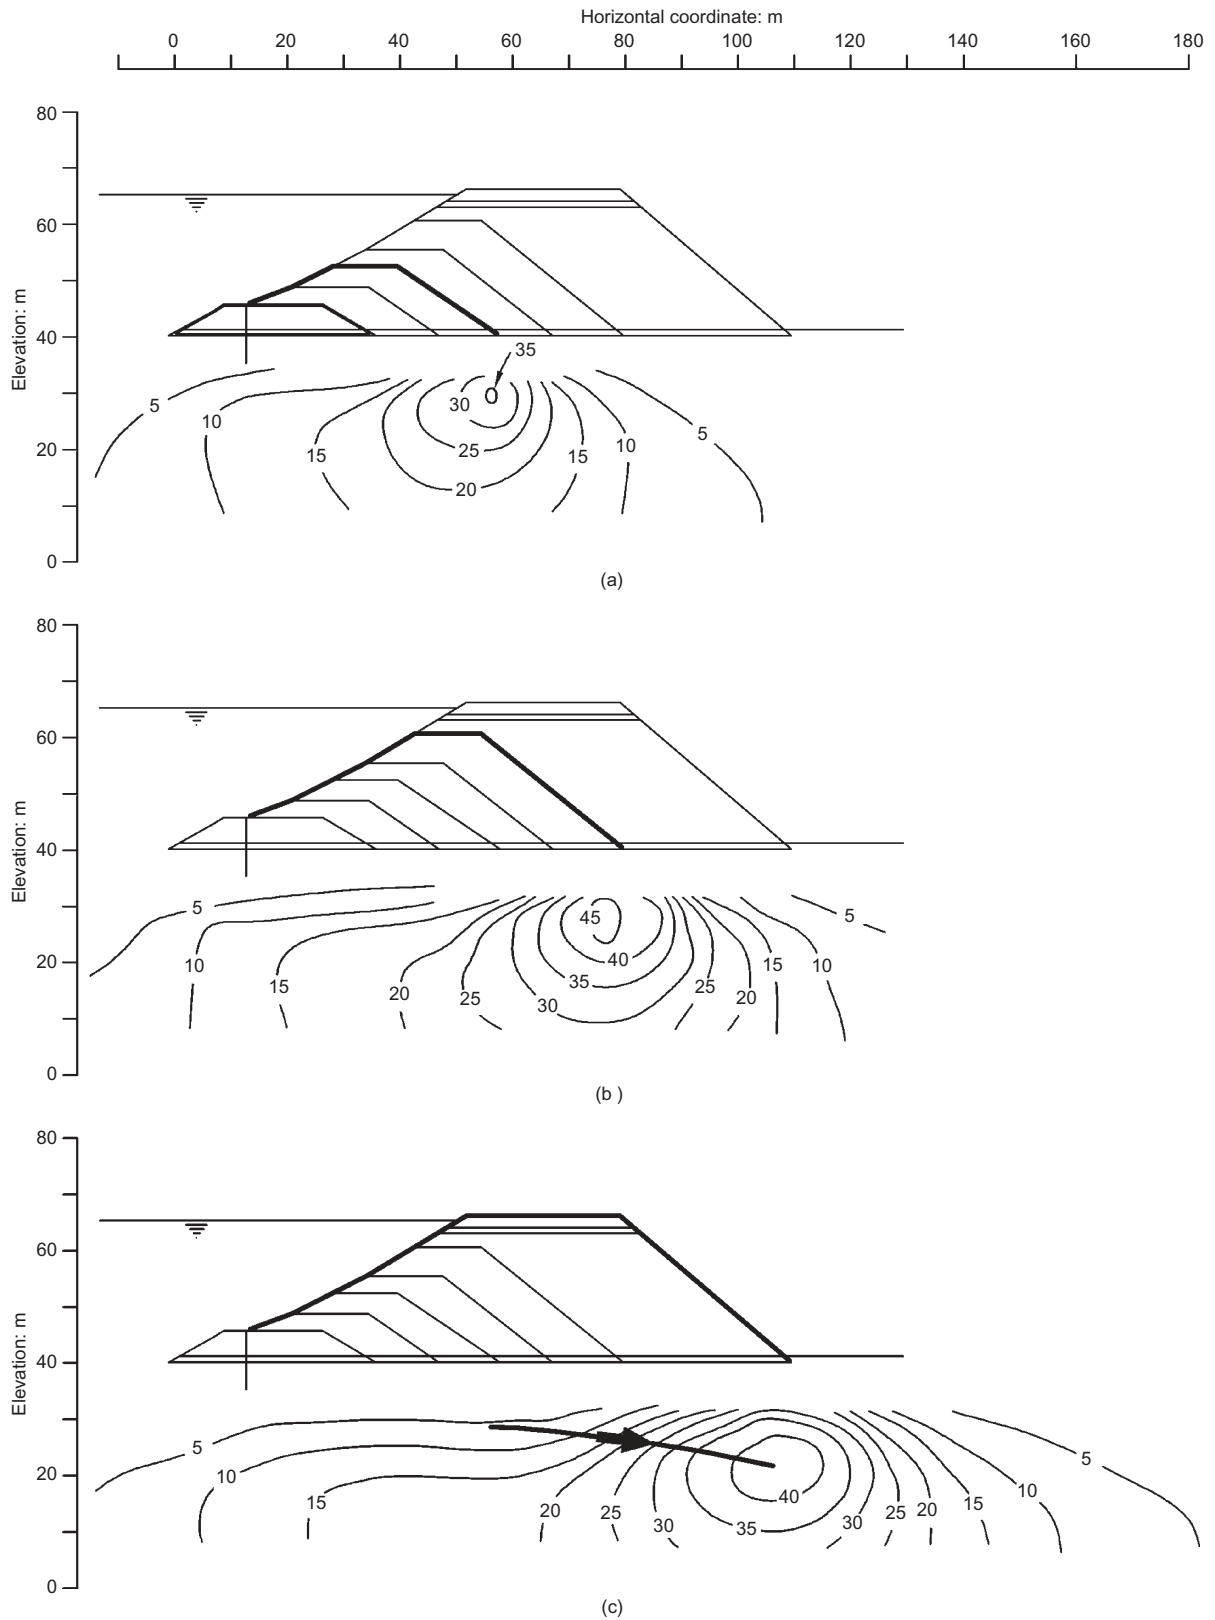
Fig. 11. Contours of equal mobilised friction on horizontal planes for three phases of construction, in terms of dam height: (a) $H = 10$ m; (b) $H = 19$ m; (c) $H = 27$ m. The line with the arrow in (c) shows the locus of the maximum mobilised angle of shearing resistance

A remarkable result is that the stress ratio reaches a peak at a certain depth within the clay. This is a consequence of the variation of pore pressures, controlled by the clay consolidation, and the distribution of shear stresses below the embankment toe. The depth of the maximum τ/σ'_n increases as the height of the embankment increases. For $H = 10$ m the maximum τ/σ'_n is found for $z = 10$ m. It increases to $z = 12$ m and $z = 17$ m when $H = 19$ m and $H = 27$ m. This result indicates the position of the sliding plane, which developed later, as the peak in mobilised friction generates the maximum damage in clay strength. In fact, the brittle behaviour of the clay, and the strength data already reported (Alonso & Gens, 2006), can be now invoked to advance a qualitative interpretation of the failure mechanism. If bedding planes do not exhibit any effective cohesion, a maximum effective friction angle of around 25° may be assumed for them. Then, in view of Figs 9, 10 and 11, the strength on a critically located bedding plane was exceeded for the first time, when the embankment had a height of 8–10 m. This initial critical point was located at a depth of about $z = 10$ m under the downstream toe of the embankment.

This was the situation as early as 1980–1981. Additional stressing in the following years could not be resisted in some areas of the clay. The brittle nature of the clay allowed additional straining in the vicinity of the critical points in a typical progressive failure mechanism. The forward construction of the embankment resulted, therefore, in an increasing extension of the area affected by progressive failure. The line plotted in Fig. 11(c) joins the points of maximum stress ratio. It is viewed as a first approximation of the position of the failed surface under the embankment. Its position is quite close to the position of the future failure plane. The inclination of this line has probably helped to concentrate critical conditions on a specific bedding plane. The line thus defined is an approximation to the failed or damaged surface immediately before failure.

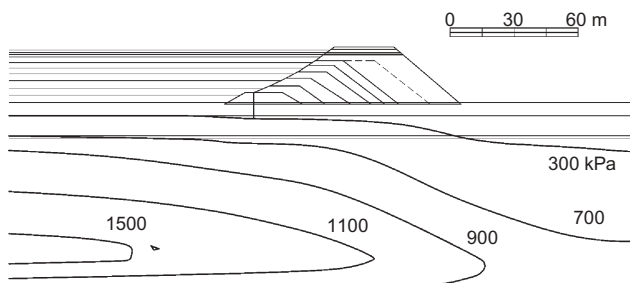
Fig. 14. Distribution of pore water pressures in last stage of FE calculations, immediately prior to failure

This FE analysis also provided data relating to the evolution of pore water pressures in the foundation. Fig. 14 shows the distribution of pressures at the end of the calculation (just prior to rupture). Note the substantial influence of the heavy tailings and the very limited dissipation of pore pressures. A profile of water pressures along the future failure plane is shown in Fig. 15. The FE prediction is compared with the result of the elastic-consolidation analysis reported before. The correspondence is very good.

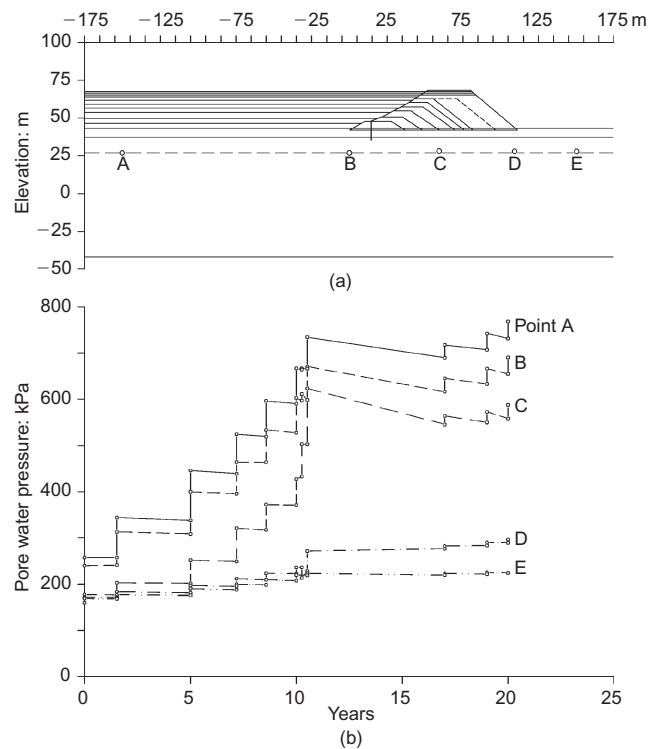
Fig. 16. Calculated development of pore water pressure at points of failure surface: FE analysis

More detailed information on the very limited dissipation of pore water pressures that took place during construction is given in Fig. 16. This shows the calculated evolution of pore water pressures for a few points under the lagoon, under the embankment structure and downstream of the embankment toe. The magnitude of the pore pressure developed is basically controlled by the added weight placed above each of the points considered.

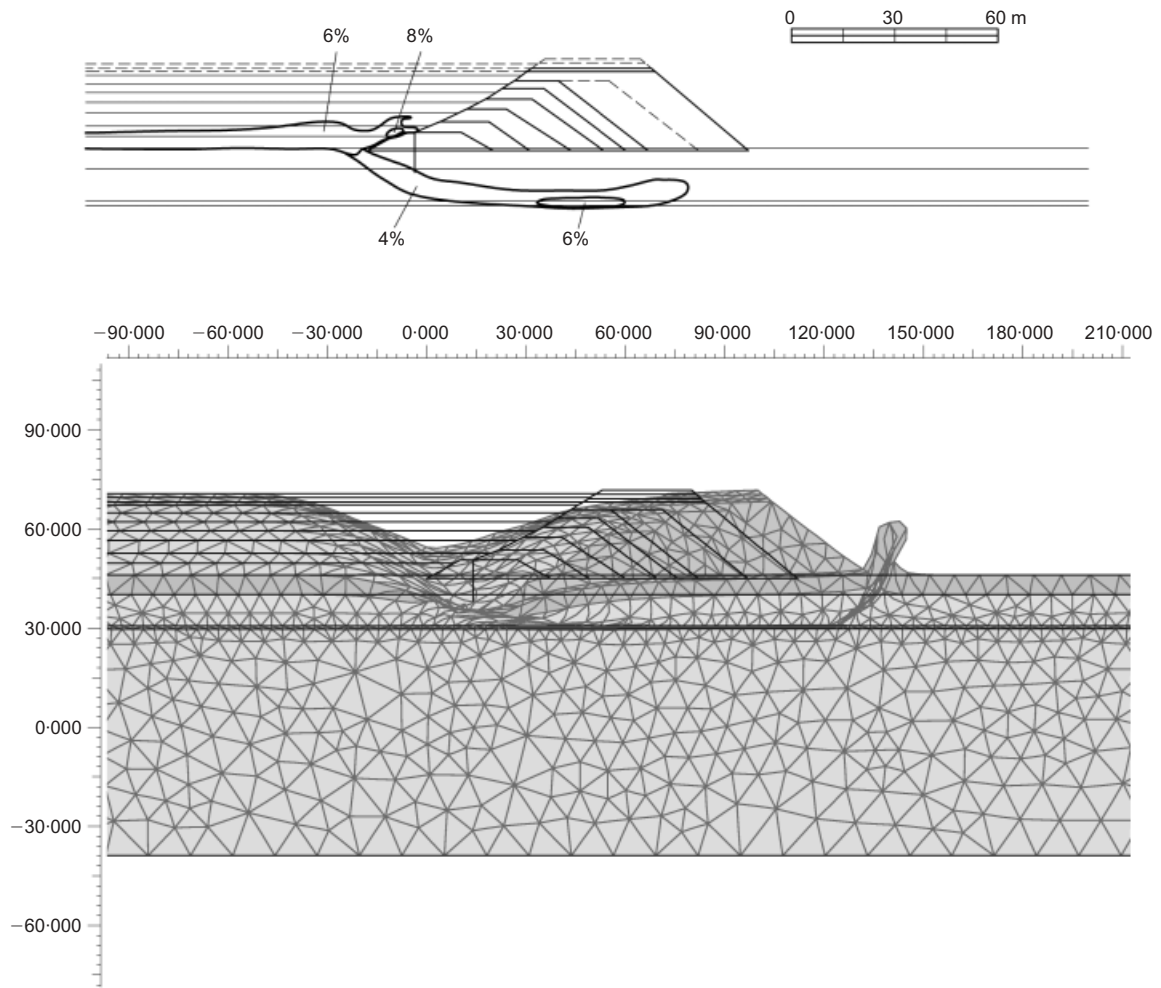
The analysis also confirms that the shear deformations accumulate on the potential failure plane, and they extend as the embankment construction advances (Fig. 17(a)). The rupture mechanism, identified by means of the mesh deformation (Fig. 17(b)), is similar to the actual failure mechanism described in the companion paper (Alonso & Gens, 2006). The failure phase was induced by a final reduction of strength parameters. Fig. 17(b) shows the passive wedge developed at the distal end of the slide, and a classic

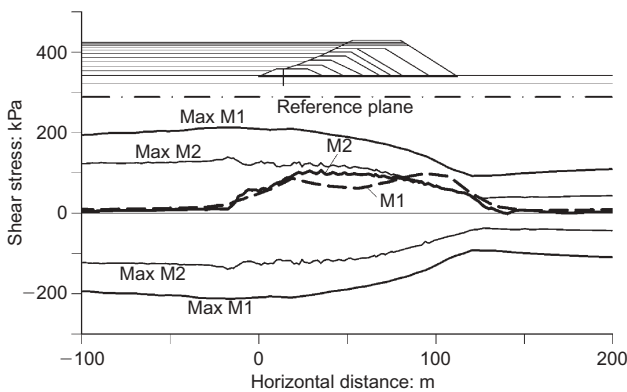
Fig. 18. Distribution of shear stresses along failure plane for two FE analyses performed. Horizontal coordinates start at upstream toe

The computed distributions of shear stresses on the failure plane at the end of the construction period are shown in Fig. 18 for the two cases analysed: M1, uniform strength ($c' = 65$ kPa; $\phi' = 24^\circ$); and M2, the case of a discontinuity with a reduced strength ($c' = 1$ kPa; $\phi' = 21.5^\circ$). The calculated shear stresses' profiles are similar in the two cases. But the real difference is clearly illustrated when the strength limits are considered in the figure. They have been calculated on the basis of the effective normal stresses against the failure plane and the corresponding strength parameters. When homogeneous matrix properties are considered, all the points remain within the strength limits, and failure cannot be explained. When a reduced strength is introduced, the excess shear stress has to be redistributed, increasing the length of the failure surface that lies at or very close to failure.

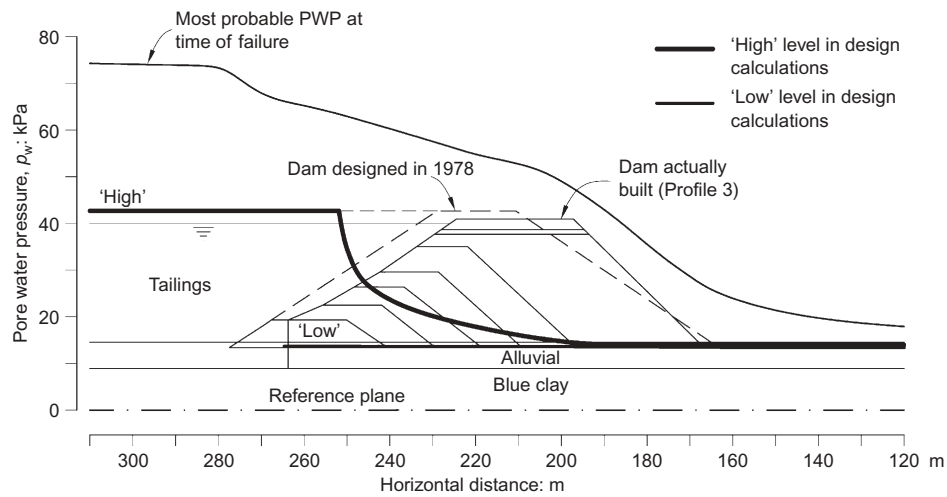
Fig. 22. Phreatic surface used in design calculations and best estimate of pore water pressure existing on sliding plane at time of failure

Pore water pressures were conventionally taken as given by a steady-state flow net, a common practice in dam design. In addition, the water levels measured in open pipes located under the dam in 1996 were taken as an indication of a general phreatic surface located within the surface

granular terrace layer. Limit equilibrium calculations using this phreatic level indicated a safety factor against downstream sliding of 1.40 for the dam configuration existing in 1998 (27 m above ground level). The two phreatic levels used in design calculations are compared in Fig. 22 with the best estimate of water pressures prevailing on the sliding surface at the time of the failure.
