Escola Politécnica Superior  
d'Edificació de Barcelona

REHABILITATION, ENERGETIC AND CHANGE OF MULTIFAMILY BUILDING USE IN FRONT.

Designer: Noelia Robles Olmo  
Director: Manuel Agustino Otero  
Date: October 2010

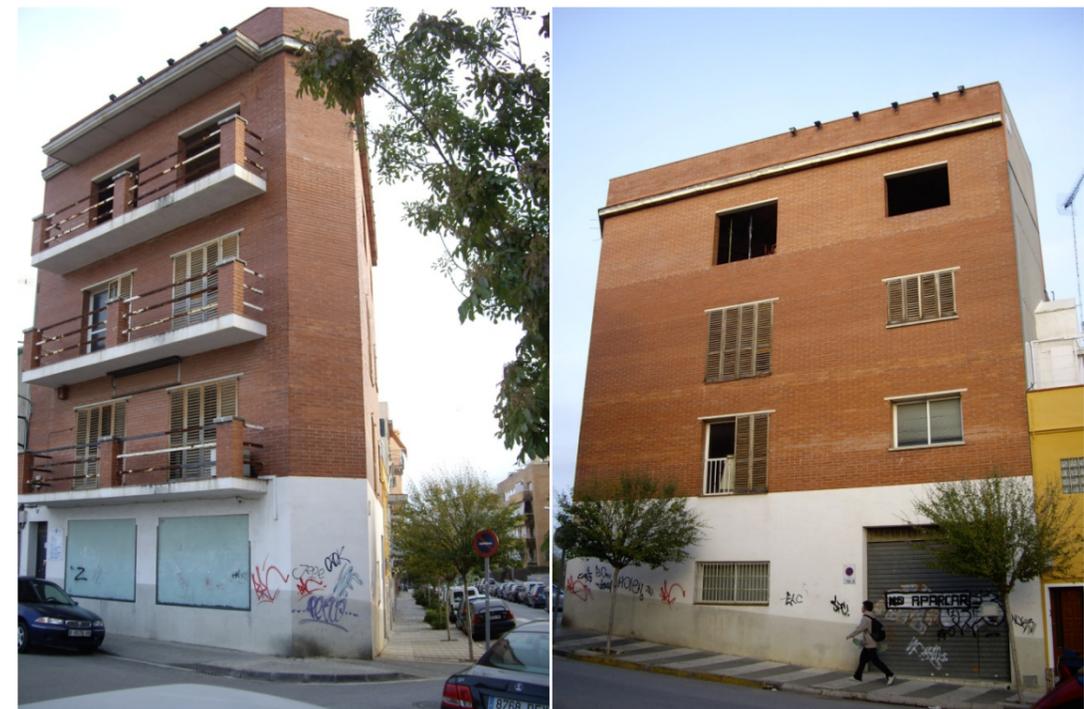
Façade C/ Muntanyà

In an outer way it can be seen that the building is worn away due al pas of the weather and to a lack of maintenance (painting in badly been, oxidation, facilities in disuse, outer carpentry in deficient state...).

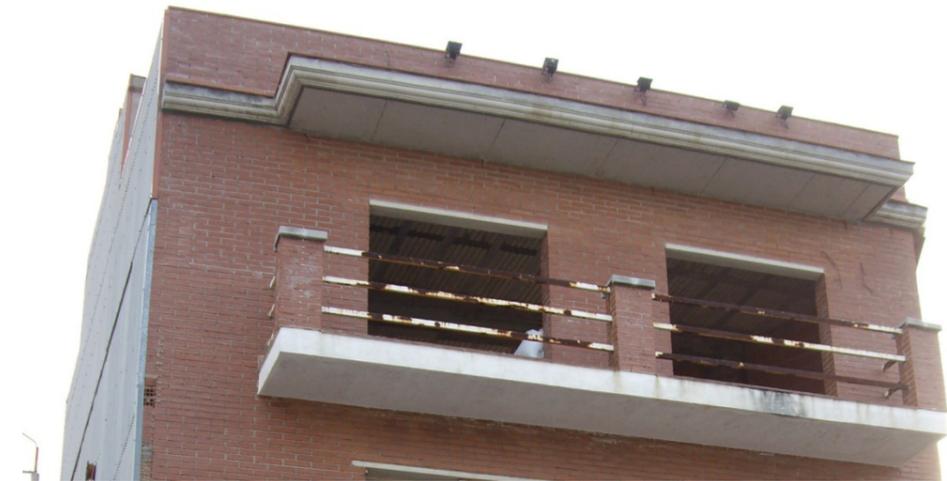
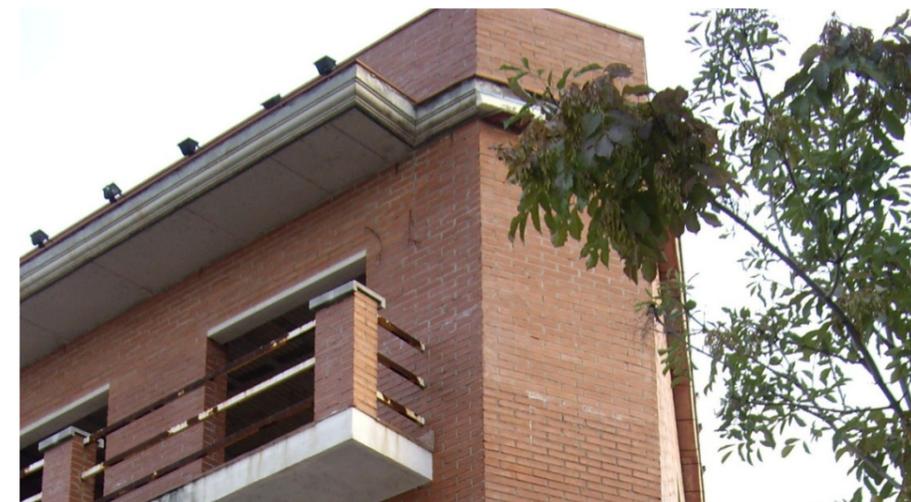
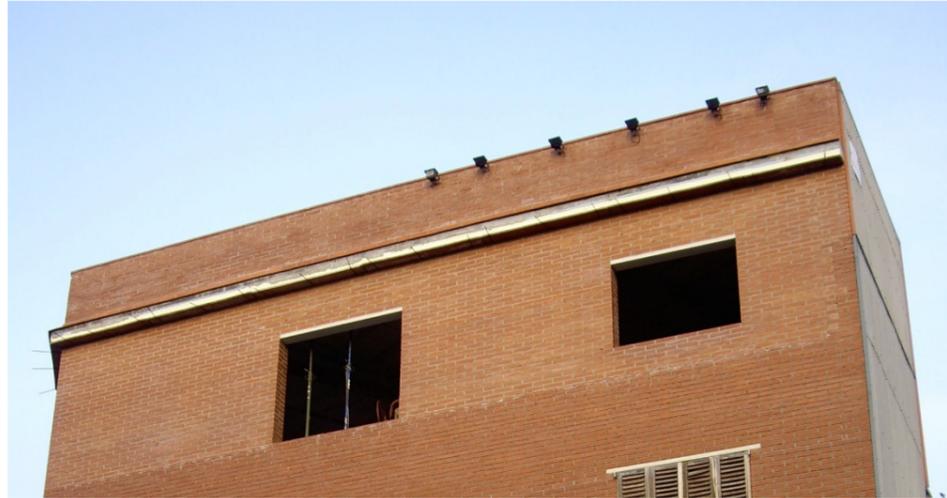
The outer carpentry was not put in that period and the building remained.

It plants Third and Covered floor.
