Damage survey and collapse mechanisms due to seismicity in Gothic Churches around Catalonia region and Mallorca

Master's Thesis

Supervisor(s): Pere Roca Fabregat

Year: 2010

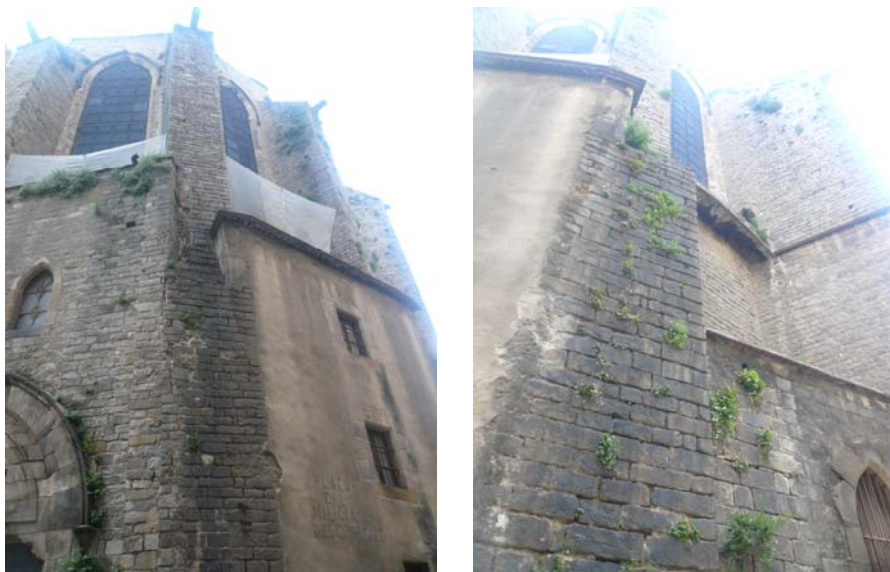
Apart from the structural damage which will be explained later, the building has deterioration due to the different reasons. The main deterioration is the discoloration and black crust that are visible especially on the exterior facades. Lack of maintenance and the previous fires are among the possible reasons of these problems.

Figure 74 – The view of the vegetation and discoloration on the façades

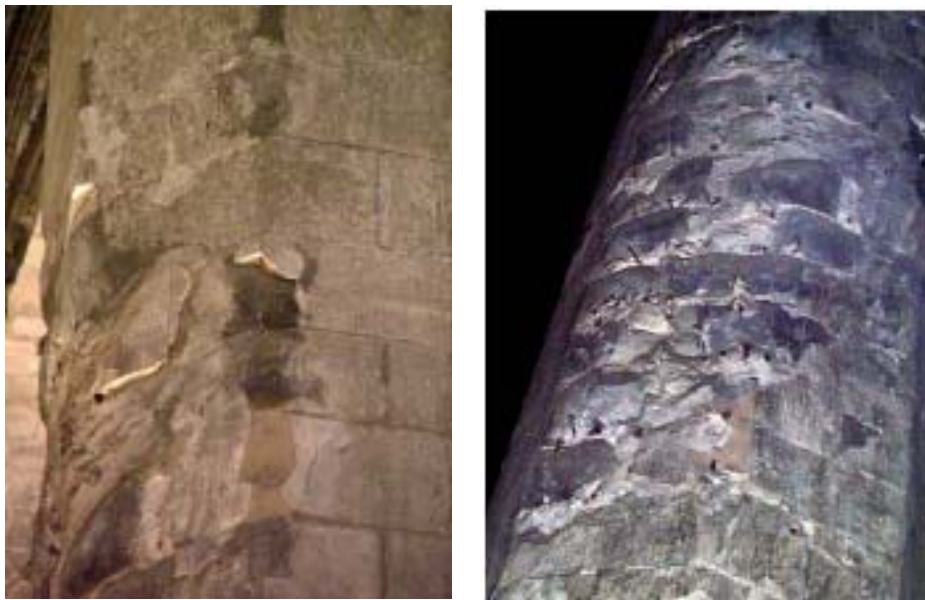
Figure 115 – The visible loss on the cross sections of the masonry piers due to the fires (Caballe, F., Giraldez, P., Gonzales, R., Roca, P. Vendrell, M. 2007)

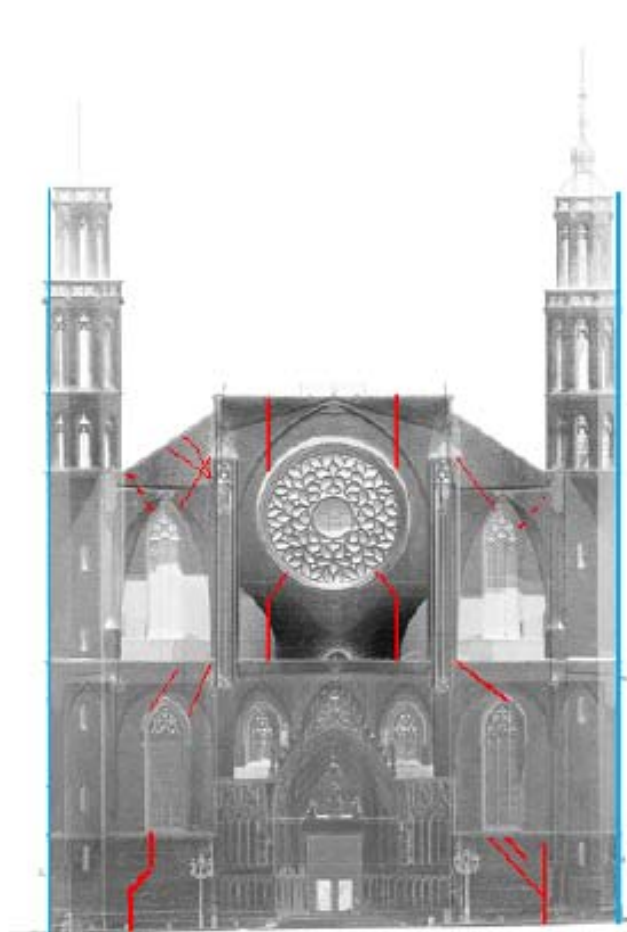
Figure 122 – The crack pattern on the front façade according to the previous studies (Caballe, F., Giraldez, P., Gonzales, R., Roca, P. Vendrell, M. 2007)

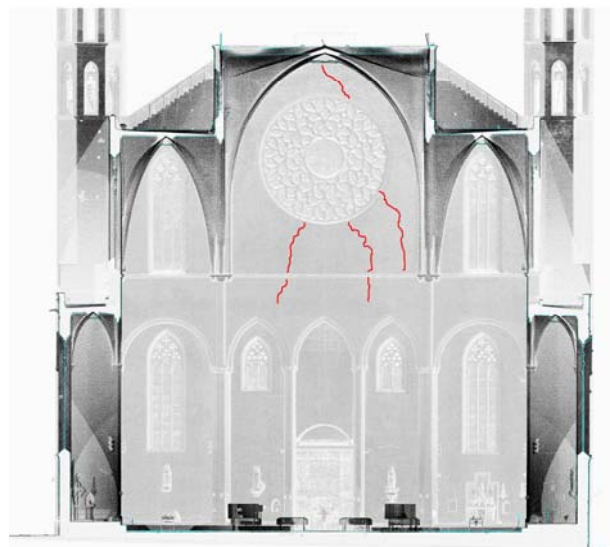
Figure 123– The crack pattern on the interior of the front façade

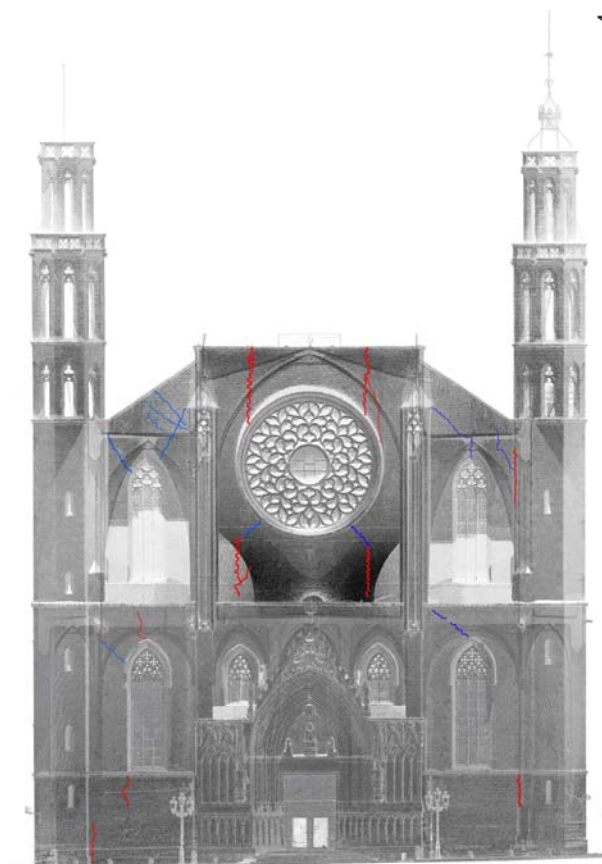
The vertical or inclined cracks which are visible under and above the openings could possibly be due to the earthquake and it can be explained as they made it possible to dissipate the seismic energy by cracking. If the possible reasons of these cracks are likely the earthquake, these cracks indicate that they prevented further damage in structural components in general.

Figure 124 – The crack pattern on the front façade (June 2010)

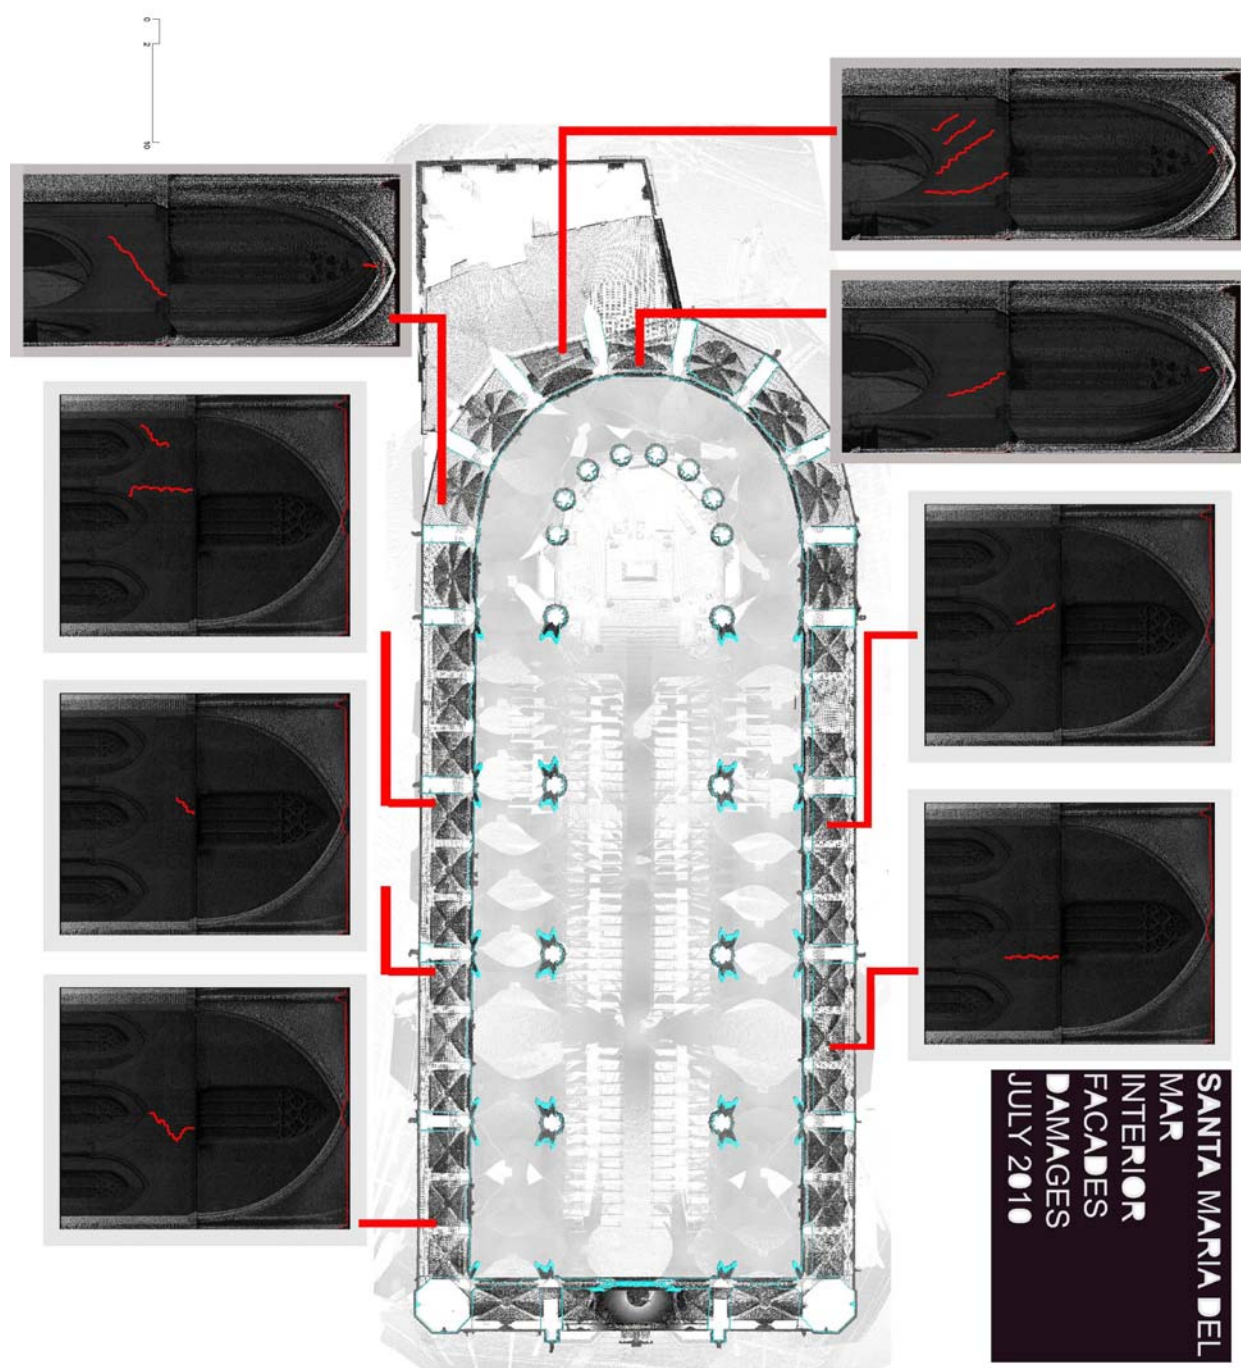
Figure 125 – The crack pattern on the interior façade

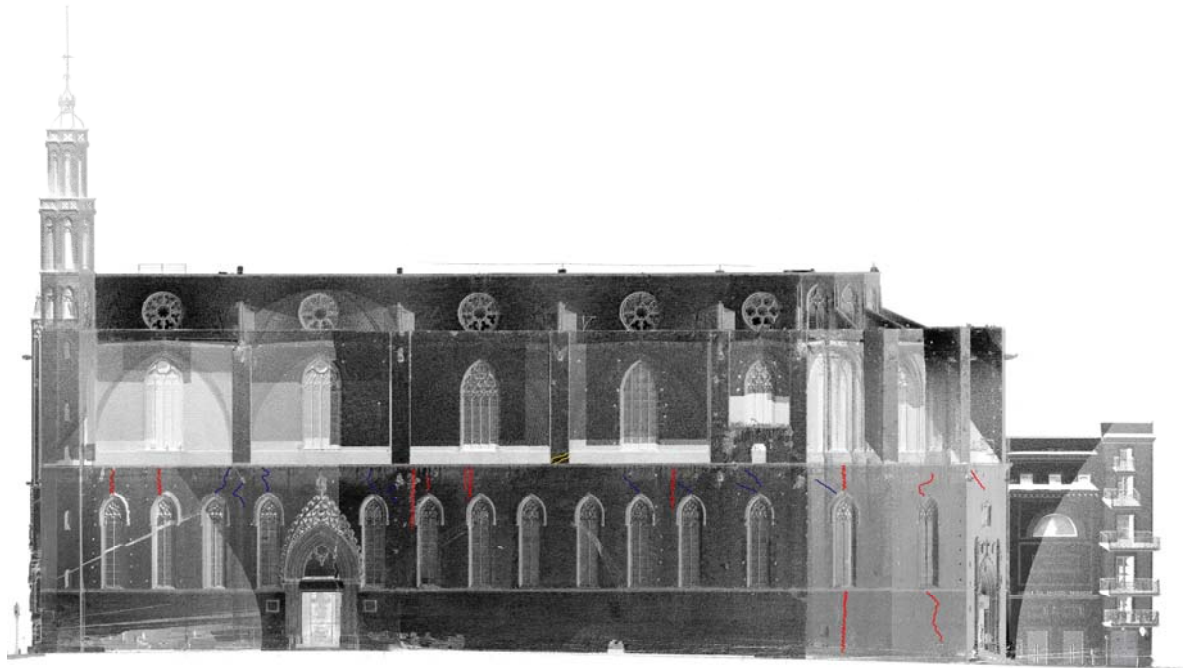
Figure 126 – The damage pattern on west façade

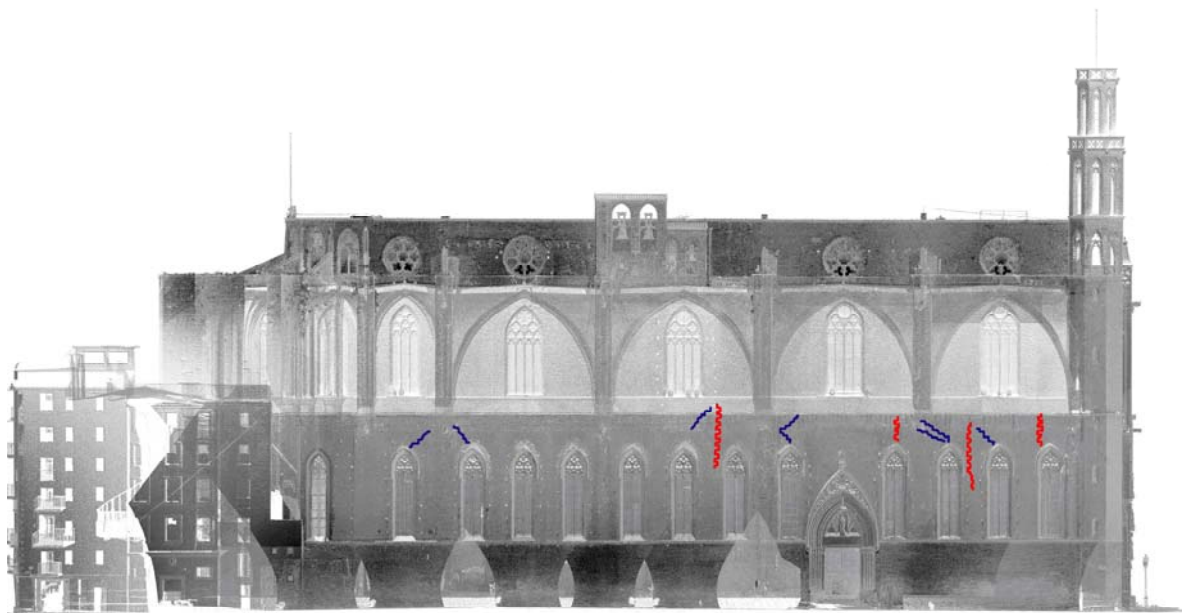
Figure 127 – The damage pattern on east façade

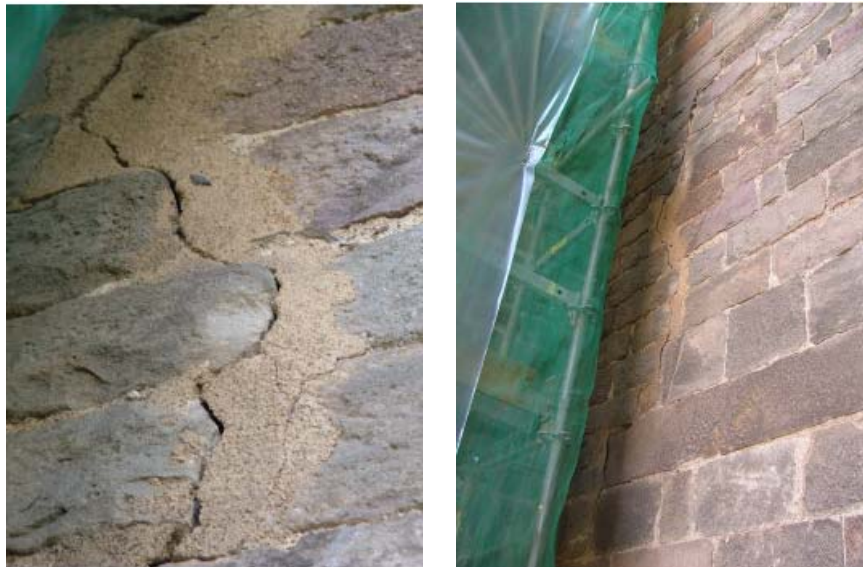
The crack which is located on the connection of the side walls with the main façade is an important damage. The crack is being monitored as a part of the previous studies. This crack is located on the northeast side whereas there is a symmetrical crack which is not as wide as this one on the southwest facade. These cracks are possibly due to the tendency of the separation between the facade and the side walls. The possible reason for these cracks can be seismic actions. The cracks have been repaired in the previous restoration works and after monitoring, the studies showed that these cracks are stable.

Figure 128 – View of the extending crack on the lateral wall connected to the main façade (Caballe, F., Giraldez, P., Gonzales, R., Roca, P. Vendrell, M. 2007)

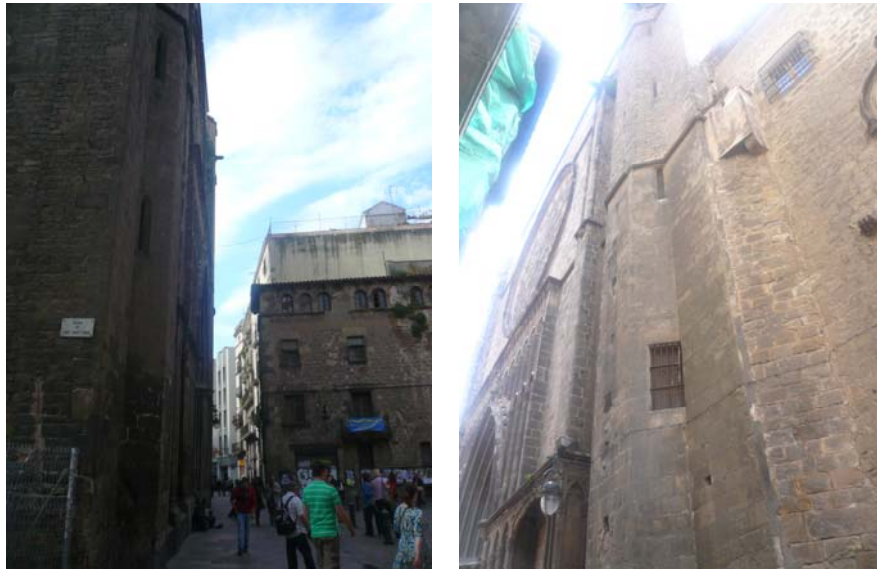
There is out of plane movement of the side towers. The previous studies were able to define the total displacement of the two towers. The west tower shows a more significant leaning with up to 12 to 15 cm while the measurement of the leaning on the east tower shows up to 2 to 5 cm. This difference is actually can clearly be seen by visual inspection. The tower shows a ratio of 1/100 leaning when it is compared to the height which is an acceptable amount when considering the age of the structure. The studies that showed that the main facade shows a leaning up to 30 cm on the east and 16 cm on the west part (Caballe, F., Giraldez, P., Gonzales, R., Roca, P. Vendrell, M. 2007).

Figure 129 – The leaning of the front façade

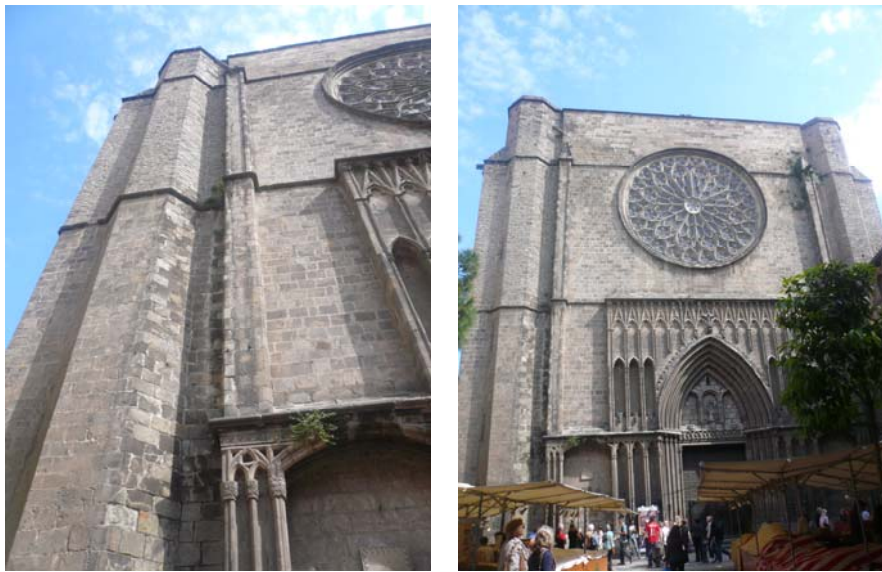
Figure 132 – The extending crack on the main façade

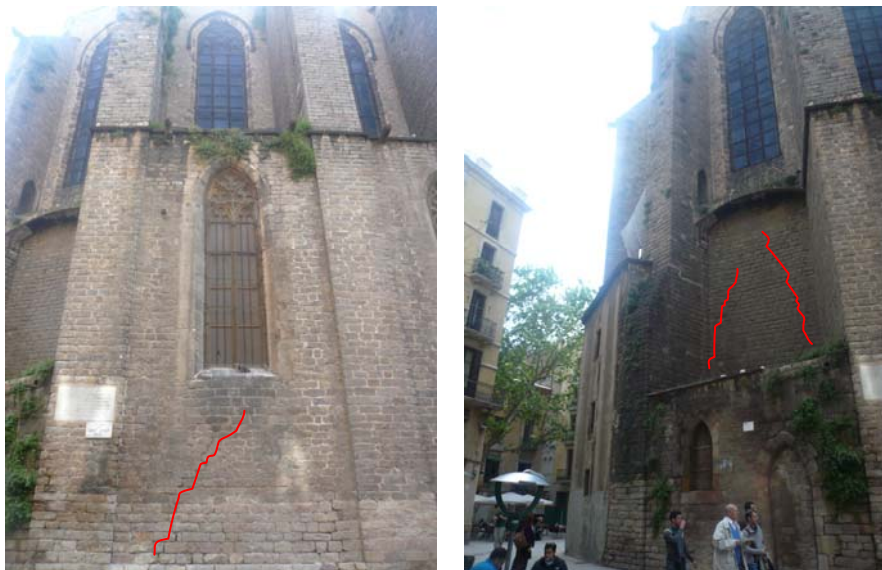
There are two inclined cracks on the perimeter wall of the apse part. These two cracks show behaviour almost symmetrical to each other. This type of cracks especially when they are X shaped can be an indicative of a shear failure due to the seismic actions. But still these cracks can be the result of a differential settlement or these cracks can be interpreted as relieving arches.

Figure 133 – Inclined cracks on the apse wall

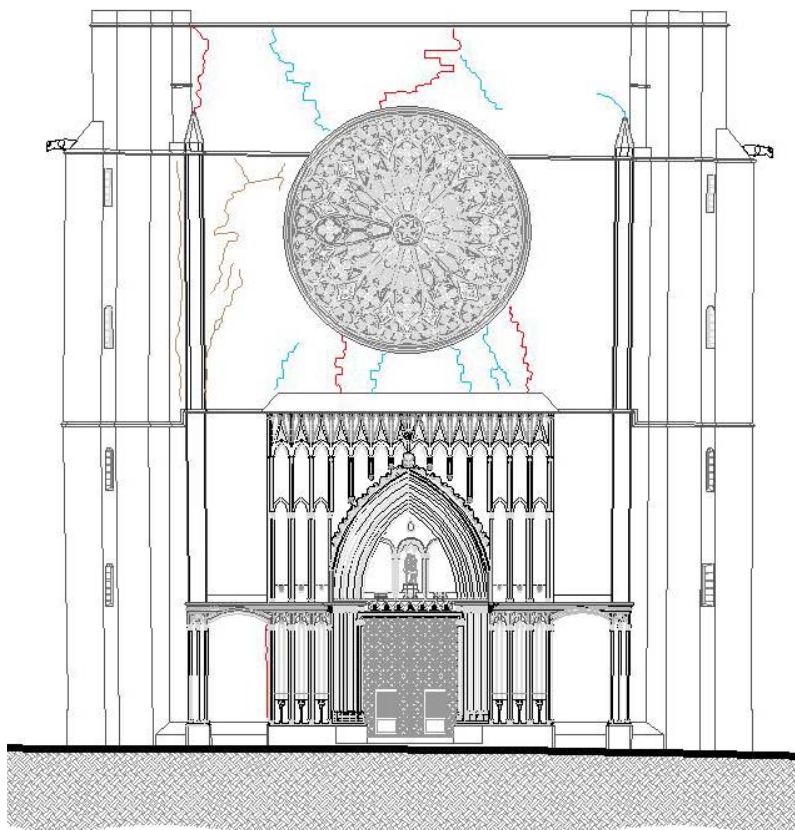
Figure 135 – The damage of the front façade of Santa Maria Del Pi

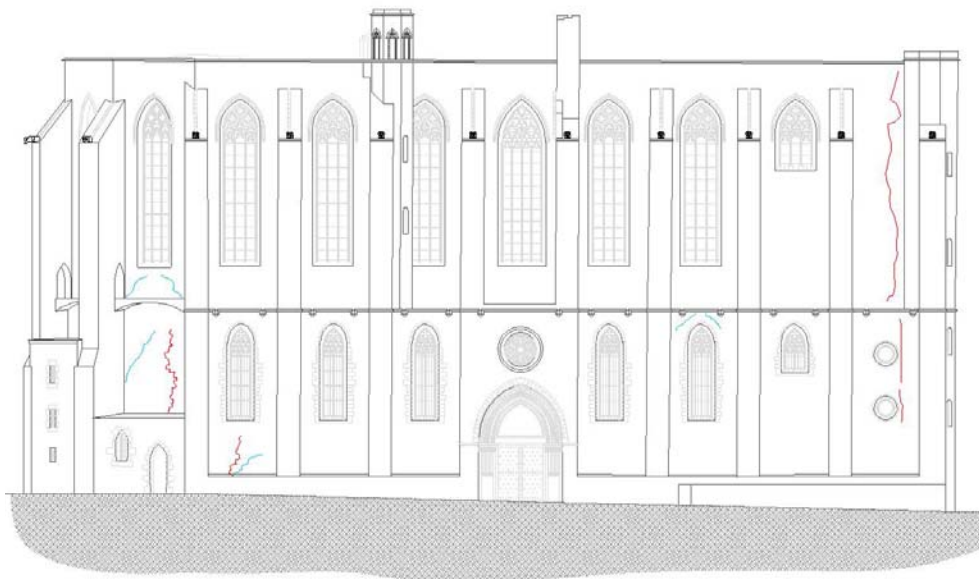
Figure 136 – The damage pattern of the side façade of Santa Maria Del Pi

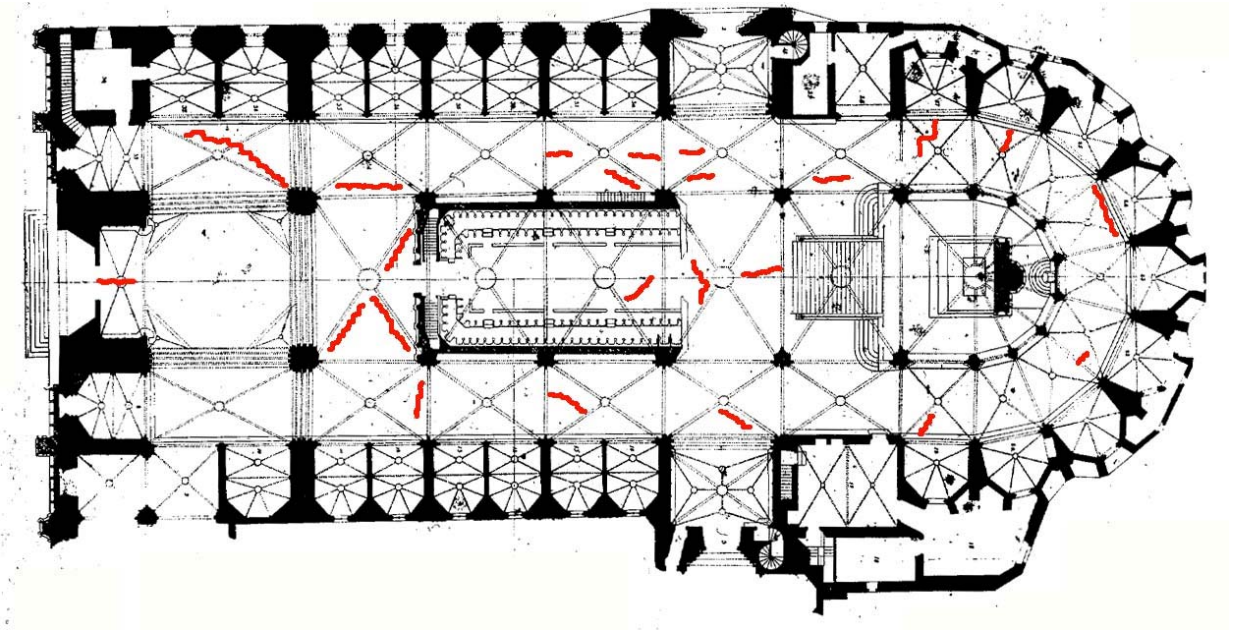
The separation on the joints is the main structural problems on the interior surfaces. This occurrence doesn't affect the vertical components and they are mainly concentrated on the cross vaults and the arches. The lateral chapels seem not to be influenced by any visible structural damage. The horizontal bearing elements constituting the superstructure of the main nave and the lateral nave on the left of the entrance have problems like the separation of the joints as mentioned. These problems are mainly concentrated around where the cimborio is located. The possible reason for this type of damage can be the different behaviour between the two parts where the high amount of load due to the cimborio exists and where it doesn't.

Figure 137 – Crack pattern on the vaults of the cathedral

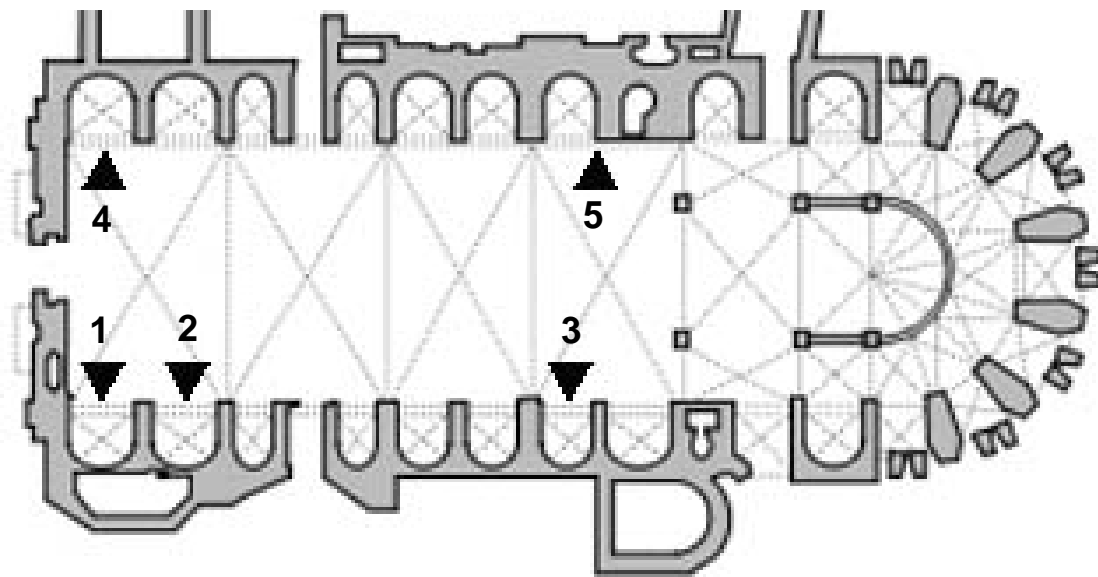
Figure 138 – The plan view showing the places of the damage

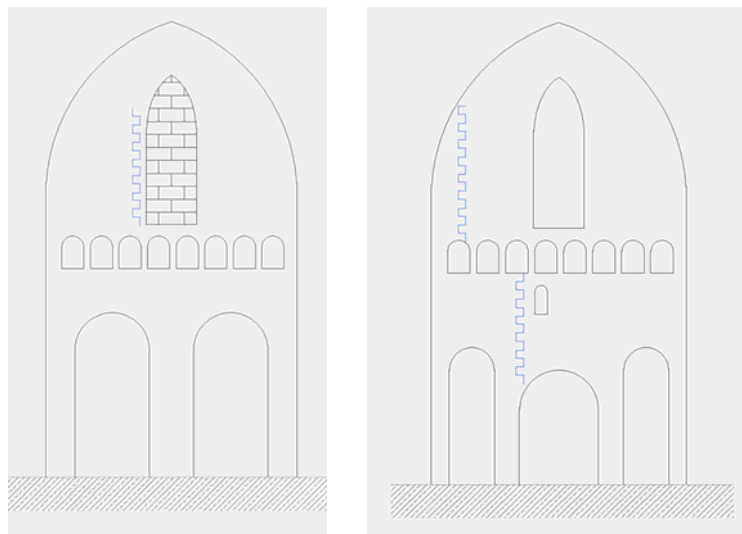
Figure 139 – The interior decays of number 1 and 2 regarding the Fig. 104

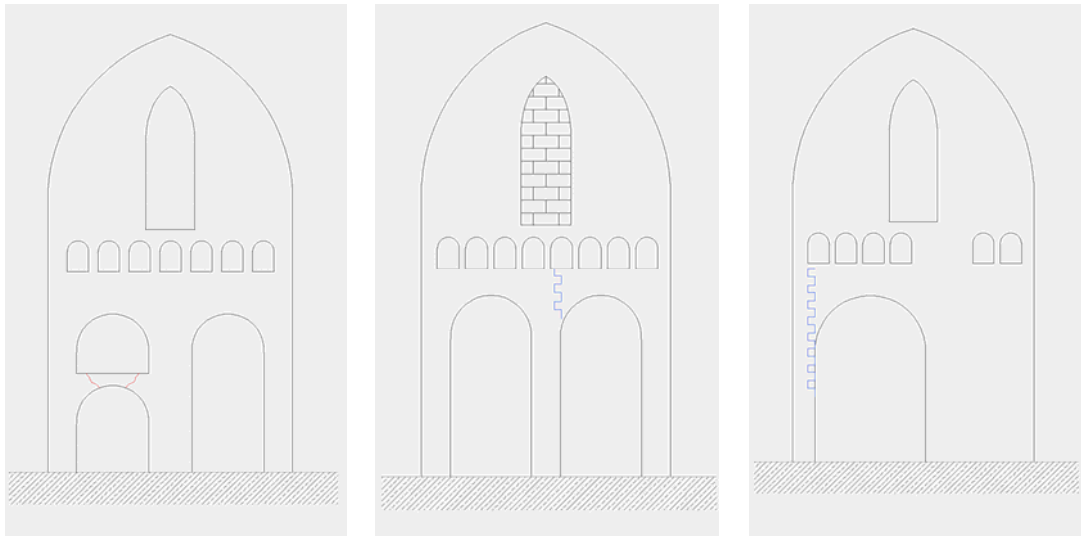
Figure 140– The interior decays of number 3, 4 and 5 regarding the Fig. 104

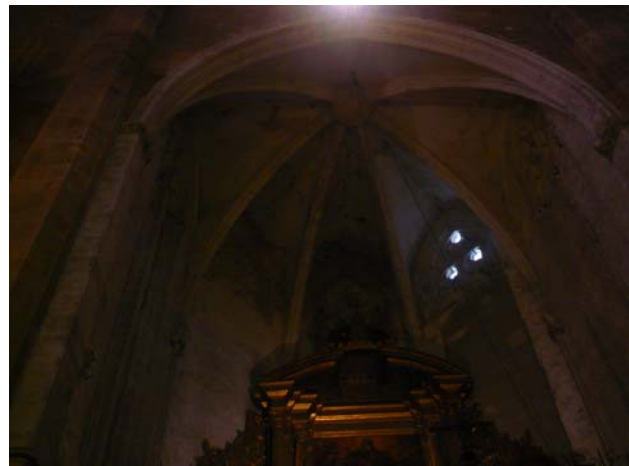
Figure 147 – The cracks on the plastered chapel

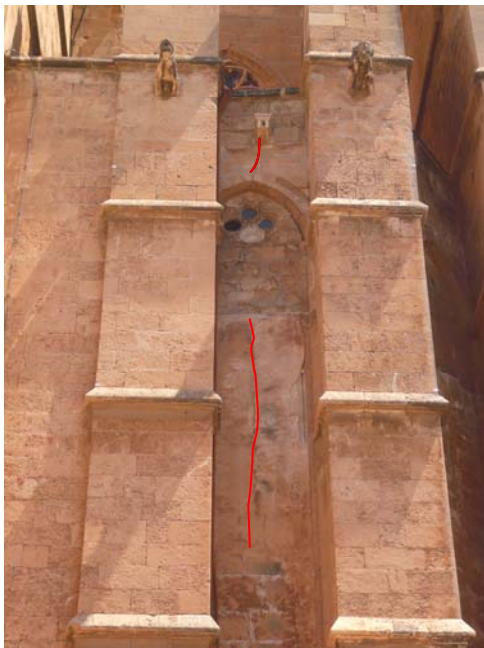
Figure 148 – The vertical crack between the buttresses

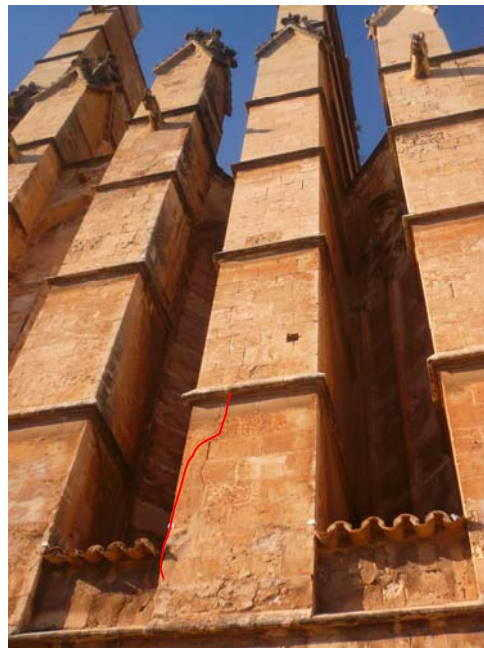
Figure 149 – Extending crack on the buttress

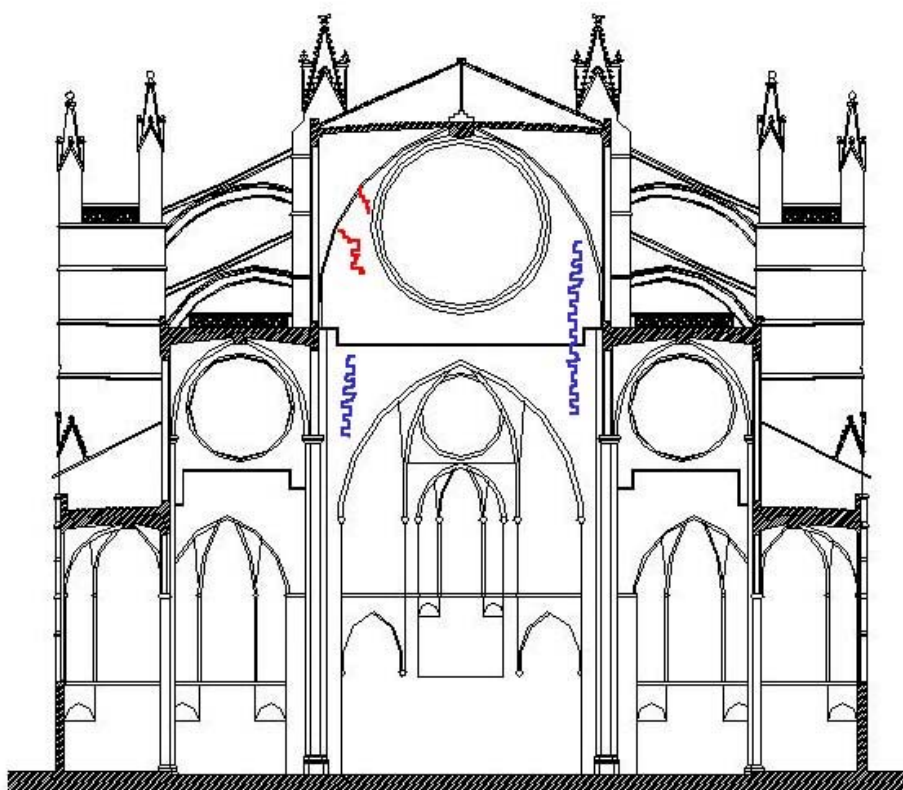
Figure 151 – The damage pattern on the interior of the apse part

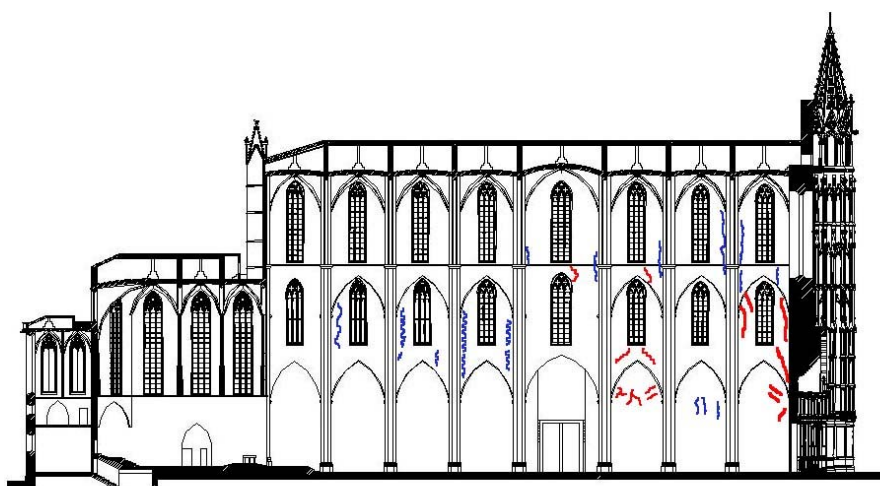
Figure 152 – The damage pattern on interior surface showing the right side of the entrance

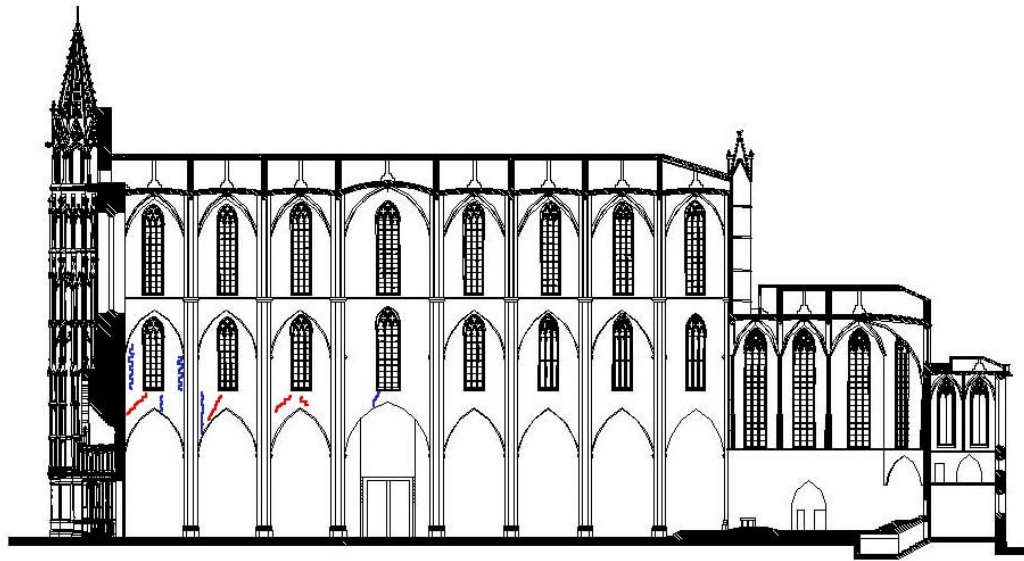
Figure 153 – The damage pattern on interior surface showing the left side of the entrance

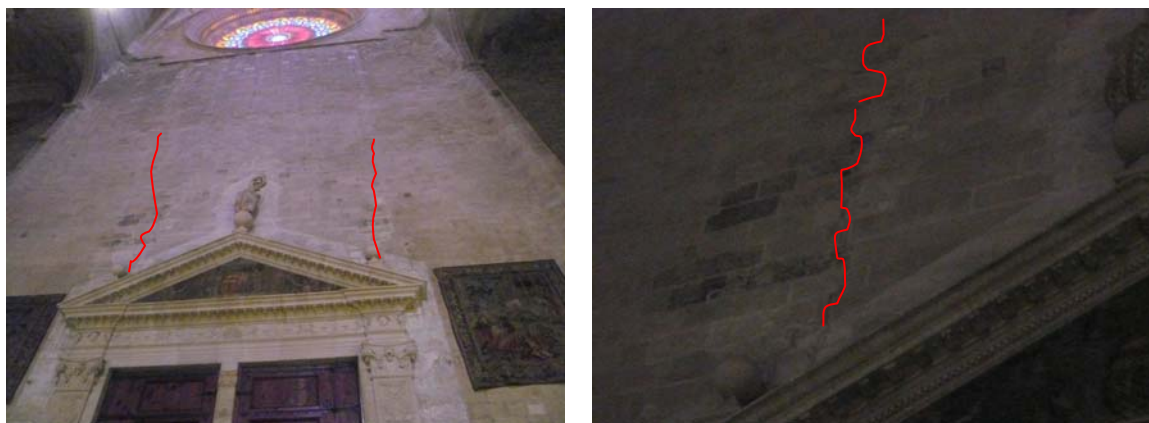
Figure 154 – Extending decay on the entrance following the joints

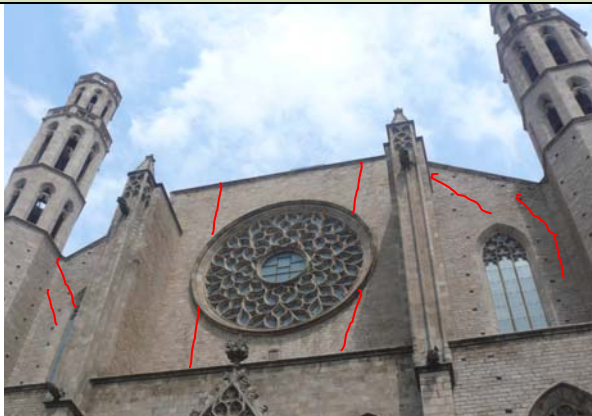
Figure 157 – The picture of the damage on the front façade

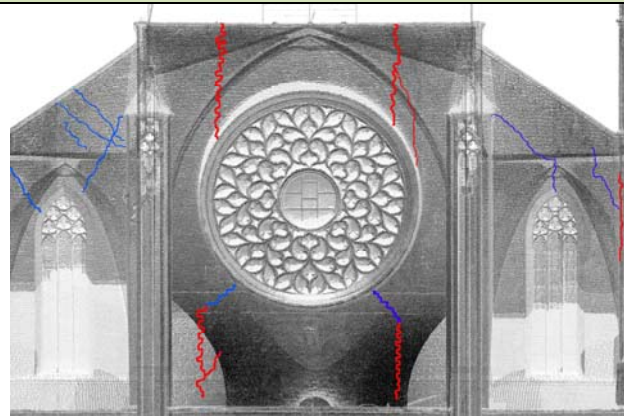
Figure 158 – The crack pattern on the front façade

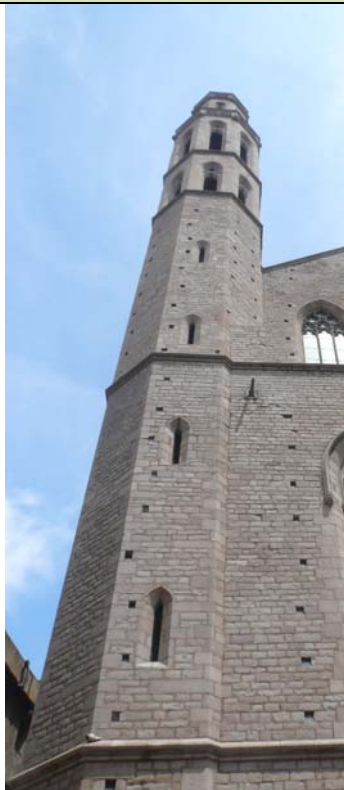
Figure 168 – Photo of the damaged part on the front façade

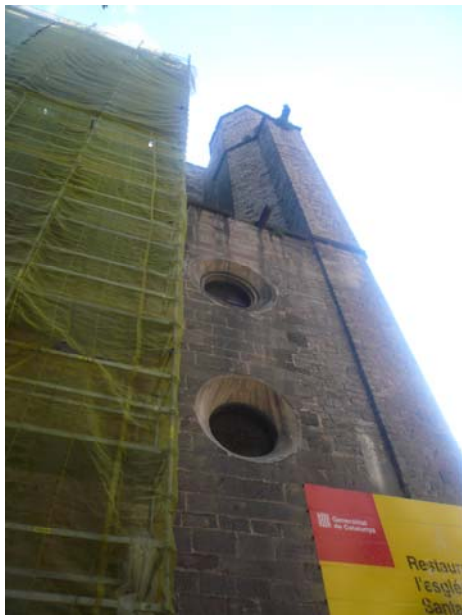
Figure 177 – The view of the damaged part of the side façade

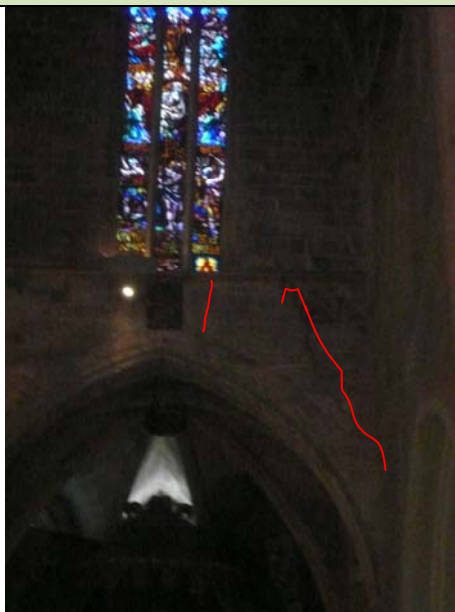
Figure 189 – The photo of the damage on the interior of the cathedral

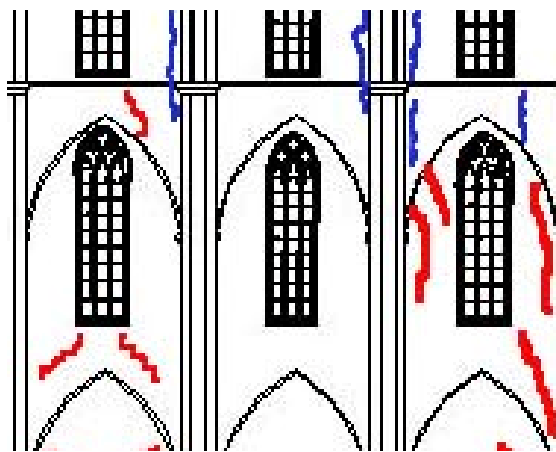
Figure 190 – The damage pattern of the crack on the interior of the cathedral
