12 voids

Twelve spaces of opportunity have been detected inside the factory complex with a strong inherited potential to nest a postindustrial activity.

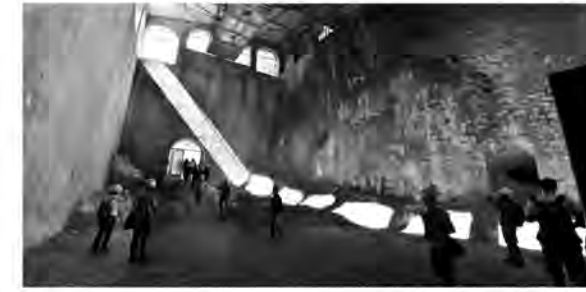
bay code	01
precedent function	clinker storage
area (m2)	365
relative enclosed coverage (%)	19
relative site coverage (%)	5
aspect ratio (1)	0.4
volume (m3)	5399
width (m)	23.9
length (m)	12.2
height (min)	14.8
base elevation (m)	6.6
roof elevation (m)	21.4
relative elevation (%)	29
floor material	original terrain
wall surface (m)	1246.16
wall max thickness (m)	1.9
wall min thickness (m)	0.65
wall material	limestone
opening count (n)	24
opening surface (m2)	8.3
opening surface total (m2)	199.2
void/solid ratio (%)	16
access points (n)	2
truss span (m)	12.2
truss count (n)	11
truss max depth (m)	1.6
truss material	cast iron
roof geometry	sloped vaults
roof layering	ceramic triple layer vaulted
roof condition	good

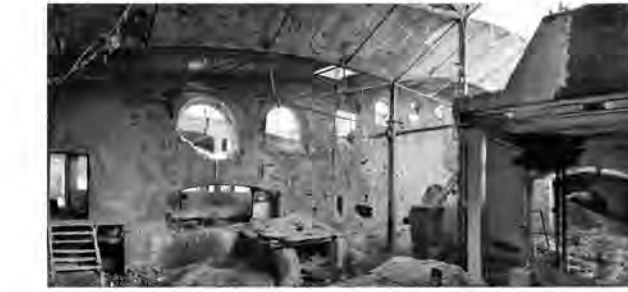
bay code	02
precedent function	refining mills
area (m2)	250
relative enclosed coverage (%)	14
relative site coverage (%)	4
aspect ratio (1)	0.5
volume (m3)	1996
width (m)	21.7
length (m)	11.5
height (min)	8
base elevation (m)	10.6
roof elevation (m)	18.6
relative elevation (%)	46
floor material	original terrain
wall surface (m)	1009
wall max thickness (m)	0.86
wall min thickness (m)	0.44
wall material	limestone
opening count (n)	12
opening surface (m2)	4.8
opening surface total (m2)	49.9
void/solid ratio (%)	5
access points (n)	4
truss span (m)	12.2
truss count (n)	3
truss max depth (m)	2.6
truss material	cast iron
roof geometry	double curved sloped
roof layering	ceramic triple layer vaulted
roof condition	small repair

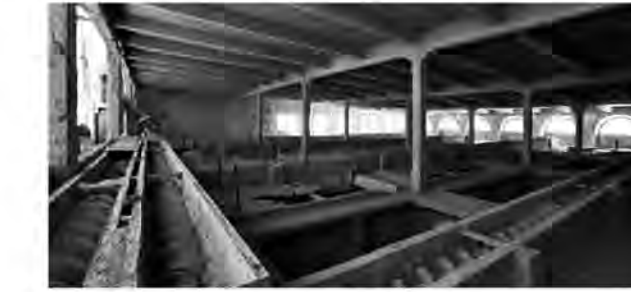
bay code	03
precedent function	cement silos
area (m2)	514
relative enclosed coverage (%)	27
relative site coverage (%)	7
aspect ratio (1)	1.1
volume (m3)	8023
width (m)	21.7
length (m)	23.7
height (min)	15.6
base elevation (m)	0
roof elevation (m)	15.6
relative elevation (%)	0
floor material	original terrain
wall surface (m)	1416.48
wall max thickness (m)	2.3
wall min thickness (m)	0.86
wall material	limestone
opening count (n)	14
opening surface (m2)	3.7
opening surface total (m2)	51.8
void/solid ratio (%)	4
access points (n)	5
truss span (m)	5.7
truss count (n)	5
truss max depth (m)	0.8
truss material	reinforced concrete
roof geometry	flat
roof layering	ceramic triple layer vaulted
roof condition	good

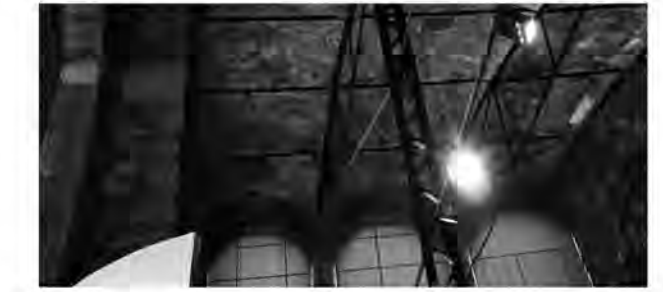
bay code	04
precedent function	sacking plant
area (m2)	196
relative enclosed coverage (%)	11
relative site coverage (%)	3
aspect ratio (1)	0.4
volume (m3)	1728
width (m)	21.7
length (m)	9.05
height (min)	8.8
base elevation (m)	0
roof elevation (m)	8.8
relative elevation (%)	0
floor material	original terrain
wall surface (m)	541.2
wall max thickness (m)	0.86
wall min thickness (m)	0.6
wall material	limestone
opening count (n)	3
opening surface (m2)	20
opening surface total (m2)	69
void/solid ratio (%)	11
access points (n)	2
truss span (m)	12.2
truss count (n)	5
truss max depth (m)	2.6
truss material	cast iron
roof geometry	sloped vaults
roof layering	ceramic triple layer vaulted
roof condition	good

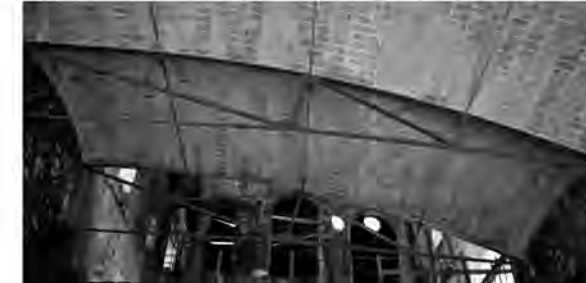
bay code	05
precedent function	coal storage
area (m2)	174
relative enclosed coverage (%)	9
relative site coverage (%)	2
aspect ratio (1)	1.7
volume (m3)	521
width (m)	10.1
length (m)	17.2
height (min)	3
base elevation (m)	23
roof elevation (m)	26
relative elevation (%)	100
floor material	original terrain
wall surface (m)	163.6
wall max thickness (m)	0.86
wall min thickness (m)	0.6
wall material	limestone
opening count (n)	3
opening surface (m2)	6.1
opening surface total (m2)	18.22
void/solid ratio (%)	11
access points (n)	2
truss span (m)	10.1
truss count (n)	7
truss max depth (m)	1.6
truss material	cast iron
roof geometry	double curved sloped
roof layering	ceramic triple layer vaulted
roof condition	good

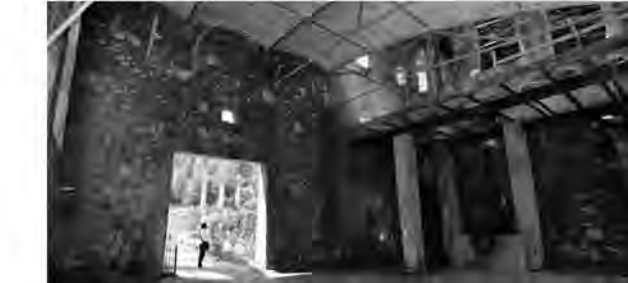
bay code	06
precedent function	coal storage
area (m2)	149
relative enclosed coverage (%)	8
relative site coverage (%)	2
aspect ratio (1)	1.5
volume (m3)	447
width (m)	10.1
length (m)	14.75
height (min)	3
base elevation (m)	18.5
roof elevation (m)	21.5
relative elevation (%)	80
floor material	original terrain
wall surface (m)	149.1
wall max thickness (m)	0.86
wall min thickness (m)	0.6
wall material	limestone
opening count (n)	3
opening surface (m2)	8.5
opening surface total (m2)	25.55
void/solid ratio (%)	17
access points (n)	2
truss span (m)	10.1
truss count (n)	6
truss max depth (m)	1.6
truss material	cast iron
roof geometry	double curved sloped
roof layering	ceramic triple layer vaulted
roof condition	good

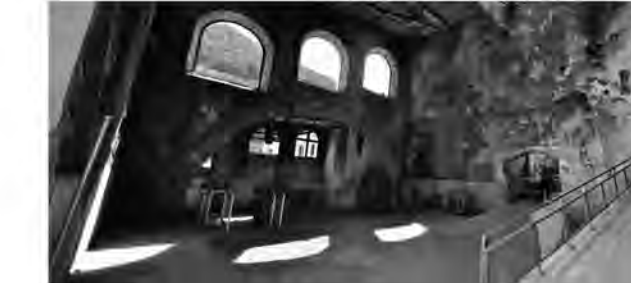
bay code	07
precedent function	cylinder mill
area (m2)	118
relative enclosed coverage (%)	6
relative site coverage (%)	2
aspect ratio (1)	1.2
volume (m3)	355
width (m)	10.1
length (m)	11.72
height (min)	3
base elevation (m)	10.24
roof elevation (m)	13.24
relative elevation (%)	45
floor material	original terrain
wall surface (m)	130.92
wall max thickness (m)	0.86
wall min thickness (m)	0.6
wall material	limestone
opening count (n)	3
opening surface (m2)	3.9
opening surface total (m2)	11.57
void/solid ratio (%)	9
access points (n)	4
truss span (m)	10.1
truss count (n)	5
truss max depth (m)	1.6
truss material	cast iron
roof geometry	double curved sloped
roof layering	ceramic triple layer vaulted
roof condition	good

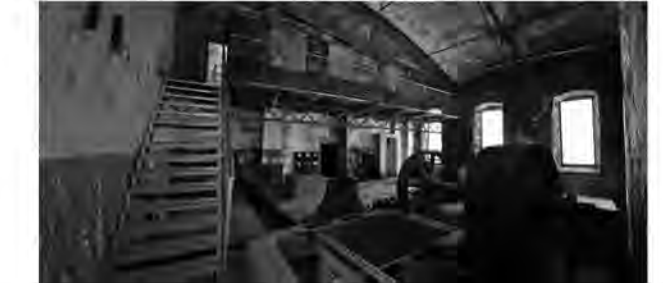
bay code	08
precedent function	drying rotating cylinder
area (m2)	88
relative enclosed coverage (%)	5
relative site coverage (%)	1
aspect ratio (1)	0.9
volume (m3)	285
width (m)	10.1
length (m)	8.73
height (min)	3
base elevation (m)	9.04
roof elevation (m)	12.04
relative elevation (%)	59
floor material	original terrain
wall surface (m)	112.98
wall max thickness (m)	0.86
wall min thickness (m)	0.6
wall material	limestone
opening count (n)	3
opening surface (m2)	4.2
opening surface total (m2)	12.7
void/solid ratio (%)	11
access points (n)	2
truss span (m)	10.1
truss count (n)	4
truss max depth (m)	1.6
truss material	cast iron
roof geometry	double curved sloped
roof layering	ceramic triple layer vaulted
roof condition	good

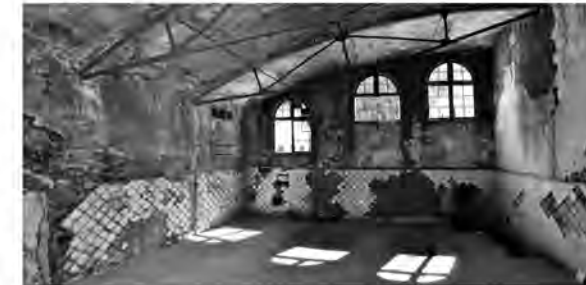
bay code	09
precedent function	refining ball mill
area (m2)	94
relative enclosed coverage (%)	5
relative site coverage (%)	1
aspect ratio (1)	0.9
volume (m3)	282
width (m)	10.1
length (m)	9.3
height (min)	3
base elevation (m)	5.42
roof elevation (m)	8.42
relative elevation (%)	24
floor material	original terrain
wall surface (m)	116.4
wall max thickness (m)	0.86
wall min thickness (m)	0.6
wall material	limestone
opening count (n)	0
opening surface (m2)	0
opening surface total (m2)	0
void/solid ratio (%)	0
access points (n)	2
truss span (m)	10.1
truss count (n)	4
truss max depth (m)	1.6
truss material	cast iron
roof geometry	double curved sloped
roof layering	ceramic triple layer vaulted
roof condition	good

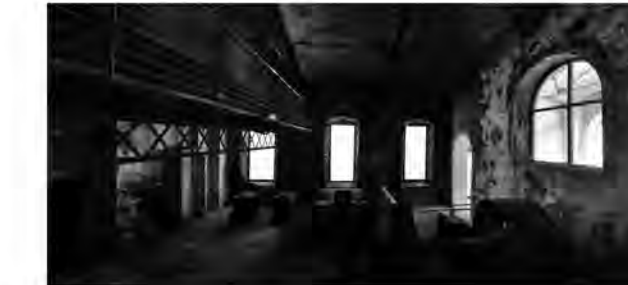
bay code	10
precedent function	dc dynamo generator
area (m2)	61
relative enclosed coverage (%)	3
relative site coverage (%)	1
aspect ratio (1)	0.6
volume (m3)	184
width (m)	10.1
length (m)	6.08
height (min)	3
base elevation (m)	5.42
roof elevation (m)	8.42
relative elevation (%)	24
floor material	original terrain
wall surface (m)	97.08
wall max thickness (m)	0.86
wall min thickness (m)	0.6
wall material	limestone
opening count (n)	3
opening surface (m2)	6.1
opening surface total (m2)	18.22
void/solid ratio (%)	19
access points (n)	2
truss span (m)	10.1
truss count (n)	3
truss max depth (m)	1.6
truss material	cast iron
roof geometry	double curved sloped
roof layering	ceramic triple layer vaulted
roof condition	good

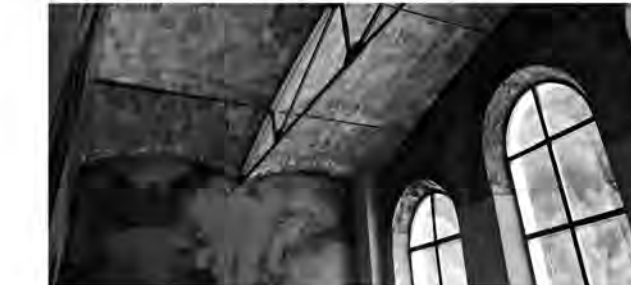
bay code	11
precedent function	sacking plant
area (m2)	96
relative enclosed coverage (%)	5
relative site coverage (%)	1
aspect ratio (1)	0.9
volume (m3)	287
width (m)	10.1
length (m)	9.47
height (min)	3
base elevation (m)	0
roof elevation (m)	3
relative elevation (%)	0
floor material	original terrain
wall surface (m)	117.42
wall max thickness (m)	0.86
wall min thickness (m)	0.6
wall material	limestone
opening count (n)	1
opening surface (m2)	6.74
opening surface total (m2)	6.74
void/solid ratio (%)	6
access points (n)	2
truss span (m)	10.1
truss count (n)	4
truss max depth (m)	1.6
truss material	cast iron
roof geometry	double curved sloped
roof layering	ceramic triple layer vaulted
roof condition	good

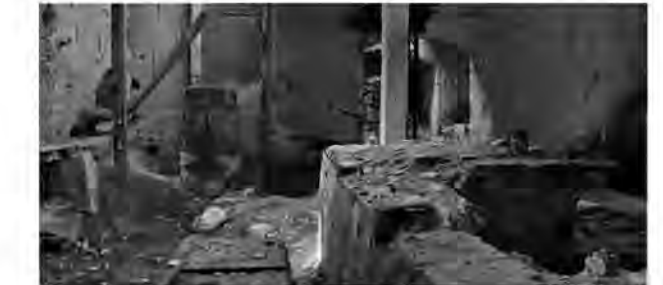
bay code	12
precedent function	rotating ovens
area (m2)	96
relative enclosed coverage (%)	5
relative site coverage (%)	1
aspect ratio (1)	0.9
volume (m3)	287
width (m)	10.1
length (m)	9.47
height (min)	3
base elevation (m)	0
roof elevation (m)	3
relative elevation (%)	0
floor material	original terrain
wall surface (m)	117.42
wall max thickness (m)	0.86
wall min thickness (m)	0.6
wall material	limestone
opening count (n)	1
opening surface (m2)	6.74
opening surface total (m2)	6.74
void/solid ratio (%)	6
access points (n)	2
truss span (m)	10.1
truss count (n)	4
truss max depth (m)	1.6
truss material	cast iron
roof geometry	double curved sloped
roof layering	ceramic triple layer vaulted
roof condition	good
