## Chapter 4

### ROAD SAFETY REVIEW: IMPLEMENTATION

The road safety review process was applied to six roadways in the Town of Natick, Massachusetts. The selected roadways included:

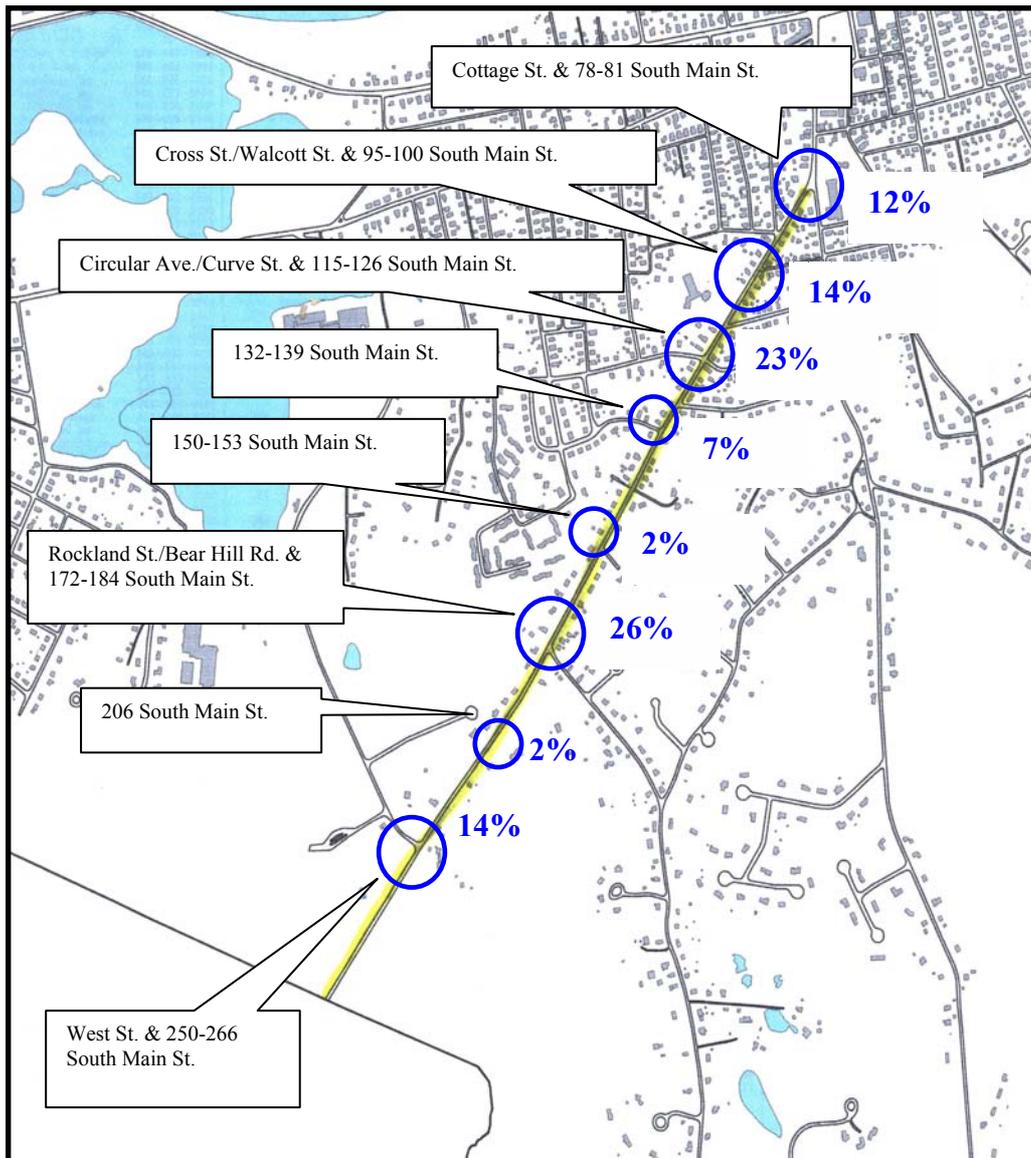
FIGURE 4-4 Crash Data by Location on South Main Street.

intersection of Rockland Street and South Main Street, where 26 percent of analyzed crashes occurred. However, no personal injuries were reported at this spot. This intersection is situated at the top of a hill, which limits visibility. The second crash trend spot was found at the intersection with Circular Avenue and Curve Street, presenting 23 percent of all reported crashes and 45 percent of personal injuries that occurred during the five years studied.

The intersection with West Street on the south side, the intersection with Cottage Street on the north side, and the segment of South Main Street corresponding to numbers 95-100 showed minor proportion of crashes (14, 12, and 14 percent respectively), but a significant proportion of personal injuries. Figure 4-4 illustrates the results.

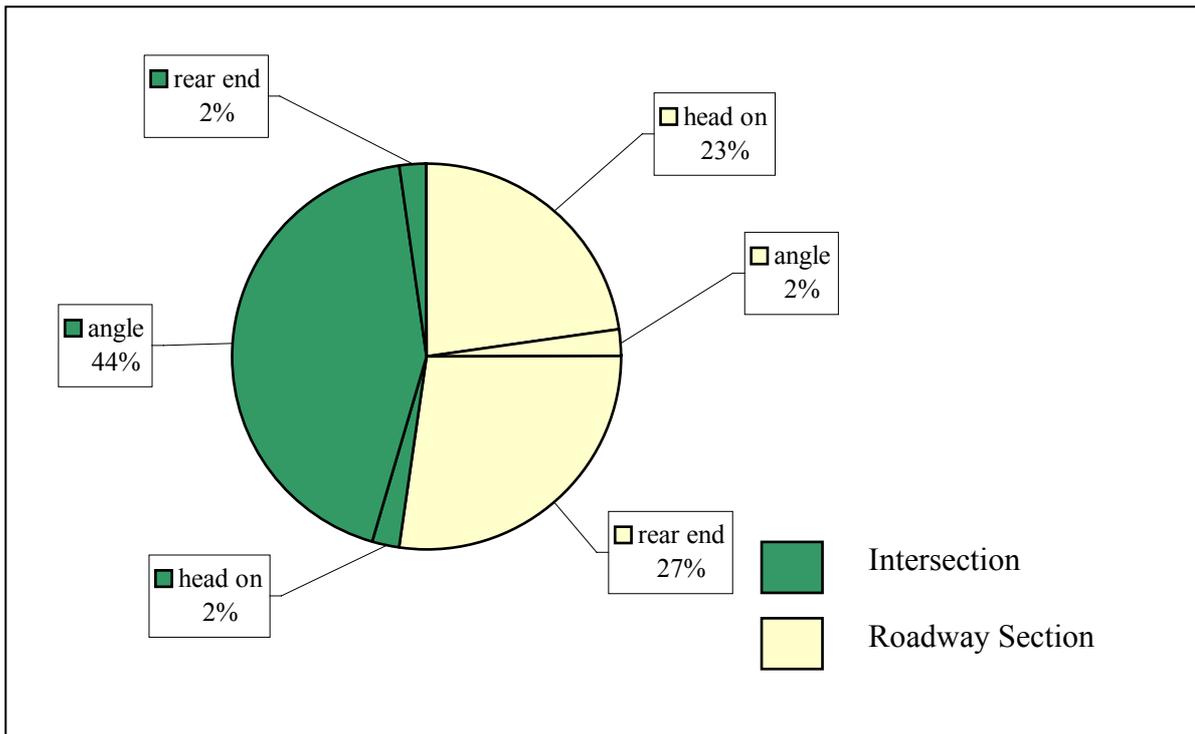
FIGURE 4-5 *Crash Data by Crash Pattern on South Main Street.*

Angle crashes on intersections presented the highest proportion, corresponding to 44 percent of all reported crashes. Head on and rear end crashes on roadway sections accounted for 23 and 27 percent respectively. Rear end and head on crashes at intersections as well as angle crashes on roadway sections occurred in a minor proportion. Figure 4-5 shows the distribution of crashes by type of crash.

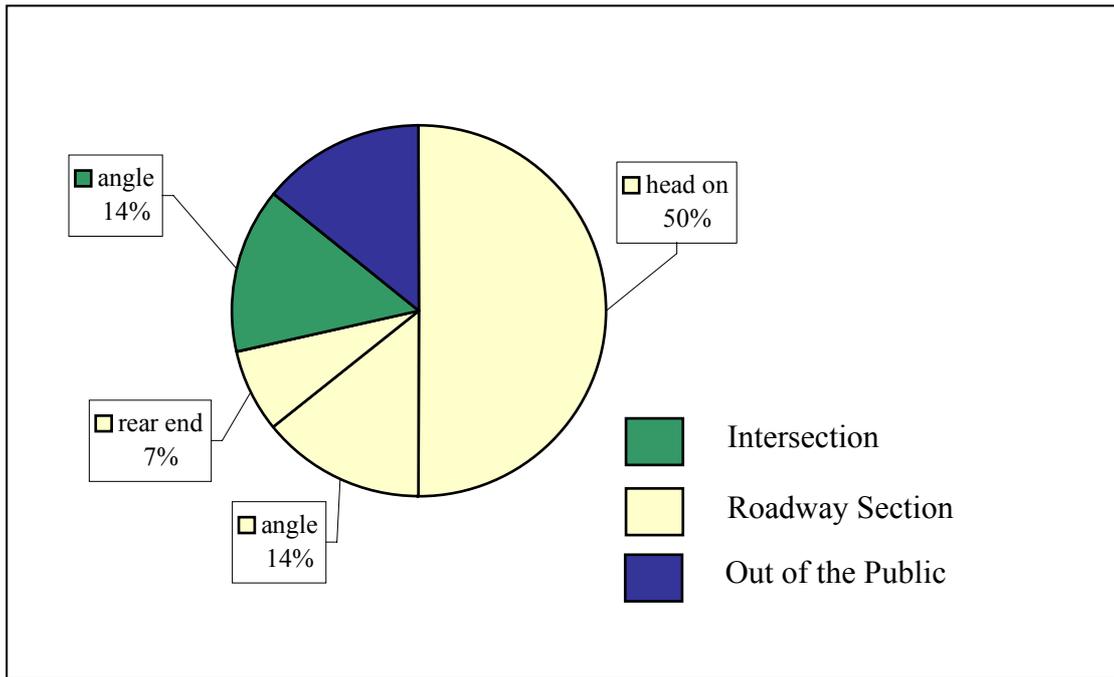
FIGURE 4-8 *Crash Data by Crash Pattern on Glen Street.*

The results of the crash pattern analysis indicated a remarkable trend. Half of the reported crashes were found to be head on collisions on roadway sections being the most common case vehicles running off the roadway.

Rear end crashes on sections and angle crashes on sections and at intersections as well as crashes that occurred out of the public road, usually on private driveways, conformed the other half of the data. The results are presented in Figure 4-8.

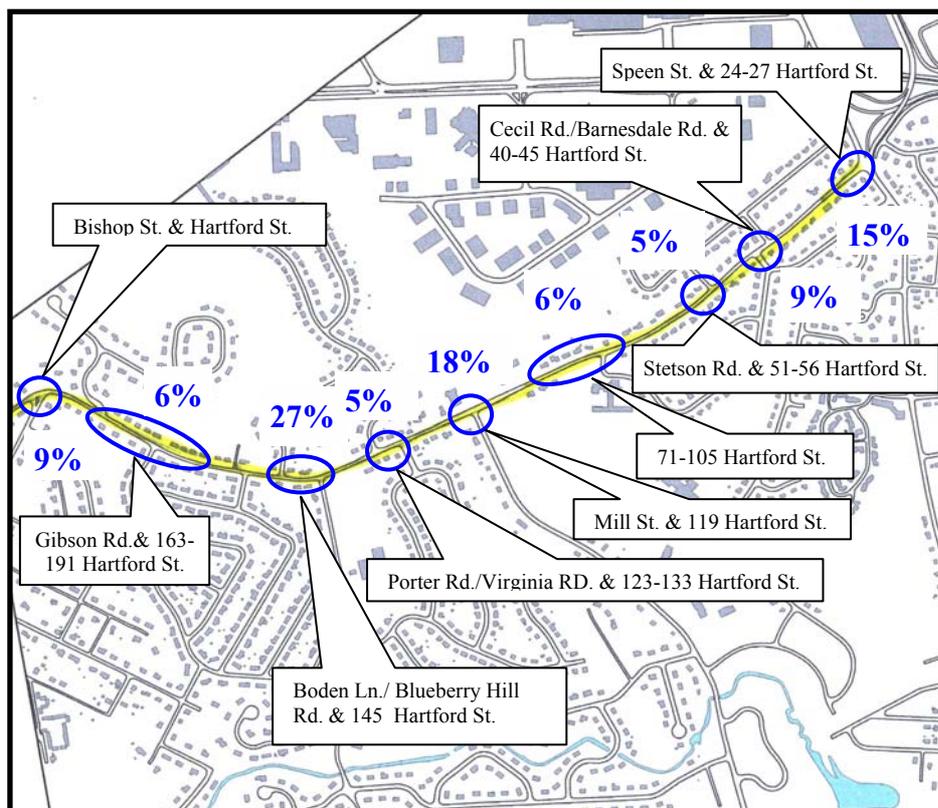
FIGURE 4-16 Crash Data by Location on Hartford Street.

The second conflictive point was the signalized T-intersection at Mill Street, accounting for 18 percent of all reported crashes and 17 percent of personal injuries. The next spot, presenting 15 percent of crashes and 13 percent of personal injuries, was found on one extreme of the roadway, at the intersection of Hartford Street with Speed Street.

The Hartford Street segment that includes the intersections with Cecil Road and with Barnesdale Road showed nine percent of reported crashes but 13 percent of personal injuries. Figure 4-16 shows graphically the results obtained on Hartford Street.

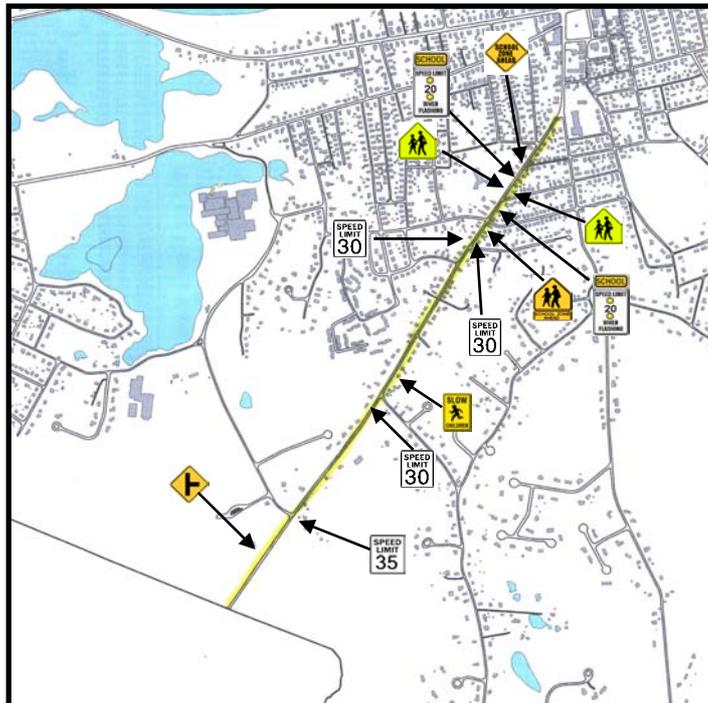
FIGURE 4-22 *South Main Street Signage.*

Although the speed limit was 30 mph and regulatory signs were posted indicating this limit, one regulatory speed limit sign showed 35 mph. The signage of South Main Street is presented in Figure 4-22.

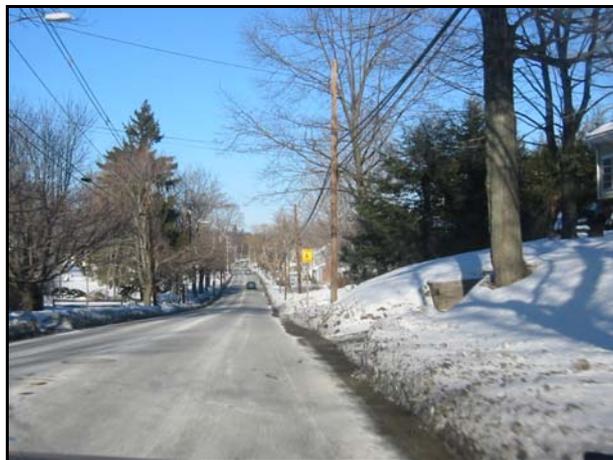
FIGURE 4-23 *South Main Street in Winter.*

Natick is located in a severe winter region. Visibility was clearly reduced due to the accumulated snow on the roadside and the risk of icy road surface increased. Although sign visibility was found adequate during winter season, pavement markings became difficult to identify. Figure 4-23 shows a picture of South Main Street during winter months.

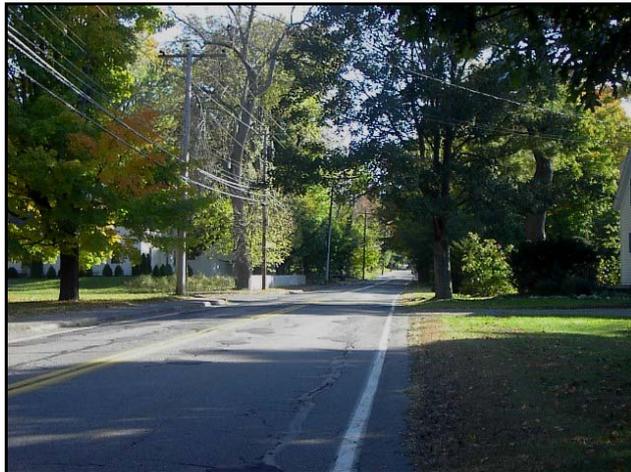
FIGURE 4-24 *Glen Street Typical Cross Section.*

The typical cross section included asphalt curbing and sidewalks only on the northbound side. Utility poles were also placed on the northbound side. Travel lanes typically measured 11 feet wide and shoulders less than one foot. One particularity of Glen Street was that the buildings were relatively separated from the traveled way. Besides, the houses were partially hidden by trees and plants, giving the perception that Glen Street was not a residential street. Figure 4-24 illustrated Glen Street cross section. The picture was taken heading south.

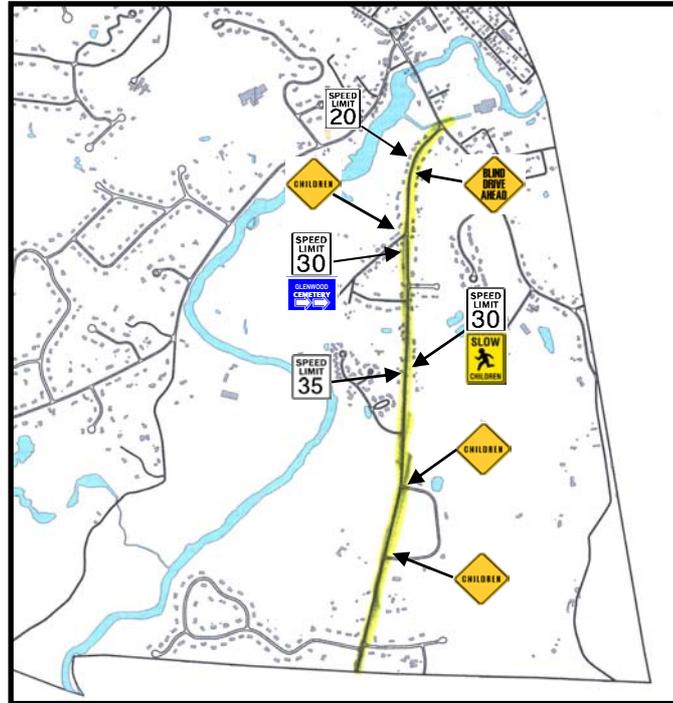
FIGURE 4-25 *Glen Street Signage.*

Incongruence among regulatory speed limit signs was detected along Glen Street. Signs indicating 20 mph, 30 mph, and 35 mph as a speed limit were found on

The street did not contain traffic signals. A few children warning signs were found close to intersections. The signage of Glen Street is presented in Figure 4-25.

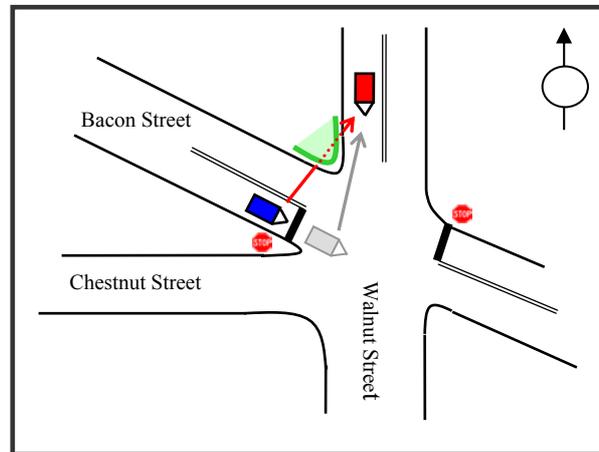
FIGURE 4-26 *Intersection of Walnut Street with Bacon Street.*

The intersection between Walnut Street and Bacon Street presented a hazardous layout. It operated as a two-way stop control intersection, being Walnut Street the right of way roadway. Figure 4-26 illustrates the intersection layout and the visibility issues.

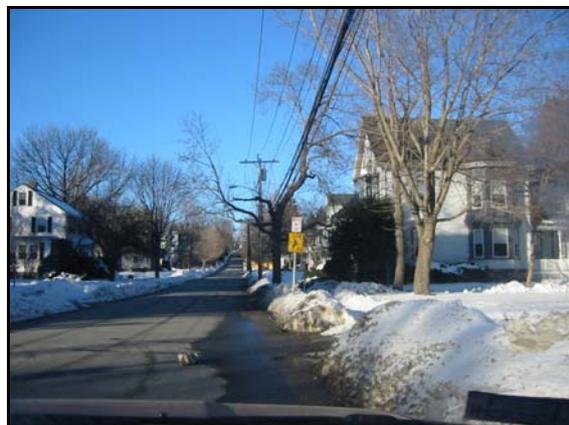
FIGURE 4-29 *Walnut Street in Winter.*

Inclement weather and snow during winter months may increase risky situations. The visibility was reduced due to the accumulation of snow and the travel lane became narrower. A picture of Walnut Street in winter conditions is shown in Figure 4-29.

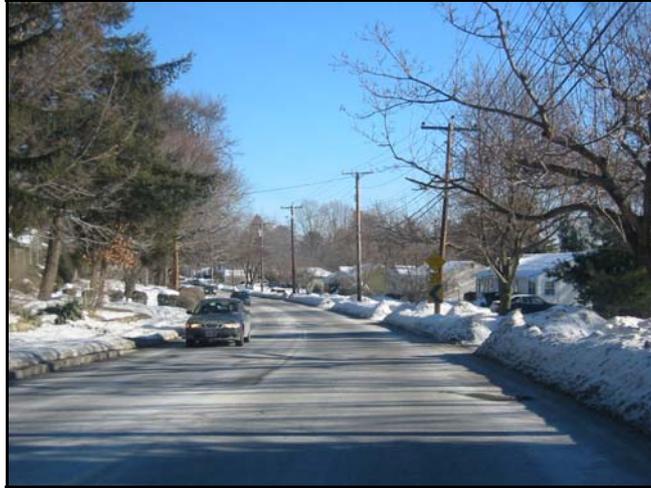
FIGURE 4-35 *Hartford Street in Winter.*

The inclement weather experienced during winter months increase risky situations. Accumulations of snow narrowed the travel lane and reduced visibility. A picture of Hartford Street under that conditions is showed in Figure 4-35.

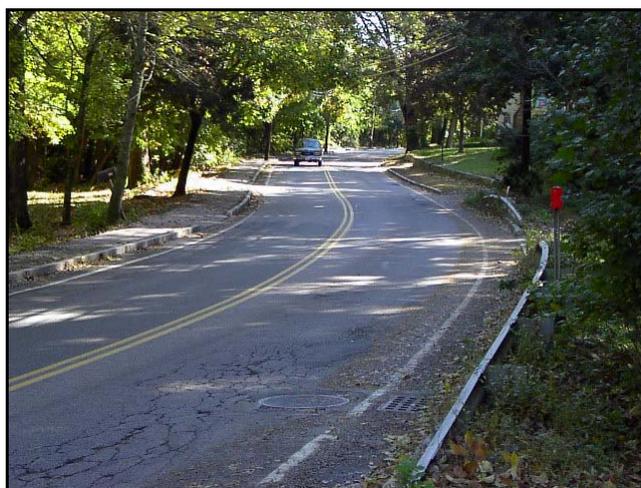
FIGURE 4-36 *Union Street Typical Cross Section.*

Travel lanes were typically wider than 12 feet and approximately one foot wide shoulders were provided along the street. The pavement was found in bad condition. Figure 4-36 shows the Union Street cross section on the curve section.
