Ground penetrating radar assessment of historical buildings: the study of the roofs, columns and ground of Santa Maria del Mar, in Barcelona

GPR assessment of the basilica Santa Maria del Mar

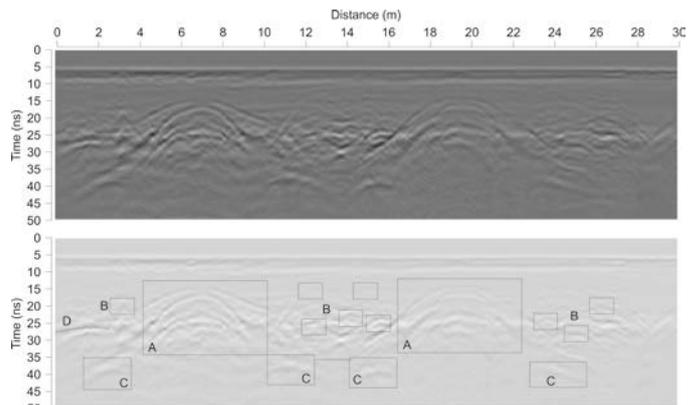
Radar data obtained in the roof allows differentiating four main features (see Figure 3). The first feature is corresponding to the anomalies associated to the structure of the vaults (labelled A in Figure 3). This structure seems to be composed by three layers with different radius of curvature. The anomaly centred on the external vault could be caused by the reflection on the keystone of the vault. The radar image is clearly regular in this zone; as consequence, materials in this area seem to be homogeneous. The second feature (labelled B in Figure 3) is a zone in the radar data characterized by small hyperbolas. The pattern could show the presence of heterogeneous filling. A possible hypothesis is the presence of several hollow ceramic elements and mortar. This possible filling could help in diminish the weigh to the roof structures. Besides, this characteristic could explicate the small hyperbolas recorded in radar data. Moreover, the distribution of the hyperbolas, corresponding to different two-way travel times, seems to indicate that those possible hollow targets could be placed at different depths. The zone is located between each two arches, being the widest part of the roof.

Fig. 3. Detail of the radar image obtained in the wall and possible interpretation. A) Reflections on the structure of the vaults. B) Reflections on heterogeneous filling between vaults. C) Reflection on chapitels of the columns supporting the vaults. D) Reflection on homogeneous materials between the vaults and the walls.

The third feature corresponds to a zone in the radargram that could be associated to the junction between arches and columns. The fourth feature is a flat and homogeneous anomaly that could be related to the junction between the arch and the main wall. This last part seems to be built with homogeneous stones. Figure 4 shows a drawing of these four possible zones deduced from the GPR survey. The heterogeneous and hollow materials between the arches could

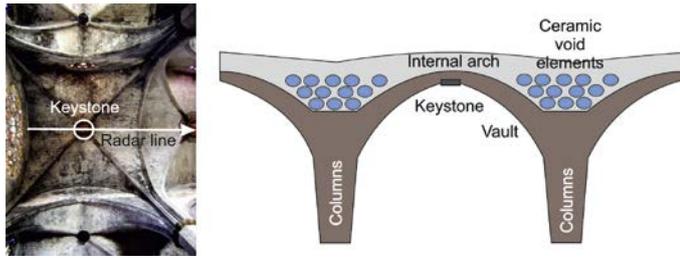
be an architectural solution that would help to decrease the weight of the roof without reducing bearing capacity. The homogenous zones could be composed by ashlars.

Fig. 4. Photograph of the vault showing the location of the GPR line on the roof and the keystone, and drawing of the possible GPR data interpretation.

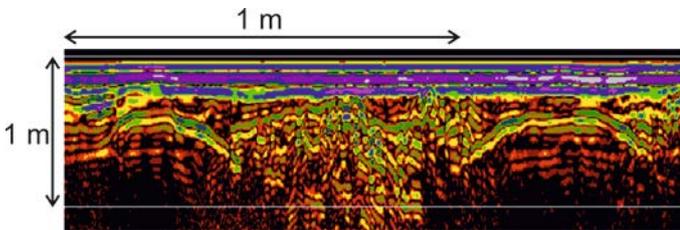
Figure 5 shows a detail of radar image obtained in the zone most likely built with those heterogeneous and hollow pieces, which were used to reduce the weight in the area between columns. In this image, the most homogeneous zone over the reflection associated to the vaults can be clearly distinguished from the area between vaults, where the great number of anomalies indicates the existence of irregular targets and heterogeneous filling. Moreover, the high amplitude of some of those anomalies reveals the important change in the wave velocity, suggesting reflections on voids or hollow targets.

Fig. 5. Detail of the anomalies between the vaults, corresponding to a void elements, most likely amphores or ceramic bottles.

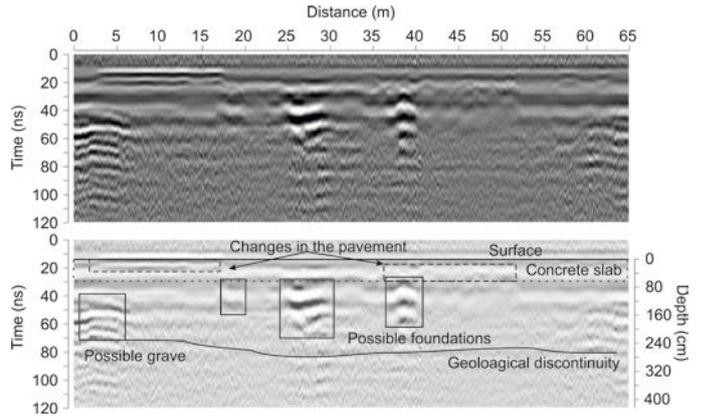
The results concerning the ground under the main façade shows the existence of a slab inside of the Basilica. This slab is most likely not completely homogeneous because GPR images presents some changes that could be related to alterations in the upper pavement or in its inner conditions. Under this slab, the ground seems to be homogeneous, being detected a possible geological layer at about 2.5 m deep. However, coincident with the two supporting structures at both sides of the front door, two important anomalies could be caused by reflections on the foundations of the church. Other anomalies could be associated to graves or buried structures. Figure 6 presents a radargram obtained in this zone, where the anomalies are clearly visible.

Fig. 6. Radar data showing important anomalies that could be associated to foundations, in the radar line inside the church, along the main façade.

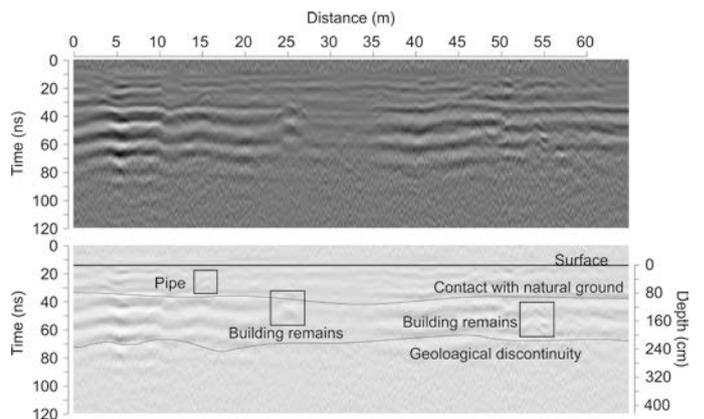
Radar data obtained outside the church (Figure 7) also contains a large number of anomalies that could be associated to walls remains of ancient houses close the church.

Fig. 7. Radar data obtained in front of the main façade, outside the church.

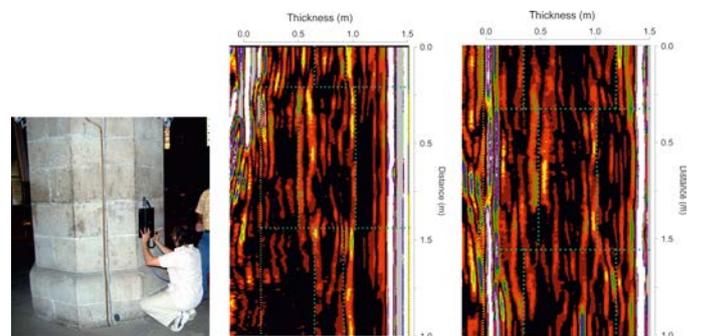
The assessment of columns demonstrates a correct state of conservation of many of them. Radar images show the inner arrangement of the ashlars and the homogeneity of the images seems indicating that no important damage affect the structures. Figure 8 presents GPR images obtained in sections of two of the assessed columns.

Fig. 8. Radar data acquisition during the columns assessment and, radar data obtained in the radar lines along two of the columns of the church.

Reflections on the contacts between stones are visible, and the lack of strong anomalies highlights the good state of conservation, being the main reflections caused in the joints between ashlars.

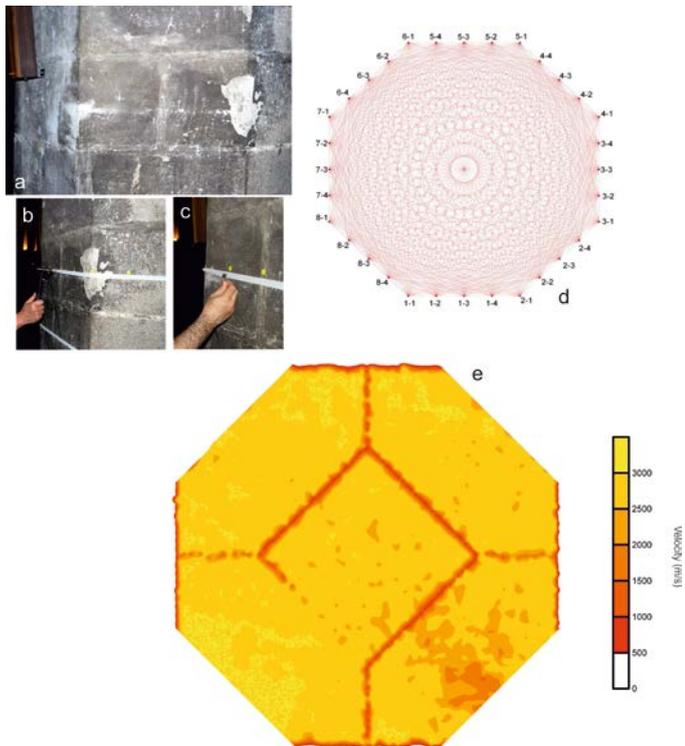
Higher wave velocities correspond to a more homogeneous rock, while possible damage corresponds to a lower velocities and contacts between ashlars.

Fig. 9. Seismic tomography. a) Assessed column. b) The hammer is used as a source of the seismic waves. c) The receivers are geophones. d) Trajectories of the wave in the hypothetical case of a homogeneous material. e) Tomography of the columns.

The result defined clearly the contacts between the stones, indicating the existence of a middle squared ashlar. In addition some areas showing lower velocities (Figure 9) demonstrate that in some parts the stone is damaged, most likely fissured.
