Assessment of Remote Cavitation Detection Methods with Flow Visualization in a Full Scale Francis Turbine

Abstract

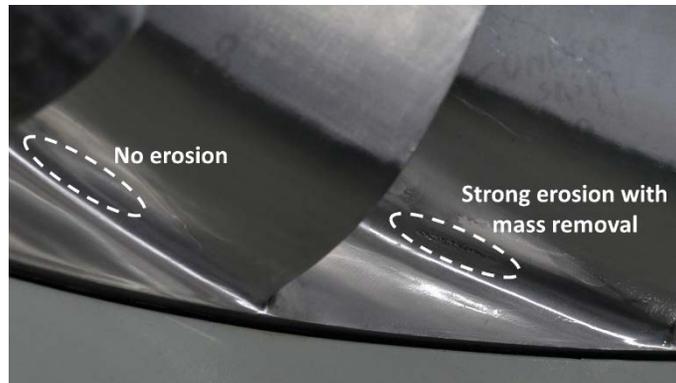
This machine is of interest because it suffers aggressive erosion on the suction side of the runner blades close to the trailing edge as it can be seen in the photograph presented in figure 1. This type of erosion is caused by cloud cavitation detaching from the blade leading edge [1]. The methods used to predict cavitation are based on induced high frequency vibrations and acoustic emissions measured on the turbine guide bearing and the guide vanes [2].

Figure 1. Photograph of the runner showing one blade with erosion and the contiguous one without erosion.

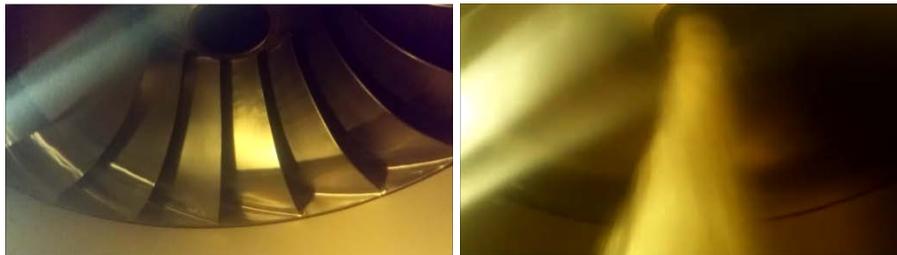
As it could be detected in a series of preliminary tests, the axis of the draft tube presents a gas-filled core for all the operation conditions as shown on the right of figure 3. The size of this cavitating vortex grows as the unit operates far from the BEP and obviously blocks the vision of the runner. Consequently, the camera had to be pointed away from the draft-tube center and given the current window positions the visible runner blades were observed when passing in front of the spiral casing end.

Figure 3. Vision of the runner from the manhole with the machine stopped (a) and with the machine operating at 19 MW (b).

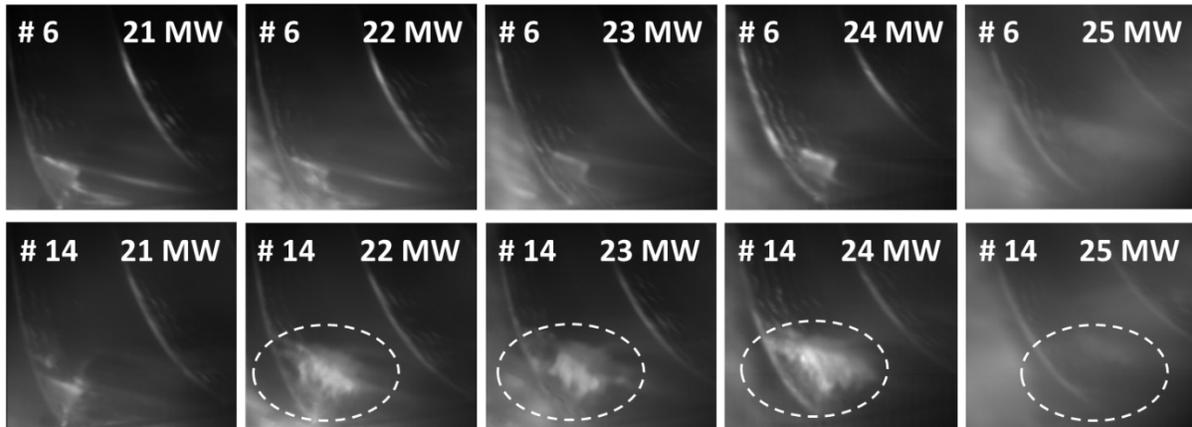
After analyzing the video records and identifying the 15 blades, it has been possible to compare their cavitation conditions among them for all the operation conditions. As it can be seen in figure 5, not all the blades present suction side cloud cavitation. For instance, blade number 6 appears not to suffer cavitation at all for any power output. On the contrary, blade number 14 is free of cavitation at BEP but develops cavitation for the rest of higher output loads. The global results regarding the presence of cloud cavitation for all the blades and operation conditions are summarized in table 1. Here it must be reminded that the field of view only corresponds to a narrow zone located next to the end of the spiral casing and no information about the evolution of the cavitation conditions as the runner blades span the whole circumference is available.

Firstly, it can be noted that only blade number 10 shows cavitation for all the loads including the BEP (21 MW). Then, cavitation starts at 22 MW for blades number 5, 13 and 14. At 24 MW, blades number 4, 6, 11 and 12 do not show cavitation yet. Operation condition at full load (25 MW) requires a special comment. Due to the significant increase of bubbles inside the flow, all the images appear excessively blurry and it is not possible to identify the presence of any type of large scale cavities. This unexpected behavior might be due to a deficient turbine setting point that reduces the available Net Positive Head (NPSHA) especially at full load.

Figure 5. Flow visualization on blades number 6 (upper row) and number 14 (lower row) for operation conditions ranging from 21 MW up to full load at 25 MW. Suction side blade cavitation is observed for blade number 14 starting at 22 MW meanwhile blade number 6 does not exhibit cavitation at any operation condition.

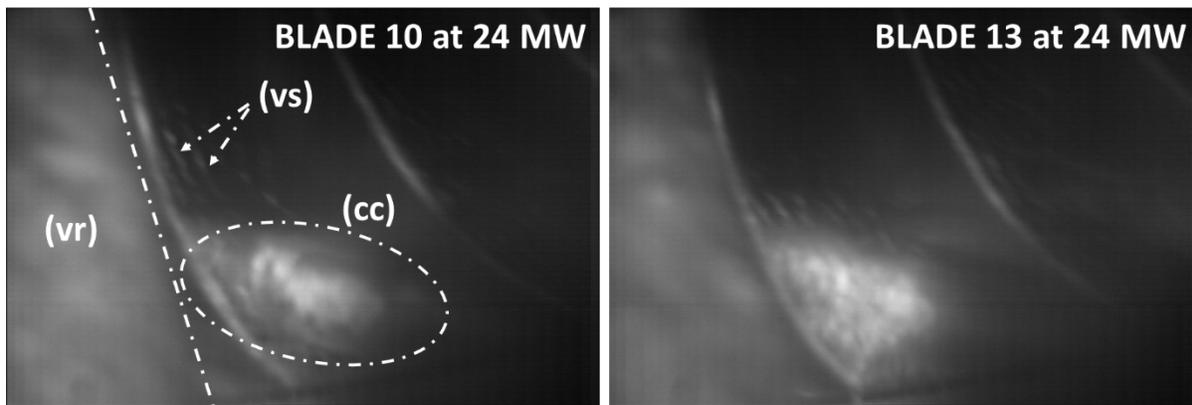
A more detailed observation of the flow field at 24 MW shown in figure 6 permits to clearly see the large-scale types of cavitation taking place when blades number 10 and 13 pass in front of the vision angle. As already commented, the closure region of the cloud cavitation on the blade suction side is observed as well as other forms of cavitation such as vortex shedding cavitation at the blade trailing edge and draft tube vortex rope cavitation from the runner hub.

Figure 6. Zoomed view of the flow field at 24 MW when blades 10 (left) and 13 (right) pass in front of the vision angle that permits to identify cloud cavitation on the blade suction side (cc), vortex shedding cavitation at the blade trailing edge (vs) and draft tube vortex rope cavitation from the runner hub (vr).

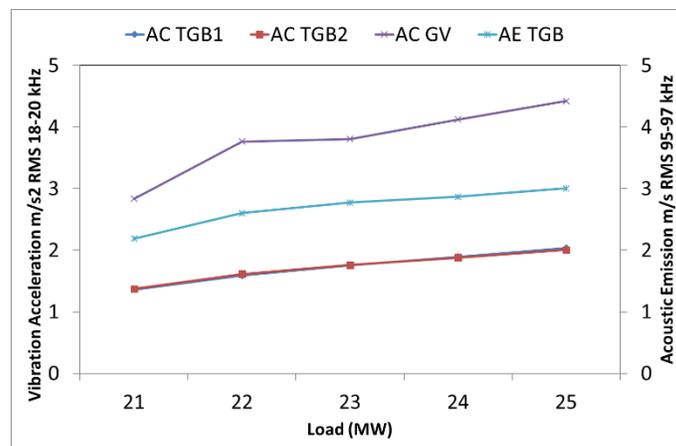
The overall RMS vibration acceleration and acoustic emission levels in the frequency bands from 18k to 20k Hz and from 95k to 97k Hz, respectively, have been plotted as a function of output load in figure 7. These results correspond to the average values from measurements taken in two different days. The data show that the levels increase with output load which corresponds to the increase of the number of blades with cavitation and the cavity sizes. The values in both guide bearing accelerometers are quite similar meanwhile the values in the guide vane are higher. The trends

from the two accelerometers and the acoustic emission sensor located on the guide bearing are analogous but the trend observed in the guide vane accelerometer differs slightly.

Figure 7. Overall RMS vibration acceleration and acoustic emission levels in the frequency bands [18k-20k Hz] and [95k-97k Hz] respectively, as a function of output load.
