STABILITY AND REDUNDANCY

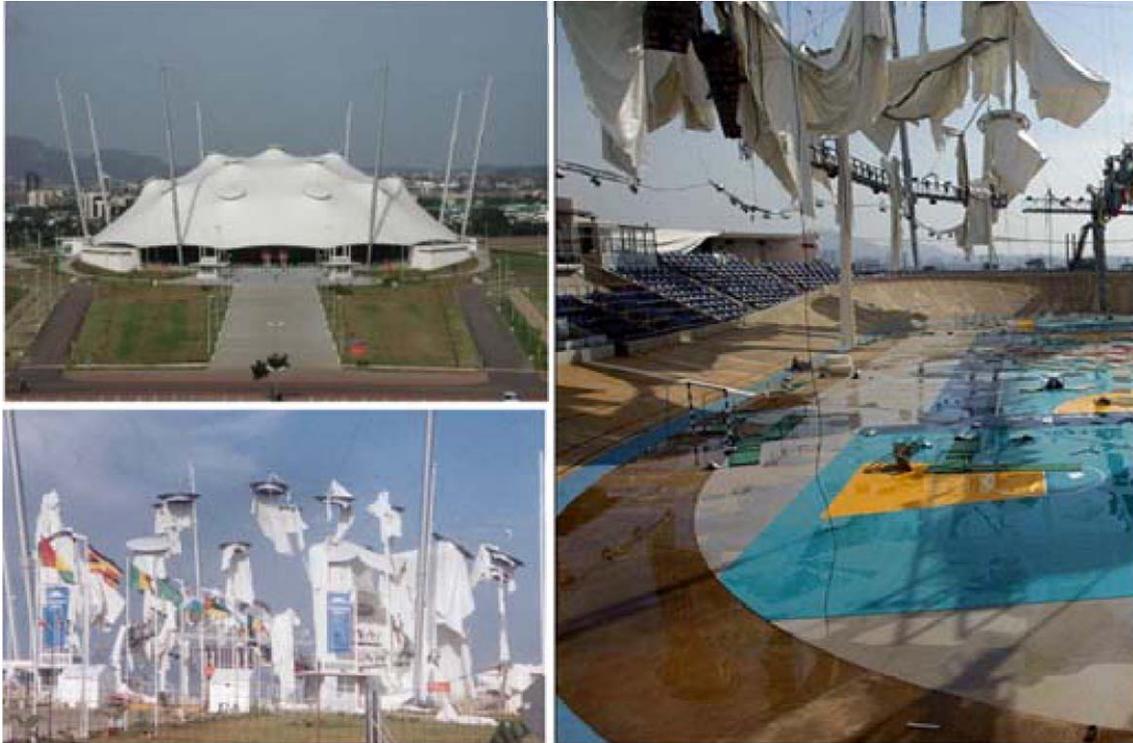
The membrane is torn but the masts are arrested by cables

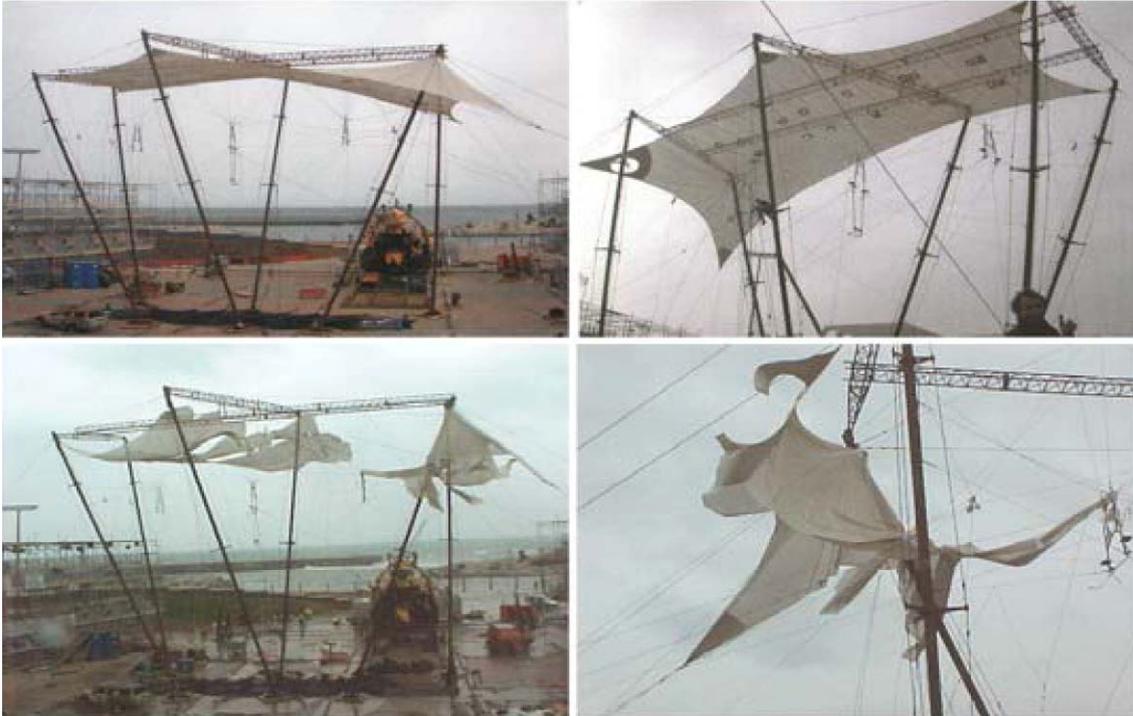
The membrane is torn but the masts are arrested by cables

However it did not survive the first storm. The membrane began to flutter and continued to flap until it tore. This was due to additional oblique cables added to the initial design. Their contacts with the membrane during its displacements under the strong wind (100 km/h speed), inevitably tore it causing its ruin (TensiNews 8, 9). Fortunately the stability of the whole structure was not dependant on the integrity of the membrane, so its failure did not cause a general collapse.

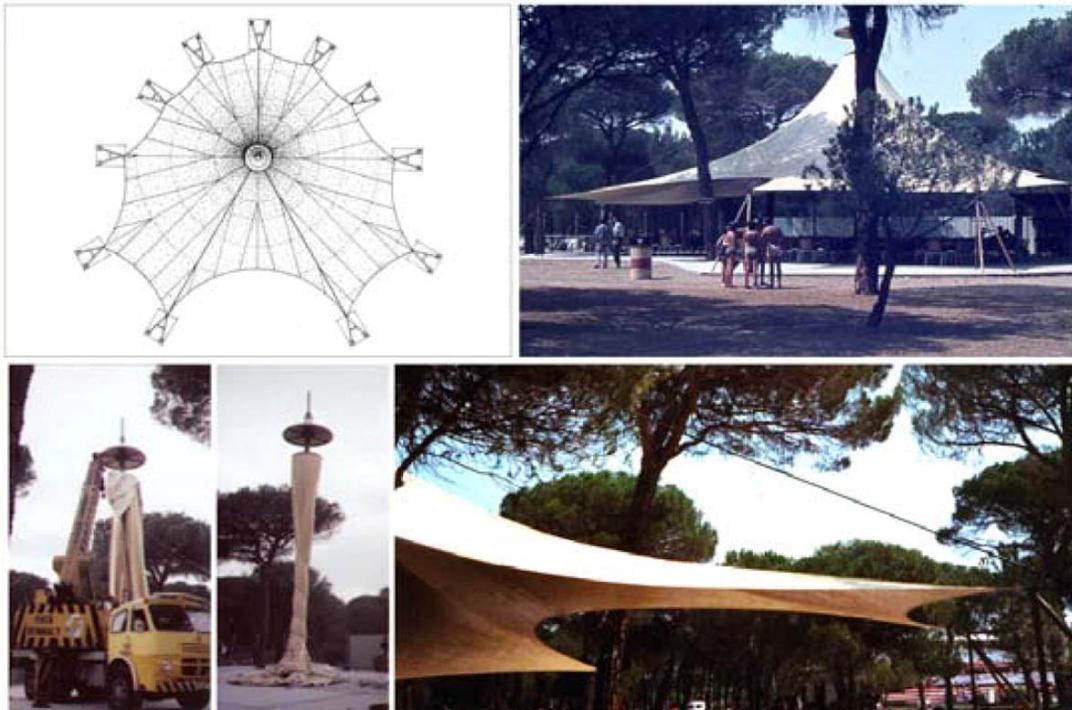
Llorens & Soldevila, Architects, 1981: FASA–Renault Sport Facilities, Valladolid.

For the FASA–Renault Sport Facilities in Valladolid, protection of the dining area from the sun was needed. **1** A surface of revolution around a central mast was designed varying the radius in plan to preserve the pine forest. Both the size and the shape make it clearly noticeable from any point of the sports and rest facilities. **2** The top is open to act as ventilation chimney. **3** To reduce heat transmission, opaque (non-translucent) fabric was used. The seams disappear because they are not seen against the light. The reading of the spatiality is not so immediate. The lightness is not perceived from the interior and the quality of the diffuse lighting is affected. **4** Notice the three redundant complementary cables that increase the safety holding the mast in the event that the membrane is torn.
