Failure investigation of a Kaplan turbine blade

Abstract

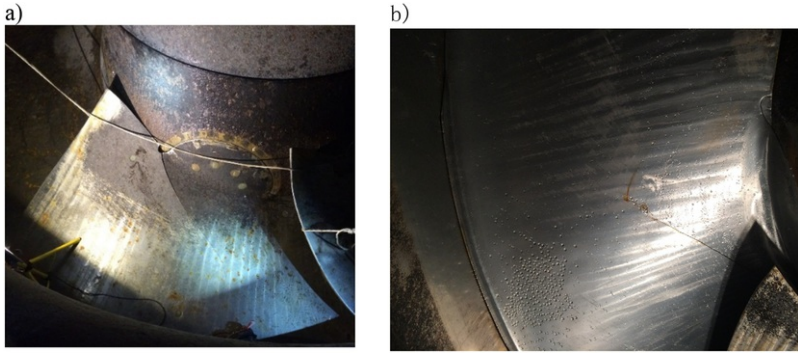
The inspection of the runner showed a large crack starting from the leading-edge side root hole of one of the blades (Fig. 2). A detail of the crack is seen in Fig. 3, where the beach marks can be also discerned. The beach marks show that the damage was caused by a fatigue problem. In addition, some scratches were found on the whole perimeter of the stationary wall and the tip-lip of the damaged blade was also found broken (see Fig. 4 and Fig. 5). This fact leads one to think that a contact between the tip-lip of the blade and the wall occurred. To better understand how the blade was broken, a further investigation using a numerical blade model is carried out in the following sections.

Fig. 2 View of the blade with crack. a) Pressure side. b) Suction side.

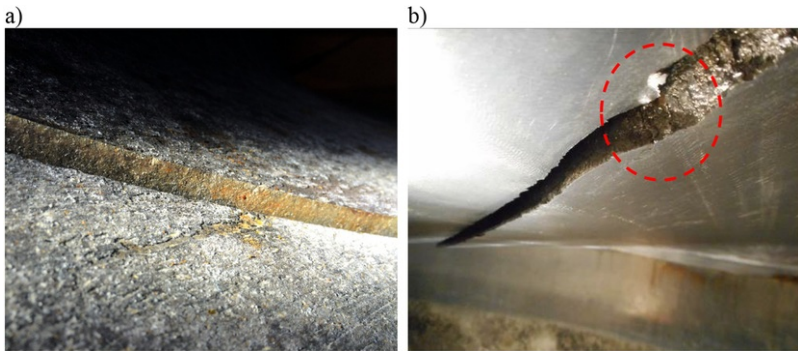
Fig. 3 Detail of the crack. a) From the pressure side. b) From the suction side.

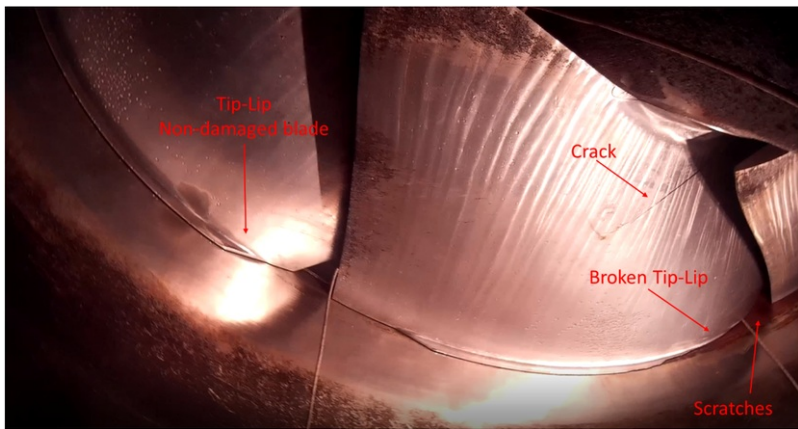
Fig. 4 View of the runner from below. Non-damaged blade (left) and damaged blade (right).

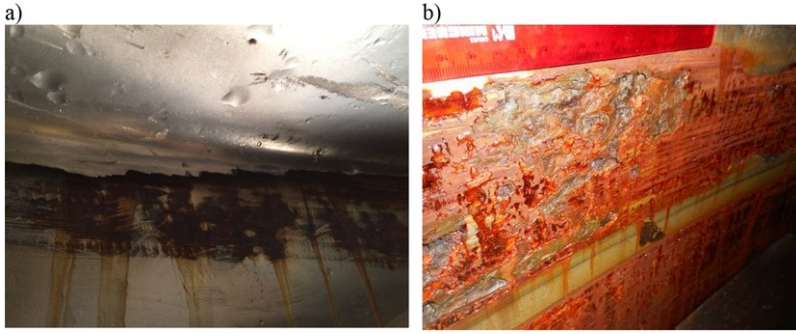
Fig. 5. Detail of the broken tip-lip and scratches in the stationary wall. a) Detail of the broken tip-lip. b) Detail of the scratches in the wall.

After inspection, beach marks were found on the crack surfaces, which indicated that the crack was caused by fatigue. At the same time, some scratches were found on the chamber wall and the tip-lip near the leading-edge was broken. This showed that there had been a contact between the damaged blade and the wall.

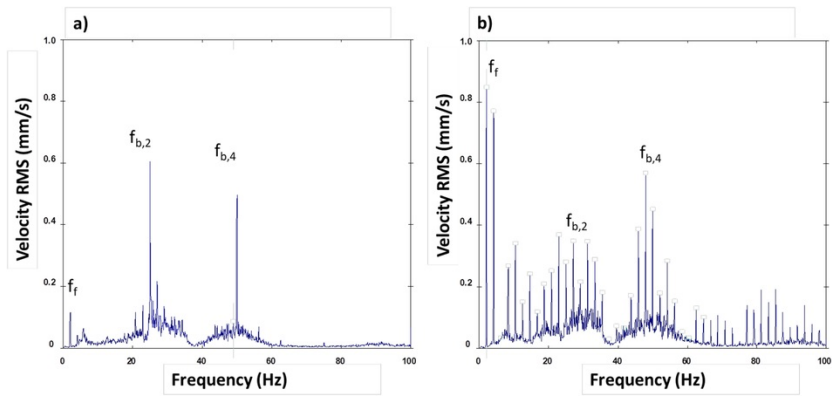
Fig. 6(a) shows a typical vibration signature of a Kaplan turbine in a turbine bearing without any damage. The vibration signature for the generator bearing without any damage is seen in Fig. 7(a). Three peaks can be clearly identified: f_r , $f_{b,2}$ and $f_{b,4}$. However, a sudden increase in the harmonics related with the f_r was found when the blade was broken (see Fig. 6(b) and Fig. 7(b)). The unbalance, related with the f_r increased considerably in comparison with the one with the machine in good condition (Fig. 6(a) and Fig. 7(a)). These symptoms coincide with a severe unbalanced rotating machine and with a blade contacting in the stationary wall during operation, which would induce one strong impact to the blade every revolution, exciting also the natural frequencies of the system.

Fig. 6. Fig. 6 Comparison between the spectra before damage (a) and with damage (b). Turbine bearing.

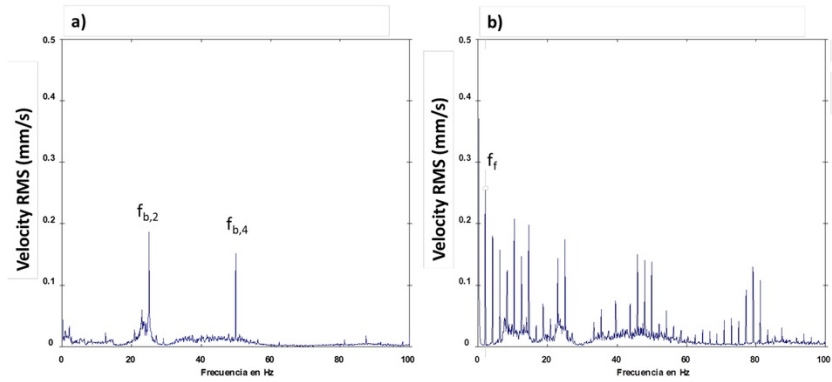
Fig. 7. Fig. 7 Comparison between the spectra before damage (a) and with damage (b). Generator bearing.

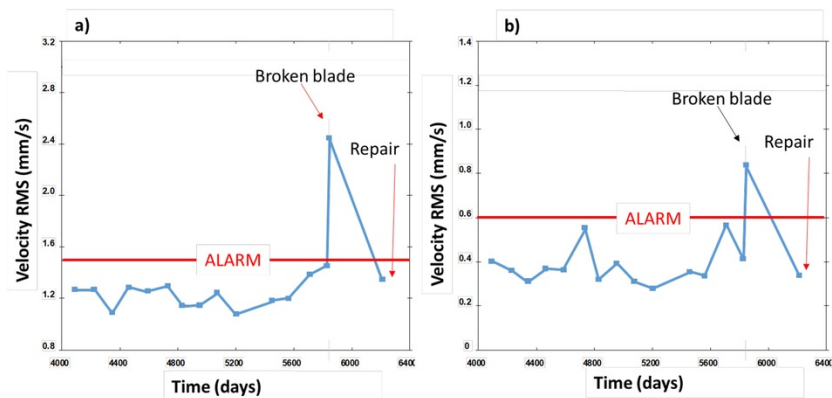
The overall vibration levels of all the measured points also increased considerably. Fig. 8 shows these levels for the turbine bearing and the generator bearing. After the reparation of the blade, the symptoms observed with the broken blade disappeared.

Fig. 8, Fig. 8 Overall vibration levels along the time. a) Turbine bearing. b) Generator bearing.

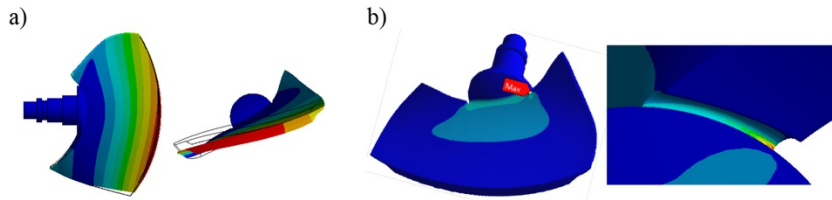
Once the pressure pattern over the blade is applied, the stress distribution due to this pressure is obtained. Therefore, this stress distribution corresponds to the normal operating conditions of the machine and it is shown in Fig. 13(a). The displacement of the blade is also shown in Fig. 13(b). It is observed that the maximum stress in the blade is located in the zone where the crack started in the machine. The stress distribution matches with other previously obtained in other Kaplan turbine prototypes [12].

Fig. 13. Fig. 13 a) Displacement of the blade under normal operating conditions. b) Stress distribution under normal operating conditions.

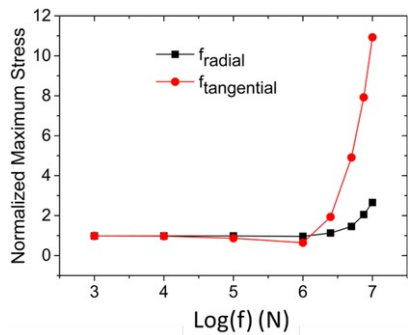
To model the rubbing, a radial force and a tangential force were applied to the blade (see Fig. 10(b)). The value of these forces is not known, hence different values were tested in the simulation. Fig. 14 shows how the value of these forces affect the maximum stress value located in the root of the blade, where the crack started. The figure shows the stress normalized against the value found without any rubbing (Section 6.1). It is seen that for the contact forces from 10^6N to 10^7N , the stress value increases drastically. From the case of the scratched wall and broken tip-lip, the contact force in this researched case ought to be very high. Therefore, with the appearance of these tangential and radial forces the stress in the root increases and it demonstrates the appearance of the crack in the blade.

Fig. 14. Fig. 14 Normalized maximum stress changes with contact force.

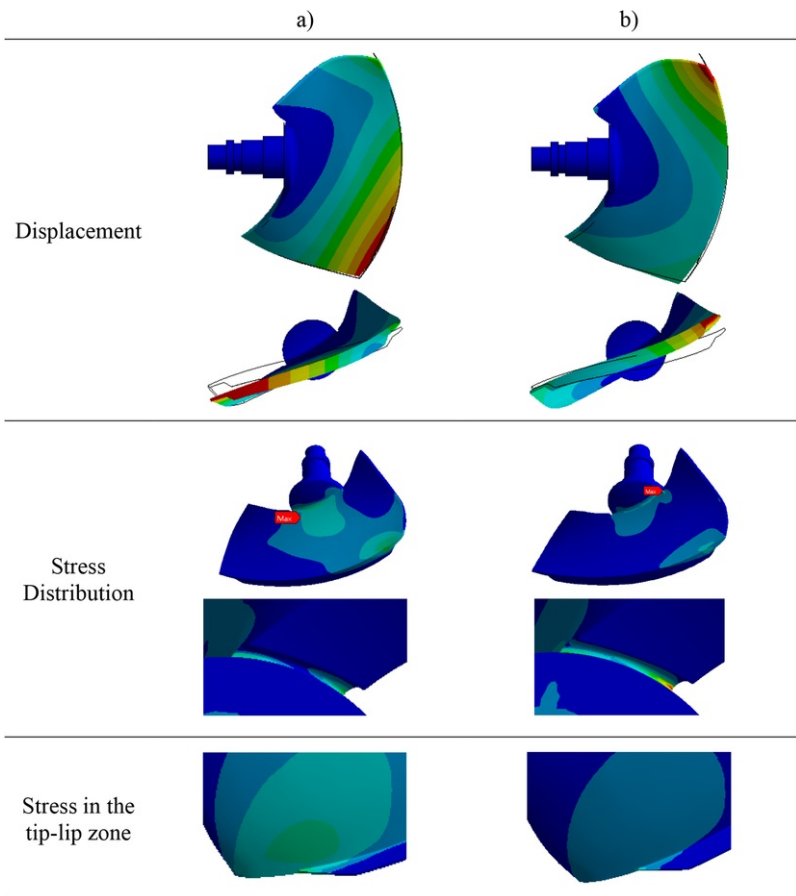
However, not only the stress in this point increases, but also the stress distribution changes due to the appearance of a tangential and radial force in the blade tip. Fig. 15 shows the displacement and stress distribution due to different values of tangential and radial forces. It can be observed that the stress is also higher in the zone of the tip-lip, just where it was also found broken. This fact demonstrates why this part was also found broken in the machine inspection.

Fig. 15. Fig. 15 Displacement and stress distribution a) Tangential force value of 10^6N . b) Radial force value of 10^7N .
