**Introduction**

Heritage buildings are fragile and valuable patrimony of cities and countries. Maintenance and repairing requires efforts and a wide knowledge of the structures. However, in many cases, the constructive methods, the distribution of supporting elements and the materials are unknown. There are two main causes of this uncertainty: the lack of information and drawings due to the age of the buildings, and the misinformation about past restorations, damages and alterations of use and structures. Non-destructive tests are widely used to obtain information since they can be applied without causing any damage [1]. One of the most extended methods in cultural heritage assessment is Ground Penetrating Radar (GPR) [e.g. 2, 3 and 4]. This technique allows a wide and quick evaluation of large parts of the structures. This paper presents examples of data acquisition methods to achieve patterns for further recognition and characterization of structures, materials and damages. The field study was completed in the terraces of *Eixample* of Barcelona, in XIX Century buildings [5 and 6].

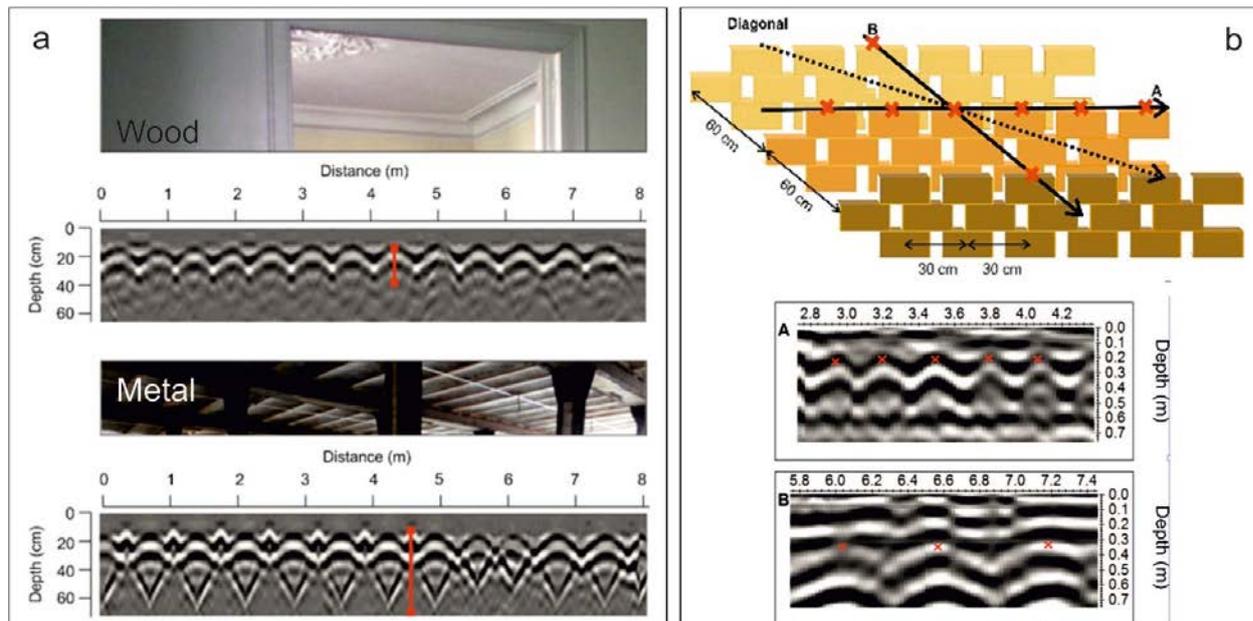
**Figure 2.** Radar images from wooden (a) and metallic beams (b), and the effect of the orientation of brick partitions (c) on the radar images (d).

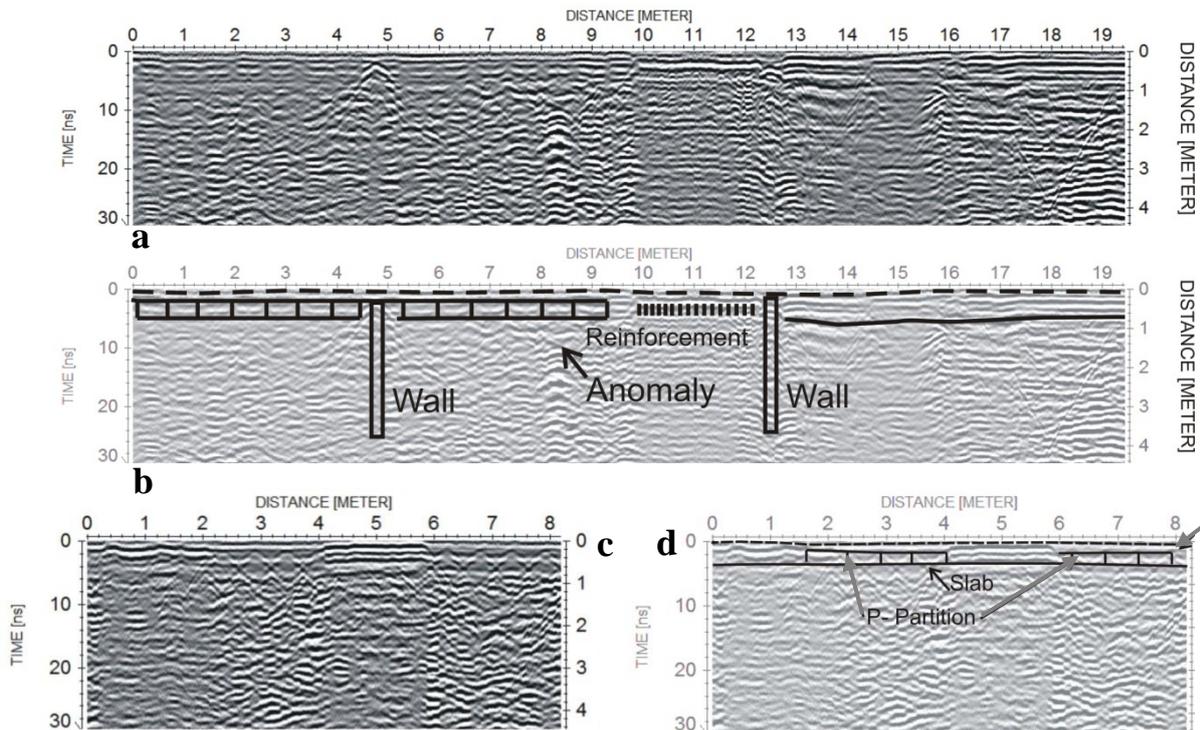
In this case, radar image in profile 2 discerns the existence of two walls (Figure 3 a). One of them in the middle of one structure built with masonry partitions and wood, and the other at the end of a reinforced slab included in a restoration. The partitions are clearly defined in this sector located at the beginning of the profile because radar line is perpendicular to the brick walls (see Figure 2), that are found separated 0.5 m apart. The reinforced slab present small hyperbolas produced in rebar. Horizontal resolution permits detecting rebar every 10 cm. The second wall separates the reinforced slab to other zone supported by brick partitions. However, in this case, the orientation of the brick walls changes and is parallel to the radar lines and the profile was carried out in the middle of two partitions. The effect of this arrangement of the structures produces a flat and horizontal anomaly in the radar images, instead of hyperbolas. The B-scan obtained in profile P3 which is perpendicular and crosses P2 between the meters 15 and 16, proves the existence of this particular partition structure (see figure 4c and 4d). In this B-scan also a slab is detected in the middle area at which the stairs are located.

The study allowed defining the position of the partition walls and other structural elements (Figure 3a and 3d). In this case, radar image in profile 2 discerns the existence of two walls (Figure 3b). One of them in the middle of one structure built with masonry partitions and wood, and the other at the end of a reinforced slab. The partitions are clearly defined in this sector located at the beginning of the profile because radar line is perpendicular to the brick walls (see Figure 3b), that are perceived separated 0.5 m apart. The reinforced slab present small hyperbolas produced in rebar. Horizontal resolution permits detecting rebar every 10 cm. The second wall separates the reinforced slab to other zone supported by brick partitions. However, in this case, the orientation of the brick walls changes and is parallel to the radar lines. The effect of this arrangement of the structures produces.

**Figure 3.** Radar images in profile P2. a) P2 B-scan. b) P2 radar data interpretation. c) P3 B-scan crossing P2 between its 15 and 16 m. d) P3 radar data interpretation.

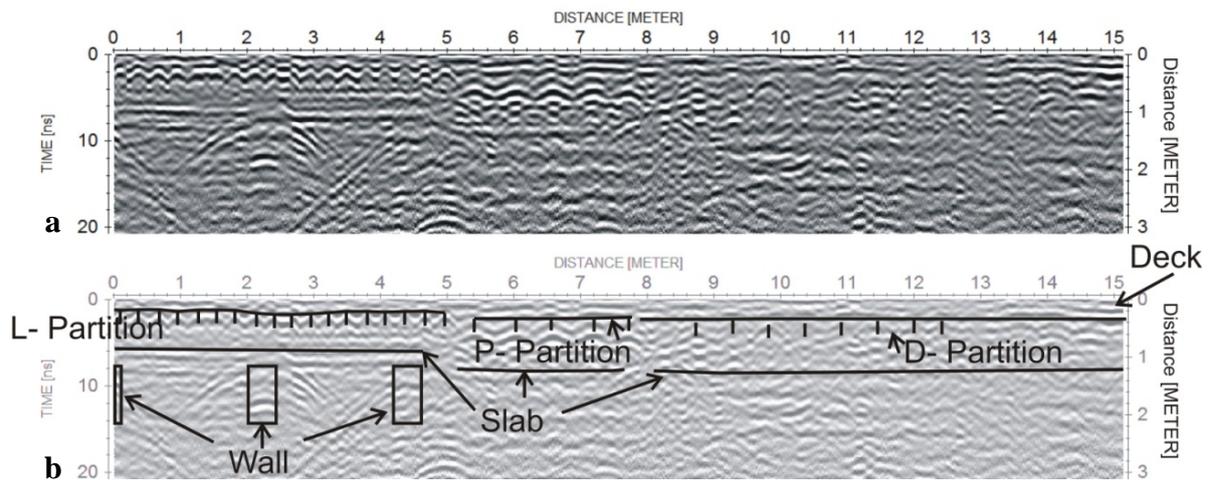
In case 2 the terrace was surveyed through the acquisition of 5 profiles, 2 perpendicular and 3 parallel radar lines to the façade (see Figure 1). The most paradigmatic profile 16 contains chief information about the inner elements present in the terrace (Figure 4). Two walls were clearly identified and half of a third wall is detected right in the beginning of the profile. Above it, it is detected a longitudinal set of parallel elements for the first meters. The following meters GPR data shows an alteration of orientation of the elements. An interesting fact is detected from the middle of the profile towards the end is detection of diagonal walls partition.

**Figure 4.** GPR images in profile 16 a) raw data, b) data interpretation.

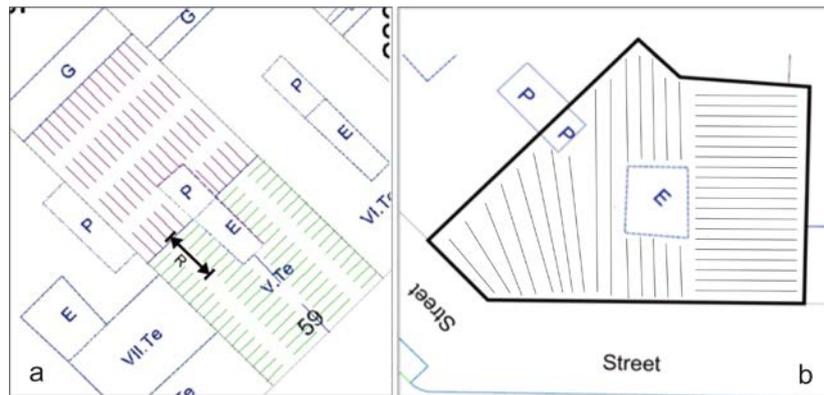
Radar data allowed the description of the arrangement of all the structural supporting structures. Figure 5 shows the structural solutions of the terraces presented in cases 1 and 2. The orientation of the structures is clear and the presence of reinforcement rebar (R in figure 5) is highlighted.

**Figure 5.** Structural solution for a) case study 1 and b) case study 2.
