Agricultural Spray Inspection According to ISO 16122: Part II—Determination of the State of Use and Conservation of Agricultural Sprayers

Alfran Tellechea Martini¹, José Fernando Schlosser¹, Emilio Gil², Marcelo Silveira de Farias¹,
Gustavo Oliveira dos Santos¹, Gilvan Moisés Bertollo¹ & Juan Paulo Barbieri¹

¹ Department of Rural Engineering, Universidade Federal de Santa Maria, Campus Universitário, Santa Maria, Brazil

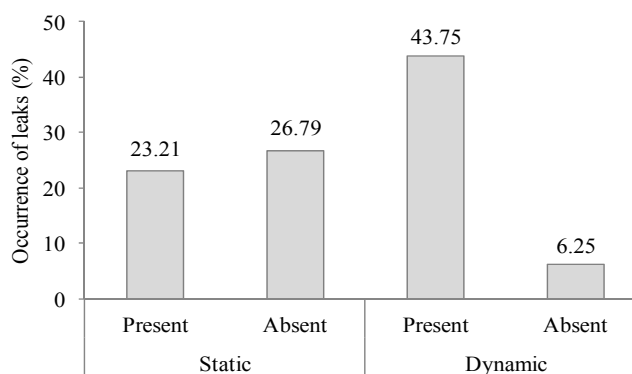
Figure 1. Percentage distribution of the occurrence of static and dynamic leakages

In relation to leaks, 23.21 and 43.75% of the inspected sprayers presented static and dynamic leaks, respectively (Figure 1).

Of the total observed, 35.10% were considered static leaks. Out of these, 34.66% were dripping and 0.44% continuous type leaks. Considering the dripping leaks, it is possible to observe that the greatest losses occurred in the nozzles, representing 76.43%, followed by 12.10, 6.37 and 5.10% of the drippings for the hydraulic circuit, pump and tank respectively. The high nozzle dripping percentage may be caused by the unsuitable operation or absence of the anti-drip valve, which according Dornelles (2008) may be related to the use of sprayers with low technological index, which its structural design did not provide for the use of this type of valve.

Taking into account the dynamic leaks, it can be observed that 64.90% of the sprayer which presented this kind of leak, 59.16% were represented by dripping and 5.74% by continuous leaks.

Similarly to what was observed in static leaks, the highest drip losses (63.43%) were observed in the nozzles, followed by the hydraulic circuit, pump and tank, which contributed with 32.46, 3.36 and 0.75% of the losses, respectively.

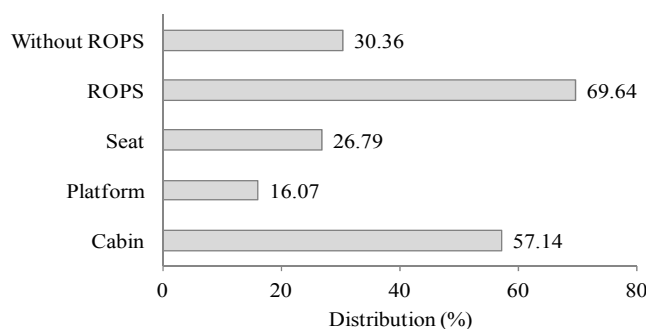
Figure 2. Evaluation of the operation station of tractors that composed the mechanized set (tractor + sprayer)

When the item "sprayer operation" was analyzed, the operation position of agricultural tractors and the performance of the activities were evaluated. When analyzing Figure 2, it is possible to notice that 57.14% of the evaluated tractors were equipped with cabins, allowing the operator to have greater protection and safety during the performed activity. In the other evaluated tractors, 26.79% presented the a seat-type operative station and 16.07% were platform-type. However, the item that is worth highlighting is related to the absence of the rollover protection structure (ROPS), which occurred in 30.36% of the tractors, leaving the operator totally unprotected.

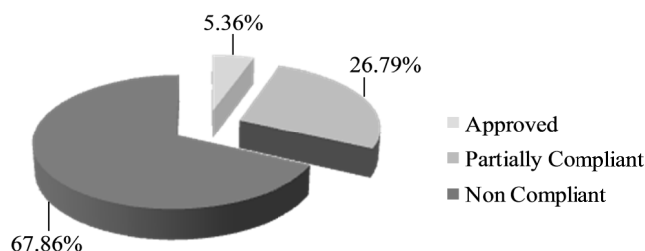
Figure 3. Classification of the inspected sprayers

Based on the results obtained at the end of the inspections, considering the premise described in the Standard ISO 16122 (2015), it is possible to observe that, out of the 56 evaluated sprayers, only three of them were approved (5.36%); however, 26.79% of the samples were classified as partially compliant and 67.86% of the sampled total (38 sprayers) were classified as non-compliant (Figure 3).

With the presented results, it is possible to observe that the most serious problems are mainly related to the safety of the operator and the environment. Considering the operator safety, the biggest serious problem are related to the fact that 41.07% of the sprayers did not have the protection for the cardan shaft, and 33.93% did not have the protection for straps and pulleys, which which, according to Dornelles (2008), the lack of protection or inadequate protection of moving parts, as well as the approximation of people to these parts, are considered unsafe attitudes and symbolize negligence. According to Debiassi et al. (2004), the unsafe attitudes in the rural environment are responsible for approximately 82.00% of the accidents involving agricultural machines.
