Spectroscopy investigations reveal unprecedented details in the corrosion of AISI 1012 UPN profiles installed in a modernist building of beginning of 20th century

In the present work, the corrosion affectation of an artistic and historical building, declared UNESCO World Heritage Site and constructed with AISI 1012 UPN profiles, was investigated. Micro-Raman and microscopy approaches highlight the complementarity and versatility of these techniques to evaluate the macroscopic and microscopic effect of the corrosion products in such reinforcing structures. The rust phases have been assessed by separating the oxide layers according to their environment placement and contaminants contact. The composition of iron oxides and oxyhydroxides in the metal surface depend not only on the oxygen concentration, but also on other elements that penetrated into the porous layers, as for example, chlorine ions, sulfur ions, and microorganisms. Taking into account the scarce information on the indoor corrosion of AISI 1012 steel, results obtained in this work are expected to help for understanding the long-term impact of such oxides and oxyhydroxides on the material durability, as well as on its st

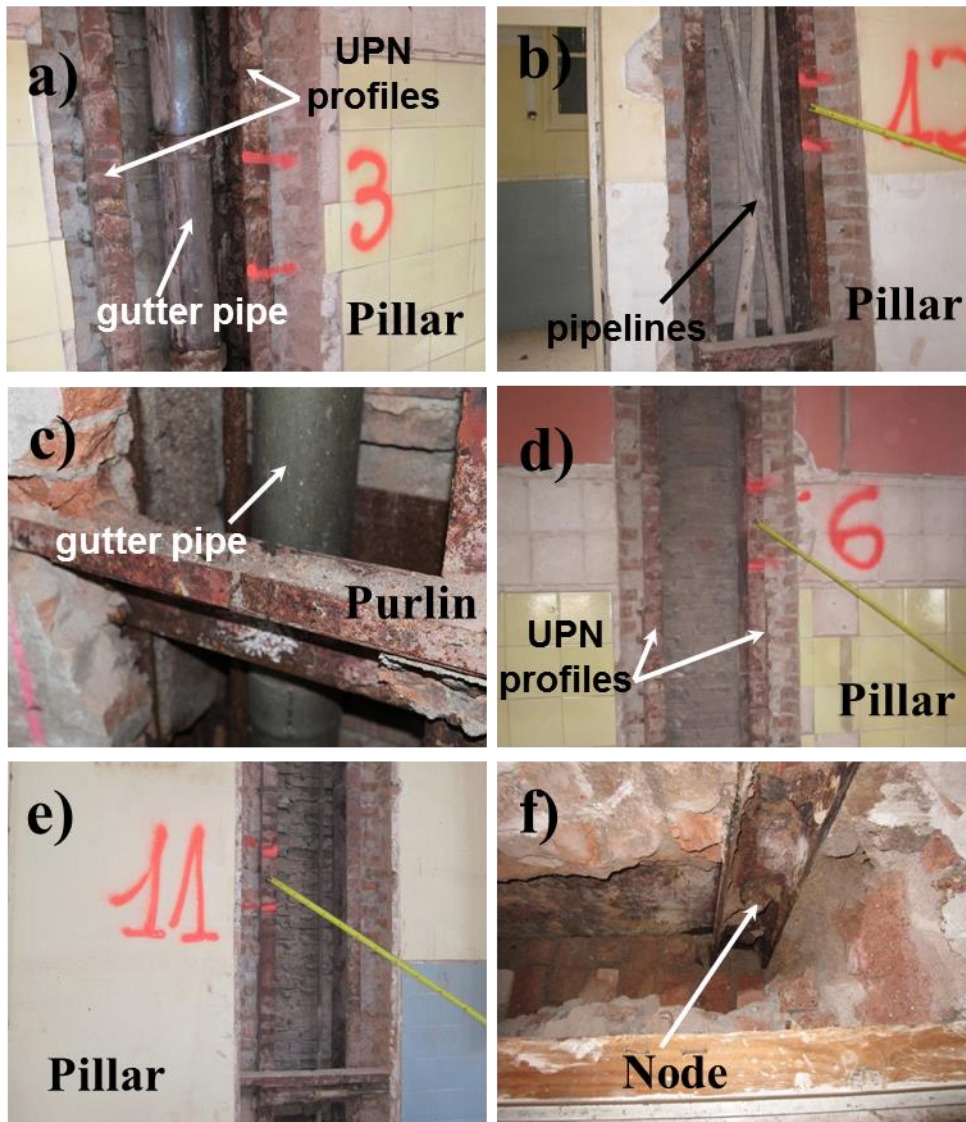
Figure 2

The metallic structures of *Sant Manuel* pavilion were built using European Standard Channels-UPN profiles of carbon steel AISI/SAE 1012 (American Iron and Steel Institute and the Society of Automotive Engineers classification). The two types of UPN profiles studied are UPN100 and UPN200. Additional information about their geometry was described elsewhere [20]. The chemical composition was confirmed by the standard ASTM E350-12 [21] and is reported in the electronic supplementary information (ESI). The study has been focused in AISI 1012 profiles in direct contact with cement, close to installed water pipes, as well as in structures without surrounding pipelines (Figure 2).

Figure 2. Corroded UPN profiles close to gutter pipes and pipelines: (a) sample M3, (b) sample M12, and (c) sample M1. Corroded UPN profiles without gutter pipes or pipelines around: (d) sample M6, (e) sample M11, and (f) sample MSB, node from reinforcing roof truss. Red marks indicate the zones where the samples for the analyses of rust layers were extracted. See Table S1 for codes identification.

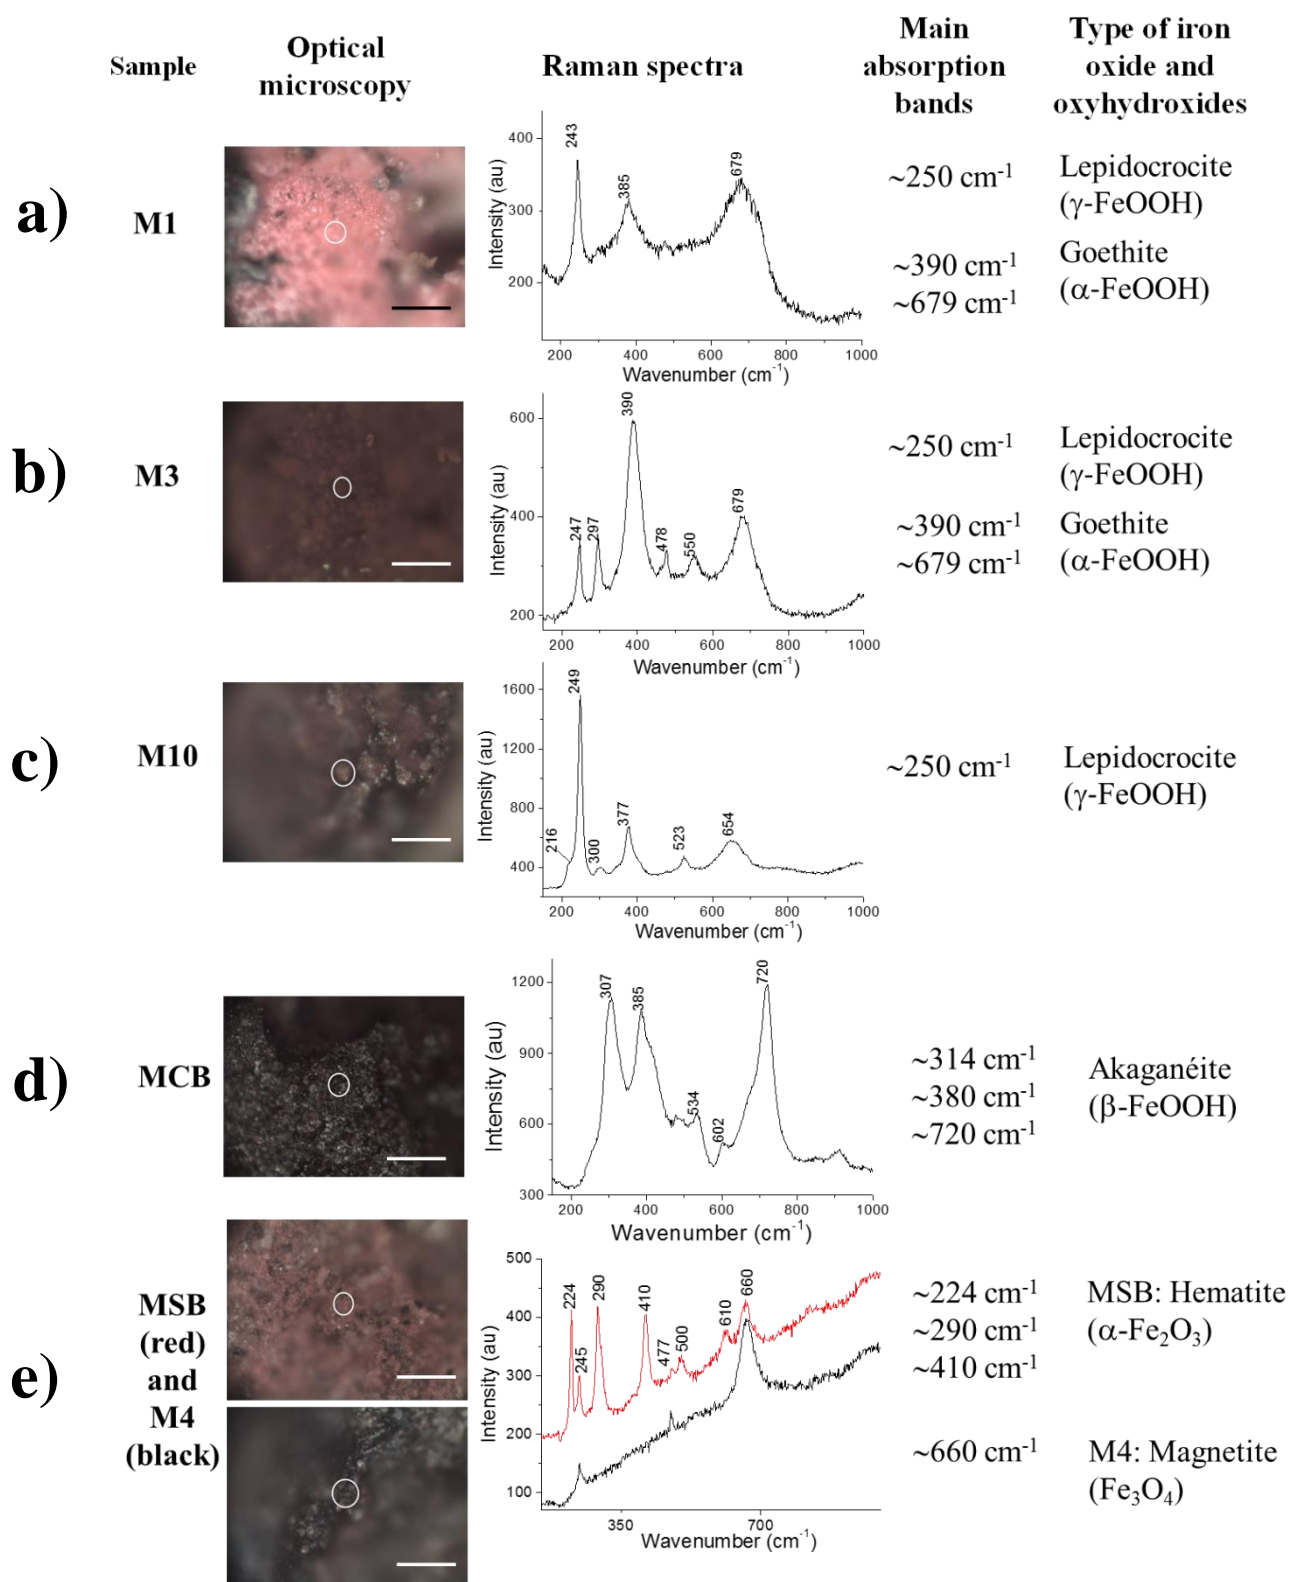
Figure 3

Furthermore, the Raman spectrum of the M10 sample (Figure 3c), with moderate corrosion degree, shows pure γ -FeOOH phase. This identification is evidenced by the characteristic features at 249 and 377 cm^{-1} and corroborated by four additional peaks at 216 , 300 , 523 and 654 cm^{-1} [28]. Again, akaganéite molecules (β -FeOOH) were identified in a panel specifically extracted from a UPN profile close to water pipes (MCB), showing very intense absorption bands at 307 , 385 and 720 cm^{-1} (Figure 3d).

Comparison of the samples with scarce delamination, like specimen M4 in Figure 3e, with other having similar rust products, like MSB in Figure 3f, which are both far from gutter pipes or pipelines, indicates that the major iron oxide structures correspond to magnetite (Fe_3O_4 ; 660 cm^{-1}) [29] and hematite (α - Fe_2O_3 ; 224 , 290 , 410 , 500 , 610 cm^{-1}) [3]. These data confirm the mechanism reported by several authors [10,30–32] with respect to the products identified in the oxide layer of weathering steel exposed to various atmospheres. Furthermore, magnetite (Fe_3O_4) and hematite (α - Fe_2O_3) were not detected on the surface of specimens classified with

Figure 3. Optical micrographs from rough oxide surfaces (left) and Raman absorption bands from the point highlighted (right) on the micrograph for: (a) M1; (b) M3; (c) M10; (d) MCB; and (e) MSB, extracted from AISI 1012 steel profiles installed in *Sant Manuel* pavilion. Scale bars inset: 50 μm .

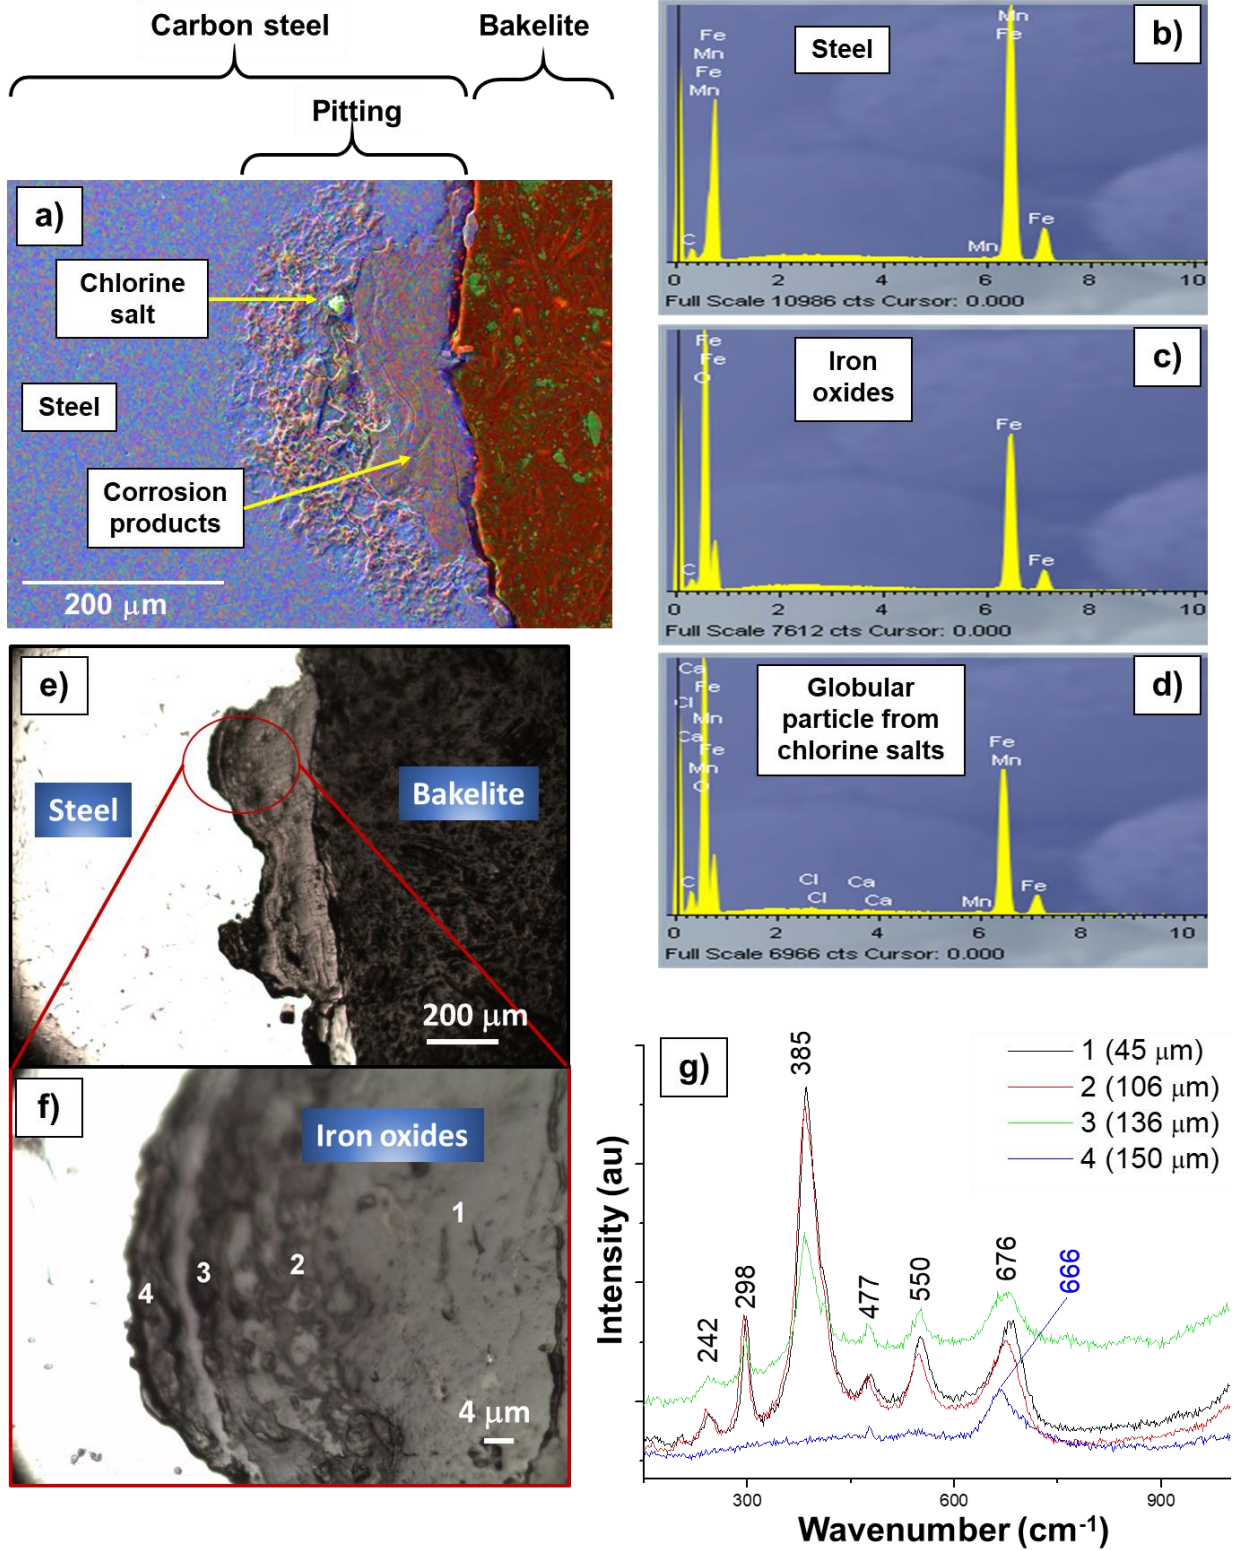
Figure 4

A detailed inspection of localized pitting corrosion in a sample with advanced corrosion degree (MCB, Table 1) allowed the detection of oxide layers with chlorine and calcium ions within the evaluated region (Figure 4). SEM micrograph showed in the Figure 4a represents one of the several localized corrosion attacks found in the AISI 1012 surface (polished cross-sectional cut). EDX analyses allowed us to corroborate that the centenary steel is free of metals like chromium and copper, which would accelerate the corrosion mechanism. The semi-quantitative EDX concentration was found to be (in atomic %): Fe > 99%, C ~ 0.80% and Mn 0.37-0.40%. The EDX from the metal surface (cross-section of the inner metal interface) has a high concentration of Mn, as shown in the Figure 4b, whereas the EDX of the main rust products inside the pitting zone (Figure 4c) revealed Fe, O and C as principal elements. In addition to the oxides and hydrated oxyhydroxides discussed before, the presence of chlorine salts was observed as spherical particles trapped inside the iron oxide molecules (Figure 4d), as well as the presence of calcium. The presence of calcium carbonate, calcium silicate hydrate, and calcium chloride substances within the cement, that is in direct contact with the metallic structures, are responsible for the AISI 1012 depassivation and pitting corrosion, as stated in our previous electrochemical study [20]. In such previous work the presence of calcium chloride (CaCl₂) salt was proved by FTIR and XRD analyses.[20] EDX results (Figure 4d) led us to confirm, once again, that chlorine contamination came from the Portland cement, which was in direct contact with the sample MCB for several years, migrating to the iron oxide layer after hydration. Mechanism of depassivation of steel reinforcement and, consequently, steel pitting corrosion under contact with cement, was reported by Bertolini & Redaelli.[33]

Furthermore, results derived from the Raman analyses of the cross-section made on another zone of sample MCB (Figures 4e-f) confirmed the above mentioned observations. From the outer layer (oxygen-rich) to the inner (metal-oxide interface) (Figure 4g):

Figure 4. (a) SEM micrograph of a typical corrosion layout observed on MCB sample (UPN profiles close to gutter pipes). EDX spectra obtained for each zone shown on (a), which correspond to: (b) carbon steel, (c) iron oxides and (d) spherical particles. (e-f) Low and high magnification optical micrographs from another cross-section of sample MCB analyzed with μRaman (g). The numbers inset are from outer to inner rust formation (1 to 4) showed in (f). Scale bars are indicated in all cases.

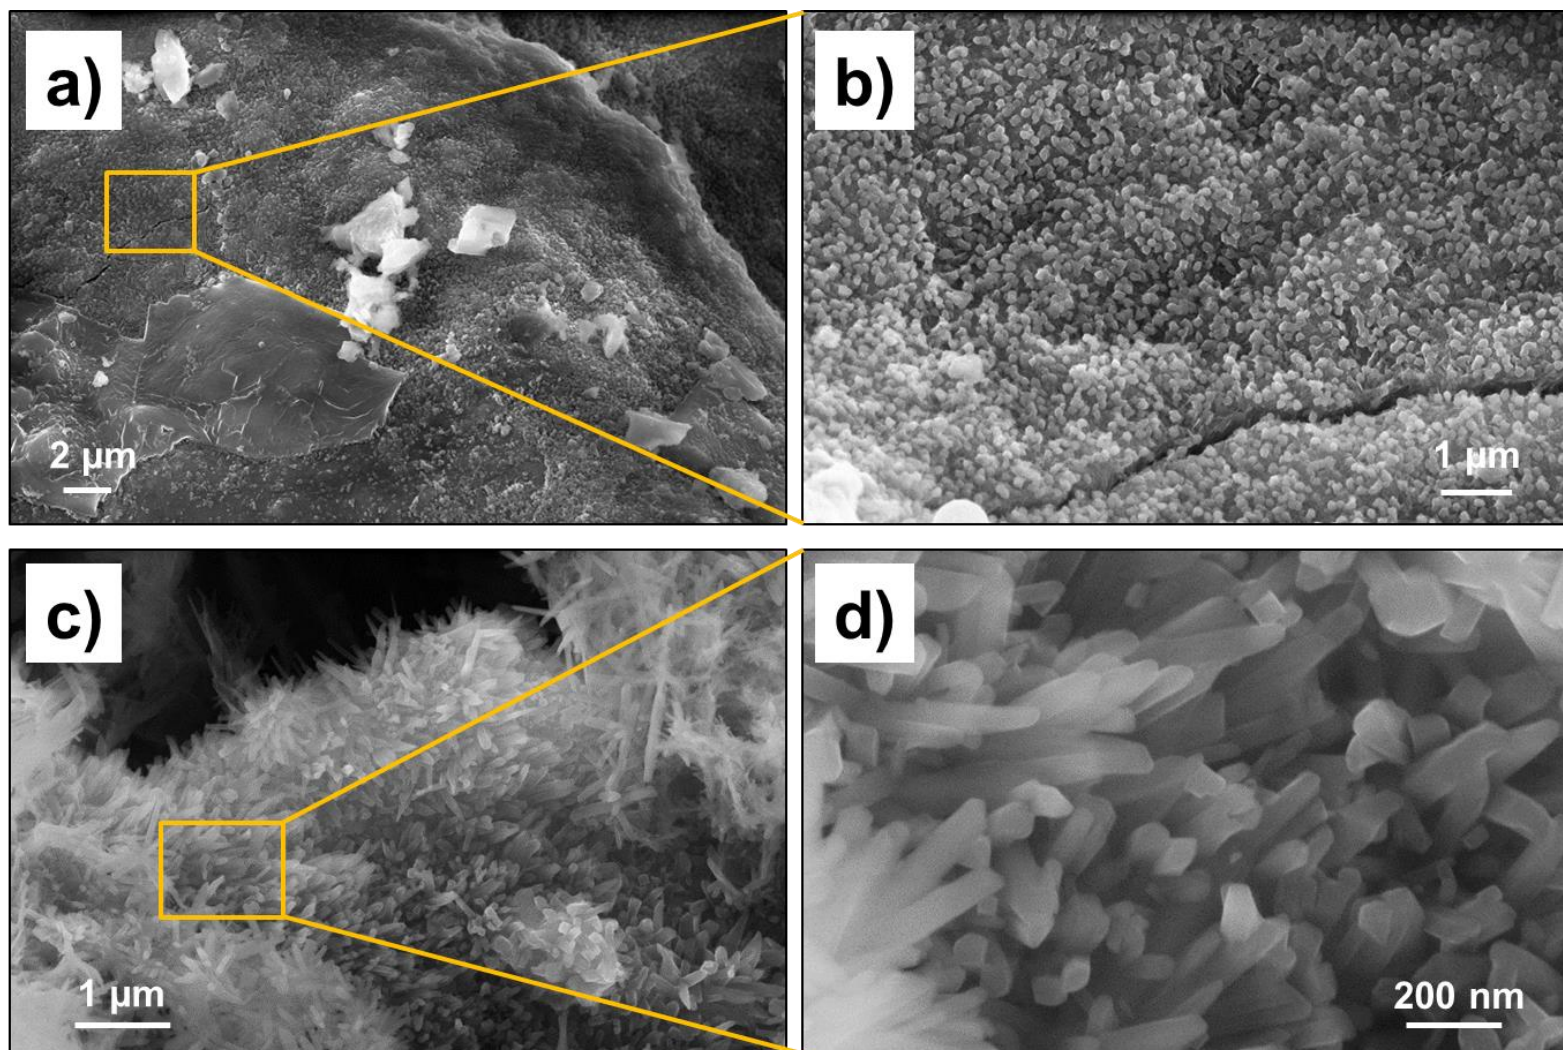
Figure 5

SEM micrographs revealed several cracking zones, flaking and high porosity topographies when evaluating the oxides layers on AISI 1012 steel. The distribution of corrosion products in the outer layers is irregular and consists of different crystalline phases. In samples with high oxide delamination, like M1, M3 and MCB (Table 1), the flakes were detached from the specimen surface and both the external side (oxygen-rich) and internal side (less oxygen-rich) were observed. In the outer layers a mixture of well-known morphologies typically found for akaganéite (Figure 5), goethite (Figure S3) and lepidocrocite (Figure S4) were found. Akaganéite ($\beta\text{-FeOOH}$) appeared meanly on specimens close to gutter pipes and covered by cement, as stated before for samples M3 and MCB, and has an elongated crystalline appearance, sometimes aggregated as distorted cubes (Figure 5b). Figures 5c-d show SEM micrographs of areas exhibiting abundant elongated crystals of akaganéite. The other sequential morphologies found and their respective classification were included in the ESI, as well as a detailed discussion. Unfortunately, in this study we did not have enough evidences to corroborate the presence of maghemite structures ($\gamma\text{-Fe}_2\text{O}_3$) and further EDX characterizations would be necessary for the quantification of Fe:O atomic concentration ratio.

Figure 5. SEM micrographs corresponding to akaganéite crystalline phase found indistinctly in samples M1, M3 and MCB: (a) low magnification of rust outer layer, showing some flakes and cracks; (b) high magnification of image (a, inset), with aggregated particles (distorted cube geometry); (c) high magnification of elongated crystals; and (d) very high magnification of the previous micrograph showing an area rich in elongated crystals.
