ADVANCED MASTERS IN STRUCTURAL ANALYSIS OF MONUMENTS AND HISTORICAL CONSTRUCTION

Master's Thesis

Significance and Conservation of Thin-Shell Concrete Structures of the 20th Century

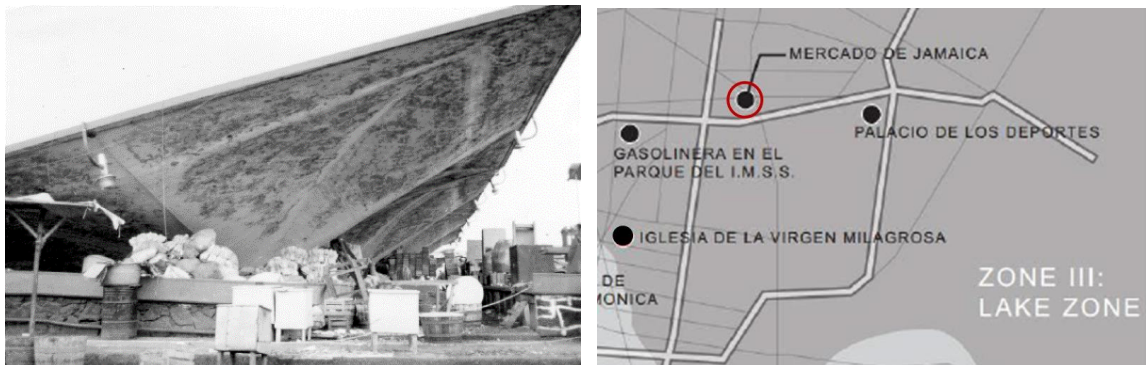
Figure 23. Collapse of umbrella columns, shells are seen without apparent noticeable damage (left) and location and soil types in Mexico City (right).

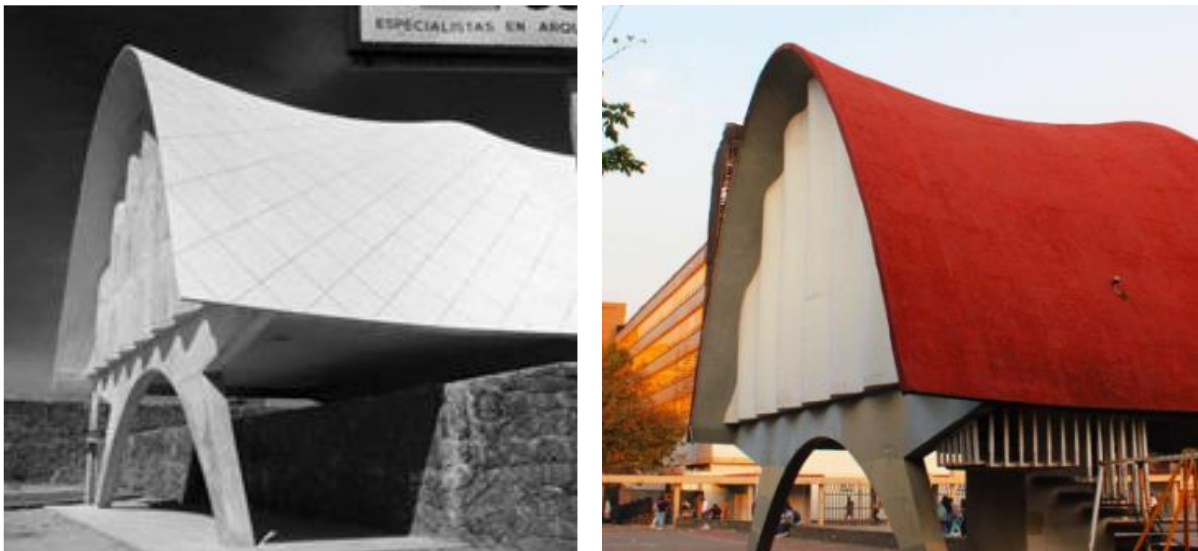
Figure 34. Cosmic Ray Pavilion hyper view in 1952 (left) and current state (right).

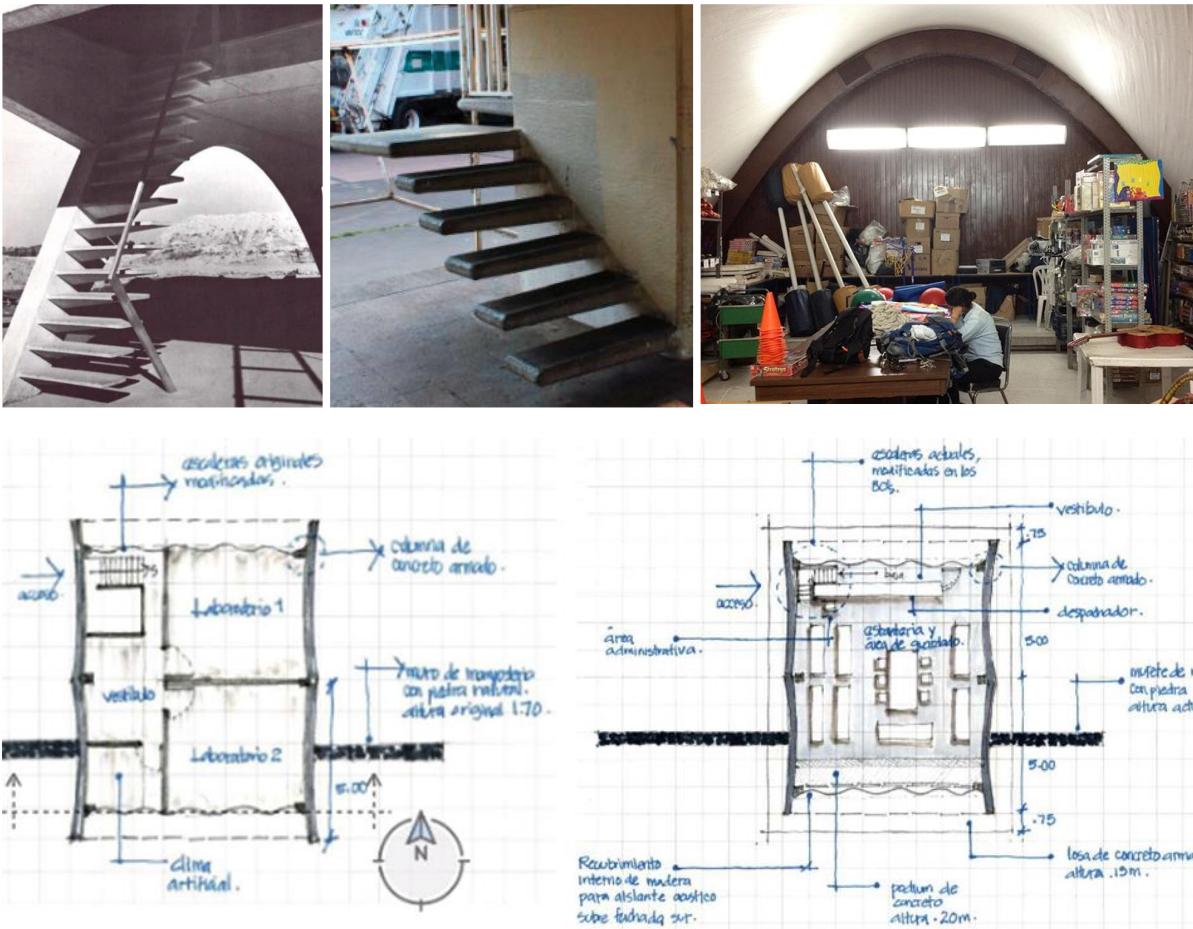
Figure 35. The images show the changes in the stairs and the acoustic timber panel. The sketches show the alterations to the original project (left) and the current state (right) of the Cosmic Ray Pavilion.

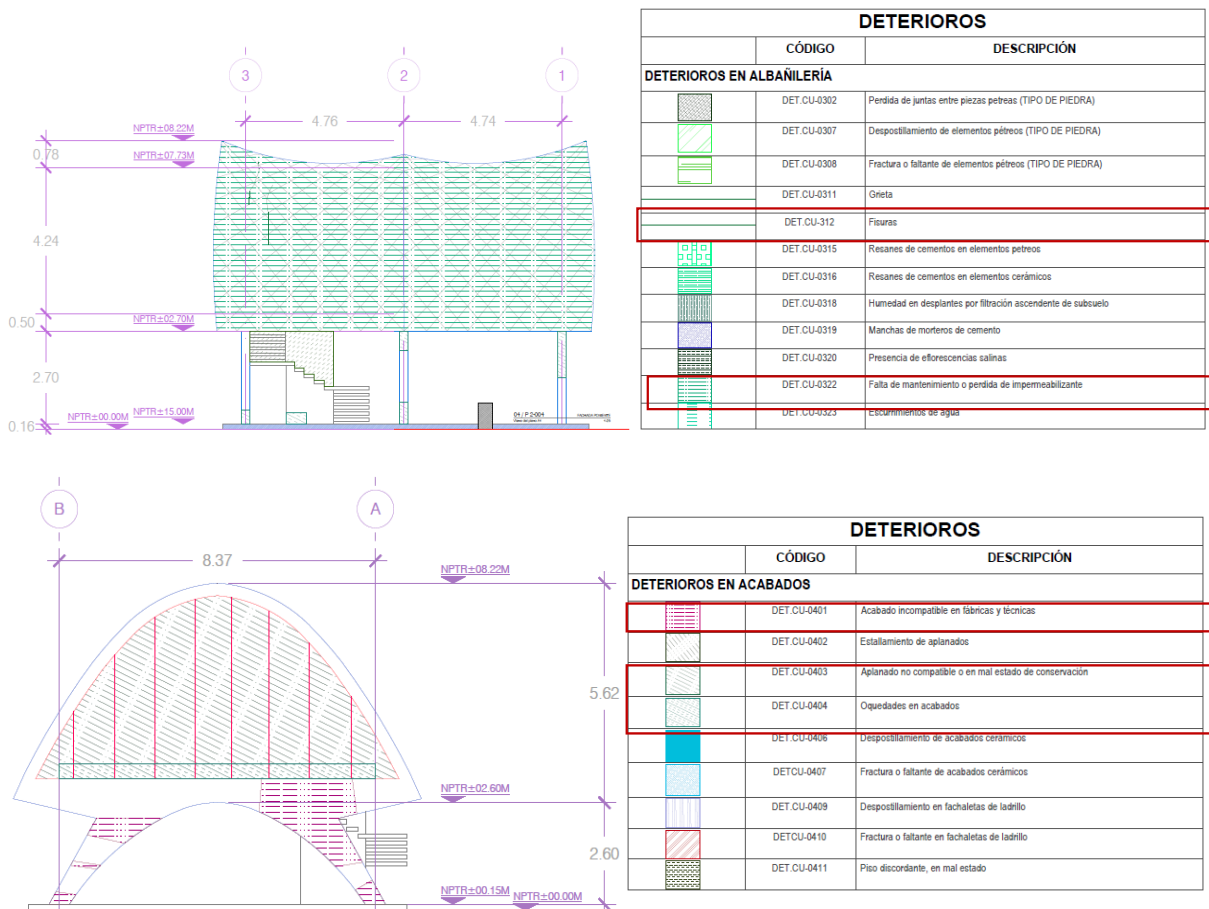
Figure 36. Damage survey elaborated for the maintenance program. West facade (top) and North façade (bottom) of Cosmic Ray Pavilion.

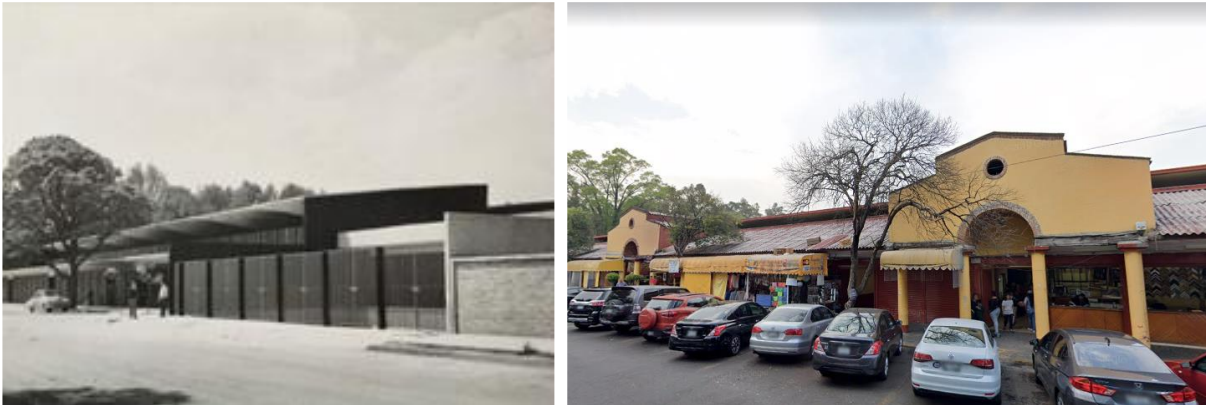
Figure 37. Façade alterations in Coyoacán market.
Note: In (Structurae, n.d.) and (Google Maps, 2019).

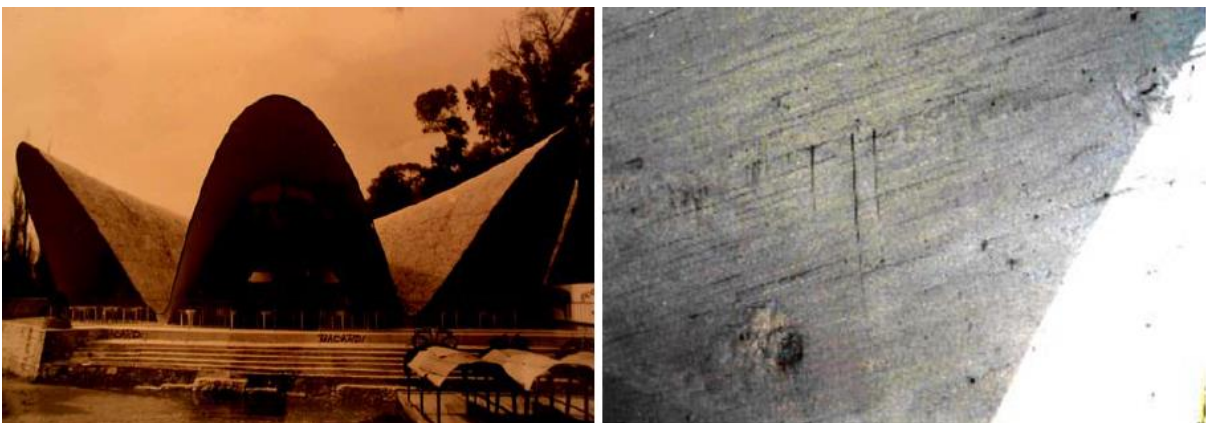
Figure 38. Shrinkage cracks pattern after construction (left) and patched leaks (right) in Los Manantiales.

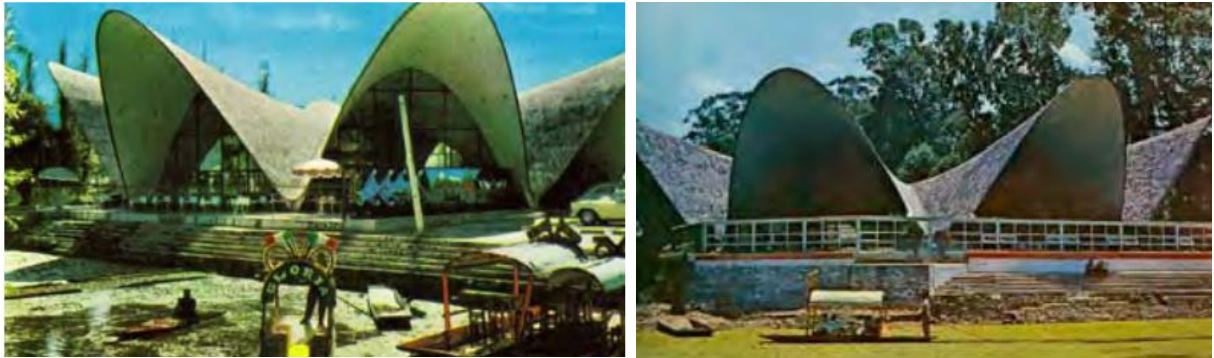
Figure 39. Water level changes and additions at the exterior of the restaurant.

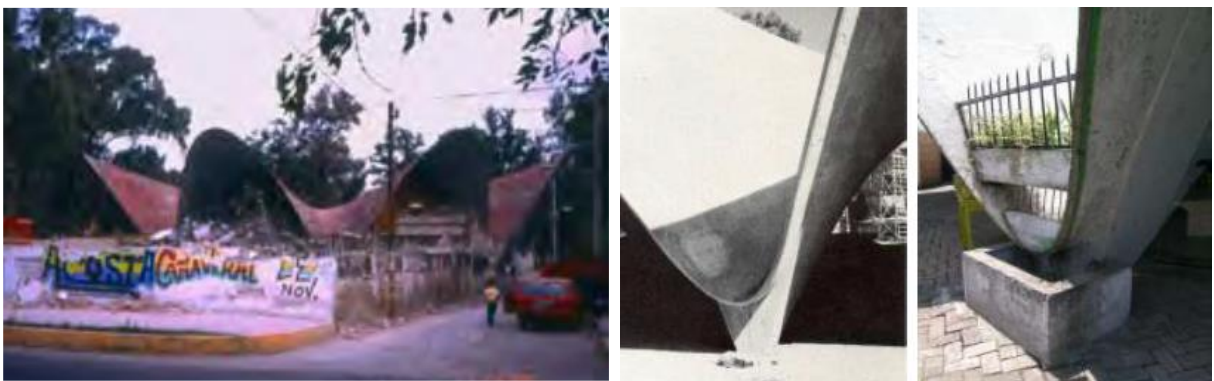
Figure 40. Red waterproofing in 1996 (left) and protections and addition of water collector (center and right).

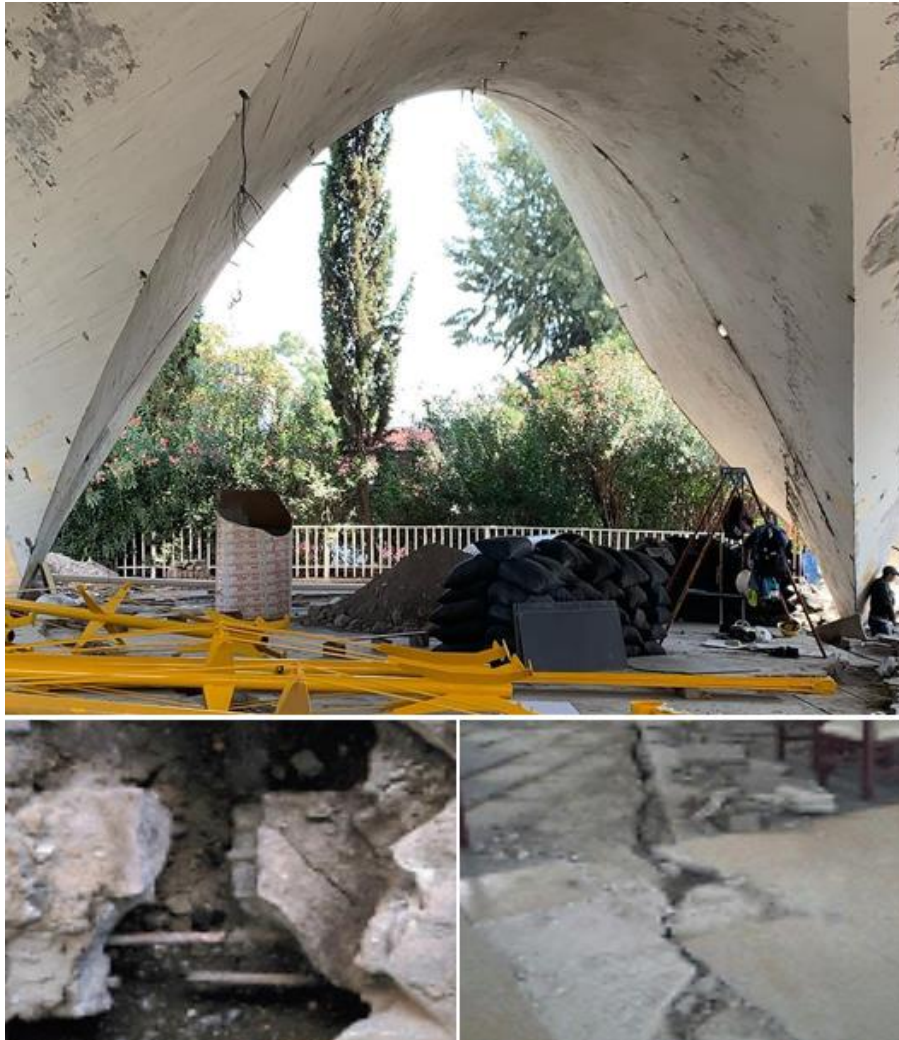
Figure 41. Lost of geometry at the hypar of Los Manantiales (top), Broke tie (left), and ground fracture (right).

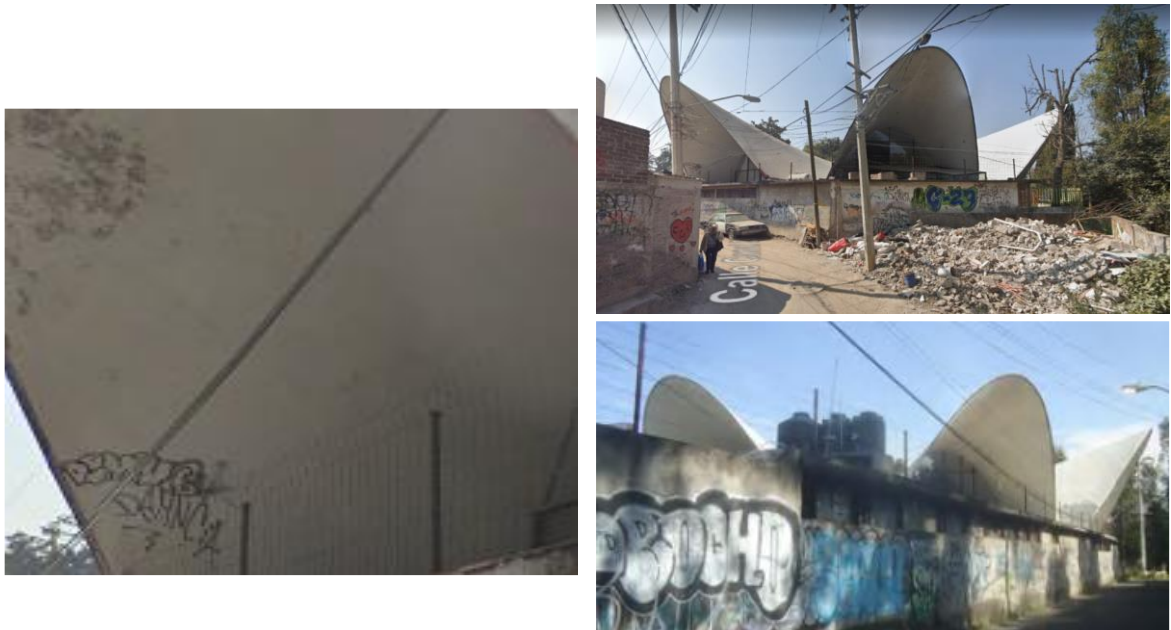
Figure 42. Urban context and vandalism.

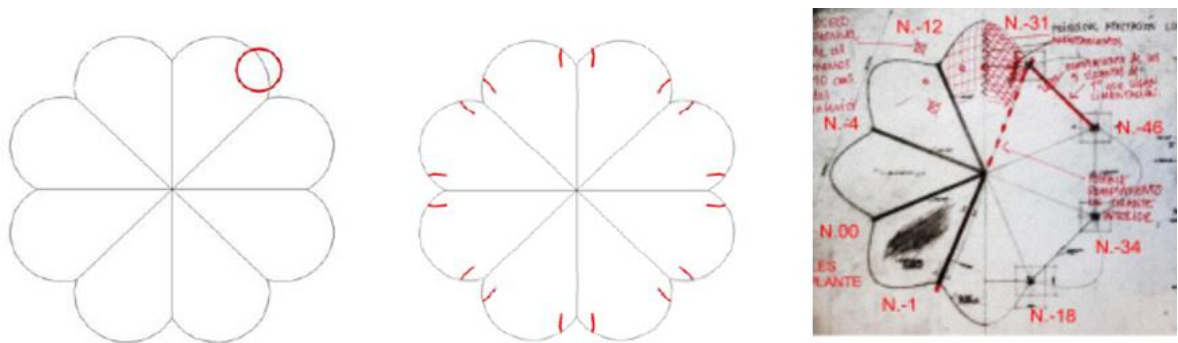
Figure 43. Los Manantiales damages in 2006 (left and center) and damages after the earthquake (right).

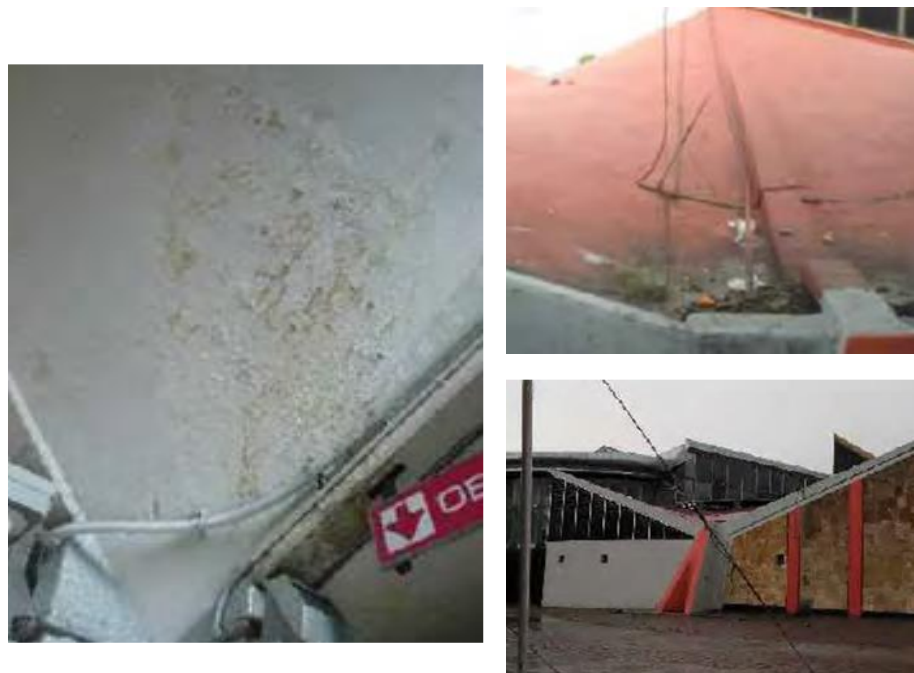
Figure 45. Moisture (left), roof water draining (top) and space additions (bottom) of Metro Station.

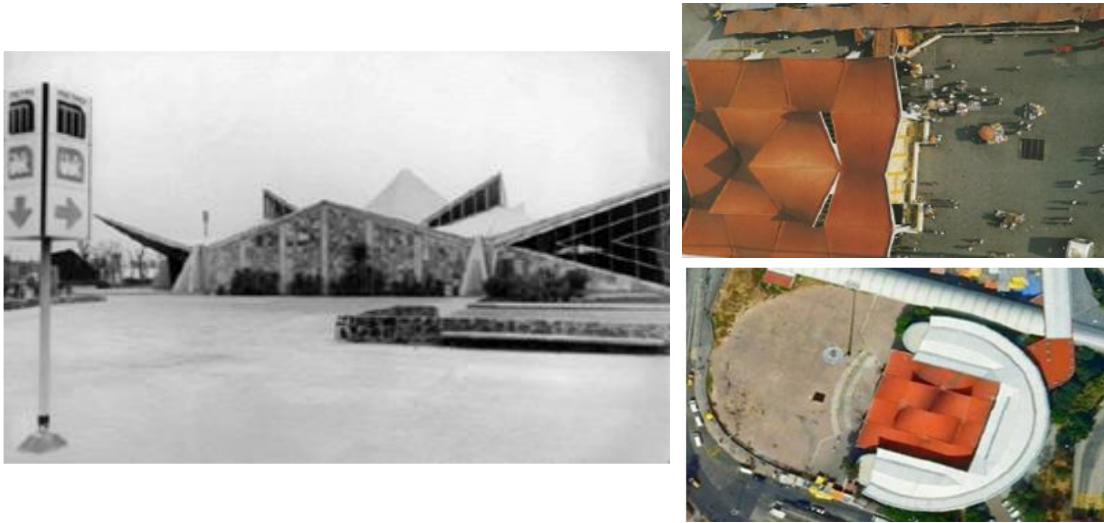
Figure 46. Esplanade with gardens and without corridors (left), Station with cover corridors at 90's (top) and esplanade after 1997 (bottom).
