Diagnosis of the unstable behaviour of a Kaplan turbine before synchronizing to the grid

G Moraga¹, V Mut², C Hijón², J Girardelo², D Valentín¹, M Egusquiza¹, E Egusquiza¹, A Presas^{1,3}

¹ Centre for Industrial Diagnosis and Fluid Dynamics (CDIF) – Universitat Politècnica de Catalunya, Barcelona, Spain

² ELECNOR S.A., Madrid, Spain

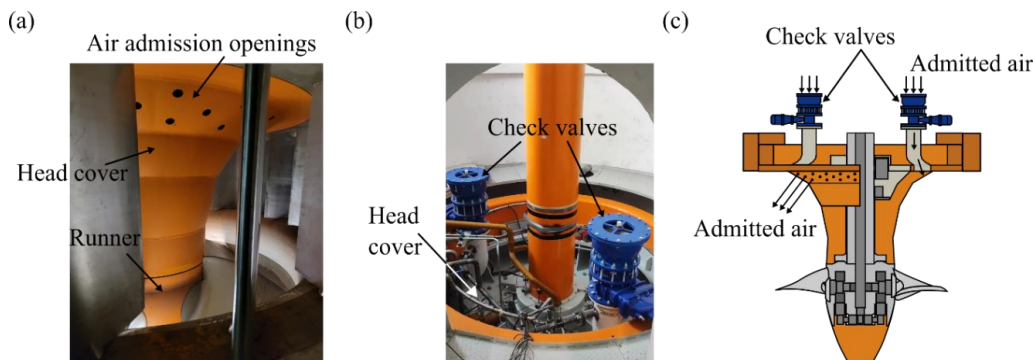
Due to the slight instability of the electrical grid where this power plant is located, frequent load rejections can be triggered. Consequently, hazardous effects, such as the separation of water columns, may occur due to the sub-pressure reached in the inlet of the draft tube after a sudden closure of the distributor. To mitigate this effect, the head cover of each unit has been equipped with an air admission system. This system allows atmospheric air to enter the runner chamber through several openings in the head cover (see figure 1a). These openings are connected to check valves, which allow the passage of atmospheric air once a certain level of sub-pressure is detected (see figure 1b,c).

Figure 1. Air admission system: (a) Air admission openings, (b) Check valves, (c) Air admission system.

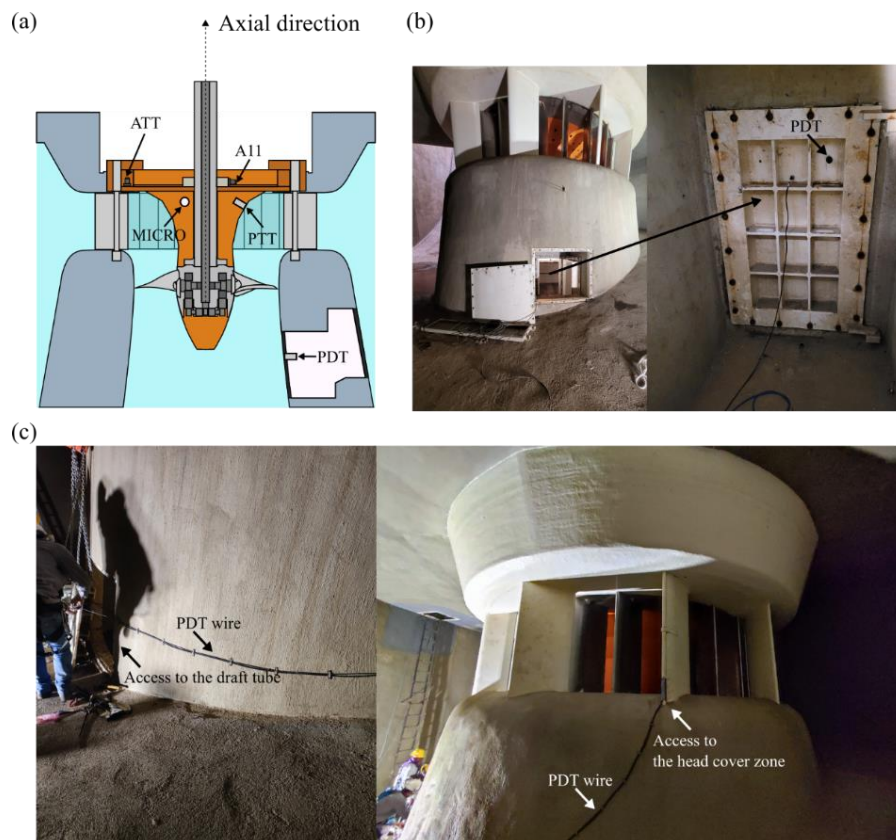
Figure 2. (a) Location of the sensors in within the unit: ATT: Accelerometer in the head cover structure, A11: Accelerometer in the turbine bearing in radial direction, MICRO: Microphone in the head cover, PTT: Pressure sensor in the head cover and PDT: Pressure sensor in the draft tube. (b) Pressure sensor installed in the draft tube. (c) Wiring of PDT towards the head cover zone.

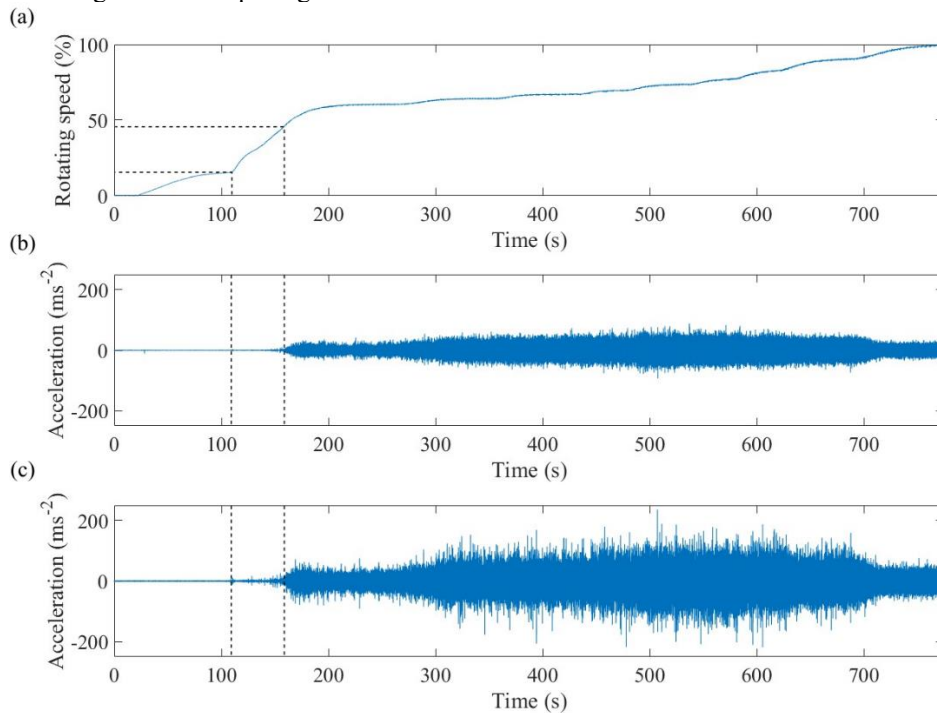
As previously explained, the unit was tested and measured during its acceleration to nominal rotating speed (NRS). As shown in figure 3a, the unit was slowly accelerated from standstill to NRS to identify when the issue arises. When the machine reached approximately 15% of the NRS, a slight increase in the vibrations amplitude was detected by the accelerometer on the head cover (see figure 3b). After this and just before the machine reached 50% of the NRS, the vibrations amplitude drastically increased (see figure 3b,c), with the highest measurements taken by the accelerometer installed in the head cover structure (ATT in figure 2). Although these vibration amplitudes decreased when the unit was reaching the NRS (after second 700 in figure 3), they remained excessive (according to ISO 20816–5:2018) while the machine was operating at speed no load. This behaviour persisted across all tested configurations for runner and guide vanes openings.

Figure 3: Acceleration to nominal speed: (a) Rotating speed as a percentage of the NRS, (b) Response of A11 ($\text{RMS} = 1.716 \text{ ms}^{-2}$) and (c) Response of ATT ($\text{RMS} = 2.624 \text{ ms}^{-2}$). All the RMS values were calculated at NRS.

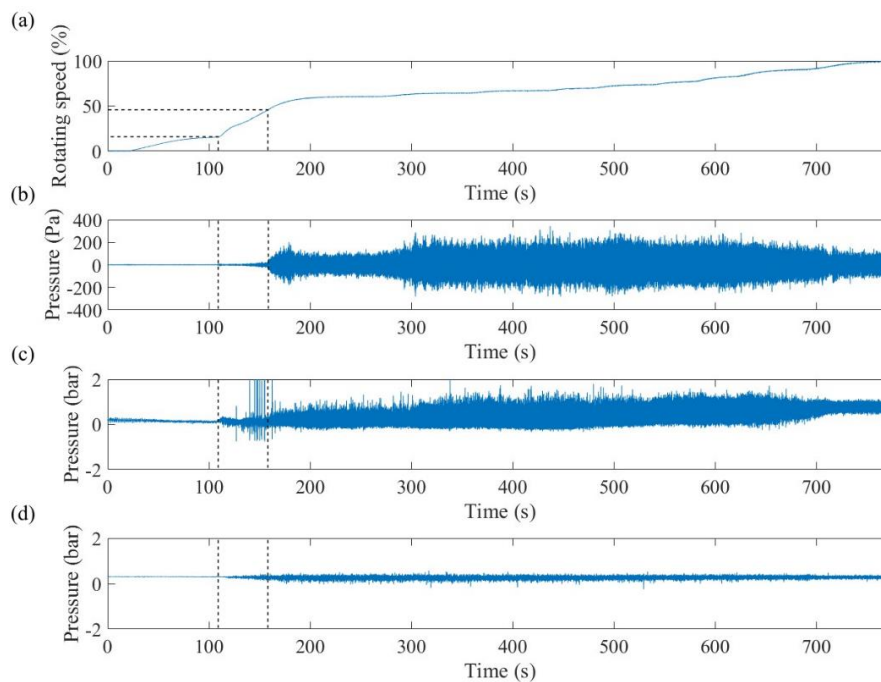
The sound pressure and pressure pulsations were also analysed. Similar to the response of ATT, the noise detected from the head cover slightly increased after the machine reached 15% of the NRS (see Figure 4b). This increasing was also detected by the pressure sensor in the head cover and the draft tube (see figure 4c,d). As shown before with the installed accelerometers, the amplitude of the noise and the pressure pulsations significantly increased when the unit reached 50% of the NRS. Regarding to the pressure pulsations, it can be seen that the highest amplitudes were measured in the head cover (see figure 4c).

Figure 4: Acceleration to nominal speed: (a) Rotating speed as a percentage of the NRS, (b) Response of MICRO (RMS = 32.912 Pa), (c) Response of PTT (RMS = 38.886 mbar), and (d) Response of PDT (RMS = 28.221 mbar). All the RMS values were calculated at NRS.

According to the results from the measurements carried out, the most intense pressure pulsations occurred in the head cover of the unit. In consequence, the highest vibration amplitudes were detected in this structure by the sensor ATT. Although pressure pulsations, resulting from fluid-structures instabilities and self-excited vibrations in the runner, could induce strong vibrations in the head cover, these pulsations should be detected by the sensor PDT, whose response was not significantly high. Moreover, it is possible to see in figure 3 and figure 4, that the general response of the sensors installed in the head cover (PTT, MICRO, ATT and A11) is stronger than the one installed in the draft tube (PDT). This suggests that the origin of the problem could be located in the head cover.

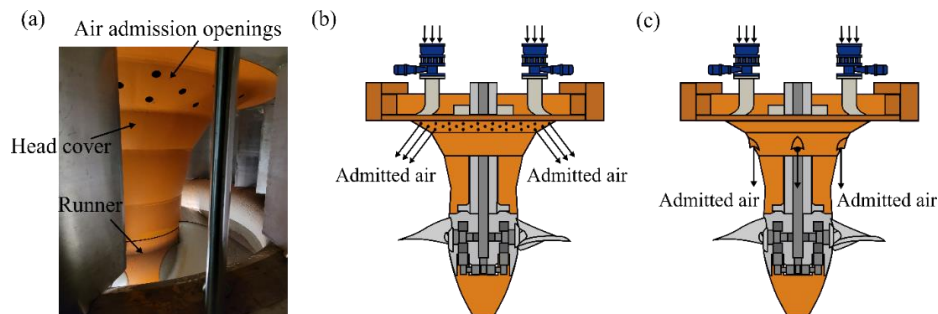
After analysing the head cover structure, shown in figure 5a, it was concluded that the passage of the water through the air admission openings in the head cover could have been exciting its structure, leading to the excessive vibrations detected by the sensors installed on it. However, as the air admission system is of paramount importance to prevent the water column separation and its dangerous rejoin, the head cover was modified in order to mitigate the fluid-structure interaction between flow and the head cover, without eliminating of the aeration openings. For this, the original openings (schematically shown in figure 5b) were sealed and replaced with five new openings (schematically shown in figure 5c). These new air admissions were nearly ten times the size of the original ones. Additionally, the orientation of these openings was altered from the original design, with the new ones positioned to face the axial

Figure 5: Air admission openings: (a) Picture of the original head cover of the unit, (b) Scheme of the original head cover and the passage of the air admitted and (c) Scheme of the modified head cover and the passage of the air admitted.

direction. Lastly, the air admission valve was calibrated to open only when a certain level of sub-pressure is reached.

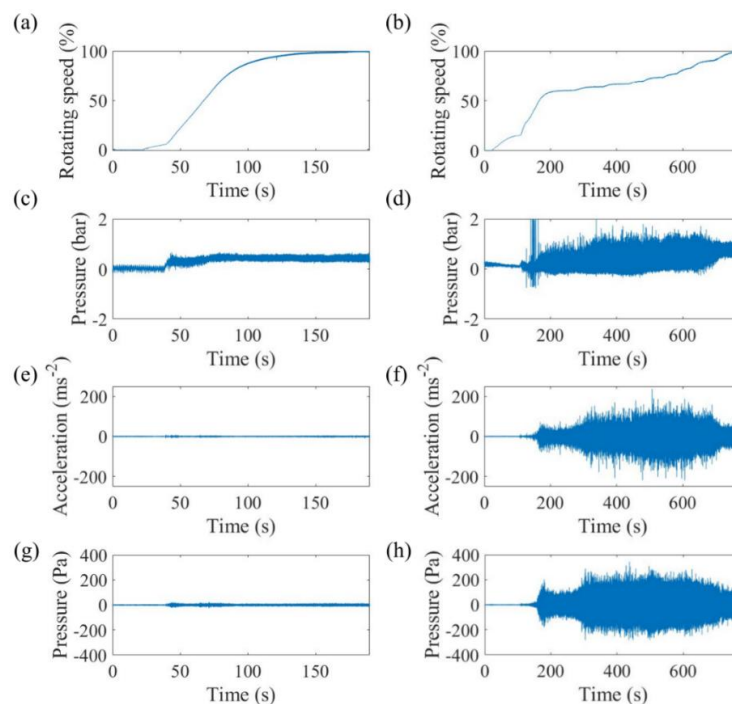
Once the head cover of the unit was modified, a new start-up test was conducted and new measurements were taken. The unit was accelerated from standstill to its nominal rotating speed (as shown in figure 6a). In this case, start-up was faster than the one shown in the past section (see figure 6b). It can be observed that following the modification of the head cover, the pressure pulsations on this structure decreased significantly (see figure 6c,d). In consequence, the strong vibrations and loud noise were also substantially reduced, decreasing up to 90.28% and 95.03%, respectively. (see figure 6e-h).

Figure 6: Start-up test after modifications of the head cover. Rotating speed as a percentage of the NRS: (a) After modifications and (b) Before modifications. Response of PTT at NRS: (c) After modifications (RMS = 51.937 mbar) and (d) Before modifications (RMS = 38.886 mbar). Response of ATT at NRS: (e) After modifications (RMS = 0.255 ms⁻²) and (f) Before modifications (RMS = 2.624 ms⁻²). Response of MICRO at NRS: (g) After modifications (RMS = 1.634 Pa) and (h) Before modifications (RMS = 32.912 Pa).

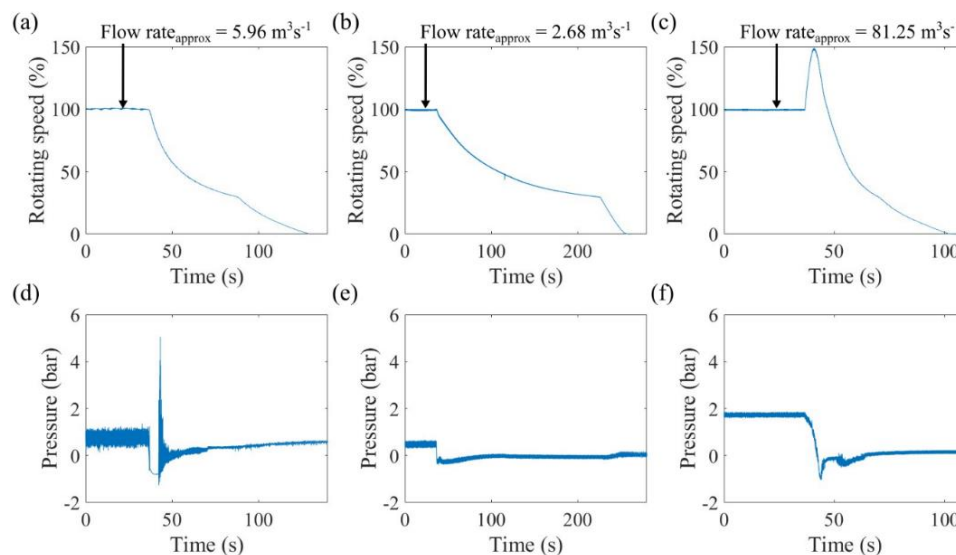
- The first situation involved an emergency stop triggered by the SCADA due to excessive vibration levels in the head cover (see figure 7a). This event took place during the initial commissioning tests prior to any modifications to the structure. At this point, the machine was operating at NRS, with no-load, and the AAS was not activated. The approximate flow rate in this situation before the closing of the distributor was approximately $5.69 \text{ m}^3\text{s}^{-1}$.

- The second situation was another emergency stop that occurred during a failed attempt to connect the machine to the electrical grid (see figure 7b). This event occurred during the commissioning tests after modifications were made to the head cover. In this case, the machine was operating at NRS, with no-load, but with the AAS activated. The approximate flow rate in this situation before the closing of the distributor was approximately $2.68 \text{ m}^3\text{s}^{-1}$.

- The third situation was a programmed load rejection during the final commissioning tests (see figure 7c), to test the behaviour of the machine under these conditions. Here, the machine was operating at NRS, at maximum load, and with the AAS activated. The approximate flow rate in this situation before the closing of the distributor was approximately $81.25 \text{ m}^3\text{s}^{-1}$.

Figure 7: Variation of pressure after a sudden closing of the distributor (relative pressure). Rotating speed as a percentage of the NRS: (a) No load and AAS disabled, (b) No load and AAS enabled and (c) Maximum load, load rejection and AAS enabled. Response of PTT: (d) No load and AAS disabled, (e) No load and AAS enabled and (f) Maximum load and AAS enabled.

Upon analysing the PTT sensor during the first situation (figure 7d) it was observed that the pressure in the head cover dropped nearly 1 bar (meaning close to the absolute 0) quickly after the distributor suddenly closed. This was followed by an abrupt pressure increase of nearly 6 bar after a few seconds, possibly due to the restoration of the column of water inside of the unit. In the second situation (figure 7e), a quick pressure drop of nearly 0.8 bar was detected after the distributor suddenly closed. However, with the AAS activated, a pressure increase of nearly 0.3 bar was detected in the head cover after a couple of seconds. It is important to note that the activation of the air admission system is the only difference between the first and second situations.

In the third situation (figure 7e), a pressure drop of 2.7 bar was measured by the PTT sensor. This was followed by a sudden increase of 0.7 bar in the head cover after a second. It is noteworthy that

before the load rejection, the machine was operating at maximum load, and therefore, a much higher flow rate was circulating through the machine. Consequently, without the AAS activated, the pressure drop and increase due to the water column restoration could be much higher in magnitude. However, because the air admission system was activated, the pressure increase after the drop was 8.5 times smaller than that in the first situation (see figure 7d). It also can be noticed that the static pressure prior to closing the distributor (see figure 7f) is significantly higher than in the other two situations (figure 7d,e). This difference can be attributed to the energy losses experienced by the flow when it passes through the distributor and runner chamber.
