Dissertation

Master of Science

ADVANCED MASTERS IN STRUCTURAL ANALYSIS OF MONUMENTS AND HISTORICAL
CONSTRUCTIONS

SULPHATE ATTACK AND THE ROLE OF THAUMASITE IN HISTORICAL CONSTRUCTIONS

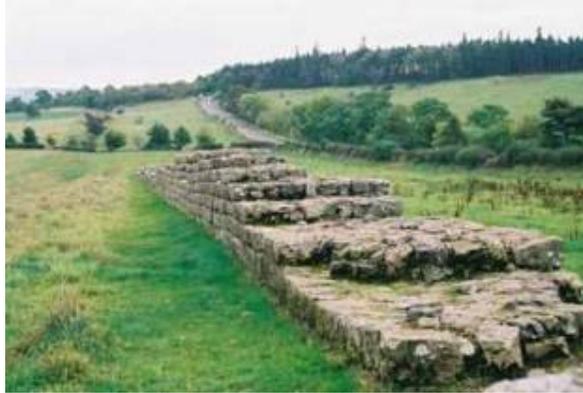
Figure 1 Hadrian's Wall, England, a few miles east of Housesteads was built in A.D. 122 by three Roman Legions, using local materials available, and in some parts the stone faced an inner core composed of concrete and rubble (Source: www.understandin-cement.com).

Historically, the techniques of producing hydraulic mortars was dominated around the 10th century BC by the Phoenicians and the Israelites, generally obtained by mixing lime and crushed ceramics (cocciopesto). After that, pozzolanic¹ sand was used by Greeks, and a type of sand of volcanic origin, present near Pozzouli (which give the name pozzolanic), was used by Romans in a concrete-like masonry made of crushed stone pieces with burned lime and water as binding material with a good performance to produce hydraulic mortars. This was principally due to the presence of silica (SiO₂) and alumina (Al₂O₃), both amorphous, that have a vitreous state and high specific surface area; those characteristics allow it to react with lime and water to form calcium silicates and aluminates hydrates (Balén et al, 1999; Popovics, 1992). An example of Roman construction using ancient cement is presented in Figure 1.

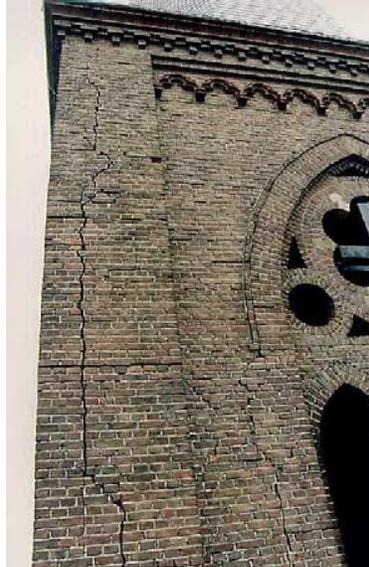
Figure 13 Church tower in Noordwijk, with both vertical and horizontal cracks (van Hees et al, 2003).

only through horizontal joints. Moreover severe cracking presenting width up to 17 mm occurs in the upper part of the tower. The damage in the tower is presented in Figure 13.

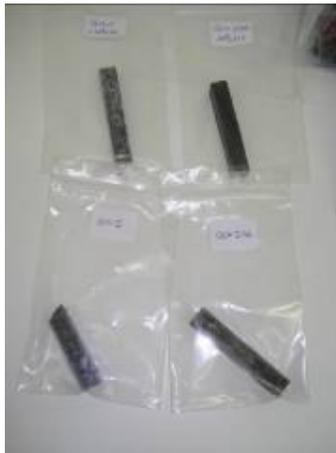
Figure 20 Samples.

Specimens of 1x1x6 cm size were produced by mixing the raw materials and using a water/cement ratio of 0.5 (Figure 20). These specimens were cured for 3 months at 21°C and a relative humidity of 95–100% and subsequently subjected to carbonation in chambers at the laboratory, at the following conditions:

- 4% CO₂ concentration and RH=75%:
 - 15 days;
 - 30 days;
- Air carbonation and providing humidity twice a day:
 - 15 days;
 - 30 days;

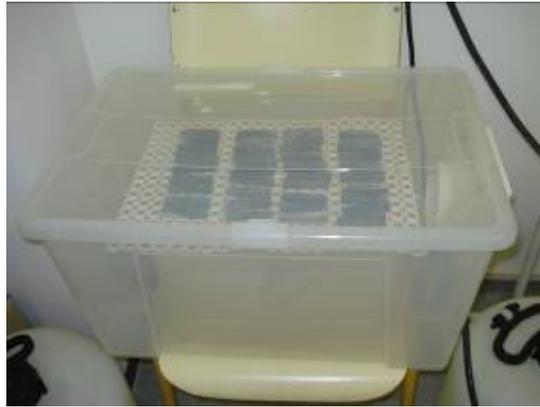
Figure 21 Samples at carbonation chambers.

The relative humidity for the first samples was assured using a recipient with water saturated with NaCl inside the carbonation chamber to maintain it at 75% (Figure 21). In this case the CO₂ was inserted in the chamber twice a day. In the air carbonation the air was circulated for one hour twice a day by a ventilator.

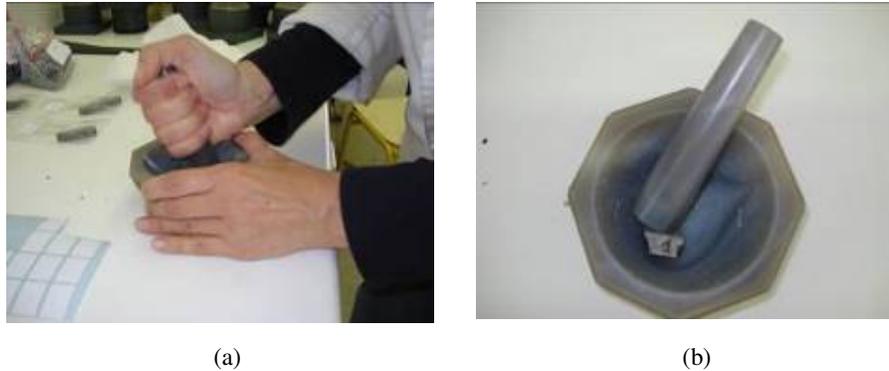
Figure 23 Samples grinding.

Paste specimens were grounded (Figure 23) and the hydration process stopped using alcohol and acetone (Figure 24). X-Ray Diffraction and Fourier Transform Infra-Red of the pastes were performed at the following times: end of the cure period; end of
