Investigation of ball burnishing process using vibration and acoustic emission sensors

Abstract: In this paper, a ball burnishing tool mounted in a CNC lathe is characterized. This tool may work as vibration assisted ball-burnishing tool and in conventional way. The characterization consists of acoustic emission measurements in both burnishing processes, and vibration measurements with tri-axial accelerometers. The acoustic emission measurements permit to investigate if any kind of damage is produced in the material by the burnishing process. An operational deflection shape exercise has been performed with the vibration measurements. This permits to investigate the movement of the tool during the burnishing process and to evaluate the rigidity of the tool.

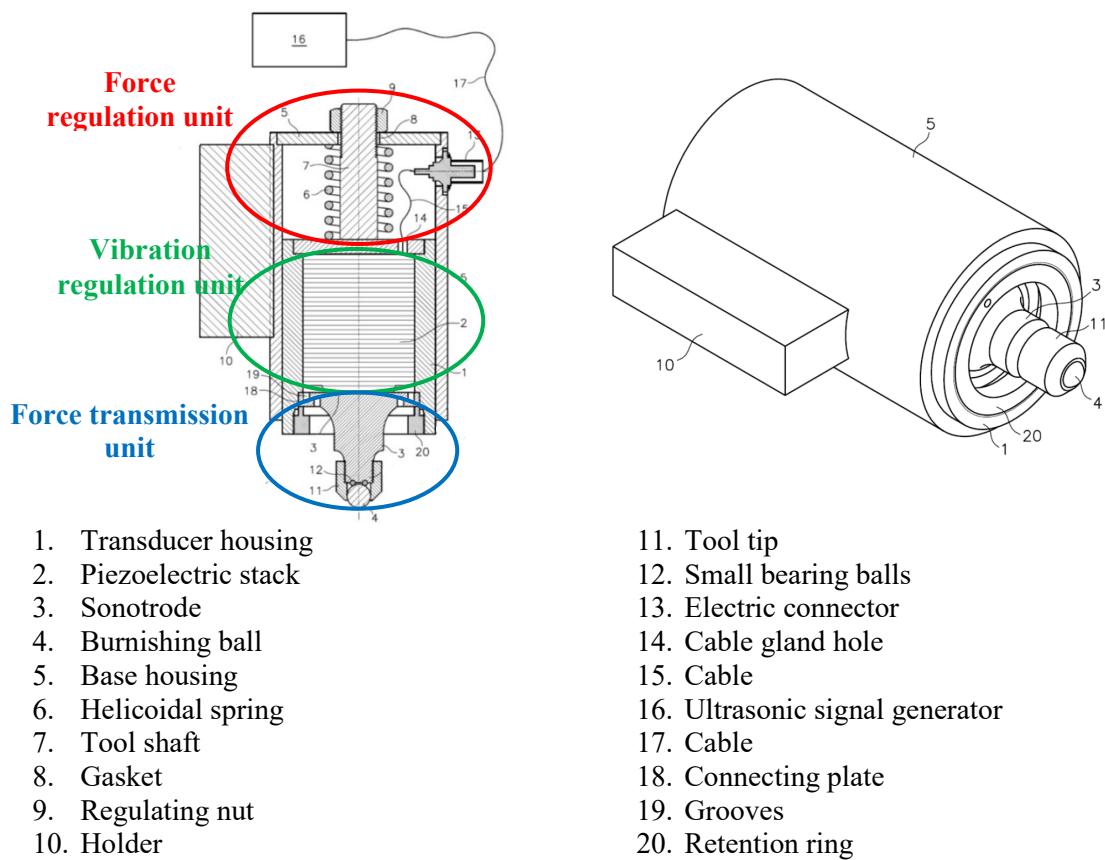
**Figure 1.** Used burnishing tool [12].

The used burnishing tool constitutes an innovative burnishing tool design that includes a piezoelectric vibration generator [12]. This tool is shown in figure 1. It consists of three parts:

- Force regulation unit. It controls the burnishing load by the compression of a spring. It also serves as the element to be clamped inside the tool holder to attach the tool to the machine.
- Vibration generation unit. It contains a piezoelectric stack that is feed by a high frequency harmonic signal and generates the assisting ultrasonic vibration. As explained before, this element called sonotrode.
- Force transmission unit. The function assigned to this module is to transmit the forces generated by the previous units (burnishing load and ultrasonic vibrating load) to the burnishing ball and, consequently, to the target surface. It incorporates an innovative system to support the burnishing ball that is composed by a set of small bearing balls embedded in the tool tip that supports the burnishing ball (figure 1, Position 12)).

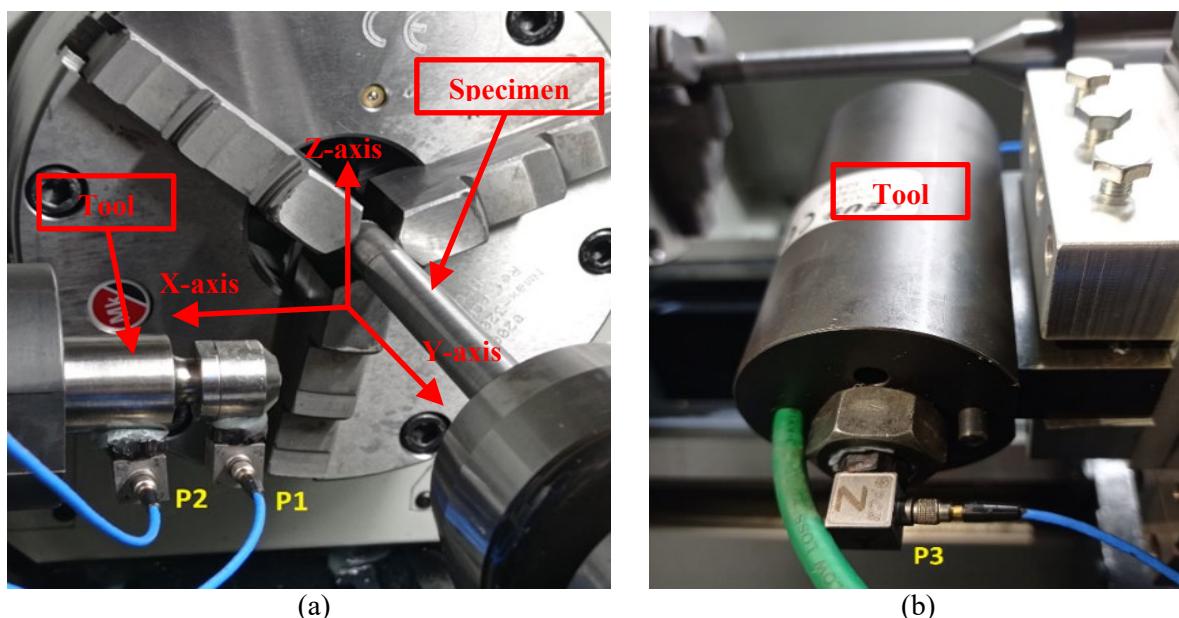
**Figure 2.** Tri-axial accelerometers mounted in the tool and axis. **(a)** Frontal part (accelerometers P1 and P2 and axis). **(b)** Rear part (accelerometer P3).

Three tri-axial accelerometers PCB 356A32/NC6 were installed in the burnishing tool in order to study its vibrating behaviour. Two ones were mounted in the frontal part, near of the burnishing ball (P1 and P2 in figure 2A), and the other was mounted in the opposite part (P3 in figure 2B).

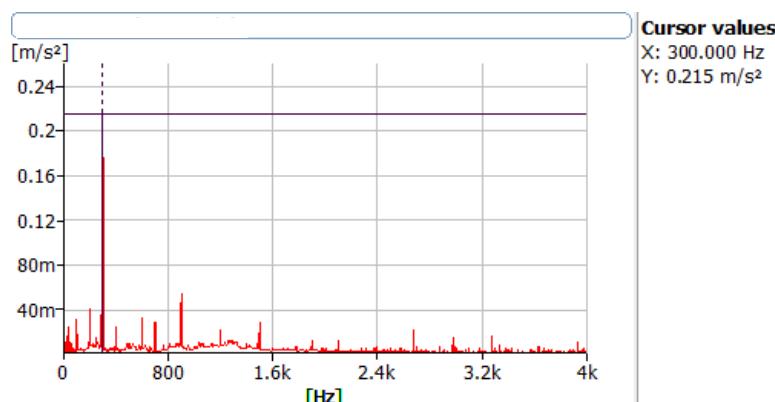
Figure 3. Vibration spectrum of point 1, X-axis.

A wire frame model was defined in the burnishing tool with the three measurement points defined, and then it was animated. The frequency of 300 Hz was selected because all points present a peak at this frequency in all directions. Figure 3 shows, as example, the spectrum corresponding to Point 1, X-axis.

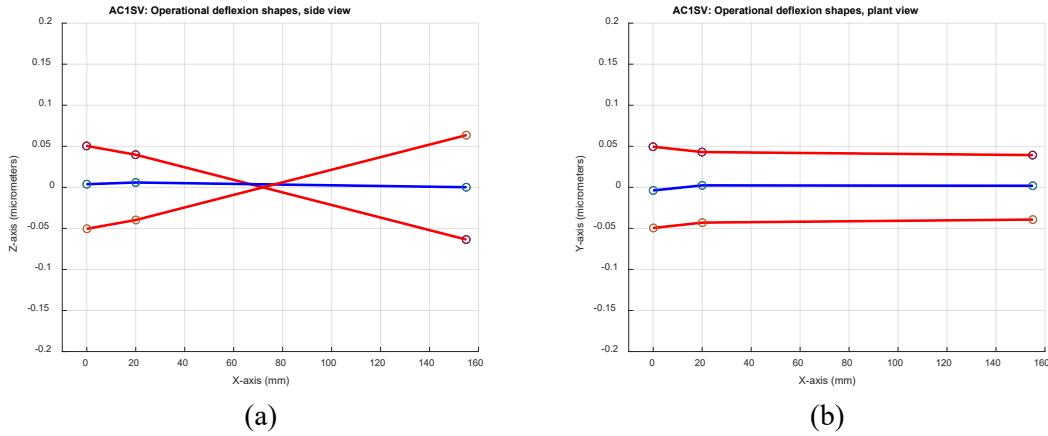
Figure 4. Tool's operating deflection shapes. The red continuous lines correspond to the extreme values and the dotted blue lines correspond to the medium values. **(a)** Left figure corresponds to the side view. **(b)** Right figure corresponds to the plant view

Figures 4 and 5 depict the animation at 300 Hz. Figure 4(a) shows the movement in vertical direction (Z-axis according to figure 2(a)): blue line shows the centre position and red lines show the extremum positions. A rotatory movement around the centre of the tool is clearly noticeable, with an amplitude of the extremes of about 0.05 μm. Figure 4(b) shows the horizontal movement in the direction of the lathe axis (Y-axis according to figure 2(a)). A translational movement of about 0.05 μm amplitude is also noticeable.

A slight tool bending deformation is perceived in figure 4. This is compatible with the constructive arrangement of the sonotrode [9,12].

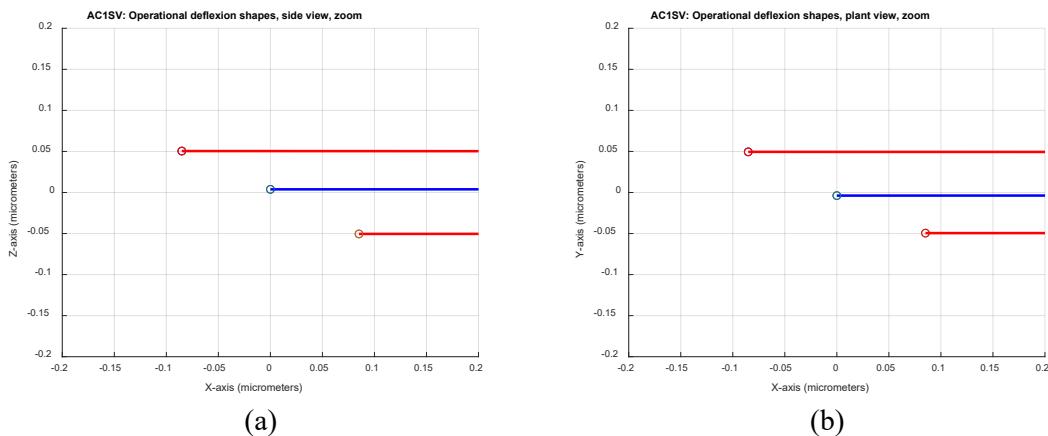
Figure 5. Zoom of the tool's operating deflection shape around the zero point of X-axis. The red lines correspond to the extreme values and the blue lines correspond to the medium values. **(a)** Left figure corresponds to the side view. **(b)** Right figure corresponds to the plant view.

In order to know the movement in the tool axis (X-axis according to figure 2(a)), a zoom around its zero point is shown in figure 5. A displacement in the X direction is clearly noticeable and its amplitude is about $0.09 \mu\text{m}$.

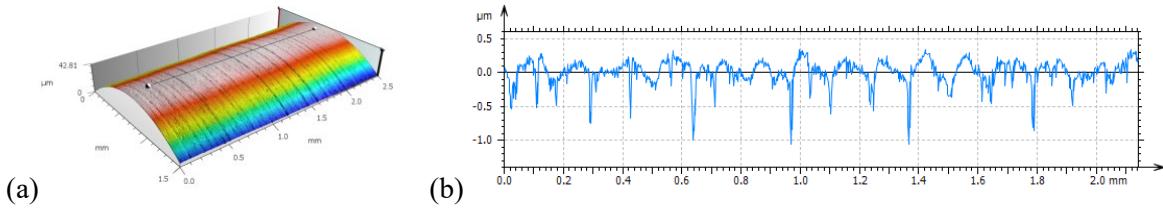
Figure 6. Roughness profile after burnishing. **(a)** Tri-dimensional profile **(b)** Longitudinal section.

After burnishing, the roughness profile was characterized. To do the surface texture analysis, a 1.5mm rectangle in the specimen radial direction per 2.5mm in the specimen axial direction was sampled. This measurement was made with a spacing of 2 μm in both directions. Measures were made by a STILL MICROMESURE2 profilometer. Then, with the MOUNTAINS software, the data collected were analysed, and the texture map and roughness profile are shown in figure 6. The values found on Y and Z axis where $R_{ay} = 0.135 \mu\text{m}$, in Y-direction and $R_{az} = 1.924 \mu\text{m}$, in Z-direction. Note that both R_a values are higher than vibratory amplitudes. Consequently, tool vibration does not affect to the final roughness.

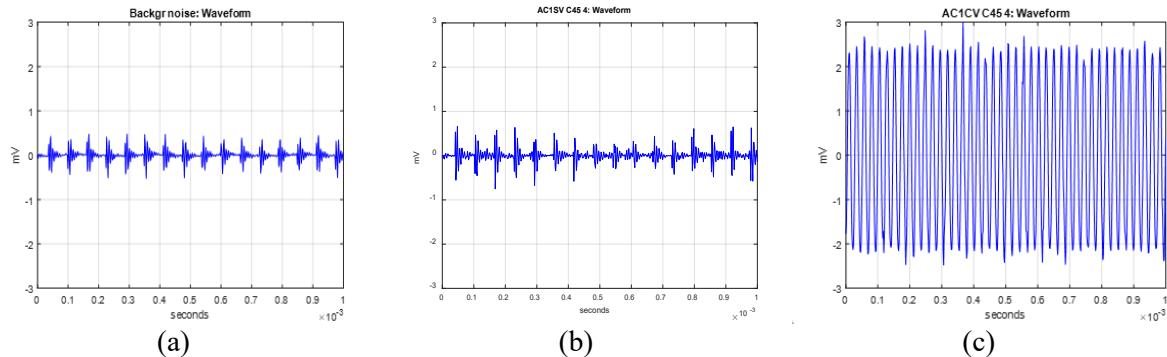
Figure 7. Acoustic emission time histories, corresponding to: **(a)** Background noise. **(b)** Burnishing without any vibration assistance. **(c)** Burnishing vibration assisted.

Figure 7 shows the acoustic emission time histories in different conditions. Figure 7(a) shows the background noise (signal corresponding to stopped lathe), figure 7(b) shows a burnishing process without vibration assistance and figure 7(c) shows a burnishing process with vibration assistance. Figures 7(a) and 7(b) are substantially the same, consequently, the burnishing process without vibration assistance does not produce acoustic emission. On the contrary, a clearly noticeable signal appears in the vibration assisted process because the sensor detects the assisting vibration (figure 7(c)).

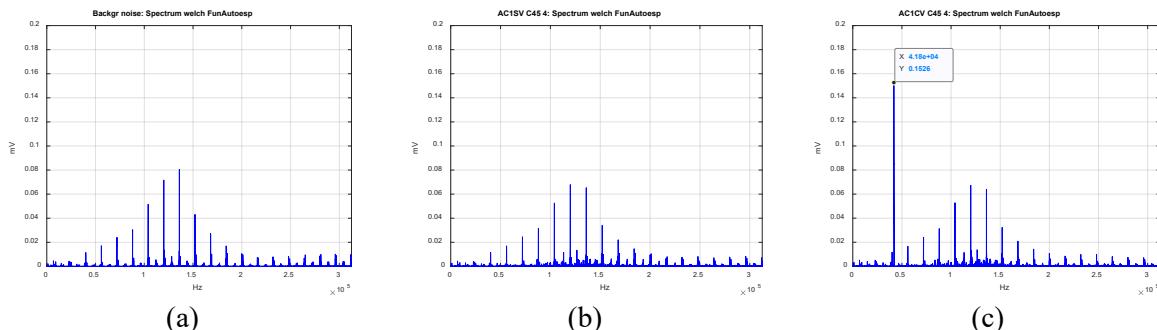
Figure 8. Acoustic emission spectra **(a)** Background noise. **(b)** Burnishing without any vibration assistance. **(c)** Burnishing vibration assisted.

Figure 8 shows the frequency spectra corresponding to the same acoustic emission signals: figure 8(a) corresponding to background noise and figure 8(b) corresponding to burnishing without vibration assistance, are also the same. This confirms the absence of acoustic emission in a burnishing process without vibration assistance. In figure 8(c), an important peak at 41.8 kHz appears. This frequency corresponds to the ultrasonic vibration assistance and confirms that the assisting vibration is detected by the acoustic emission sensor. This is consistent with that reported by Jerez-Mesa et al [9] for vibration assisted burnishing in a milling machine.

In figure 8(c) can be noted that the measured level corresponding to the vibration assistance has an order of magnitude comparable with the background noise. It has to be taken account that the acoustic emission sensors do not have a flat frequency sensitivity throughout their frequency range. The sensor Vallen VS700-D used for the acquisition has a very low sensitivity around 40 kHz (figure 9), then the peak of 41.8 kHz is highly attenuated.

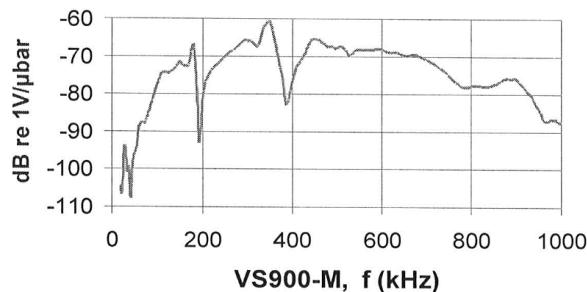
Figure 9. Frequency sensitivity of acoustic emission sensor VS700-D.
