COMPARTMENT AND FAÇADE LARGE SCALE TESTS: BEHAVIOR COMPARISON OF DIFFERENT INSULATING MATERIALS IN CASE OF FIRE

Elsa Pastor^a, Beatriu Corberó^a, Oriol Rios^a, María Pilar Giraldo^b, Laia Haurie^c, Ana Lacasta^c, Eva Cuerva^d, Eulalia Planas^a

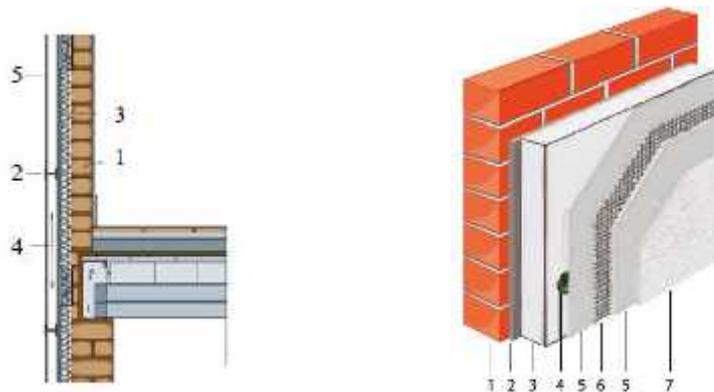
Fig. 1. (left) Elements of a ventilated façade: 1- support, 2- substructure, 3- insulation, 4- air chamber, 5- cladding; (right) elements of an ETICS system: 1- wall, 2- adhesive, 3- insulation layer, 4- anchors, 5- base coat, 6- reinforcement mesh, 7- finishing layer (Adapted from EAE, 2015 and Giraldo et al. 2013)

The use of ventilated facades (Fig. 1) has grown significantly in recent years due to its technical and aesthetical value, as this configuration has a very good hygrothermal and acoustic behaviour;

Another façade configuration whose use has also been recently widened is the externally insulated facade (see Fig. 1), also called External Insulation Composite System (ETICS). This system is designed specifically to improve the energy efficiency of buildings; however, concerning its response to fire, it presents major concerns due to the fact that most of the materials used in its insulation layer are combustible and can contribute significantly to the growth and spread of the fire along the façade.

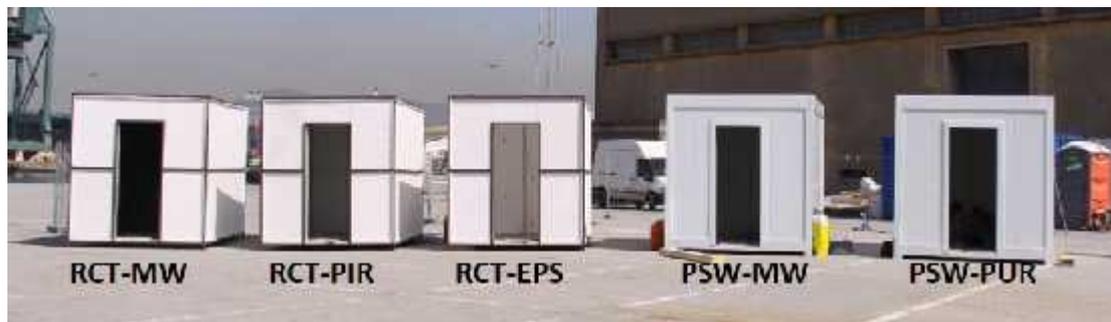
Fig. 2. Compartments of the RCT and PSW tests

and polyurethane (PUR) were tested as insulators within sandwich panels. It is noteworthy to mention that materials from different natures –polymeric and mineral– were compared. The five compartments were identical in size and shape. They were 2.4 m long and wide and 3.6 m high (Fig. 2) with a front opening of 0.8 m-width and 2 m-height.

The ignition source was a 170 mm-long and wide and 200 mm-high propane burner located at the right corner at the back of each compartment. The burner supplied a heat flux of 100 kW during the first 10 minutes of the tests, and 300 kW for the following 10 minutes (a test was considered completed 20 minutes after ignition). Monitoring systems recorded data during the whole duration of the experiments. When tests were finished, fire brigades would extinguish the fire by means of water hoses.

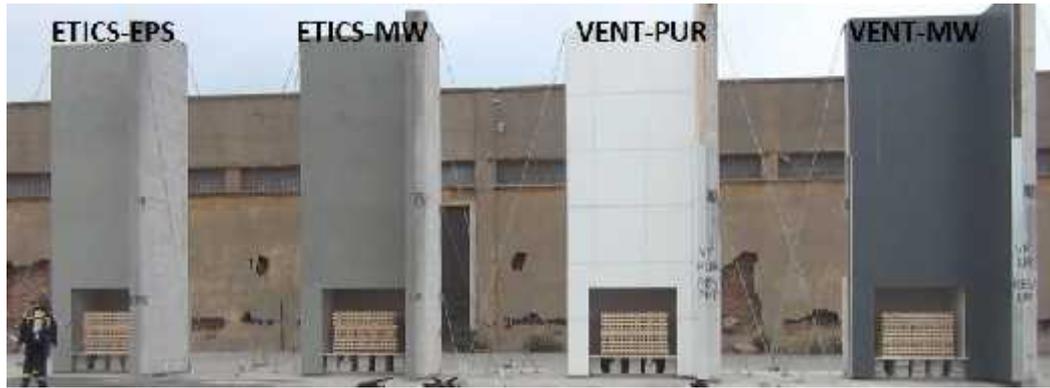
Fig. 3. Façade modules

The four façades were identical in terms of dimensions. They were 2.8 m wide and 8 m high, with a 1.5 m-wide lateral wing. There was a hollow in the base of the façades, representing a 2 m x 2 m window, from which the fire might spread outwards (Fig. 3).

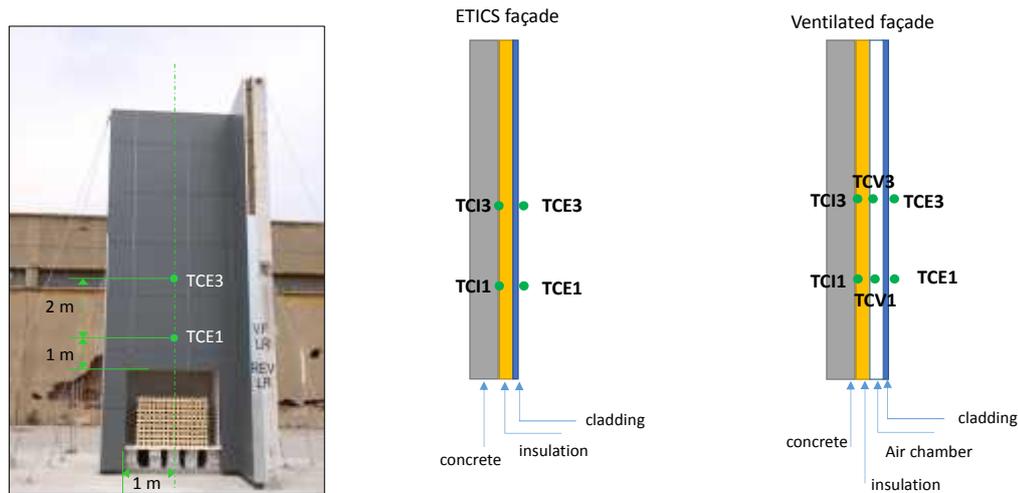
Fig. 4. Thermocouples location

As in the compartment fires, the façade tests were filmed using a standard video camera and an IR camera. Both cameras were located in front of the façades, capturing the four tests in the same field of view. K-type thermocouples were used to measure point-temperatures at several positions (Fig. 4) at a frequency of 1-Hz too. In the ETICS façades, we placed centred at the façade's width, two external thermocouples at 1 m and 3 m above the lintel (named TCE1 and TCE3 respectively), and two internal sensors at these same heights, between the concrete and the insulator layers (named TCI1 and TCI3). The ventilated façades were also monitored by thermocouples placed at these same positions (TCI1, TCI3, TCE1, TCE3) and by two more thermocouples placed at 1 m and 3 m in the air chamber (TCV1, TCV3). Note that out thermocouples setting is simpler than what is stated in the BS 8414 standard.

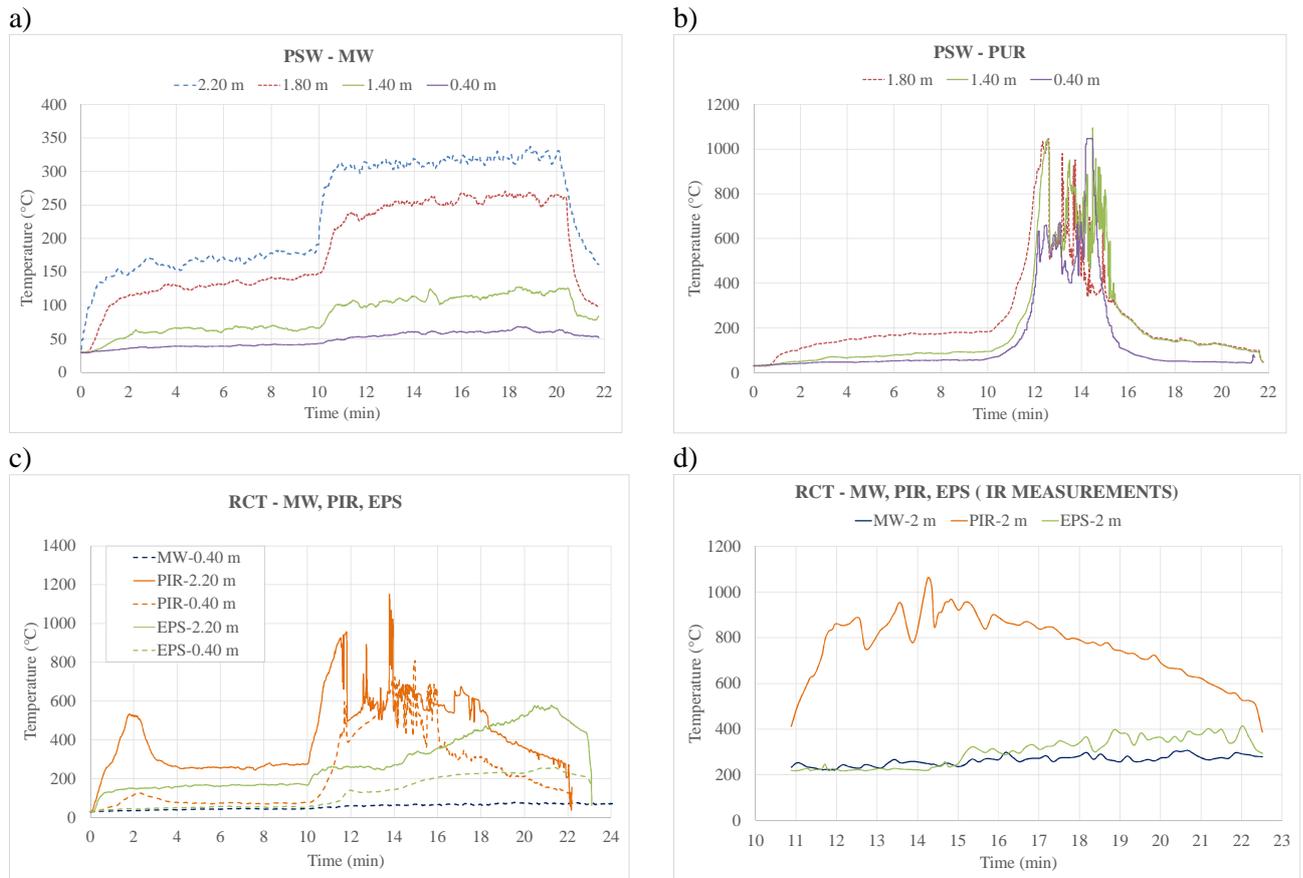
Fig. 5. a) Temperature evolution sensed by thermocouples at different heights of the PSW-MW specimen; b) temperature evolution sensed by thermocouples at different heights of the PSW-PUR specimen; c) temperature evolution comparison of the RCT-MW, PIR and EPS tests sensed by thermocouples at two different heights; d) temperature evolution comparison of the RCT-MW, PIR and EPS tests sensed by the IR camera at 2 m height.

Temperature evolution with time at different heights of the compartment is plotted in Fig. 5 for all the tested specimens. Concerning the PSW tests, the different behaviour of the MW module compared to the PUR one can be clearly observed (see Fig. 5 a) and b)). While in MW compartment maximum temperatures were always below 350 and flashover did not occur, the compartment insulated with PUR experienced flashover roughly 12 minutes after the beginning of the test, getting maximum temperatures around 1100°C. In the RCT specimens, the different behaviour of the three types of insulators is depicted in Fig 5. c) and d). The PIR compartment was the one exhibiting worse performance, with maximum temperatures exceeding 1000°C – detected both by the 2-m height thermocouple and the IR camera– ending up to flashover. By contrast, EPS

specimen reached maximum temperatures roughly below 600°C without experiencing flashover, probably due to the floor collapse during the test.

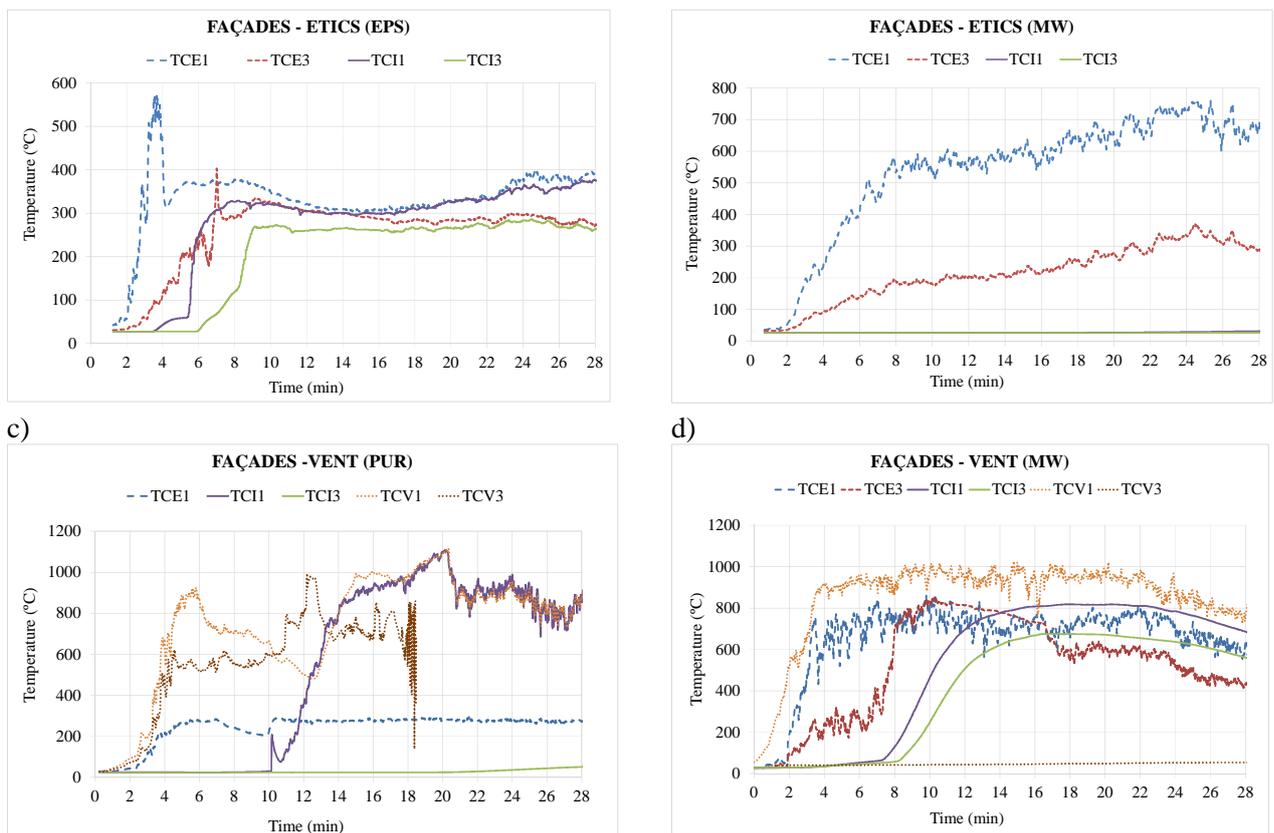
Fig. 6. Temperature evolution sensed by thermocouples of the a) ETICS-EPS b) ETICS-MW c) VENT-PUR and d) VENT-MW façade modules

Temperature evolution with time sensed by the thermocouples located at the different positions of the façades is plotted in Fig. 6 for all the tested specimens. Concerning the ETICS façades, the different behaviour of the EPS specimen compared to the MW one can be detected (see Fig. 6 a) and b)). From minute 3, it was visually evident that ETICS insulator was consumed; at this instant, TCE1 temperature started decreasing while TCI1 increased. 8 minutes later, temperatures at 1 m height, both external and internal, converged to 300 °C and 3 m-temperatures did so at around 24 minutes after the beginning of the test. This might indicate a travelling EPS consumption front of around $1/6 \text{ m}\cdot\text{min}^{-1}$. In contrast, MW insulator exhibited good performance, since internal temperatures (both at 1m and 3 m) were constant and much lower. TCE1 thermocouple in ETICS-MW module experienced temperatures between 500°C and 750°C practically during the entire test, due to flame impingement.

In the ventilated façades tests, flames propagated through the air chamber from the beginning of the experiments, since all the TCV thermocouples sensed temperatures above 600 °C in both PUR and MW specimens. PUR insulator was consumed by the fire (TCI1 thermocouple registered temperatures of around 1000 °C during the second half of the test), while MW insulator layer reached temperatures of 800°C at 3 m and 650 °C at 1 m without losing integrity.
