Compressive strength and elasticity of pure lime mortar masonry

Anastasios Drougkas¹, Pere Roca, Climent Molins

Departament d'Enginyeria de la Construcció, Universitat Politècnica de Catalunya, Campus Diagonal Nord, Building C1, Jordi Girona 1-3 UPC, 08034 Barcelona, Spain

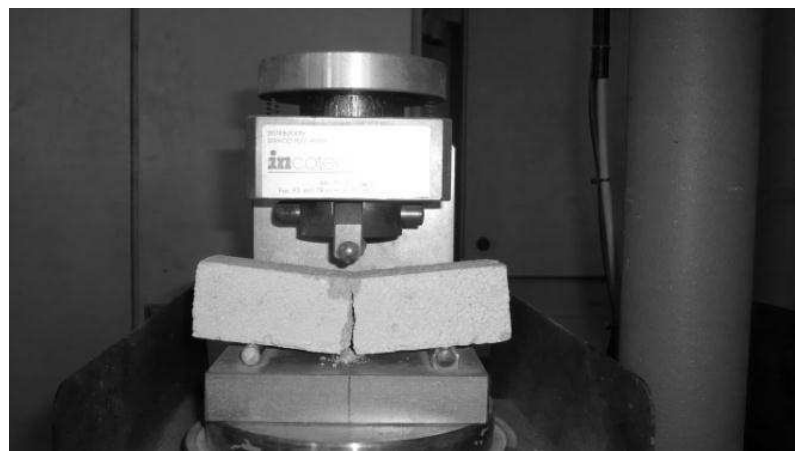
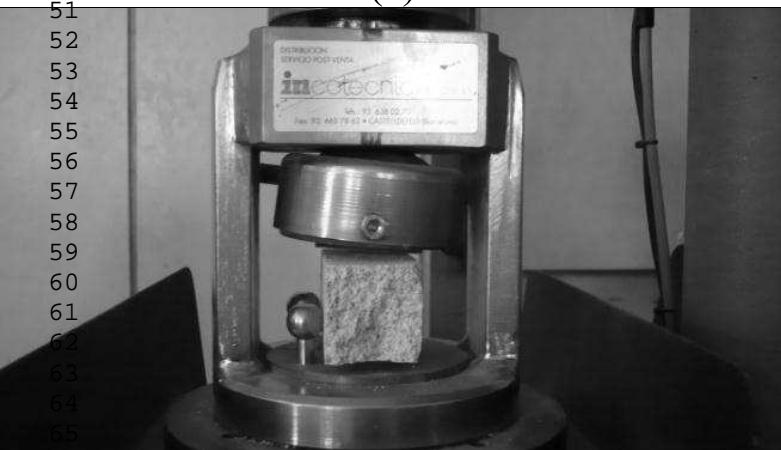
Figure 3 Test and measurement layout for compressive tests: (a) single, (b) double and (c) triple samples.

41 For the compressive tests on the cylindrical samples, a 200 kN capacity load cell was used in a
42 hinged configuration. The load was applied in displacement control, in order to record the softening
43 branch with more ease, at a rate of 0.002 mm/sec. Measurements were taken from three LVDTs
44 placed in the perimeter as shown in Figure 3, and from the load cell readings. These devices were
45 fixed on the loading plates, as the small height of the cylinders, even when stacked, was not
46 sufficient for the LVDTs to be properly attached directly on them. Overall, eleven single samples,
47 eight double samples and six triple samples were tested for a total of 25 compression tests. With the

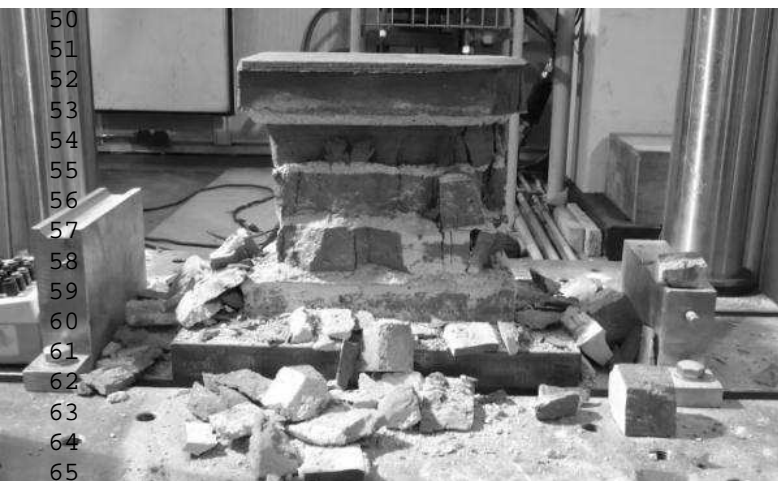
Figure 12 ALM prisms after testing: (a) with sulfur mortar cap and (b) with neoprene sheet.

11
12 Significant agreement was found between the values of the capacity obtained for the two
13 prisms with the sulfur mortar cap (prisms 1 and 3). The stress-displacement diagrams for the ALM
14 masonry prisms are shown in Figure 11 and the results are summarized in Table 7. The failure
15 mode was similar as well. The first visible cracks were observed at around 70% of the load and
16 they included diagonal cracks originating from near the edges of the top of the prism and were
17 mostly visible on the faces of the units. As cracking progressed, peripheral superficial cracking
18 developed which eventually outlined a mostly crack-free core of masonry with its minimum width
19 at mid height and spreading to the top and bottom units, which were almost intact. The condition of
20 the ALM masonry at the end of the test is shown in Figure 12.
21
22
23
24
25
26
27
28
29
30
31
32

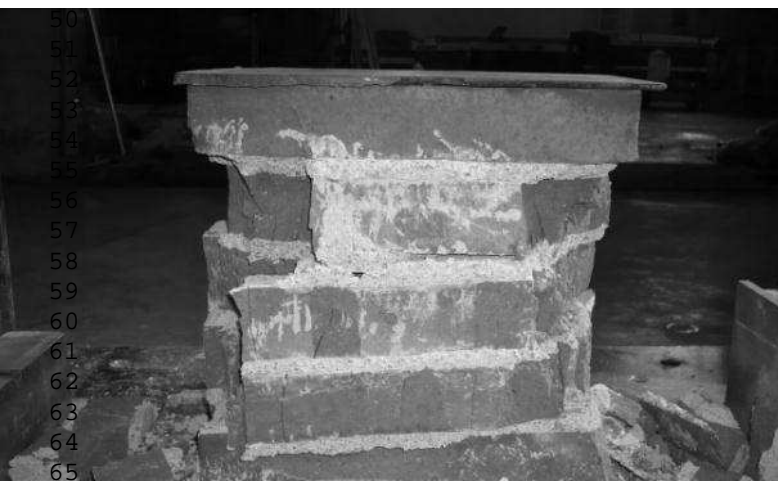
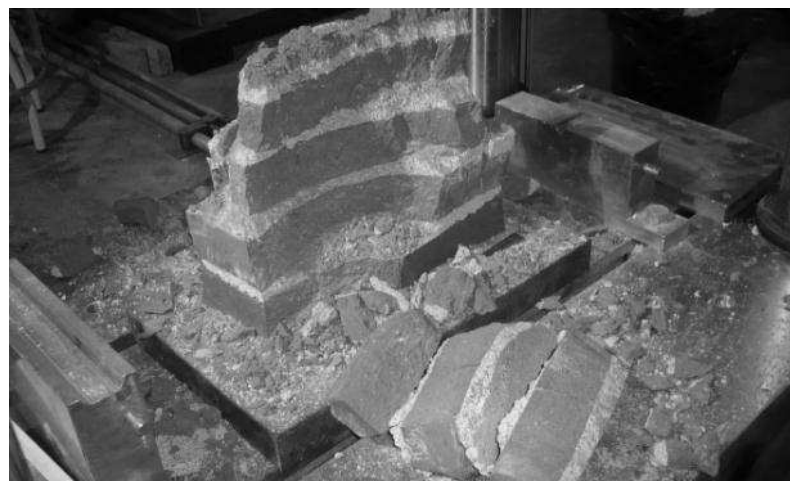
Figure 13 HLM prisms after testing: (a) with sulfur mortar cap and (b) with neoprene sheet.

1 There appeared to be evidence of more extensive unit cracking than in the ALM case. The
2 broken off pieces of brick were generally of smaller size and there was noticeable presence of unit
3 dust, which was not present in the ALM samples. Due to the relatively high compressive strength
4 of the units, it seems unlikely that the unit dust is the result of unit crushing. Overall, the above
5 evidence appears to point towards a more prevalent influence of unit cracking in the failure mode.
6
7 The condition of the HLM masonry after the test is shown in Figure 13,
8
9
10
11
12
13
14
15
