3. THEORETICAL FRAMEWORK

3.1 Background

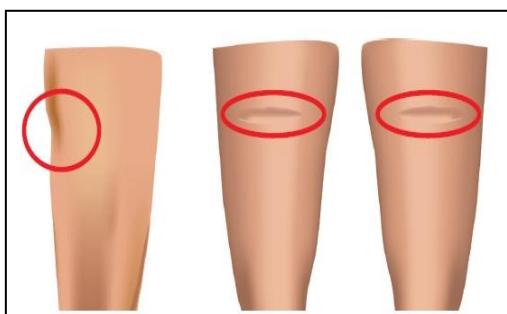
Figure 3.4 Location injury

In some cases accompanied by symptoms of fatigue and heavy legs. It is located at 72 cm from the ground, coinciding with the height of the table (Figure 3.4 and 3.5). (Reinoso et al., 2010, Ortega et al., 2009; Macia and Juanola, 2009; Zafra et al. 2008).

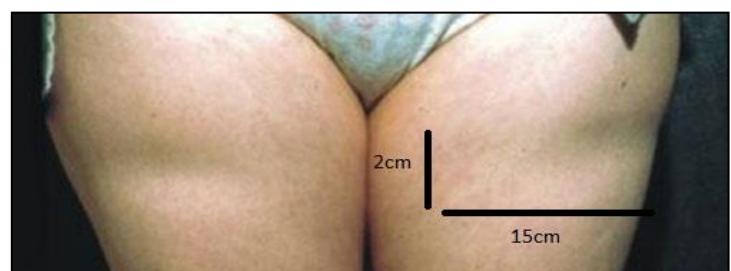
Figure 3.5 Measures of injury. 2cm wide and 15cm long

The lesion measuring 5 to 20 cm long, 2 wide and 1 to 5 mm deep (picture 3). You semicircular shape and is located in the anterior and lateral thigh, forearm, abdomen, buttocks and ankles. These bands are usually visible to the naked eye, but sometimes they are not, but are palpable.

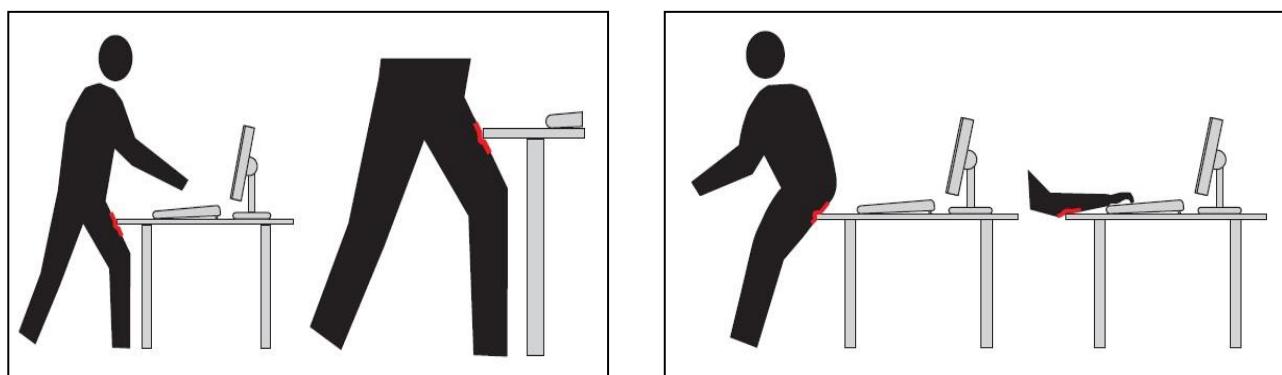
Figure 3.6 Furniture electrostatically charged in contact with a body

In short, the cause of LS is caused by accumulation of electrostatic loads on objects such as work teams that generate downloads friction between the thighs explain the activation of macrophages and production of cytokines that destroy fat cells.

On the other hand, the electromagnetic fields generated by the wiring and equipment installed in the work environment can be absorbed by the metal structures of the tables, unloading when a body come in contact with this metal structures. (Figure 3.6). Finally, measurements of the electric field altered the wiring tables and air conditioning systems with low relative humidity contribute to the presence of high levels of electrostatic energy (Rodriguez and Madrid, 2008; Ubeda et al. 2011; Macia and Juanola, 2009 , Ortega et al. 2009 by Cuevas et al. 2008 by Perez et al. 2010; Apellániz, 2007).

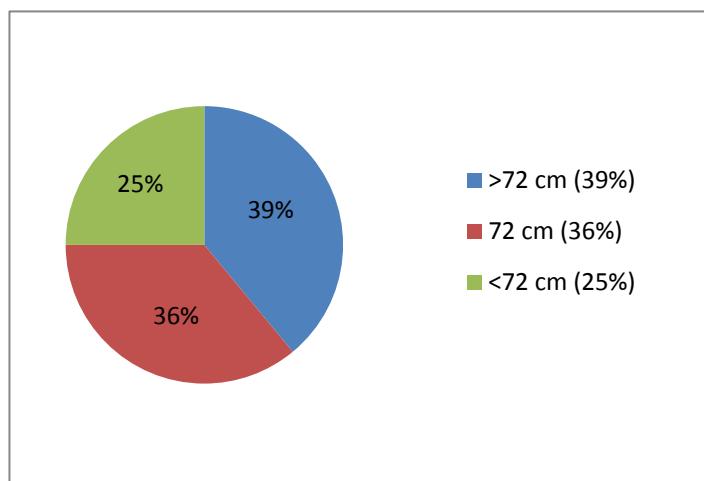
They studied 45 cases, 75% were eventually diagnosed LS and a large majority of cases occurred in women (93%). As for the location, all cases stood in the thigh in a uni-or bilateral, but two exceptions suffered LS in an arm and a dissection leg, and an other in the dissection of the gluteal region (who often was sitted on the end of the table). The characteristics of the lesion are defined to be in the ground to a height ranging between 62 and 84 cm. The height of 72 cm is considered standard tables and other office furniture desk. (Figure 3.7).

Figure 3.7 Perpendicular distance land-injury

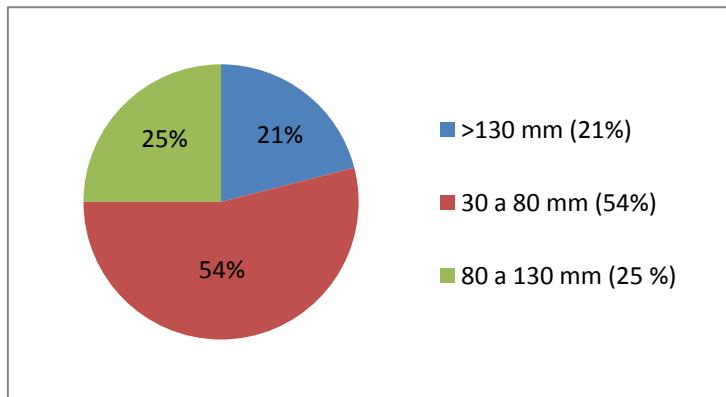
As for the length, the range was between 30 and 180 mm. (Figure 3.8).

Figure 3.8 Length of the lesion

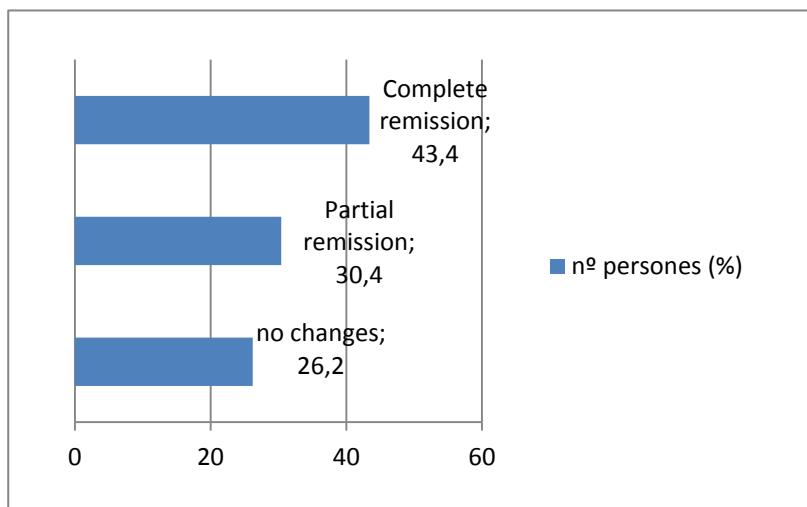
A review at 3 months, almost 75% of cases have a recovery trend, showing an 43.3% in complete remission, 30.4% in partial remission and 26.6% showed no changes. (Figure 3.9).

Figure 3.9 Evolution after 3 months

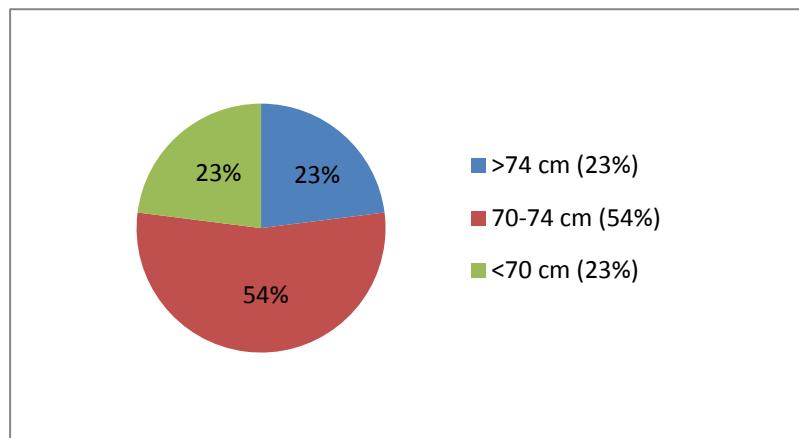
arms and the other in the gluteal region (attributed to the fact that the patient is often was sitted in the extreme of the table). The characteristics of the lesion are defined to meet the ground at an altitude ranging between 51 and 84 cm with an average of 69 cm (Figure 10.3).

Figure 3.10 Perpendicular distance land-injury

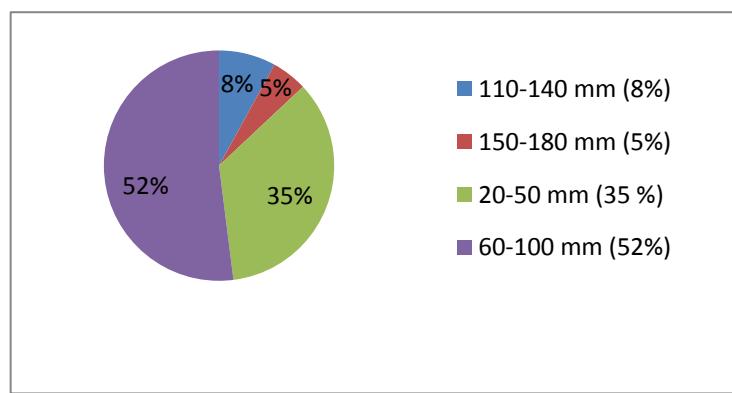
As for the length of the lesion (Figure 3.11):

Figure 3.11 Length of the lesion

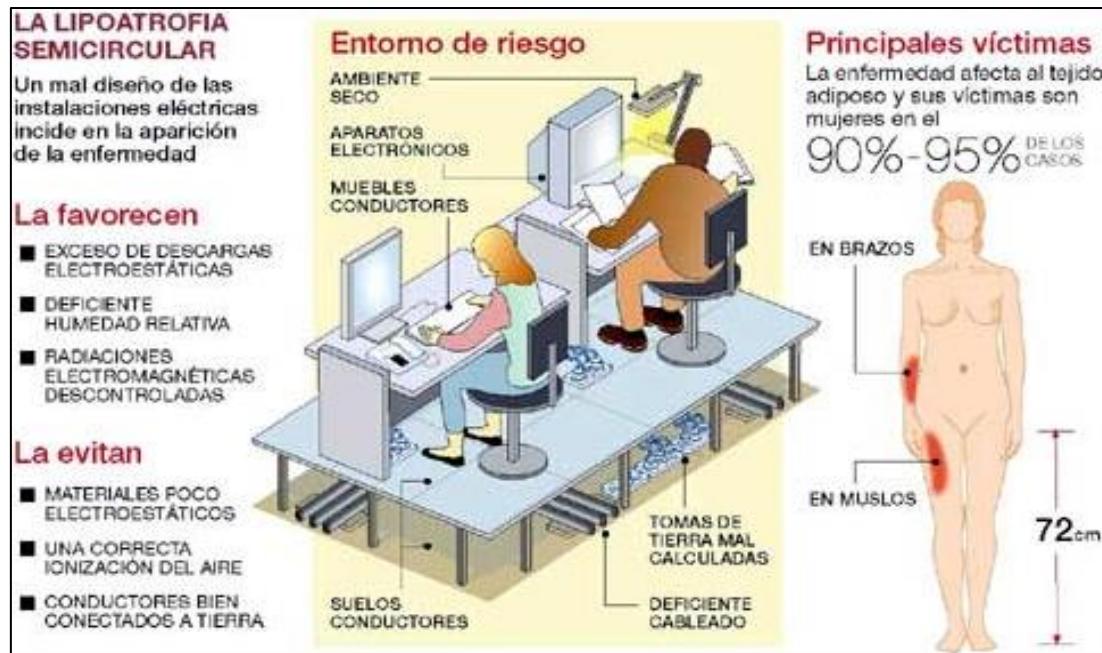
Although, the specific cause of Semicircular lipoatrophy is not yet known, the factors described three related hypotheses (contact with furniture, static electricity and electromagnetic fields) that play an important role and, depending on the characteristics of the site work, each of these factors can affect a greater or lesser extent. (Figure 12.3).

Figure 3.12 Common factors in cases of lipoatrophy

- Workplaces that have a general ventilation system with air without humidification.
- Relative humidity levels below 50% (often around 30%).
- Employees who experience discomfort usually by electrostatic discharges.
- Staff working that are in contact with work surfaces (tables, desks...) and other pieces of furniture (drawers, shelves...), including administrative personnel, technical and cleaning staff.
- Work surfaces with a metallic structure not connected to the protective earthing of the electrical circuit, with the presence of office equipment (computer, phone, printer...), with plenty of wiring.

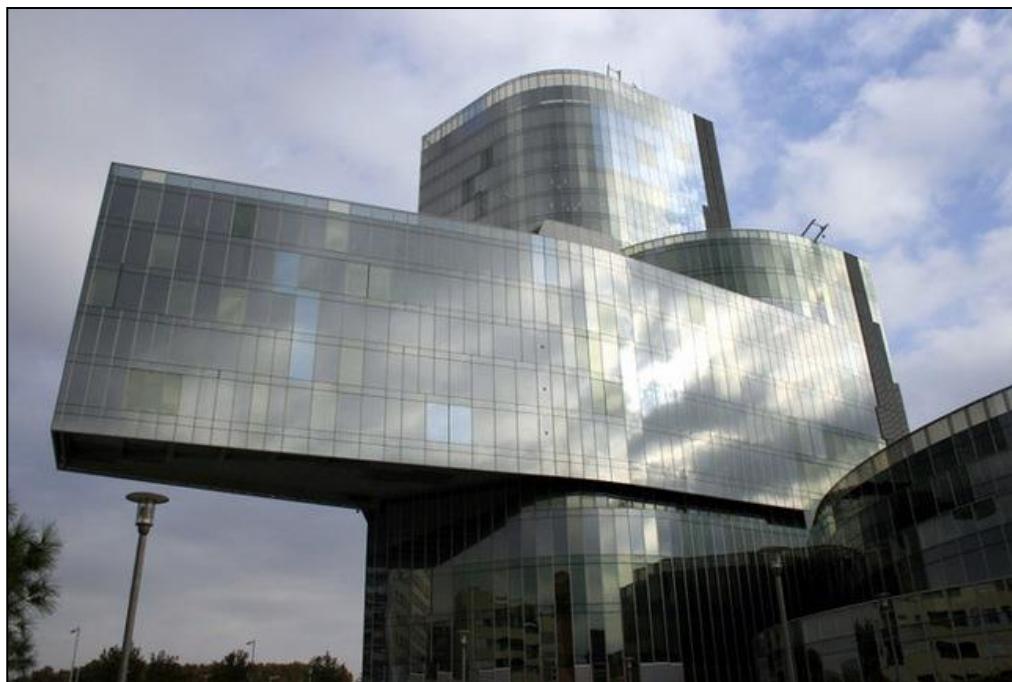
Figure 3.12 Building of Gas Natural

The first case of LS Spain, diagnosed in Catalonia, was the building of gas natural (Figure 3.12) located in the area of the Villa Olímpica. It is a building of 20 floors with a close with a glass curtain wall that unifies the whole.

After they had detected these outbreaks of semicircular lipoatrophy, the company was forced to close to implement the necessary improvements preventive. They install humidifiers and also extended the grounding for the amount of wiring that goes under the tables.
