Experimental evaluation of the shear strength of aerial lime mortar brickwork by standard tests on triplets and non-standard tests on core samples

Luca Pelà*, Konstantina Kasioumi, Pere Roca

Department of Civil and Environmental Engineering, Universitat Politècnica de Catalunya (UPC-BarcelonaTech), Jordi Girona 1-3, 08034 Barcelona, Spain

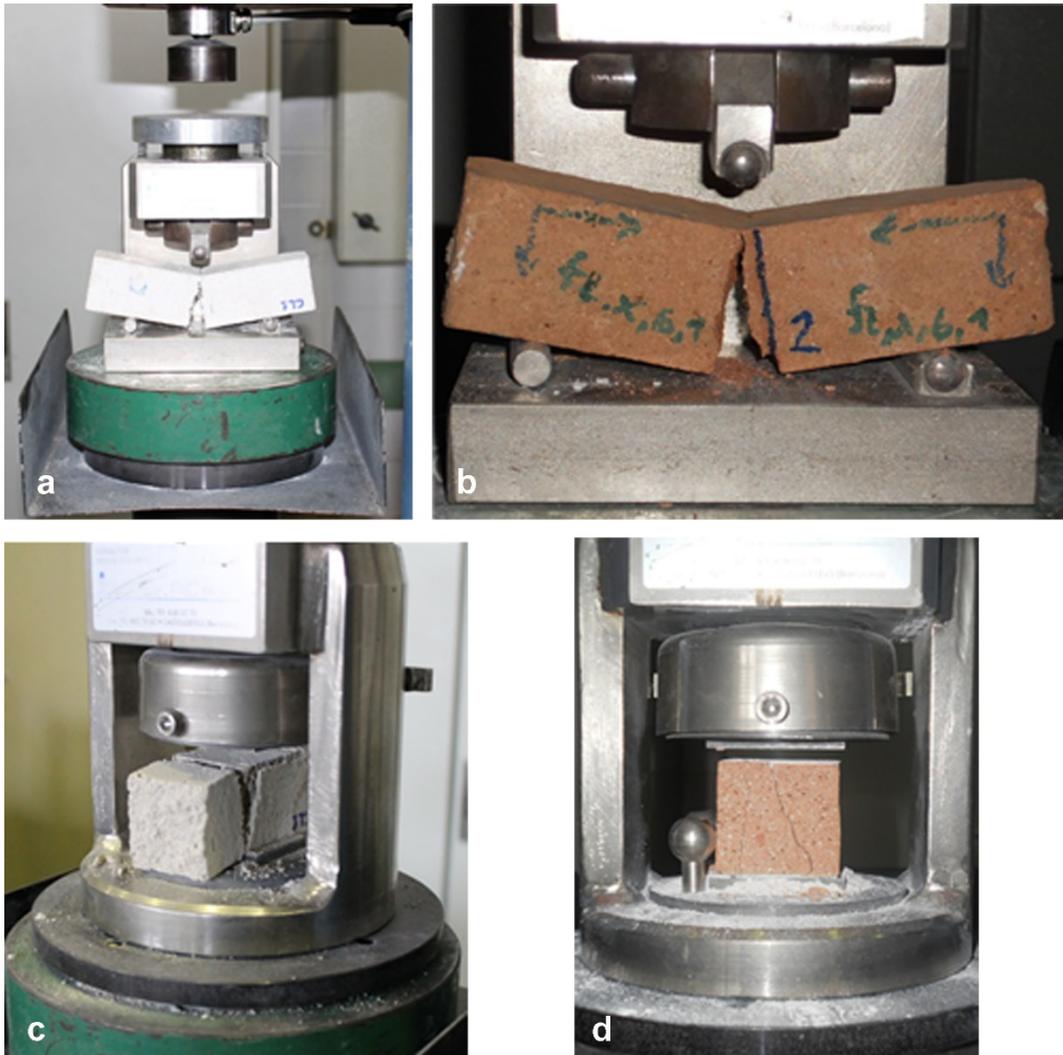
Figure 1 – Testing of prismatic samples of material components: flexure and compression tests on mortar (a,c) and brick (b,d).

According to EN 1015-11:2007 [2], prismatic samples with dimensions $160 \times 40 \times 40 \text{ mm}^3$ were prepared to evaluate the strength of CL90 mortar. Flexural strength f_{fm} was evaluated on four prismatic specimens (Figure 1a), whereas the compressive strength f_{cm} was assessed on the eight halves produced

by the splitting of the prisms from the four flexure tests. Those halves were tested in compression under $40 \times 40 \text{ mm}^2$ steel platens (Figure 1c). Both flexure and compression tests were carried out using a load cell of 10 kN in load control, but with different loading rates of 10 N/s and 50 N/s, respectively. Table 1 summarizes the experimental results that were obtained after one year from mortar pouring. The average values are $f_{\text{fm}} = 0.55 \text{ MPa}$ and $f_{\text{cm}} = 1.63 \text{ MPa}$ and their coefficients of variation (CV) are 9.5% and 5.3%. The average values of flexural and compressive strengths fall within the typical ranges of these properties for historical lime mortar.

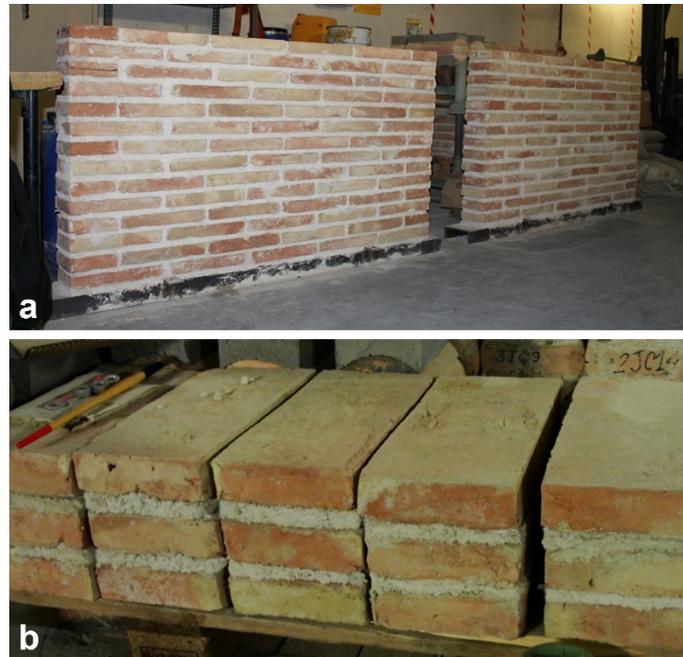
Figure 2 – Prismatic specimens of masonry built in the laboratory: a) walls and b) triplets.

The materials described in the previous section were employed to build two walls in stretcher bond with dimensions $1605 \times 870 \times 145 \text{ mm}^3$ (Figure 2a). The two walls reproduced portions of structural members that may be encountered in typical historical buildings made of low-strength masonry. They were used in this research to simulate, under laboratory controlled conditions, a generic in-situ sampling activity consisting in the core-drilling of 90 mm diameter cylindrical specimens. Each wall was built in-between two steel C beams that were placed below the base and over the top of the specimen. The beams were interconnected by four low-tensioned tie rods. In this way, a very small pre-compression was applied to the walls with the sole purpose of guaranteeing their easy transportation inside the laboratory, as well as their sufficient stability during the coring operations.

At the same time of the construction of the two walls, nine triplets were also built using the same materials, having dimensions $305 \times 145 \times 165 \text{ mm}^3$ and including three units and two mortar joints (Figure 2b).

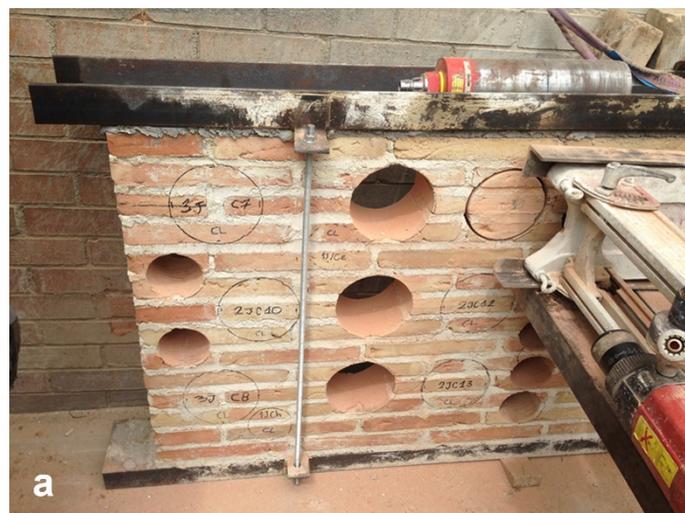
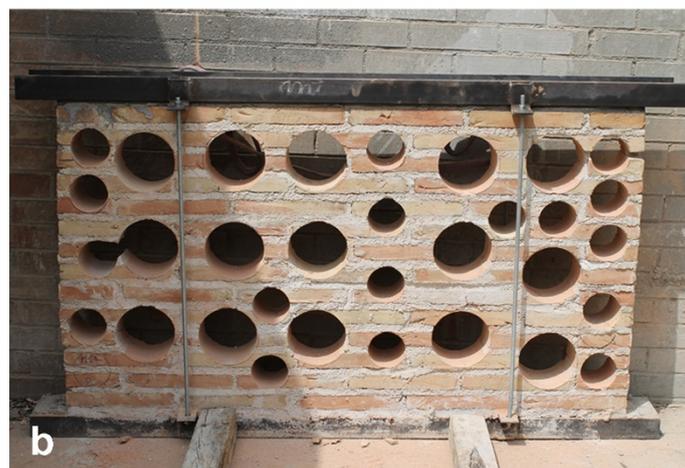
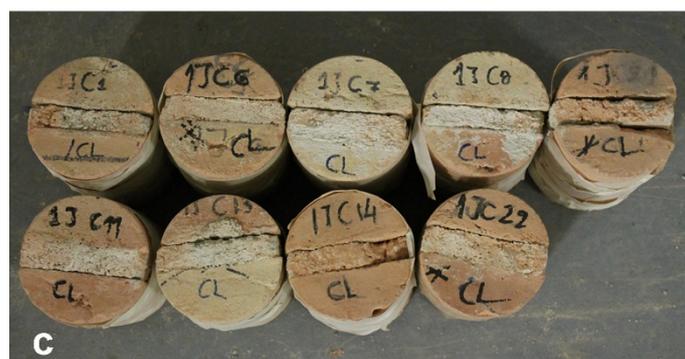
Figure 3 – Extraction of the cylindrical specimens from masonry walls: a) core drilling, b) wall at the end of the extraction and c) 90 mm diameter cylinders for Brazilian tests.

After one year from the construction, the two walls were taken out of their storage to carry out the extraction of the cylindrical samples (Figure 3a). The core drilling followed a dry procedure that was proposed in previous works by the authors [4,24]. The absence of water is a remarkable advantage of this improved sampling technique, since it minimizes the risk of disjuncting the cylindrical specimens. The wet core drilling, commonly adopted for concrete structures, is not fully adequate for existing masonry buildings since the water may wash the mortar joints away and spoil the samples. On the other hand, the dry core drilling uses an aspirator to cool the bit and to remove the dust. This important feature allows the optimization of the sampling procedure by increasing the number of successful extractions of cores. This is very important in the study of historical constructions, where the minimization of the impact of the inspection on the existing structure is mandatory. As soon as they were extracted, the masonry cylinders were properly confined by strong adhesive tape stuck on the lateral curved surface to avoid any damage during their subsequent storing and transportation. Figure 3b shows the wall after the core-drilling. As it can be noticed, the cut of the bit is precise and does not damage the surrounding material. The procedure proves to be remarkably clean thanks to the absence of dust that is completely drawn by the vacuum cleaner conveniently connected to the drilling

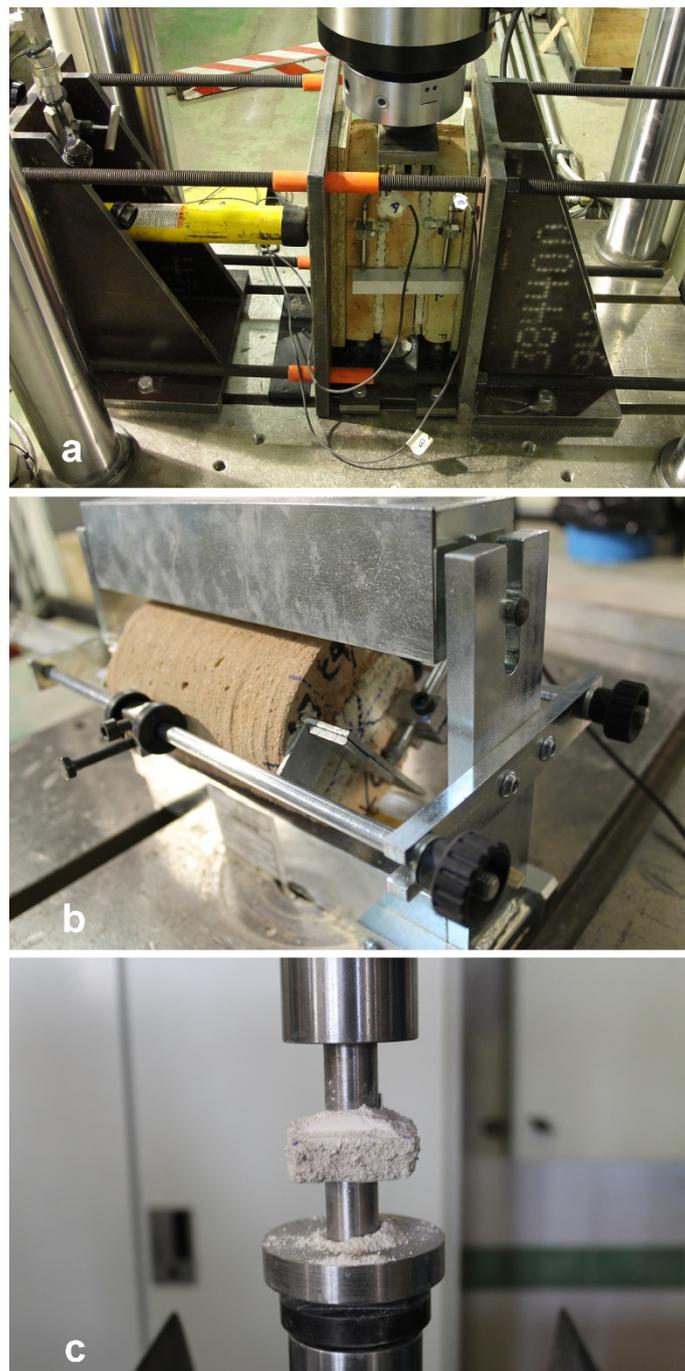
Figure 4 – Experimental setups of the different tests: a) shear tests on triplets, b) Brazilian tests on core samples and c) double punch tests on mortar joints.

Both core samples and triplets were tested one year after their construction [28]. Nine triplets were considered first to determine the shear strength of horizontal bed joints in a conventional manner according to the standard EN 1052-3:2002 [12]. All the specimens were tested in a machine with a load cell of 200 kN to apply the shear force to the centre brick. The experimental setup is shown in [Figure 4a](#). The force normal to the bed joints was applied by a 10 kN loading jack. Three triplets were tested for each level of normal stress, i.e. 0.3 MPa, 0.6 MPa and 1.0 MPa. Each normal stress level was kept constant during the test, whilst the increasing shear force was applied to the mortar joints of the triplet. Four Linear Variable Differential Transformers (LVDTs) with ± 5 mm range and 5 μm precision were used to control the tangential displacements in the mortar joints during the shear tests. Fifteen core samples were subjected to Brazilian tests with variable inclinations of the diametric mortar joint. Due to the novelty of this kind of test, there are not specific standards. The only standard related, to some extent, with the tests carried out is the EN 12390-6:2000 [29] about the splitting test of concrete specimens. Hence, the experimental setup was the same adopted in previous works by the authors [22–24]. The core samples were laid horizontally between the loading platens. Two wooden stripes were inserted between the platens and the specimen, in order to distribute correctly the diametric longitudinal load. The specimen was compressed along two opposite longitudinal generators until failure. The test was carried out under displacement control at a rate of 0.005 mm/s. The core samples were tested for different inclinations α of the diametric mortar joint with respect to the horizontal direction, as shown in [Figure 4b](#). This peculiar experimental setup allows the application of a combined compression-shear load over the mortar joint of the core samples. The magnitudes of the shear and compression stresses acting on the mortar joint during the test is determined by the angle α of inclination of the diametric mortar joint with respect to the horizontal direction, see [Section 3.2](#). Increasing values of α correspond to increasing shear and decreasing normal compression on the mortar during the test. A crucial point before the execution of the experiments was the decision of the inclinations of the diametric mortar joints for the different Brazilian tests. The range of inclinations must be carefully chosen in order to avoid the vertical splitting of the core sample and to trigger the frictional failure in the mortar [23]. Since the mortar had rather low strength, the Brazilian tests were cautiously carried out with lower inclinations than in previous studies [22–24], i.e. $\alpha = 40^\circ$, $\alpha = 45^\circ$ and $\alpha = 50^\circ$. Five core samples were assigned to each one of these inclinations.

After the extraction of the core samples, the remains of the masonry walls were dismantled with the aim of extracting mortar layers. Small mortar samples with dimensions roughly $50 \times 50 \times 15 \text{ mm}^3$ were cut from the layers to be tested according to the Double Punch Test (DPT), see [Figure 4c](#). This test was carried out following the DIN 18555-9:1999 standard [30] and relevant references [22,24,31,32]. The specimens were placed centrally between the 20 mm diameter loading platens. The irregular surfaces of the joints were regularized by using gypsum powder. The testing machine had a load cell with 10 kN capacity and the loading rate was 0.0094 kN/s.

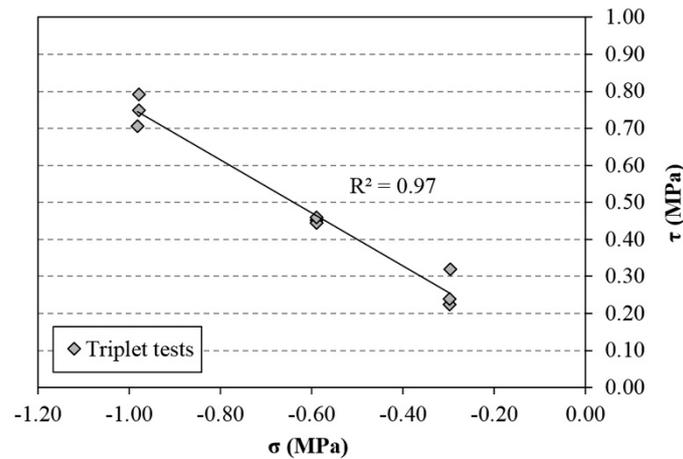
Figure 5 – Interpretation of shear tests on triplets: failure envelope ($\Phi = 35.65^\circ$ and $C = 0.04$ MPa).

where C is the cohesion and Φ is the internal friction angle. These two parameters can be evaluated by using a linear regression of the experimental results depicted in the σ - τ plane. The experimental results are the points of coordinates (σ_p, τ_{\max}) . [Figure 5](#) shows the failure envelope derived from the triplet tests, with Mohr-Coulomb parameters resulting $\Phi = 35.65^\circ$ and $C = 0.04$ MPa. The coefficient of determination is $R^2 = 0.97$, proving the good representativeness of the linear interpolation of the experimental results.

In the shear tests on triplets the failure mechanism was the sliding at the bond interface, proving the appropriateness of processing the experimental results through the interface model. The Mohr-Coulomb parameters resulted $\Phi = 35.65^\circ$ and $C = 0.04$ MPa.

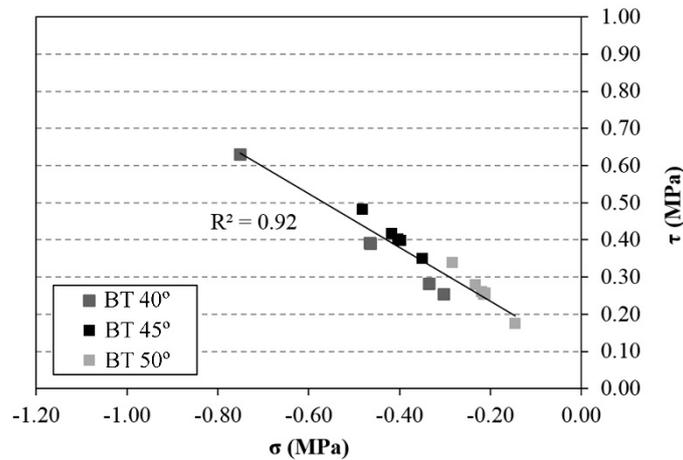
Figure 6 – Interpretation of Brazilian tests on core samples: failure envelope obtained by the interface model ($\phi = 35.86^\circ$ and $C = 0.09$ MPa).

The results of the Brazilian tests with varying inclination of the mortar joint interposed between two brick cylindrical segments can be interpreted by using the micromechanical approach proposed in [23] that is based on two different procedures. The first one is called *interface model* and it analyses the strength behaviour of the diametric mortar joint as that of a plane interface. From the theoretical point of view, this model seems appropriate to describe the ultimate behaviour of mortar joints exhibiting a failure mechanism with pure sliding along the brick–mortar interface. The ultimate conditions of core samples with different inclinations of the diametric mortar joints can be represented in the σ – τ plane by points with coordinates $(\sigma_{\max}, \tau_{\max})$ calculated according to [Equations 4a-b](#). The linear regression of the experimental results provides the Mohr-Coulomb parameters of [Equation 2](#), i.e. the same adopted for the triplet tests. [Figure 6](#) shows the failure envelope derived from the Brazilian tests executed in this research, yielding $\Phi = 35.86^\circ$ and $C = 0.09$ MPa. The coefficient of determination was $R^2 = 0.92$ proving an acceptable representativeness of the linear interpolation of the experimental results, given the inevitable scattering of the Brazilian tests.

In this experimental program, the interface model applied to the Brazilian tests provided $\Phi = 35.86^\circ$ and $C = 0.09$ MPa, i.e. Mohr-Coulomb parameters quite close to those obtained from triplet tests. The dimensions of the core samples are smaller than those of triplets and this fact produces inevitably a higher experimental scattering since the Brazilian test results depend more on the local conditions of the material components in the small specimen. The coefficients of determination results $R^2 = 0.97$ for standard shear tests triplets and $R^2 = 0.92$ for Brazilian tests on core samples. The discrepancy between the test on triplets and the Brazilian tests was expected due to the different testing setups and natures of the samples and in any case it shows that the interface model can be acceptably applied to both the standard and non-standard shear tests.

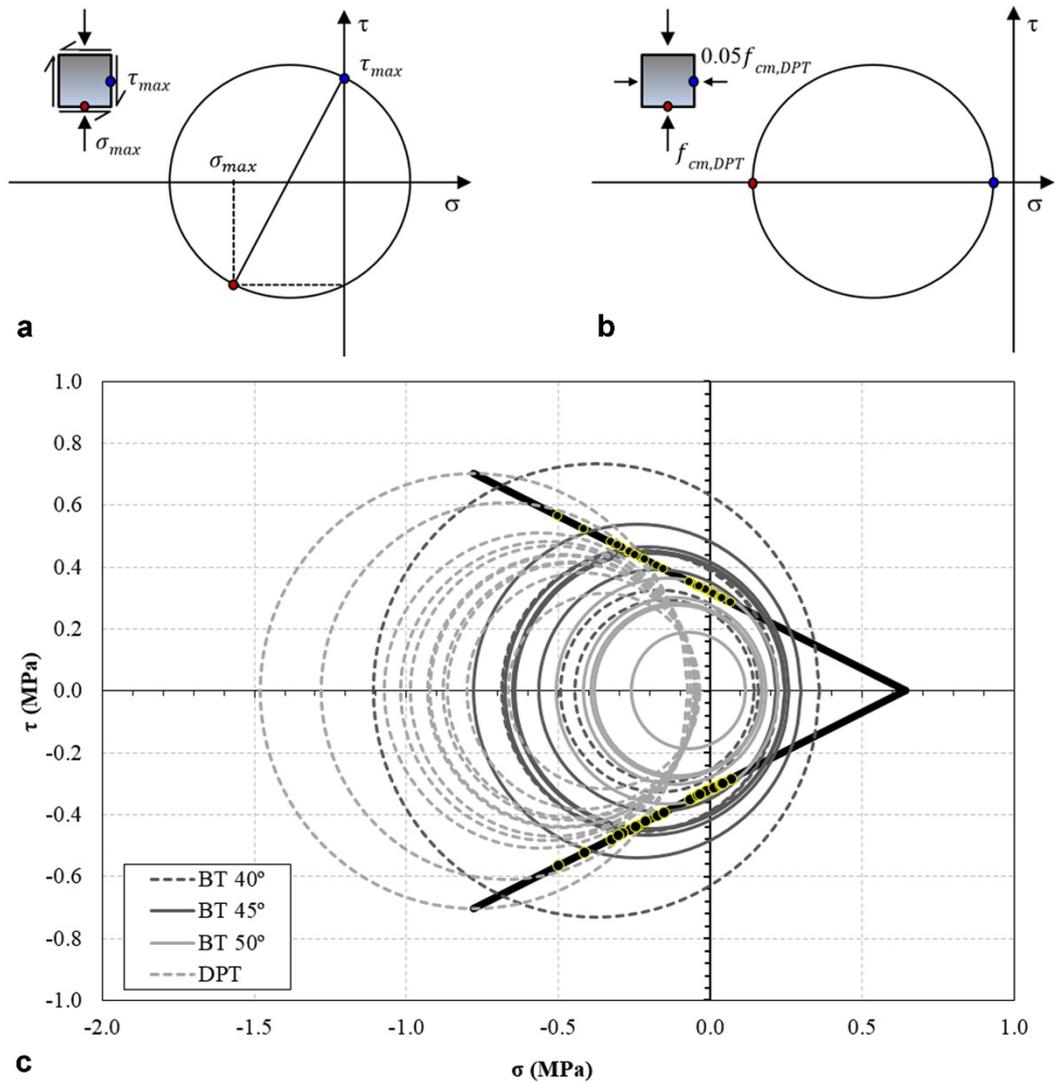
Figure 7 – Interpretation of Brazilian tests on core samples and double punch tests on mortar joints: construction of Mohr's circle representing the stress state of mortar at failure a) in Brazilian tests and b) in double punch tests; c) failure envelope obtained by the continuum model ($\phi = 26.35^\circ$ and $c = 0.32$ MPa).

Figures 7a-b show the construction of the Mohr's circles corresponding to the Brazilian tests and double punch tests. In the first case, the stress state in the mortar is shear-compression with stress components evaluated according to Equations (4a,b). In the second case, the stress state is not considered uniaxial due to the small thickness of the joint sample and the confinement exerted by the punches, as well as by the mortar material surrounding the loaded area. A previous numerical study by the authors evaluated the amount of the transversal confinement as the 5% of the vertical stress [24]. The Continuum Model is thus able to provide a joint interpretation of Brazilian tests on core samples and double punch tests on joint samples within the same theoretical framework, in order to evaluate the strength of the investigated mortar. The Mohr-Coulomb failure envelope of mortar subjected to different shear-compression combinations is expressed as follows:

where c is the cohesion of mortar and ϕ is its internal friction angle. According to the Mohr-Coulomb's theory, the material reaches the failure when the Mohr's circle representing its stress state becomes tangent to the lines given by Equation 4. Given a set of several experimental results, together with their corresponding Mohr's circles built as shown in Figures 7a-b, the values c and ϕ of the overall failure envelope are those that minimize the sum of the squares of the distances between the failure envelope and the Mohr's circles. Figure 7c shows the failure envelope obtained thanks to the Continuum Model applied to the experimental results from double punch tests and Brazilian tests. The Mohr-Columb parameters result $\phi = 26.35^\circ$ and $c = 0.32$ MPa. According to Mohr-Coulomb's theory, it is possible to evaluate the corresponding values of the compressive and tensile strength of mortar f_{cm} and f_{tm} using the two following expressions:

These equations provide $f_{cm} = 1.02$ MPa and $f_{tm} = 0.39$ MPa. The first value provides a good estimation of the average compressive strength of mortar obtained from the double punch tests ($f_{cm,DPT} = 0.91$ MPa, see Table 6). The tensile strength derived from Mohr-Columb theory results correctly lower than the flexural strength obtained from tests on prismatic specimens ($f_{tm} = 0.55$ MPa, see Table 1).

On the other hand, the continuum model applied to the Brazilian tests and the DPTs provided $\phi = 26.35^\circ$ and $c = 0.32$ MPa, that are parameters obviously completely different than those of the interface model since they were derived from a different failure theory based on continuum mechanics.

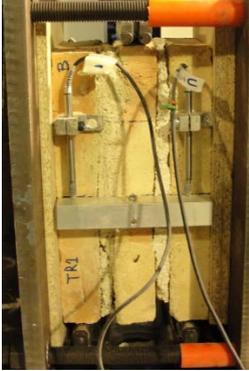
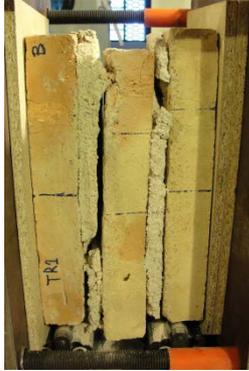
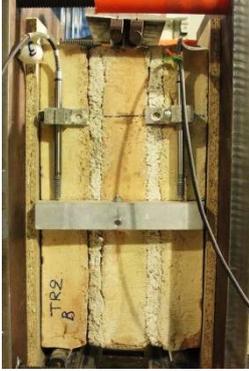
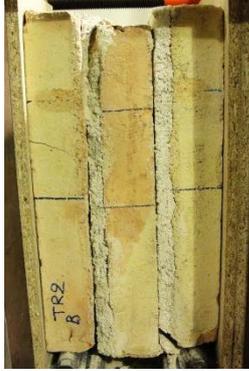
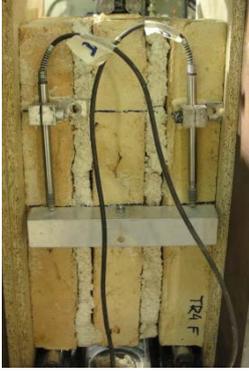
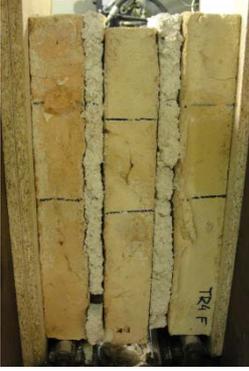
Table 3 – Experimental results of shear tests on triplets with $\sigma_p=0.3$ MPa

27.73	0.32
TR2

19.50	0.22
TR4

20.75	0.24
Average				22.66	0.26
CV				16%	16%

Tables 3-4-5 show the experimental results from the shear tests on triplets. Each table reports the images of each specimen before and after the test, the sketch of the failure mode, the values of F_{\max} and τ_{\max} . The progressive increase of the normal pre-compression load σ_p from 0.3 MPa to 0.6 MPa and 1.0 MPa corresponds to an increase of the maximum shear force due to the frictional behaviour of the material, as expected. Most of the specimens exhibited a sliding failure at the brick-mortar interfaces, although the cracks crossed the mortar material of the joint, through a fracture propagating from one interface to the opposite one. The CV resulted higher in the set of triplets with lowest pre-compression ($\sigma_p = 0.3$ MPa), as also observed in previous works [8,33].

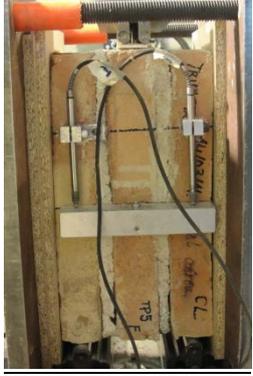
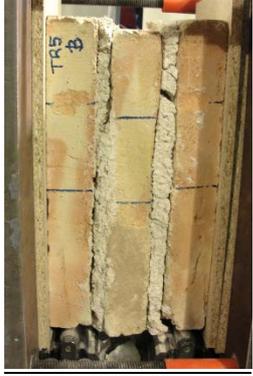
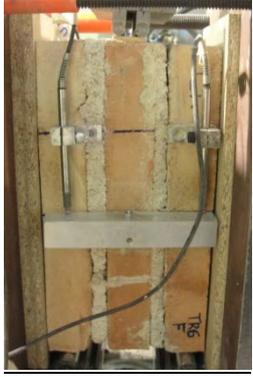
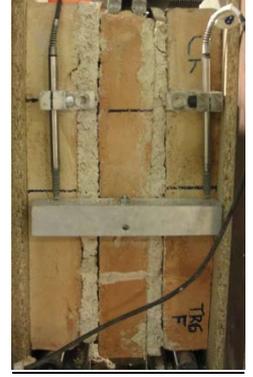
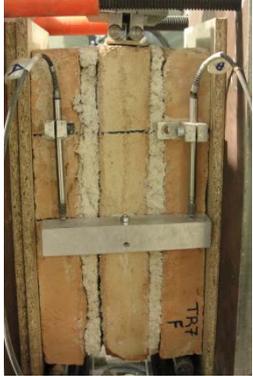
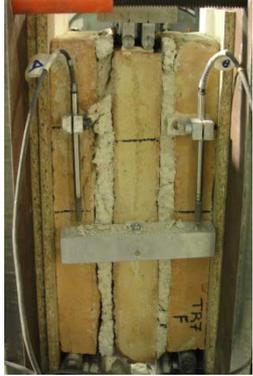
Table 4 – Experimental results of shear tests on triplets with $\sigma_p=0.6$ MPa

39.26	0.45
TR6

38.64	0.44
TR7

39.99	0.46
Average				39.30	0.45
CV				1%	1%

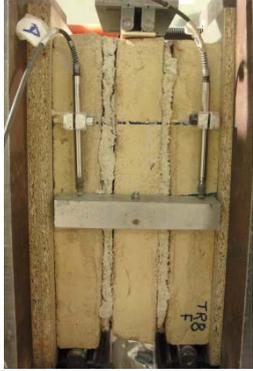
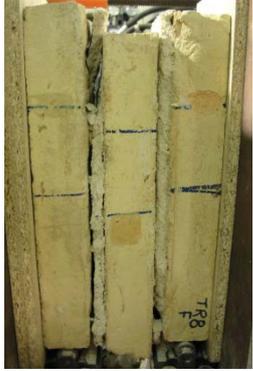
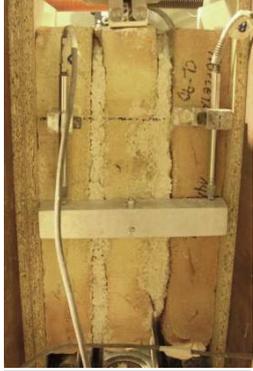
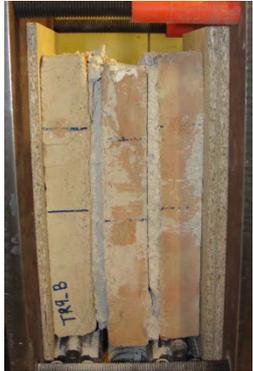
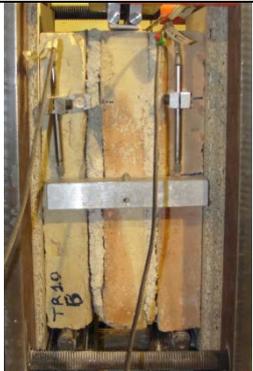
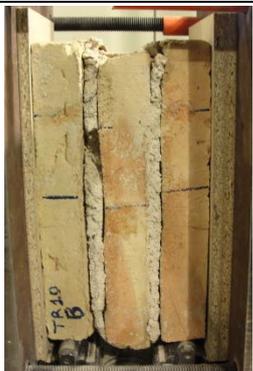
Table 5 – Experimental results of shear tests on triplets with $\sigma_p=1.0$ MPa

65.12	0.68
TR9

68.9	0.72
TR10

61.33	0.64
Average				65.12	0.68
CV				5%	5%
