Textile Roofs 2016

The 21st International Workshop on the
Design and Practical Realisation of
Membrane Structures

PATHOLOGY

Josep Llorens – Barcelona School of Architecture.
Technical University of Catalonia (UPC) - Spain

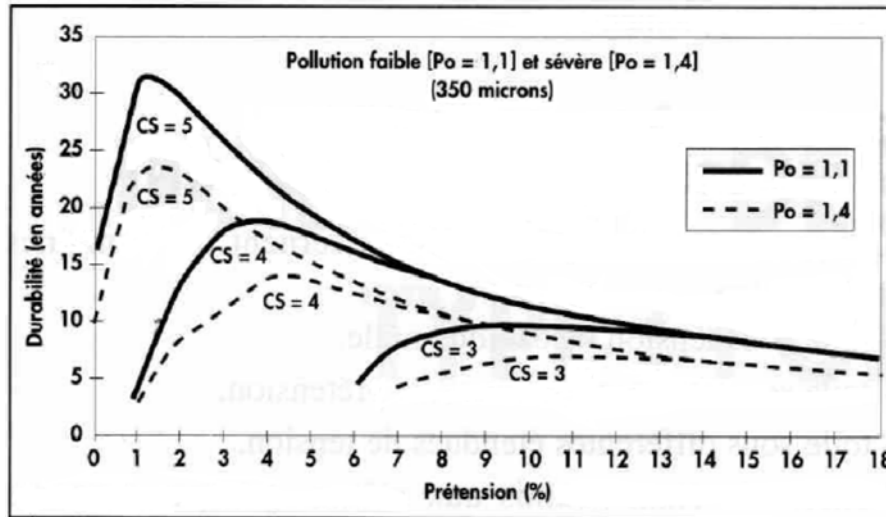
Durability estimation (N.Stranghöner et al. 2016)

Durability-pretension-diagram. Low pollution $Po = 1,1$. Severe pollution = $1,4$. CS: safety factor related to fracture. Level of pretension related to fracture.

It can be noted that the strong pretensions are harmful to durability, as well as pretensions less than 1% of the rupture. In general, it can be found that diagrams $Po = 1.1$ and $Po = 1.4$ are each tangent to a curve.

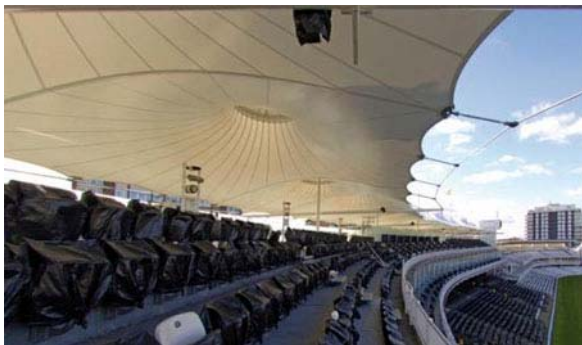
Dampness can affect the threads or the coating with formation of colonies of micro organisms. The edges of the cuts are especially vulnerable if left unprotected.

Mound Stand Lord's Cricket Ground textile roof. It has been replaced.

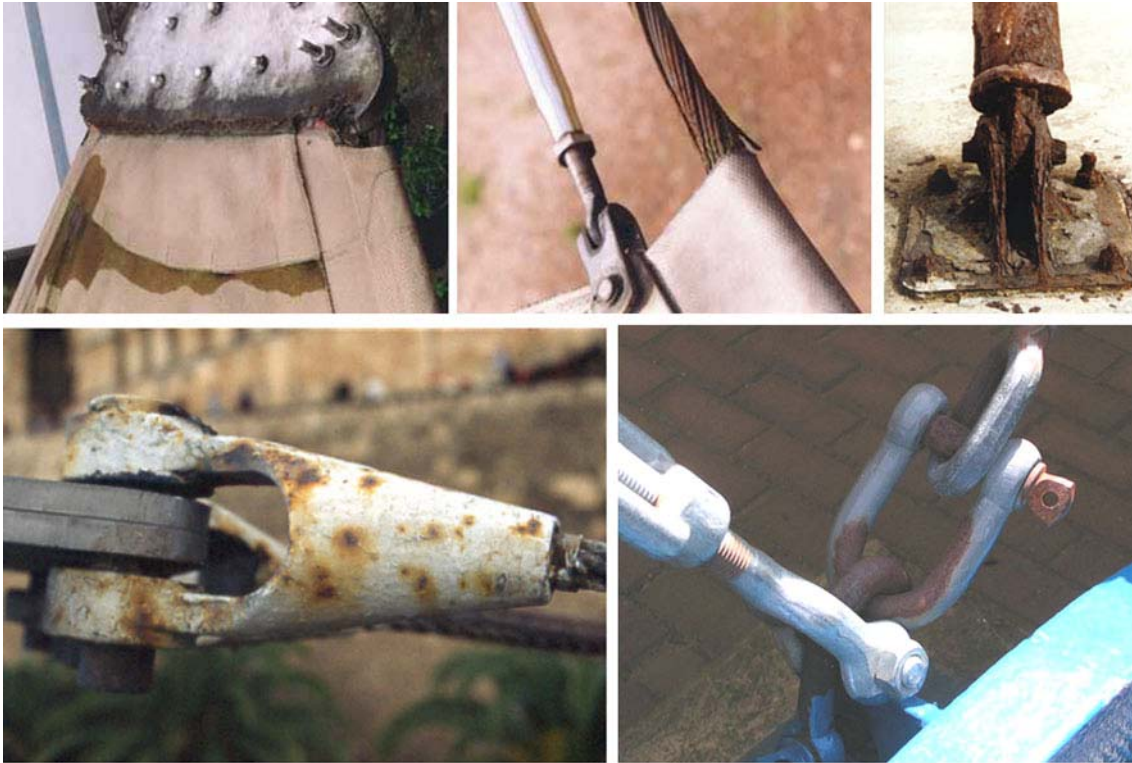
Aerial and galvanic corrosions affect the metallic parts present in edges, corners, fittings and structure.

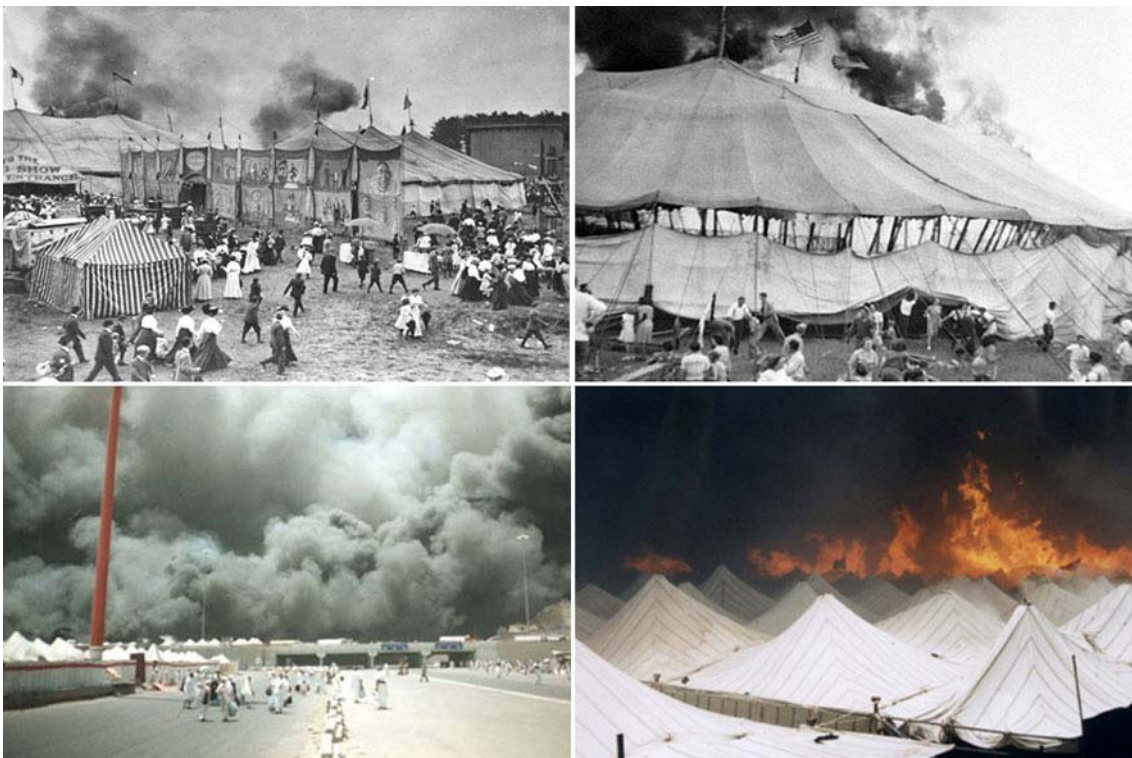
In May 21, 1910 a spectacular fire destroyed the main tent of Barnum & Bailey Circus in Schenectady. The **Hartford circus fire**, which occurred on July 6, 1944, in Hartford, Connecticut, was one of the worst fire disasters in the history of the US. The fire occurred during an afternoon performance was attended by 6,000 to 8,000 people. 167 people died and more than 700 were injured. The tent's canvas had been coated with paraffin wax dissolved in gasoline, a common waterproofing method of the time.

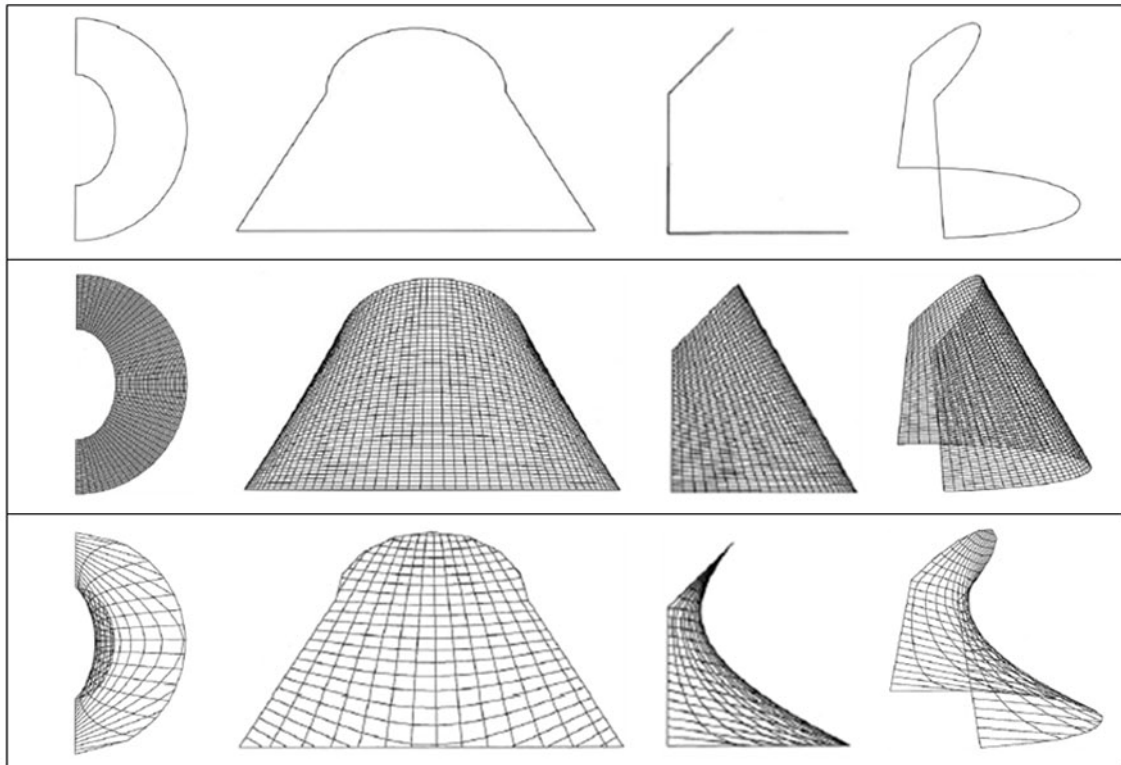
Top: Some computer programs, like AutoCad, build surfaces from closed perimeters. Middle: Equilibrium and feasibility are not checked. Bottom: The surface created inside the same closed perimeter in equilibrium.

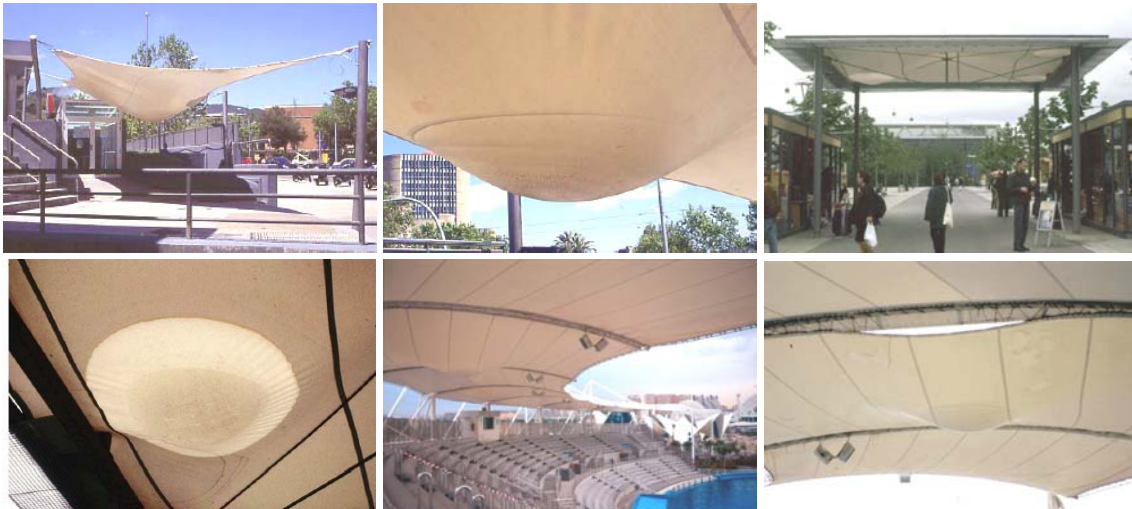
Water ponding is the result of horizontal flatness and lack of pre-stress. It has to be controlled within the form finding process and tested during the installation. The danger of shallow gradients is that accumulation of water can cause a depression in which rain can collect more water with the surface geometry having changed from “anticalstic” to “synclastic”. This in turn increases the depth of the depression allowing more water to pond and hence creating a larger depression and so on. It may remain as water or convert to ice according to weather conditions. The effect however is for snow loads to progressively increase far beyond those applicable to a more rigid structure. The objective must be the achievement of a form which as it deflects maintains positive gradients under the effect of the worst credible loading conditions.

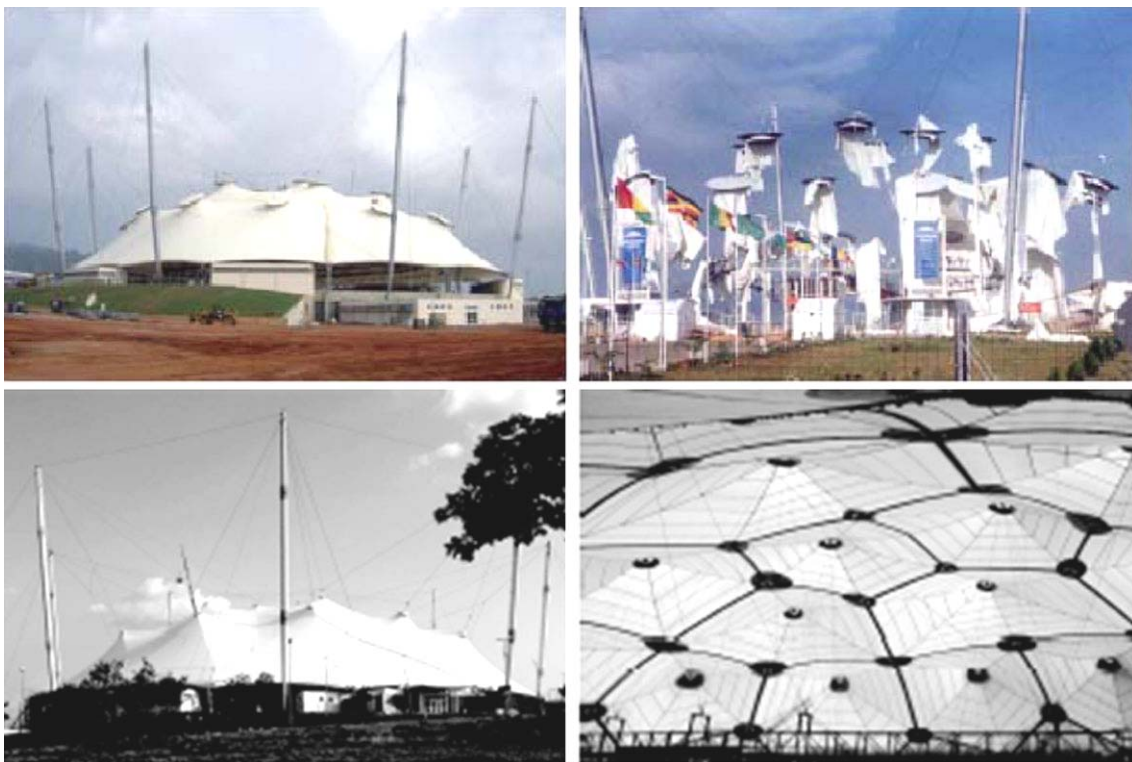
Top left: before the storm. Top right: after the storm. Bottom: redesign. The roof of the Velodrome was replaced by a more redundant system, with the same appearance and avoiding any modification on the main masts. A circumferential ring cable was added to minimize the asymmetric loads on the tie-down cables. (B.Stimpfle, 2008)

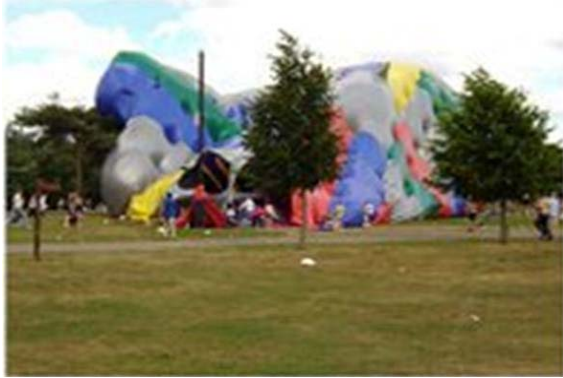
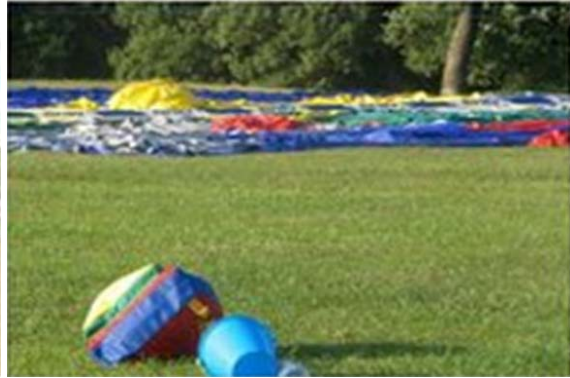
Saturday, February 16, 2008: The Liverpool arts company Brouhaha International has finally been charged, along with artist Maurice Agis, two years after their inflatable sculpture *Dreamspace* broke its moorings killing two people and injuring 13 others.

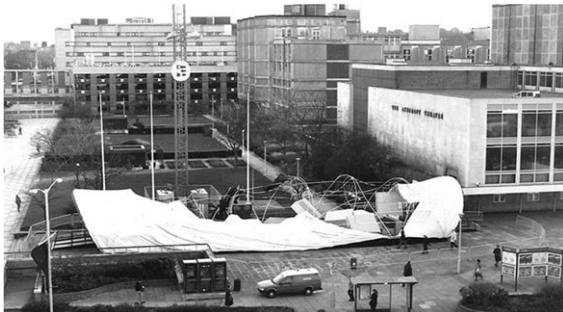
1 November 2013: The Museum of Moving Image in Croydon was ravaged due to 145 km/h wind.

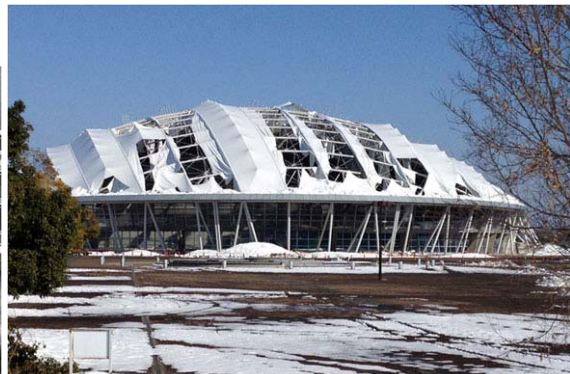
Kumagaya Dome under the snow.

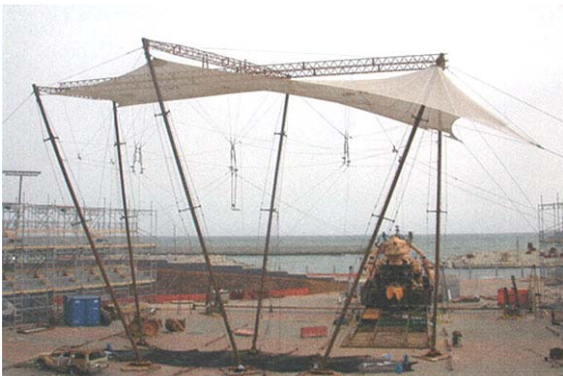
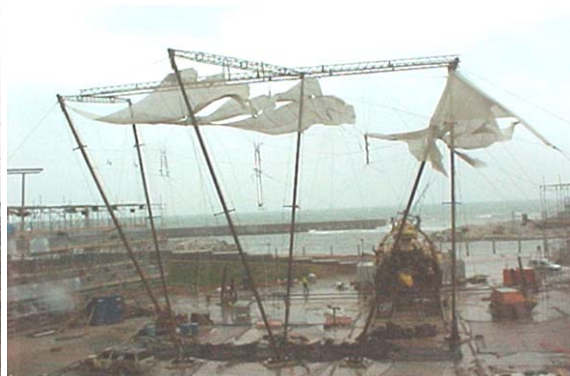
The Giant of the Seven Seas show. Barcelona Forum of the Cultures, 2004.

A 230 m² textile roof was designed for the "Giant of the Seven Seas" show to protect the performers from direct sunlight at noon. It did not survive the first storm under the east 100 km/h (28 m/s) speed wind. The membrane began to flutter and continued to flap until it tore. This was due to the installation of additional oblique cables for the tackles of the trapeziums that hurt the membrane during its displacements under the violent storm (N.Pauli, 2005).

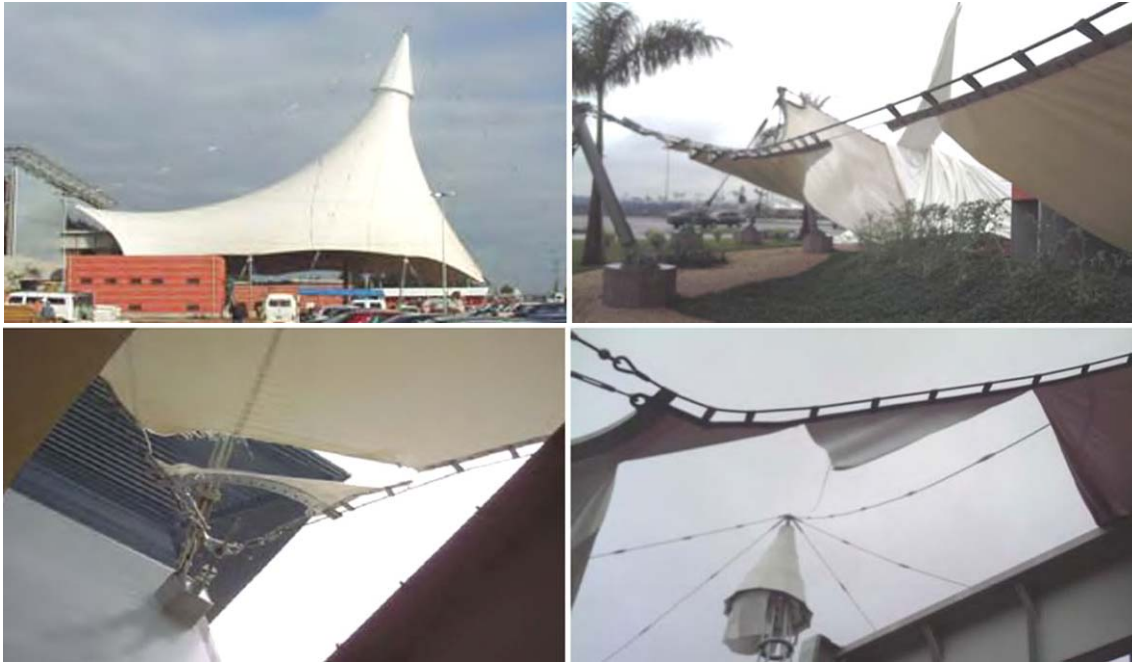
Another wind-induced trouble was that of the "Centro Cultural" of Paulinia. It was an asymmetrical conical tent built in 2004. It covered an area of 2.200 m² with a total surface of 3.700 m² with a central mast 42 m high, inclined 13° with respect to the vertical (R.M.O.Pauletti et al.2007). It collapsed in 2005. An analysis was developed to infer the possible causes of the failure.

The collapse occurred for a 100 km/h wind speed, corresponding to a dynamic pressure of 480 N/m² and maximum traction value of 26 kN/m, below the 100 kN/m informed by the supplier. Tests extracted from the collapsed membrane indicated 20% to 40% reduced values. Localized tears were detected previous to general collapse. They propagated easily because the tear strength is considerably lower than the tensile strength.

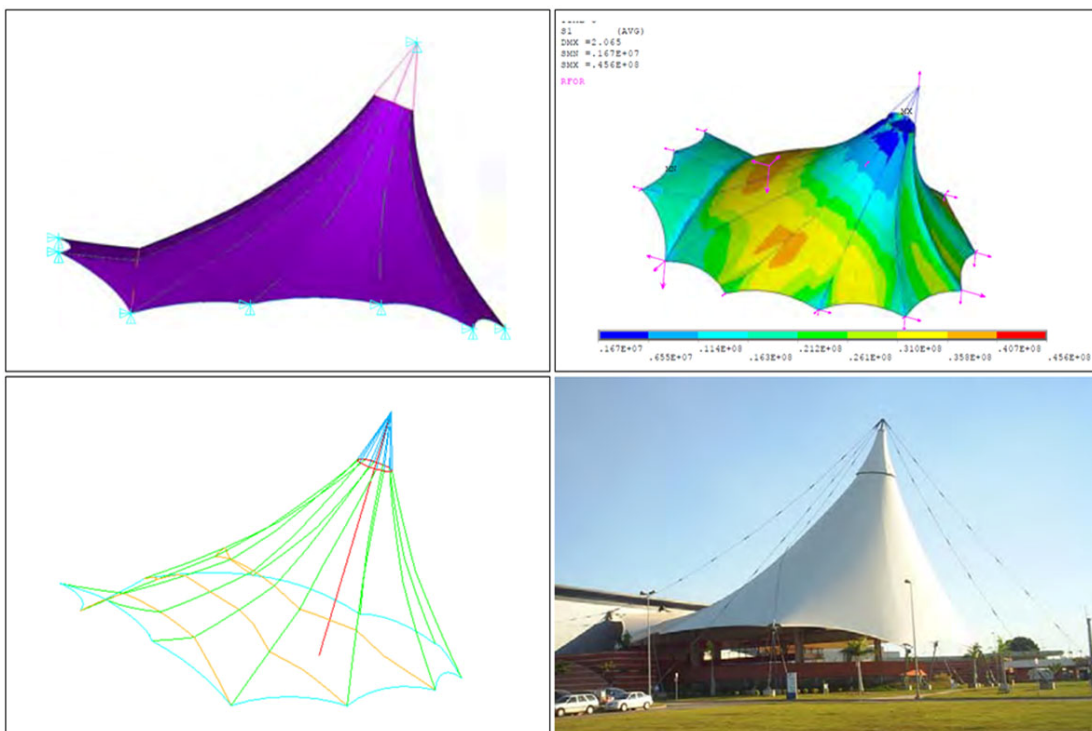
To rebuild the tent much higher loads were considered: 168 km/h wind speed corresponding to a dynamic pressure of 1.340 N/m². The original geometry and level of prestress were also improved to avoid ponding and reduce displacements by means of a set of 3 transversal steel cables combined with 11 radial cables that also alleviated stresses in the membrane.

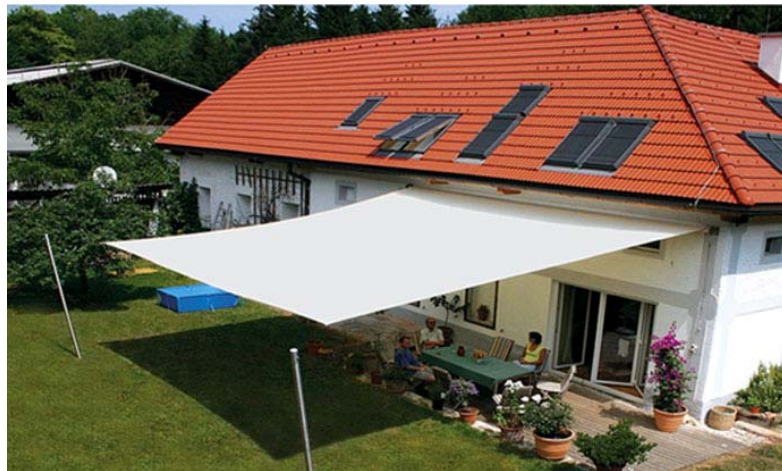
About the flatness effect

Equilibrium of a piece of membrane shows that radius of curvature are denominators, so tensions increase proportionally to them. According to the formulation: $R = 0$ (flatness) means $T = \infty$. In other words, equilibrium is not possible between tension stresses and external loads acting perpendicular to the membrane. But what happens is that equilibrium is possible because of the elastic strain, not taken into account in the above formulation. In fact, flat and curved membranes deform till equilibrium is reached. Taking into account the elastic strain of the material, the membranes deforms till equilibrium is reached between the tension stress and external loads acting perpendicular to the membrane surface (R.Wagner, 2008).

Nevertheless, the pitfalls of building flat surfaces are fluttering, ponding and high stresses.

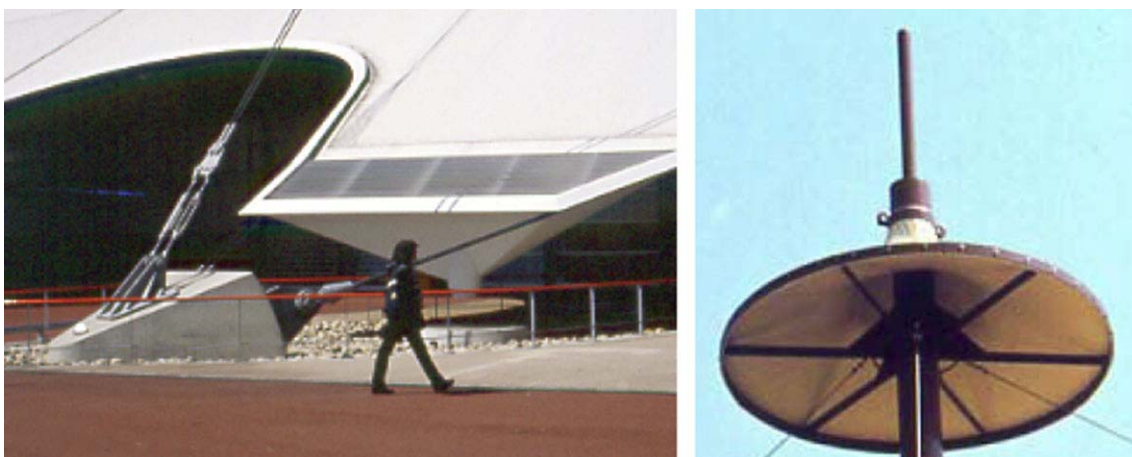
Space is needed where cables meet and loads pass from fabric to steel. **Preliminary designs and computer models tend to underestimate the dimensions of connections and joints.** Moreover, impermeability, drainage and ventilation also require space → points are not points, lines are not lines, lines become strips.

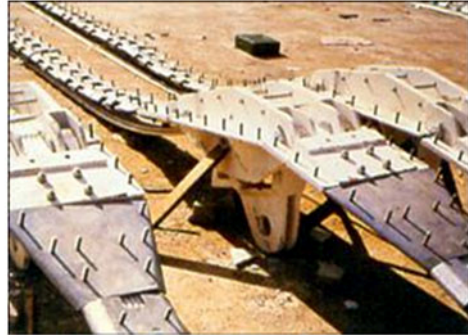
The ridge cables of the cable-dome become strips because the fabric cladding was installed by attaching it to aluminium castings that cover them.

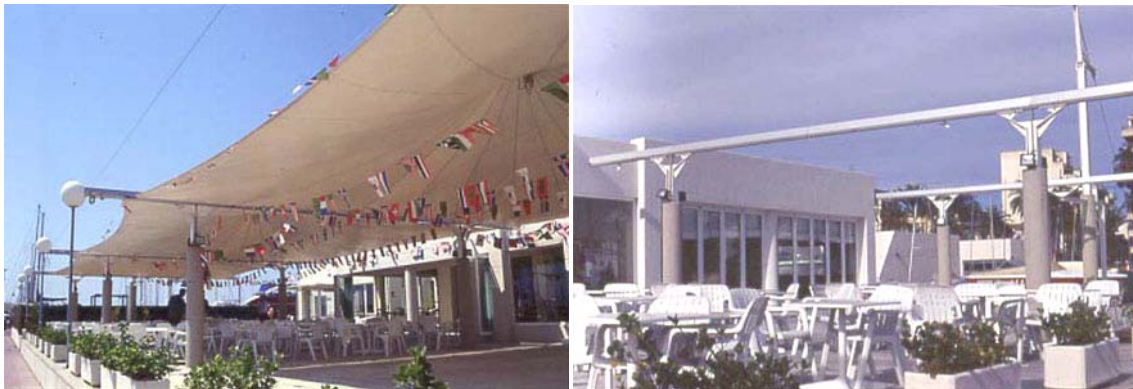
The canopy for the Restaurant of the Yachting Club was made of rectangles. Two opposite edges were free and two were continuous, connected to aluminium sections. The double curvature and pretension were introduced hoisting the central point and forming conoids with a rectangular perimeter. As the direction of the roof starting from the slot was not horizontal, the membrane was cut. Possible solutions were: changing the direction of the slot, softening the edge of the slot or/and reinforcing the membrane.

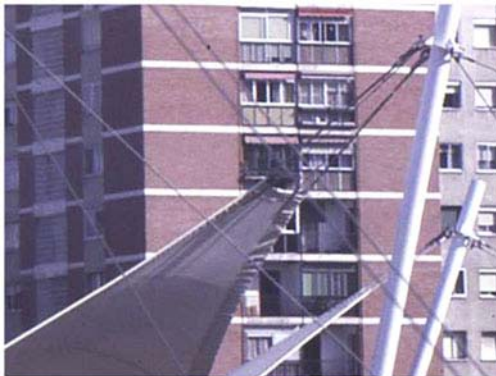
Wrinkles due to the gliding of the fabric.

Corners of flexible edges are created by a spandrel. The spandrel region is very critical to overstresses since the short distance between the edges neither allow an elongation of the membrane nor an angular displacement of the fabric in order to reduce overstresses. In addition to that, the membrane has the tendency to glide off the spandrel under pretension which might lead to an overloading of the membrane. However, looking at the tension in a membrane spandrel between two flexible edges, it cannot be assumed that the membrane overstresses in the region are compensated by the “flexibility” of the edges. Edge cable, edge fitting and corner support or foundation together form a relatively stiff building member in this region. Here the term “flexible” is not an appropriate description when compared with the flexibility of the membrane. (N.Stranghöner et al. 2016).

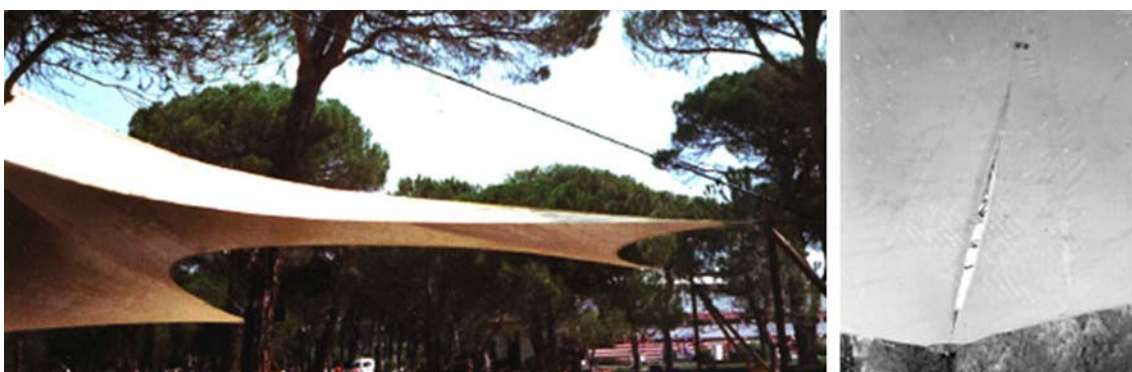
Sewing and welding may affect the resistance, waterproofing or the properties associated to the coating. Moreover, a manufacture defect appears when the patterns are joined with different stresses. The one less stressed wrinkles.

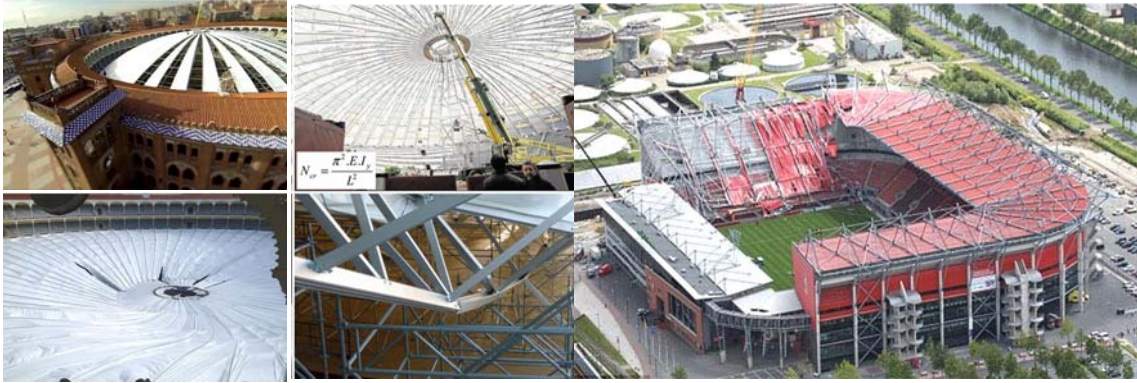
Left: To enable events to take place outside of the bull fighting season, a roof was designed for Las Ventas bullring, Madrid, 2003, costing a reported 4 million Euros. It collapsed before its inauguration to the public under a 47 km/h speed wind. The structure has been designed in aluminium to affect as little as possible the existing building, but the values adopted by the computer program were those of steel. The consequences were twofold:

1 Buckling: the critical load (or length) was lower than expected. Modulus of elasticity of aluminium = 0.354 x modulus of elasticity of steel. In addition, if wind suction overcame the self weight, stresses were reversed: tension elements went into compression and buckling.

2 Instability: Lack of temporary bracing during installation favoured the instability. (In the final position, the membrane under tension was supposed to stabilize the trusses).

Right: During the construction, temporary bracing, in the form of steel cables, were being used to provide stability to the roof structure. As the project progressed, the temporary stabilizing cables were removed, requiring the permanent bracing components of the structure to engage and support the loads and forces acting on the roof. Upon removing the final temporary stabilizing cable, the partial collapse of the stadium roof was triggered.

Upon investigation, it was determined that the temporary bracing was removed before adequate permanent bracing was erected. The absence of coupling pipes at the back ends of the roof beams as well as stabilizing connections in the roof structure contributed to the partial collapse of the roof structure.

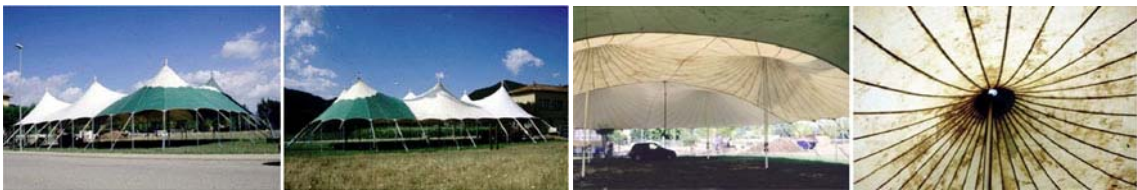
Dirty execution. Protection from the soil was needed because of muddy conditions.

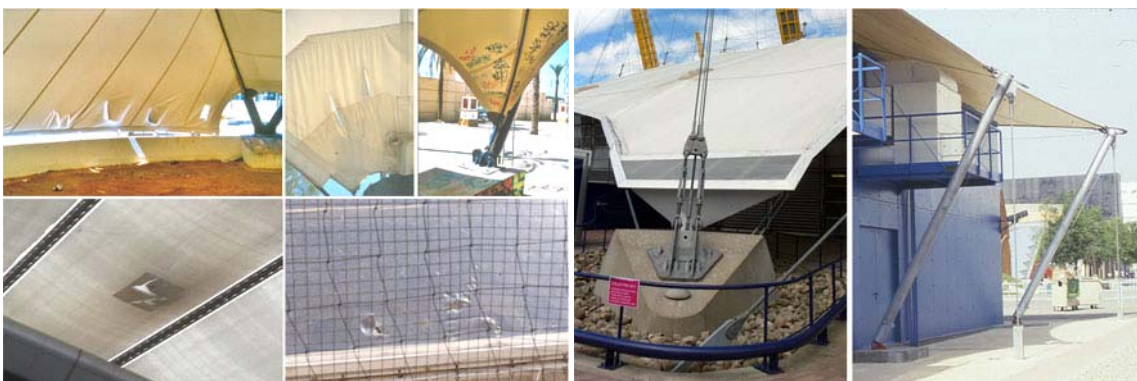
Left: Membrane materials are easy to cut with a sharp knife and are therefore susceptible to accidental damage from vandalism and flying objects. It usually occurs in the lower parts that can be easily accessed voluntarily or accidentally. They also occur on top of the roof due to falling objects, firecrackers or birds.

Right: Direct access to the fabric may be prevented in order to avoid vandalism. This measure can be taken in two ways:

- 1) introducing elements of separation between users and the membrane such as vegetation or street furniture or decorative elements.
- 2) the membrane is set above the reach of users.

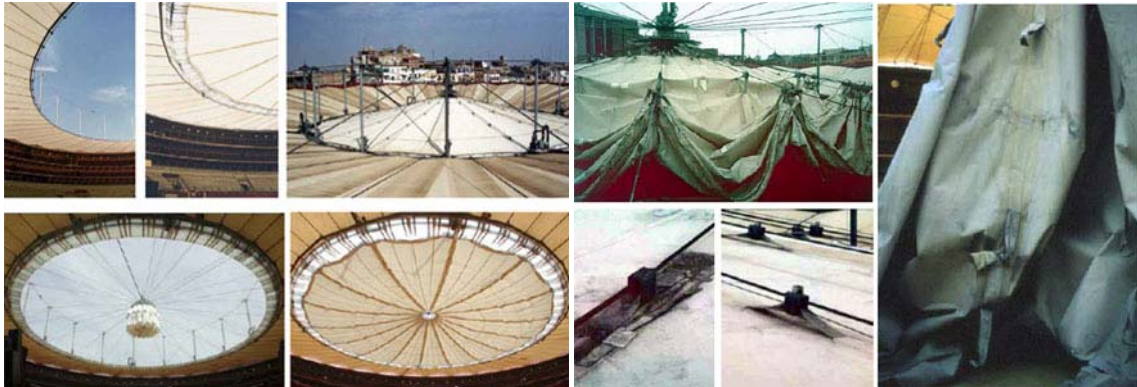
Textile roofs are sometimes asked for retractability, that conditions the design and materials. It was the case of the Retractable Roof of the Zaragoza Bullfight Arena. 10 Years after completion a repair was needed because coating against UV radiation was ineffective, folded lines and suspended points tore and flexibility was lost. Opening and closing the fabric may end up causing the breakage of the fibres at points where the folding occurs persistently. The breakage of these fibres can facilitate initiation of the tearing of the fabric.

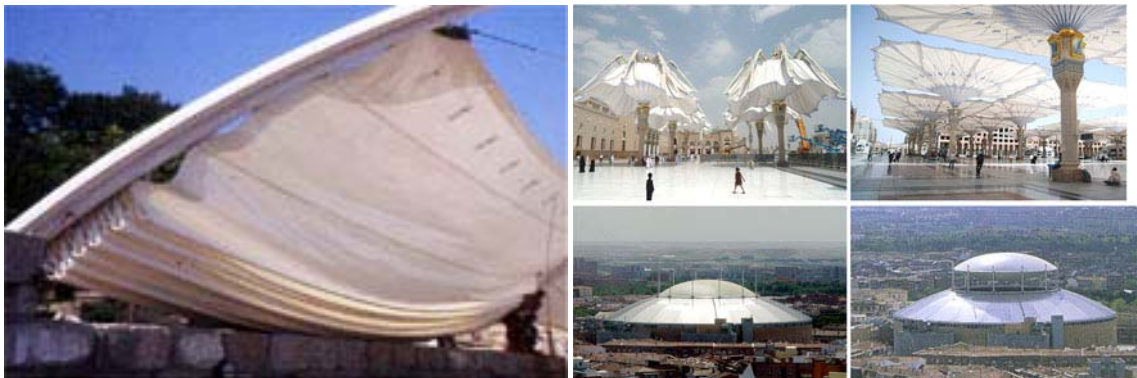
Left: For fabric folding and unfolding, the type of material needed is a flexible fabric. The border reinforcements must also be flexible, especially when the folds are very close. Polyester strings are preferred to steel cables. Parallel folding produces longitudinal folds not so aggressive than radial folding towards a point that produces point folds.

Right: An alternative solution for retractability is a more flexible fabric. In the Prophet's Holy Mosque umbrellas, white PTFE fabric integrated with strengthening belts was used. Movement is another alternative solution to retractability. Instead of folding the membrane, the whole structure is displaced. It is illustrated by the Vista Alegre Bullfight Arena Roof, Madrid.

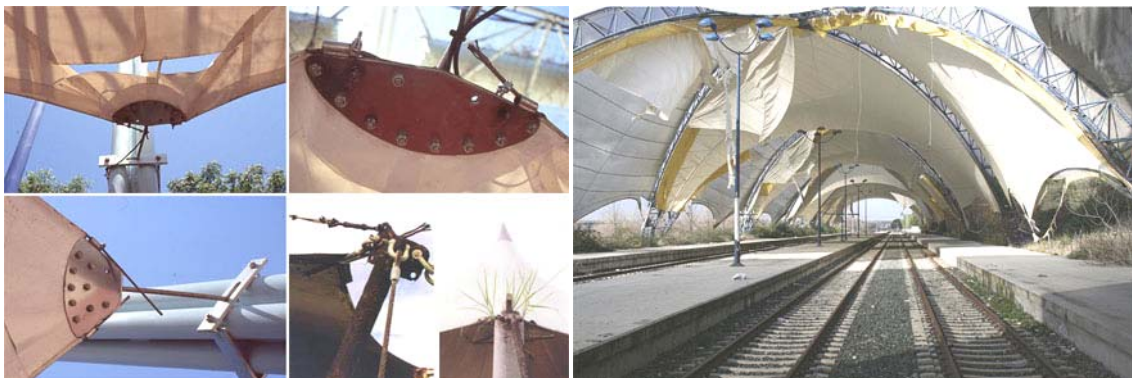
Abandonment. Left: No maintenance means degradation. Right: Railway halt, Sevilla after Expo 92. Some administrations and firms do not think or do not provide for the maintenance or dismantling after the event that caused the construction. When the prestress relaxes, the wind causes fluttering, a significant movement of the fabric in the direction perpendicular to its surface, due to the alternating pressure and suction. This repeated action causes fatigue on the fabric and ends up tearing it. This occurs mainly in the free boundary of the cover, more affected by the wind.
