# INTEGRATED DYNAMIC AND THERMOGRAPHY INVESTIGATION OF MALLORCA CATHEDRAL

Ahmed Elyamani<sup>1</sup>, Oriol Caselles<sup>2</sup>, Pere Roca<sup>2</sup> and Jaime Clapes<sup>2</sup>

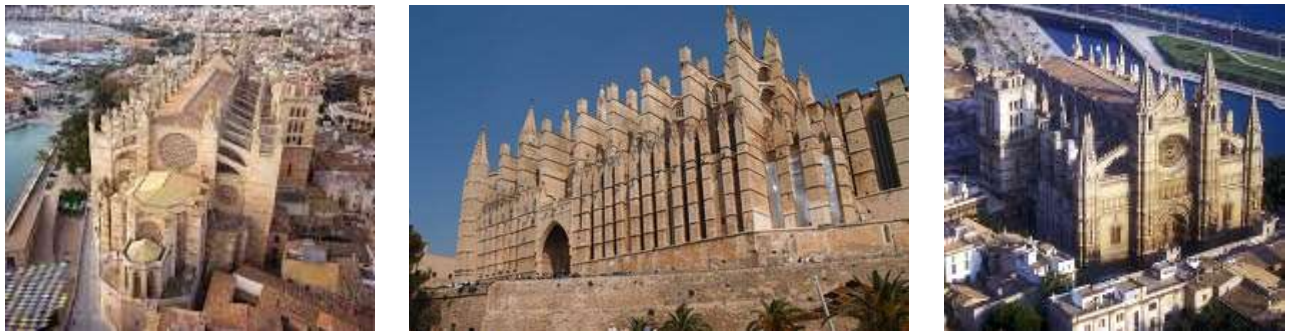
Figure 1. Mallorca Cathedral from outside: apse area (left), south façade (centre) and main façade (right).

Mallorca cathedral is a Cultural Heritage of National Interest in Spain since 1931 (Figs.1 and 2). It is located in the city of Palma, in Mallorca Island. When compared with other worldwide Gothic cathedrals, it is found that its piers show an unusually large slenderness ratio, while its main nave span is the second longest span among Gothic cathedrals after Girona cathedral. Its main nave is among the highest ones after those of Beauvais and Milan cathedrals.

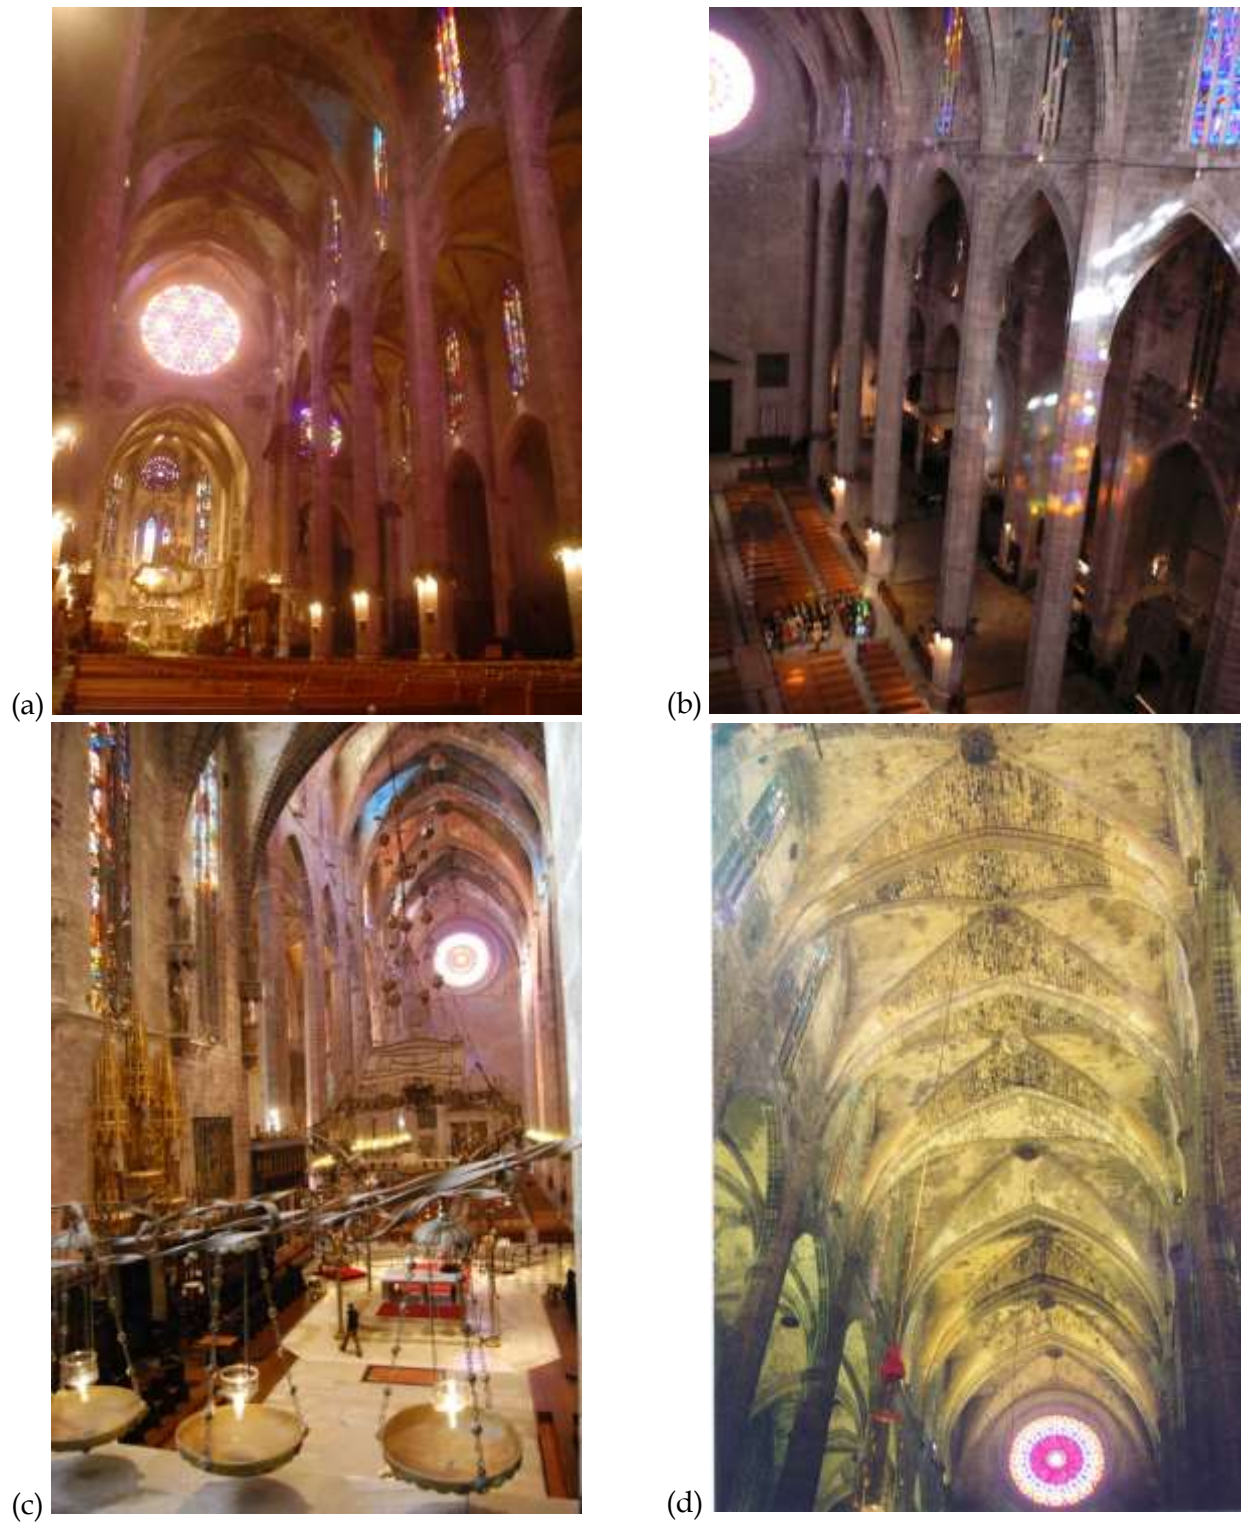
**Figure 2.** Internal views of Mallorca cathedral: (a) view of the choir, central nave and south lateral nave; (b) view of the west façade and north nave showing the slenderness of columns and the upper and lower clerestory walls; (c) view of the central nave from the choir; and (d) central nave vaults .

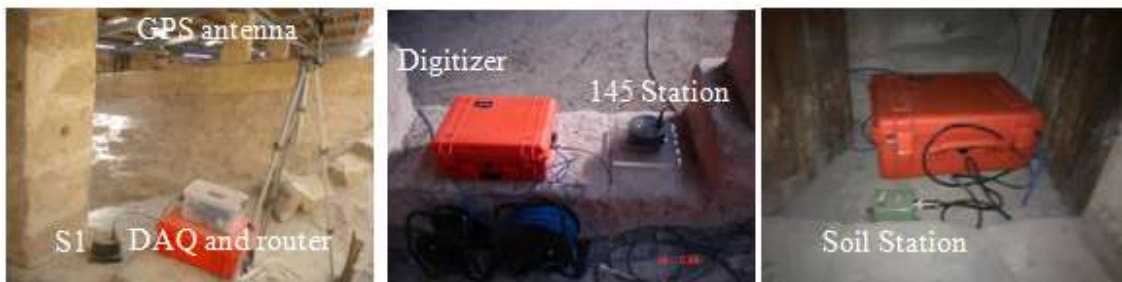
Figure 4. The dynamic system in operation: accelerometer S1, DAQ, router and GPS antenna (left); accelerometer 145-Station and digitizer (middle); and accelerometer Soil-station (right).

The use of AVT was followed by a continuous dynamic monitoring system. A brief is given here and more details can be referred to at (Elyamani *et al.*, 2017b; Elyamani, 2015). The system was composed of a digitizer, a Data Acquisition system (DAQ), a Global Positioning System (GPS) antenna, an internet router and the three tri-axial accelerometers previously used in the dynamic identification tests, Figure 4. The system worked properly for two periods: from 17/12/2010 to 13/9/2011 and from 18/5/2012 to 29/12/2012. Within this second period, the system was interrupted from 30/7/2012 to 4/9/2012. The system was programmed to continu-

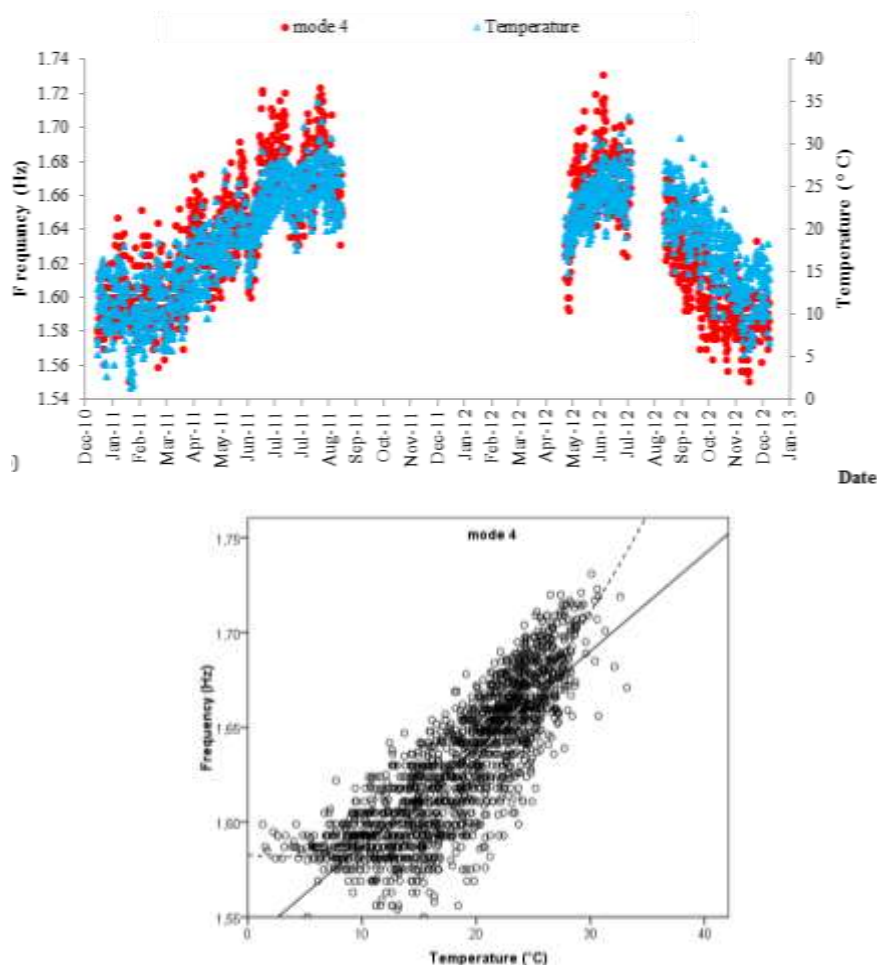
**Figure 6. Changes of the natural frequency of mode 4 with external temperature (top) and correlation with external temperature (bottom). Linear and quadratic regression models are in solid and dashed lines, respectively.**

The change of the frequencies with temperature was plotted for the eight detected modes (Figure 6 for mode 4 as an example). It was noticed that the relation was clearer and the in-phase oscillation was more evident for modes 2, 4 and 8 than for modes 3, 5, 6 and 7. The frequency variations under changes of exterior temperature were investigated and both the correlation and the regression were studied, Figure 6. It can be noticed in Figure 6 that the trend is not exactly linear. Therefore, both of linear regression and quadratic regression were considered to investigate into more detail the type of the relation between temperature and frequencies. The obtained correlation coefficients are summarized in Table 3. As can be seen from the comparison among all models, a linear relation between temperature and natural frequencies provided a good approximation. No significant increase in the coefficients of correlation was obtained when considering a higher degree model. The correlation coefficient of the quadratic model was only slightly higher than that of the line-

ar one. The highest correlation value was around 0.80 to 0.86 for modes 2, 4 and 8, followed by the correlation coefficients ranging from 0.55 to 0.66 for modes 3, 5, 6, and 7.

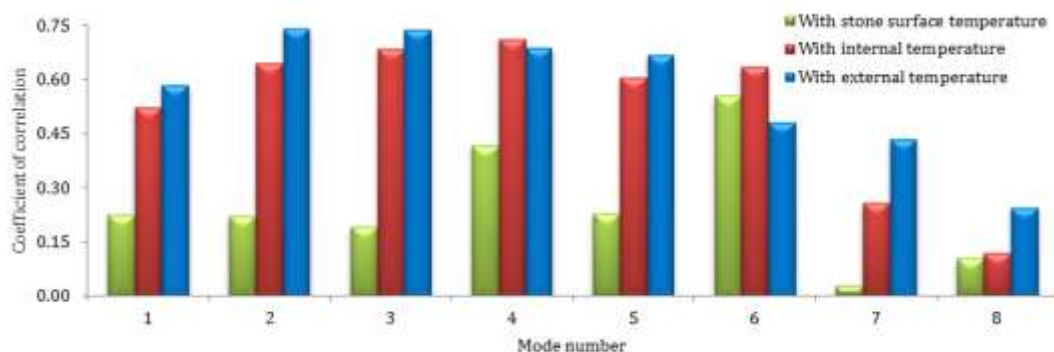
Figure 14. Summer period: comparison between coefficients of correlation of different temperatures with the first eight modes of the cathedral.

In Figures 14 and 15 the coefficients of correlation between the natural frequencies of the cathedral and the different temperatures are presented. For the summer period and during the period of thermography monitoring, the eight modes were identified, whereas, for the winter period only the modes number 2, 3, 4 and 8 were identified. The other modes were local ones; therefore, their identification was not always attainable as can be noticed in Figure 5. It can be noticed for the summer and the winter periods that the coefficients of correlation with the stone surface temperature were less than those with the external and the internal temperature. In the summer period, the coefficients of correlation with the external temperature were in average 0.57 and were

clearly higher than those with the stone surface temperature which were in average 0.25.

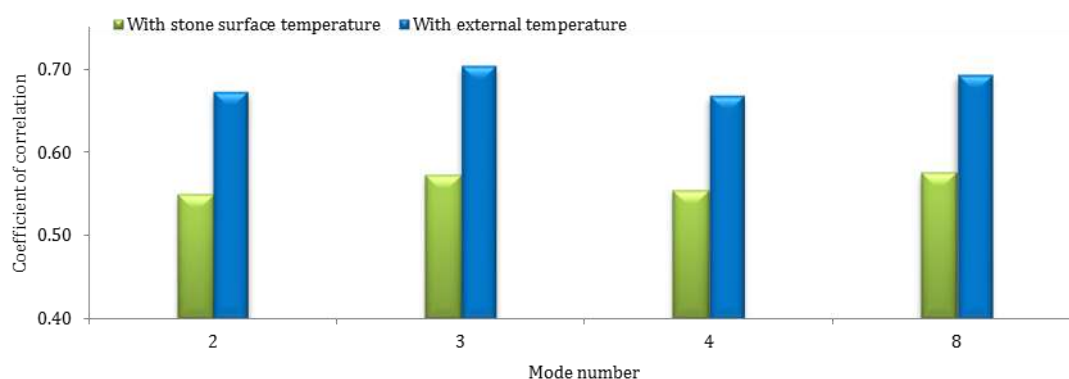
Figure 15. Winter period: comparison between coefficients of correlation of different temperatures with four of the cathedral modes.

On the contrary, in the winter period the coefficients of correlation with the stone surface temperature were in average 0.56 and were not so far from those with the external temperature which were 0.68 in average. The discussion given in the previous section (3.2) may explain this finding. The statistical variations in the identified modes during the summer and winter monitored periods are reported in Table 4.
