**Application of Distributed Optical Fiber Sensors for the Health
Monitoring of two real structures in Barcelona**

António Barrias¹, Gerardo Rodriguez¹, Joan R. Casas¹ & Sergi Villalba²

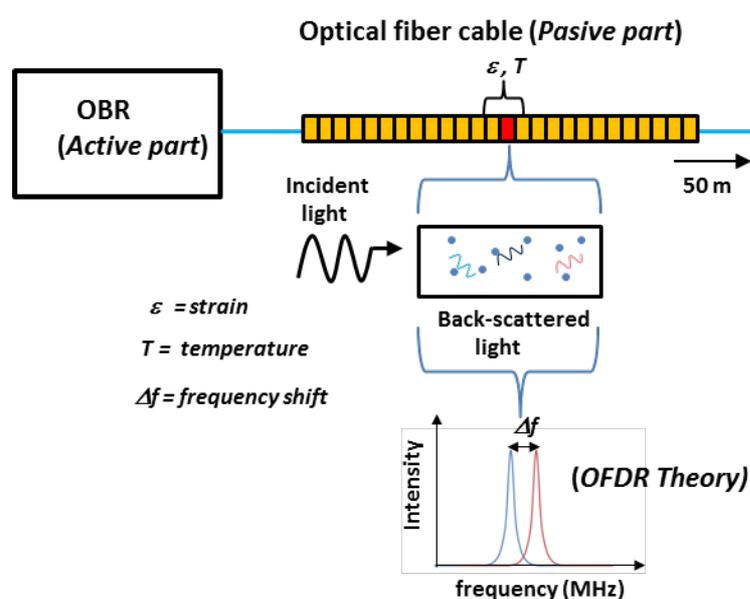
Figure 1. Measuring process by OBR system

The Optical Backscatter Reflectometry (OBR) is based on the Rayleigh backscattering Optical Frequency Domain Reflectometry (OFDR) which enables it to obtain strain and temperature measurements with high spatial resolution (Güemes, Fernández-López, & Soller, 2010; Rodriguez, Casas, & Villalba, 2014). Although this implies also a limitation in terms of sensing length of around 70 m (LUNA, 2012), this technique allows the potential monitoring of different types of structures where it is possible to detect and locate, not only the premature emergence of cracks, but also their evolution and behaviour. The OBR technique, Figure 1, is composed by an active part

which sends a laser light through an optical fiber, and a passive part, where the light is reflected by the intrinsic variations along the fiber length (Samiec, 2012). This pattern of the reflections and the corresponding time of flight of the light is measured and stored, acting as a unique fingerprint for each fiber. When an external stimulus (like strain or temperature variation) happens, a temporal and spectral shift in the local Rayleigh backscatter pattern occurs. This new reflection pattern is then stored and compared with the original one providing through cross-correlation the variation and evolution of generated strains along the entire length of the fiber due to this external stimulus (Grave, Håheim, & Echtermeyer, 2015).

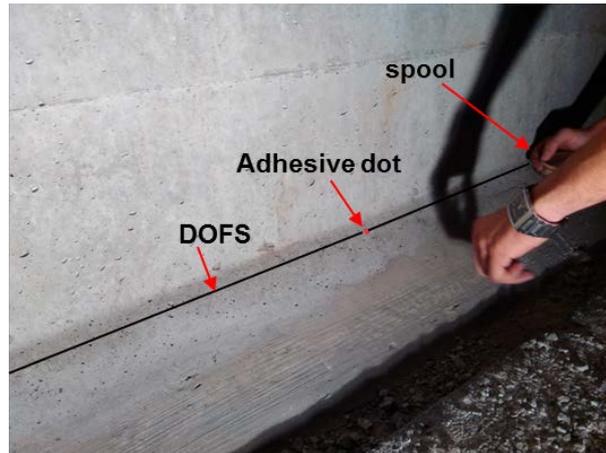
Figure 2. Unwind of the DOFS onto the chosen area of monitoring

Firstly, and in general form, a DOFS route was planned in order to measure strain at the locations and the directions of interest. The elected surfaces were prepared to develop a suitable bond area. These areas were cleaned with alcohol to free them from grease and facilitate the DOFS adhesion to the monitoring surface. The DOFS arrives from the manufacturer rolled on a spool. In general, the DOFS is strong in tension but weak in shear, therefore care needs to be taken in the installation to avoid its rupture. To prevent this, a carefully unwind of the DOFS from the spool is recommended followed by the attachment only using small adhesives dots, spaced at a maximum distance of 1 m, to hold the DOFS in the planned route without any previous layer of adhesive on the monitoring surface. A view of this step of the sensor installation in the Sarajevo bridge, is shown in the Figure 2.

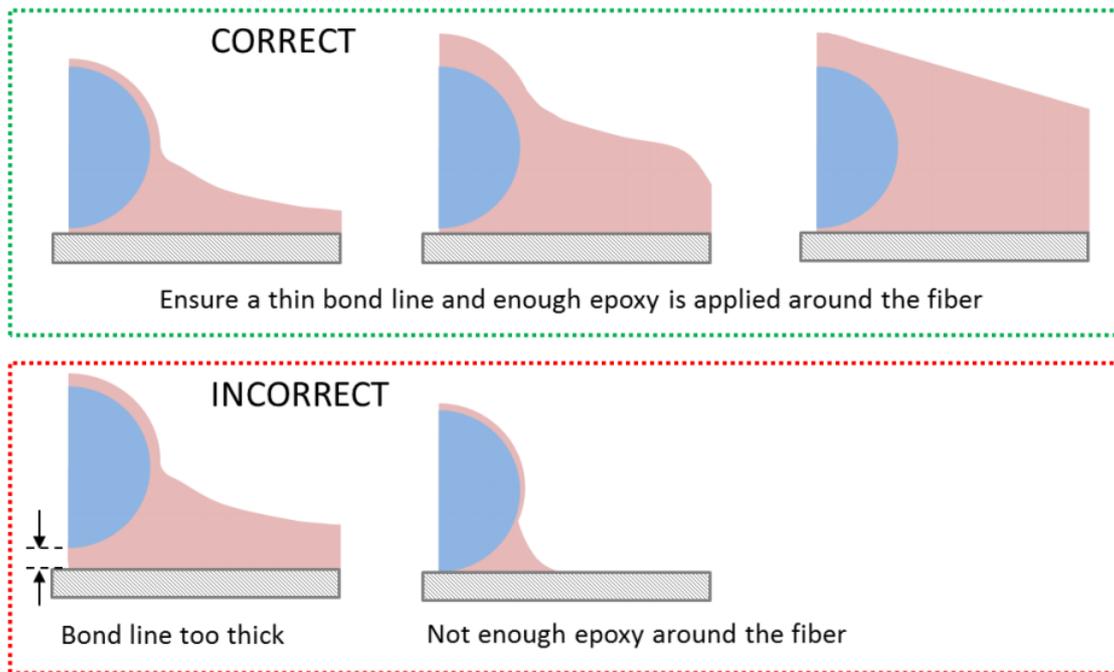
Figure 3. Adhesive application around the DOFS, (LUNA, 2017)

Therefore, a commercial bicomponent epoxy adhesive was applied to the bond area. A small brush to cover was used to cover the DOFS with epoxy avoiding to apply adhesive in excess (Rodriguez et al, 2015a). The bond thickness, amount of epoxy between the fiber and the surface, should be minimized to ensure that the fiber is truly resting on the surface of the monitored structure as shown in Figure 3, (LUNA, 2017).

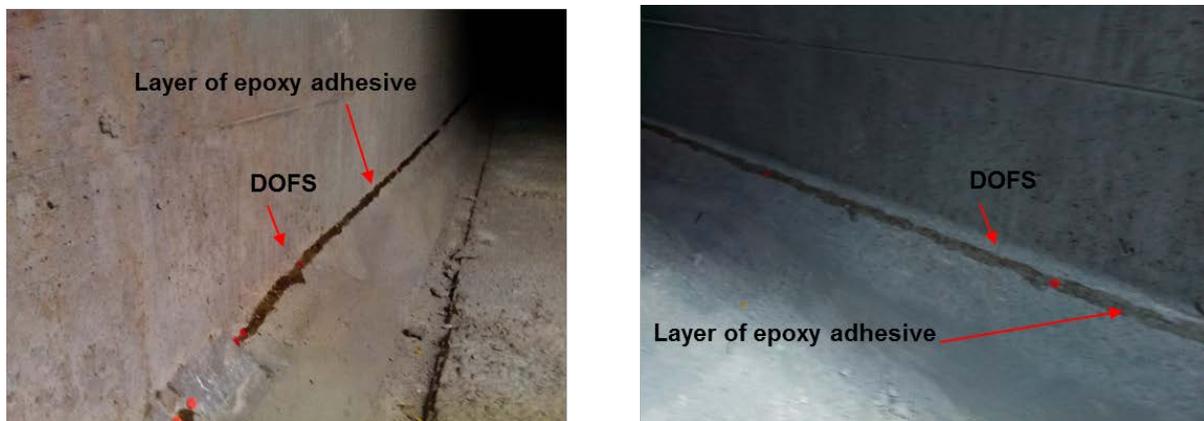
Figure 4. Final aspect of the sensor installation in Sarajevo Bridge

A general aspect of the sensor installation in the Sarajevo bridge is shown in Figure 4.

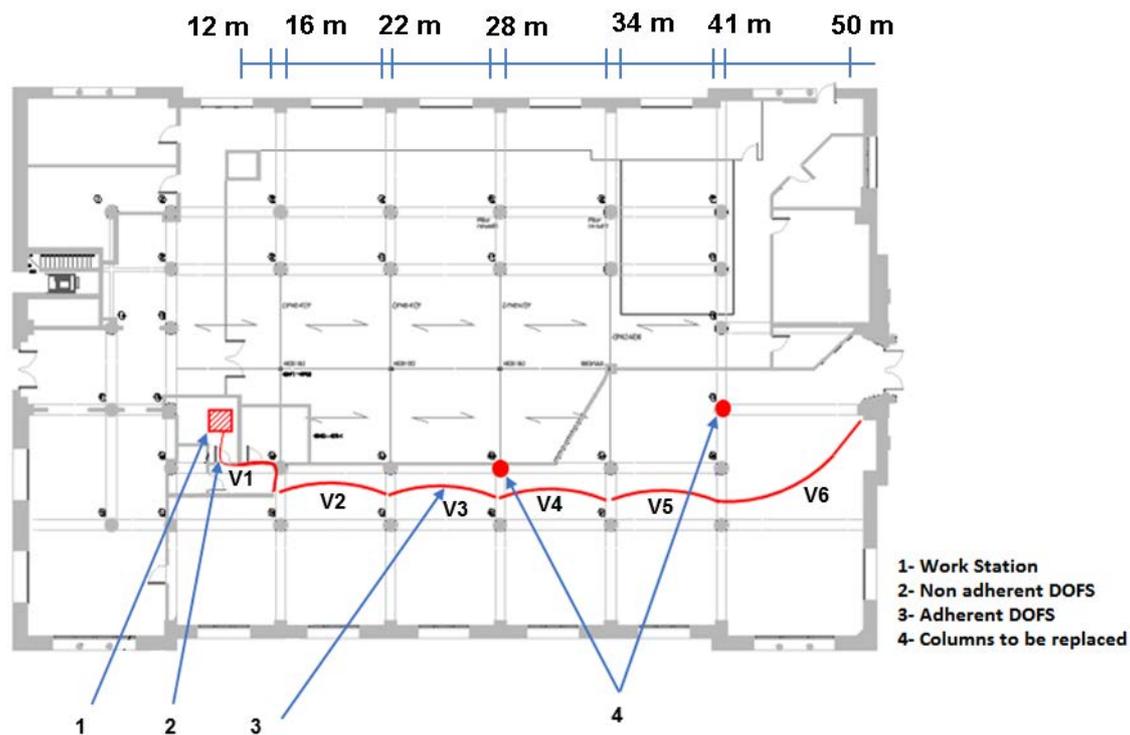
Figure 6. DOFS monitoring scheme. Plan view of the building

After a complete structural assessment, it was decided to replace two of those columns that were assessed to be working unsatisfactorily (represented as red circles in Figure 6) by new columns with steel as main structural material. The floor above was being used to accommodate recovery drug patients and their relocation during the restoration works was not an option. Therefore, it was mandatory to carry out the replacement/strengthening work with the building in full service. For this reason, a full structural monitoring was deemed as necessary during the rehabilitation works.

The continuous monitoring in space of the whole affected area because of the column removal could be hardly achievable by using conventional sensors that are normally used for discrete monitoring (strain gauges, LVDT). Thus, in order to analyse and monitor the correct stress distribution of the slab supported by the columns during the replacement process in a cost-effective and in a truly distributed way, a DOFS was deployed. Otherwise, a large and unaffordable number of sensors would be required. The DOFS monitoring system was placed in a strategically zone sensible to the evolution of movements and crack forming and widening, as seen on Figure 6 and Figure 11.

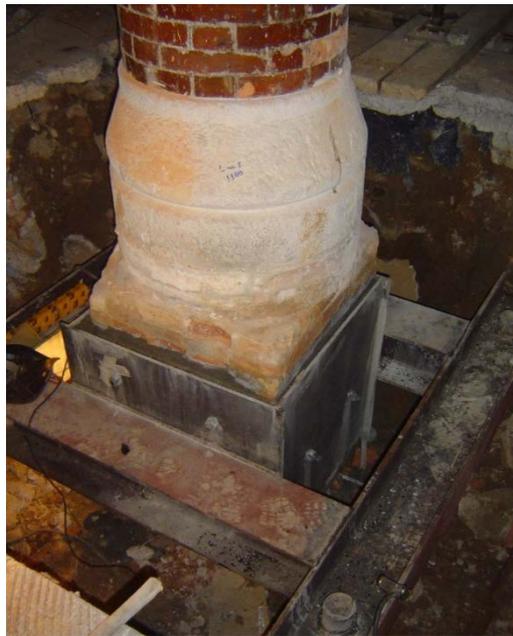
Figure 7. Preparation of columns to be replaced in this procedure

The replacement procedure consisted on implementing a steel structure surrounding the column to be replaced, just to transfer the load from the masonry column to this temporary bearing steel structure (see Figure 7 and Figure 9). Afterwards, the masonry columns were cut and removed (see Figure 8) and then replaced by definitive steel columns. The load was further transferred from the temporary bearing steel structure to the new column. These new members were then

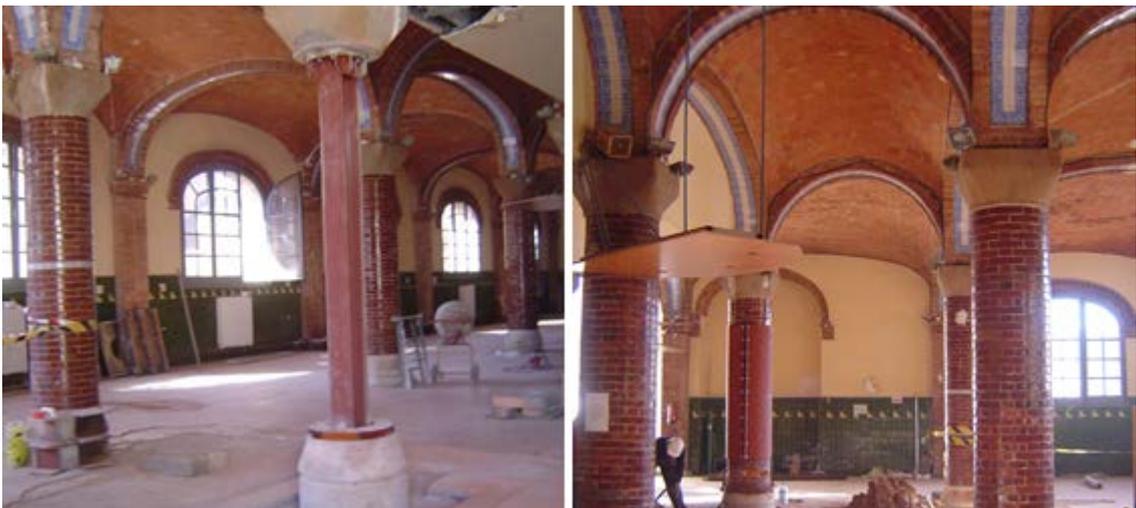
Figure 10. Final works. Implementation of steel profiles and following encapsulation

covered and protected with masonry elements in order to preserve the same architecture pattern as the remaining columns (see Figure 10).

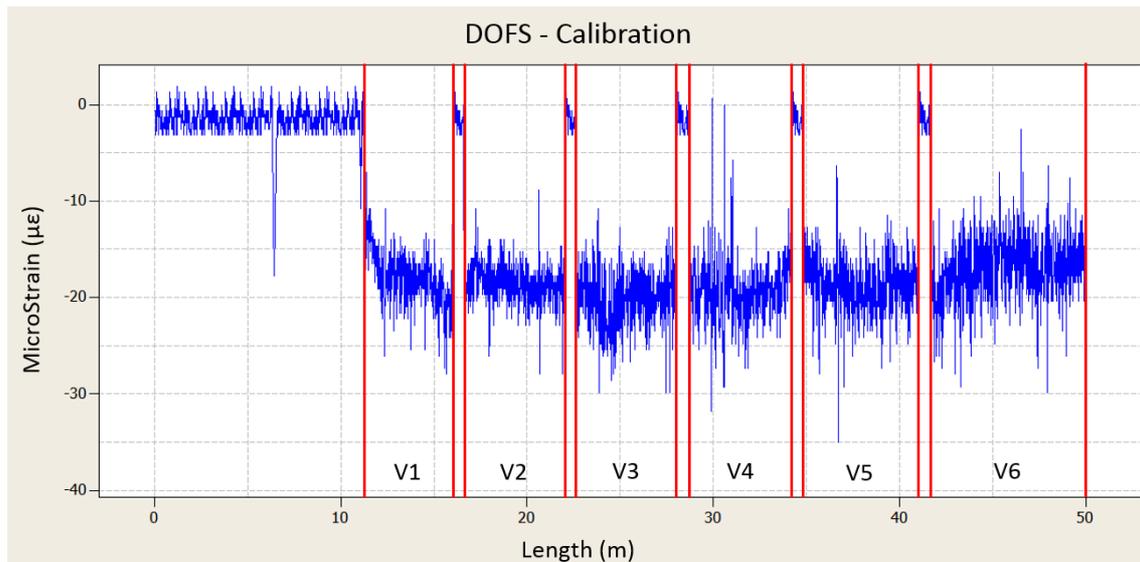
Figure 12. DOFS initial calibration

Previously to the start of the DOFS measuring under construction works, it was necessary to obtain an initial calibration of the system as shown in Figure 12. This provided the zero point from where the strains were measured. From the results presented in Figure 12, two clearly bands are highlighted. A first one where the strain is practically null (microstrain in the order of 0-5 $\mu\epsilon$) and a second one, where nonzero values with an average of 20 $\mu\epsilon$ are obtained. The first 12 m of the fiber (necessary length required to reach the first monitored arch) corresponds to one of the areas where the fiber is not attached to masonry structure. Then, in the corresponding sections around 16, 22, 28, 34 and 41 meters, also a null strain value is recorded in a zone of around 60 cm. This corresponds to the transition zone between low arches vaults where the fiber is also not bonded (see Figure 11).

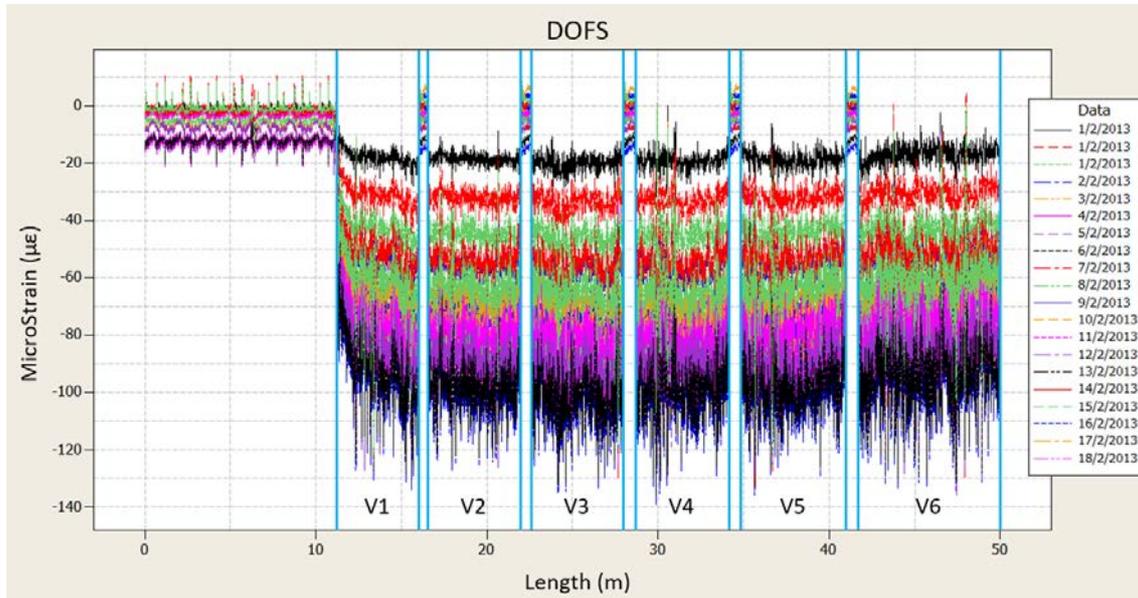
Figure 13. DOFS measurements for the whole length of the fiber during different days of the columns replacement

Figure 13 shows the superposition of measurement plots obtained in the days between the 1st and 18th of February of 2013. In this figure, the obtained strain along the entire length of the fiber is displayed. Here it is possible to observe the evolution of the measured strains in each of the instrumented masonry vaults for the total monitoring period. Due to the distributed capacity of this technology, it is possible to analyse separately this evolution for each vault as seen in Figure 14. Nevertheless, in order to enhance and clarify the evolution of strain with time and length, it is advisable to further zoom the window of analysis as seen in Figure 15 for a zoomed section of 10 cm. Furthermore, measurements at each point versus time can be plotted to better follow the evolution of works as seen in Figure 16.

Additionally, there was no evidence of the emergence of new cracks, either through visual inspection or from the obtained information acquired through the DOFS based monitoring system. As seen in Figure 13 and Figure 14, the observed peaks present small values without showing significant jumps in the measured strain, that would represent the formation of a crack at that location. By analysing the evolution of strain at one point over time, Figure 16, it is possible to observe the increase of compressive strains due to the implementation of the external metallic supports and the two drop-offs that correspond to the transfer of load between these and the columns replacement.

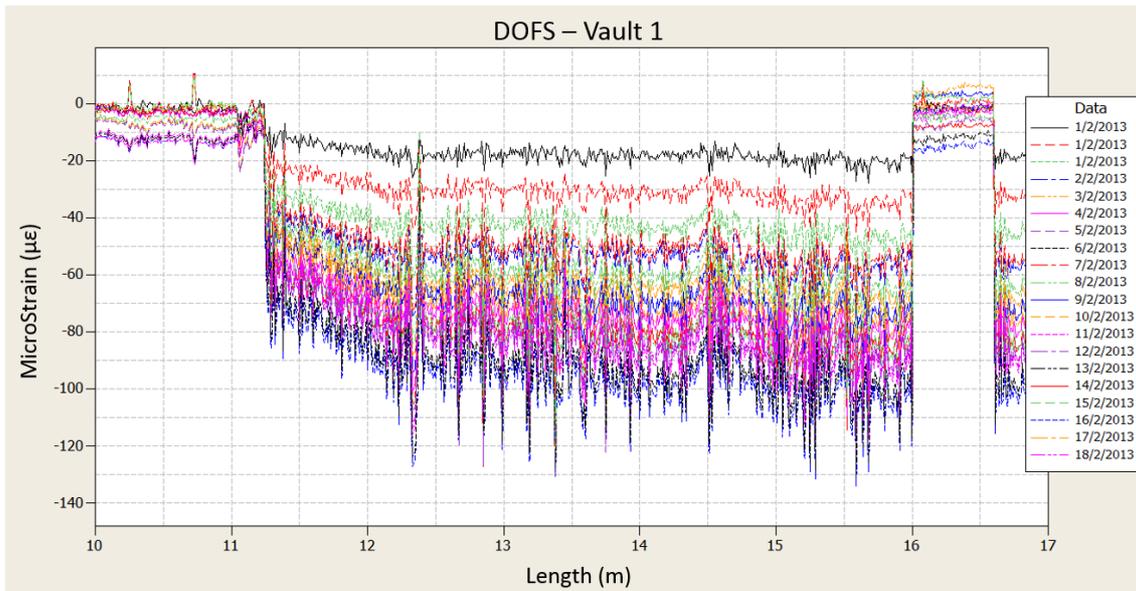
Figure 14. DOFS measured data for the instrumented vault V1

From this analysis, the range of deformation after the initial calibration was obtained. The range of strain change for the period that corresponds to the replacement of the first column (1st of February of 2013) is of 20-40 µε. After the replacement of the second column, an increase of the strain was observed with a maximum value of 100 µε. Since, it is necessary to subtract the initial calibration value of 20 µε to this value, it is possible to conclude that the replacing operation caused an increment of the strain in the vault in the order of 80 µε, almost uniform along the whole roof. The objective of the operation was that during the removal of the old column and placement of the new one, the state of the strains in the vaults would not change significantly (thanks to the temporary steel frame) and also that any small change would be as uniform as possible in the whole roof. The observed increment in strain and its uniformity along the different vaults is in agreement to what was desired and predicted.

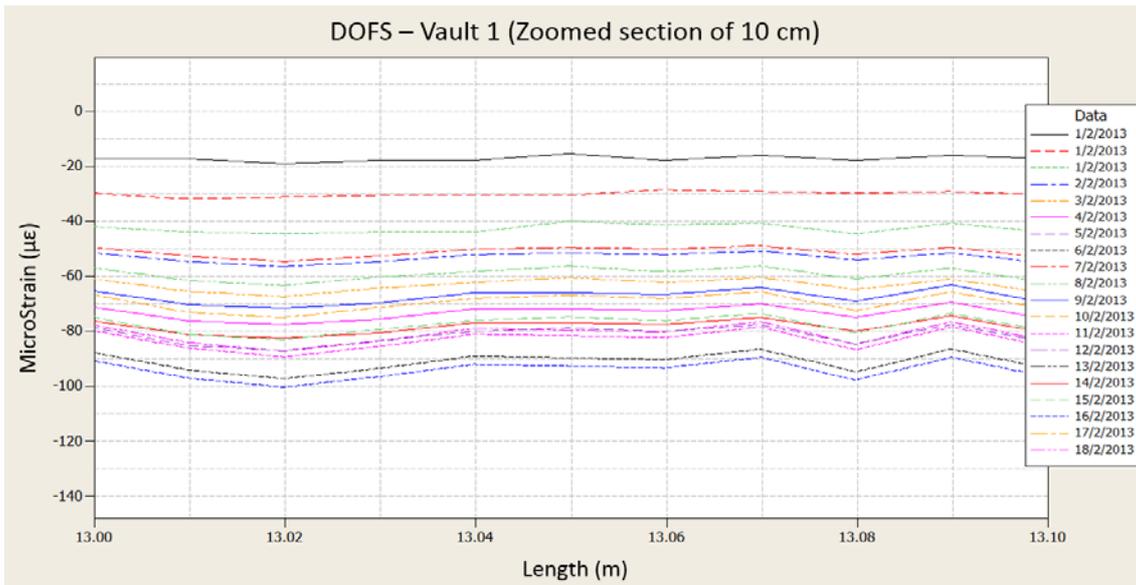
Figure 15. DOFS measurements for a 10 cm stretch of V1

Finally, it is worth mentioning that in the last readings shown in Figure 15 and Figure 16 (17th and 18th of February), is observed a recovery in the strain of 20 $\mu\epsilon$, that perceives a certain turnaround and stabilization that was maintained throughout subsequent obtained readings. Therefore, it was concluded that the stresses in the masonry were stabilized without relevant modification in its structural response induced by the columns replacement. The replacement operation was carried out successfully and with the hospital in full operation as required by the owner.

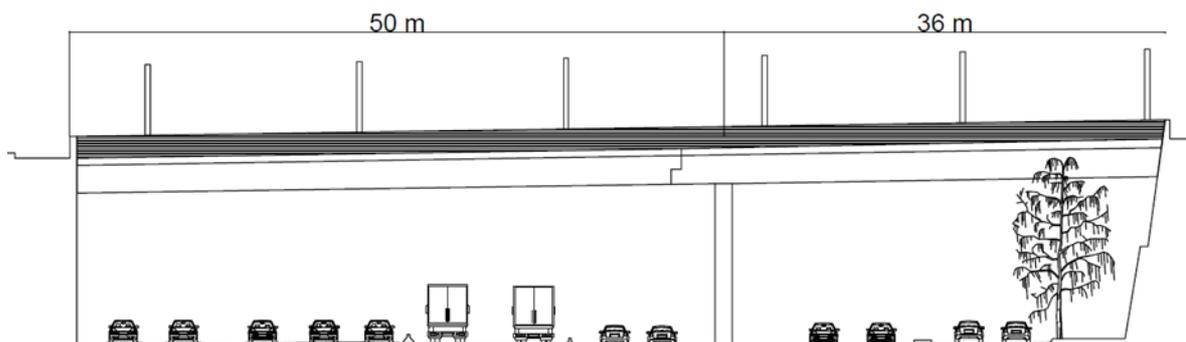
Figure 18. Side view of Sarajevo bridge

This bridge is located at one of the main entrances of the city of Barcelona, Spain (Figure 17). It is a simply-supported two span bridge with span-lengths of 36 and 50 m (Figure 18). Each span consists of three box-girder prestressed concrete beams connected by an upper reinforced concrete slab (Figure 19).

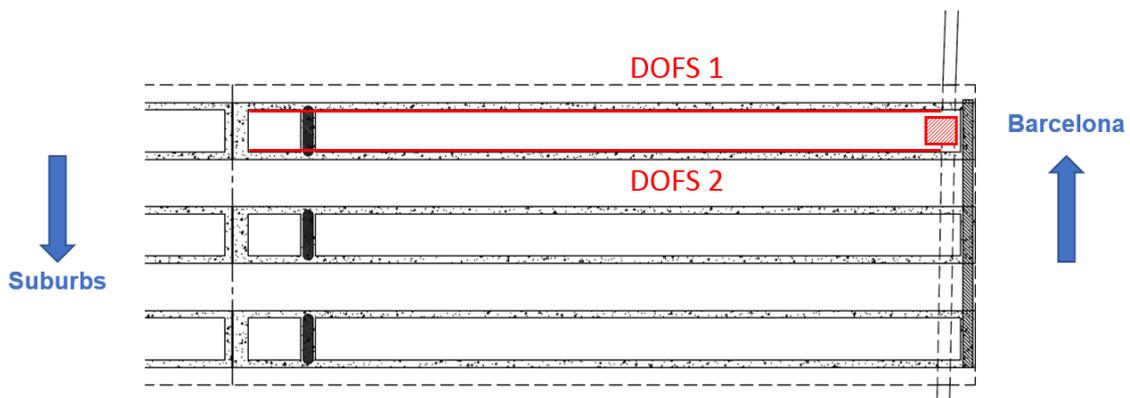
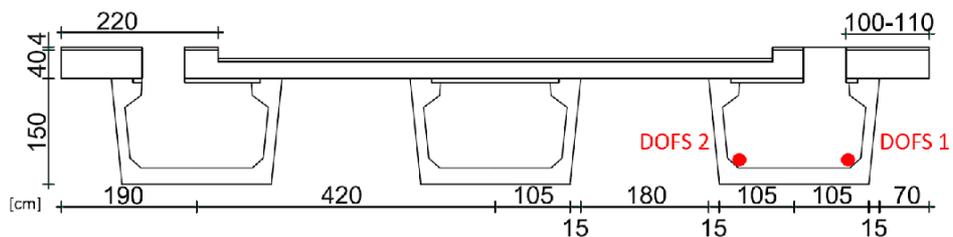
Figure 21. General scheme of DOFS monitoring

Bridge Cross Section

Work Station

Distributed Optical Fiber Sensor

planned (due to an increase length of 2.30 m overhang), it was decided to instrument this beam (Figure 21).

As seen in Figure 20 and Figure 21, DOFS were placed inside the box girder

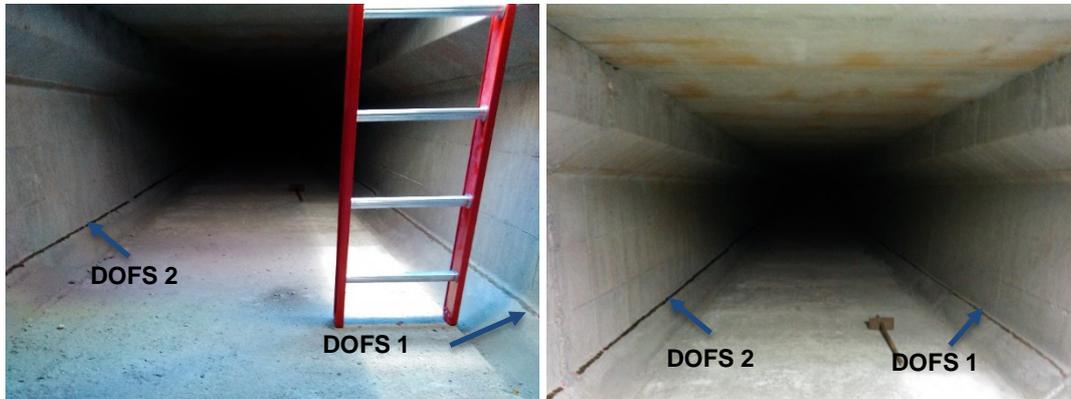
Figure 20. Deployed OBR system

allowing for a better protection of the sensors and an easier access for their installation and operation. The type of sensors as well as the installation procedure were similar to those described for the Hospital de Sant Pau. Due to the anticipated long duration of the monitoring period, the correct and careful implementation of these sensors assumes an even greater importance since any potential rupture or misuse of the fiber may compromise its performance. In this way, the use of two sensors instead of one also provides a desirable redundancy level.

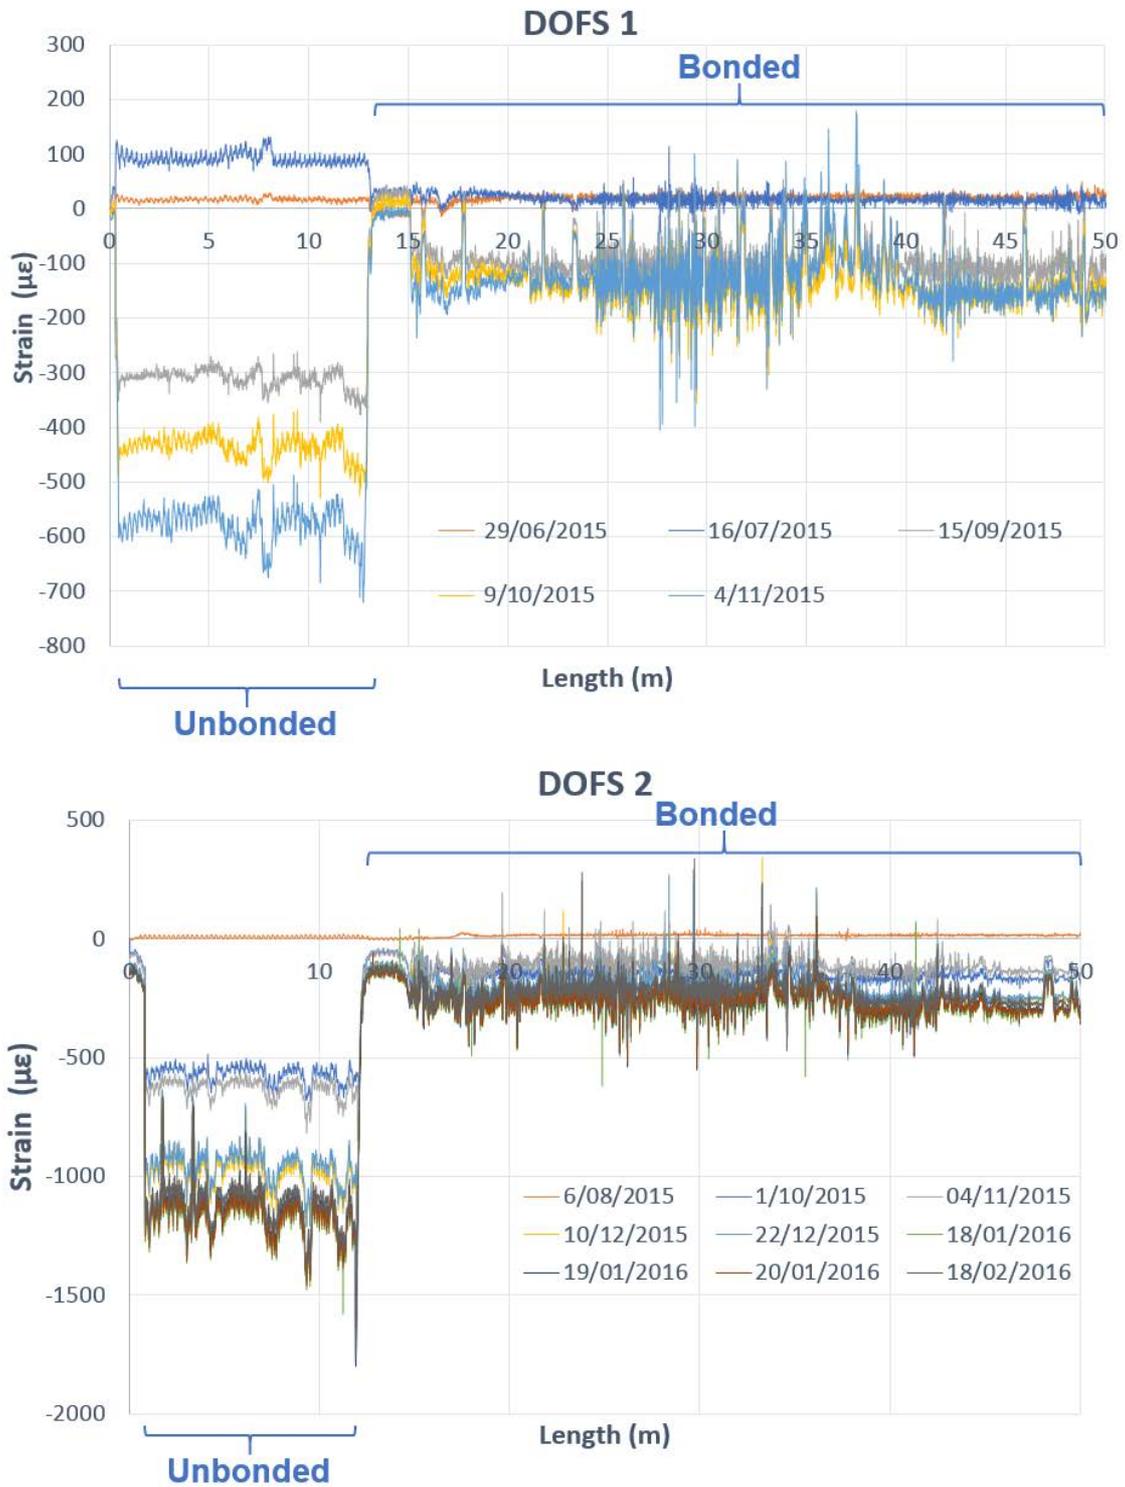
Figure 22. DOFS 1 and 2 readings evolution for the monitoring period interval

In Figure 22, is plotted the evolution of the strains measured by the DOFS 1 and 2. It is important to point out, that this comparison is made with measurements from different days taking care of selecting readings within the similar time interval period in order to mitigate the influence of daily time dependent phenomenon. It is detected by both deployed fibers the increase of compression strain. This was a result of the construction works being done in this time window, such as the removing of asphalt layers (see Figure 23) and some bridge equipment in the first stages of the procedure and naturally the effect of the temperature variation from summer to winter.

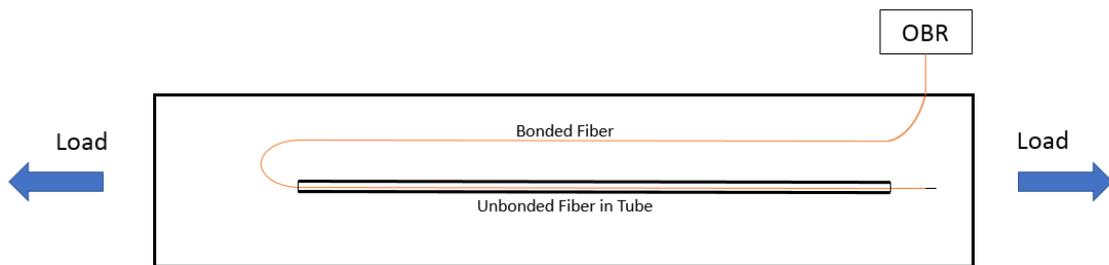
Figure 24. Point-to-point thermal compensation method scheme

This thermal compensation method can be used in the situation where significant temperature gradients are expected throughout the entire active length of the DOFS. Here, an unbonded fiber segment is implemented beside the bonded fiber segment, floating in a tube. Therefore, the output of this unbonded segment is only dependent of the temperature variation and can be used to perform a point-to-point compensation of the mechanical strain measurements of the bonded fiber as represented in Figure 24.

In this way, Equation (2) can be formulated, where in order to obtain the mechanical strain in point i of the bonded fiber segment, it is necessary to subtract the thermal effects outputs from the unbonded segment of the fiber in point i to the total strain measured in point i of the bonded segment.

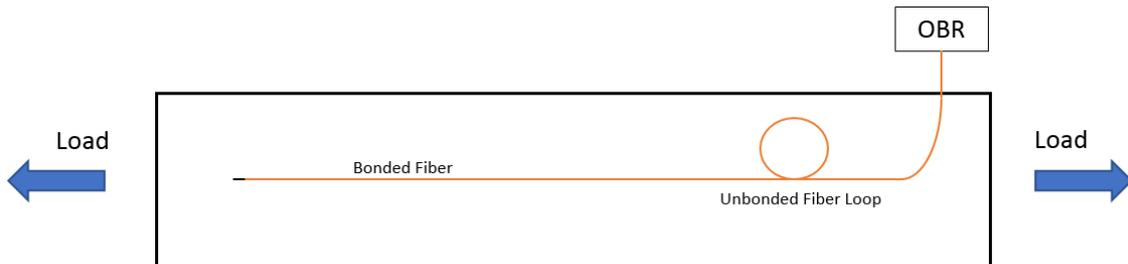
Figure 25. Fiber loop thermal compensation method scheme

described before (2), with the only difference being that while in point to point thermal compensation, the spectral shift of the unbonded segment is subtracted in each measured point to the correspondent point of the bonded segment counterpart, in the

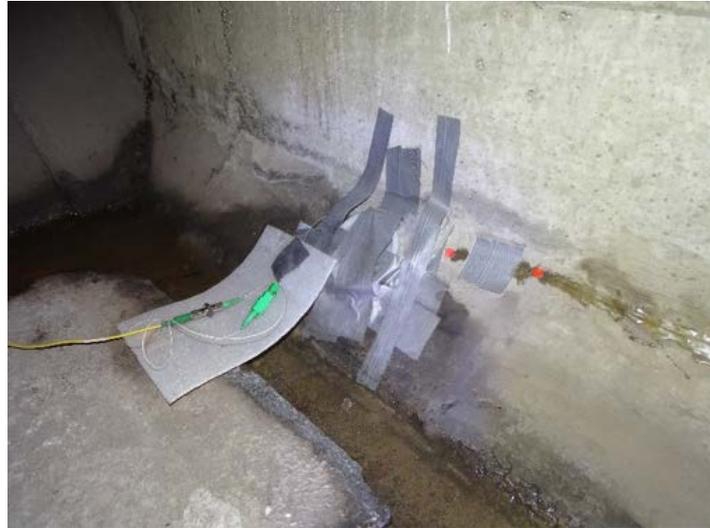
Figure 26. Unbonded loop of the DOFS thermal compensation by fiber loop, an average of the spectral shift measured for the entire length of the unbonded segment is calculated and then subtracted to the calculated average of the measured data of the bonded segment. This was the method adopted in this real-world monitoring application, by the use of the unbonded loop segment of the fiber located at the end, inside the beam, as seen in Figure 26.

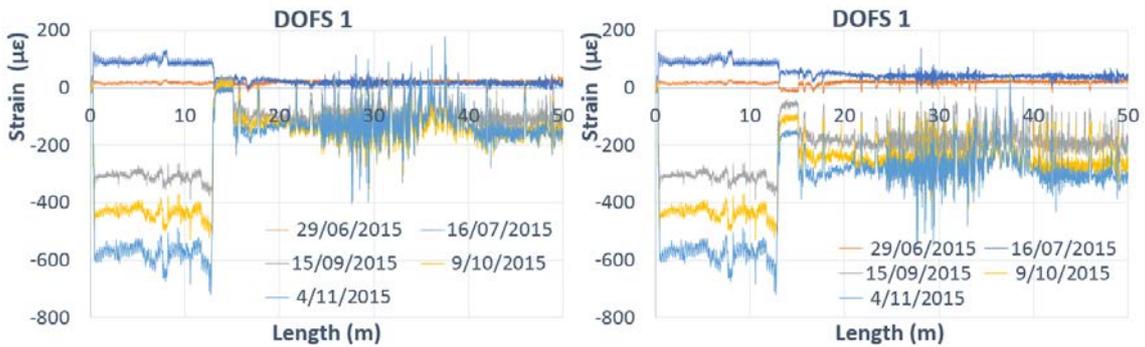
Figure 27. Comparison of DOFS 1 readings before (left) and after temperature compensation (right)

Since the strain measured by the first 14 meters of the fiber that are not bonded is exclusively dependent from the temperature variations, one may obtain from its measurements the information to calculate RIAS and TEAS. The values obtained in this temperature compensation process are presented in Table 2 and 3. The results of Figure 22 were updated to the ones shown in Figure 27 and Figure 28.

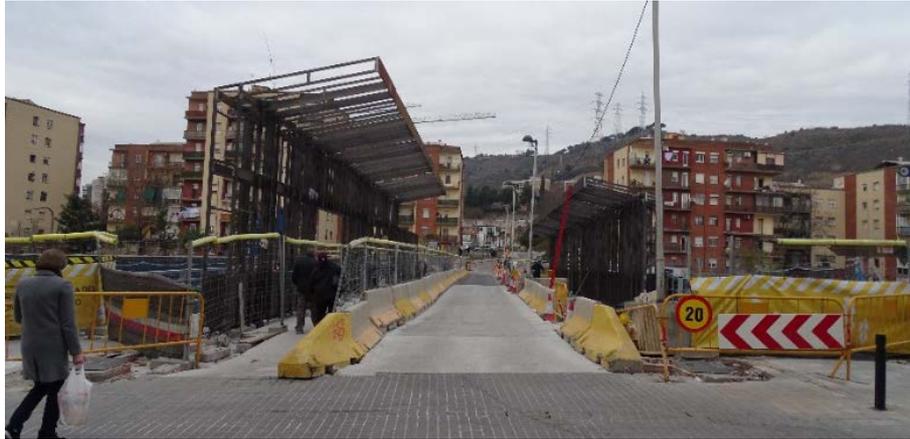
Figure 29. Photograph of the load increase on the non-instrumented span of the bridge taken in January 2016

From these results, the effect of the general unloading that the bridge suffered due to the removal of the slabs, pavement and the milling of the agglomerate, when compared to the loading values at the time of calibration and the structure's shrinkage behaviour induced by the decrease of temperature, is further evidenced. Furthermore, this continuous increase of compression of the bottom part of the monitored span is also explained by a higher induced load on the adjacent span compared to the one applied to the instrumented span, as seen in the photograph taken in January observed in Figure 29.

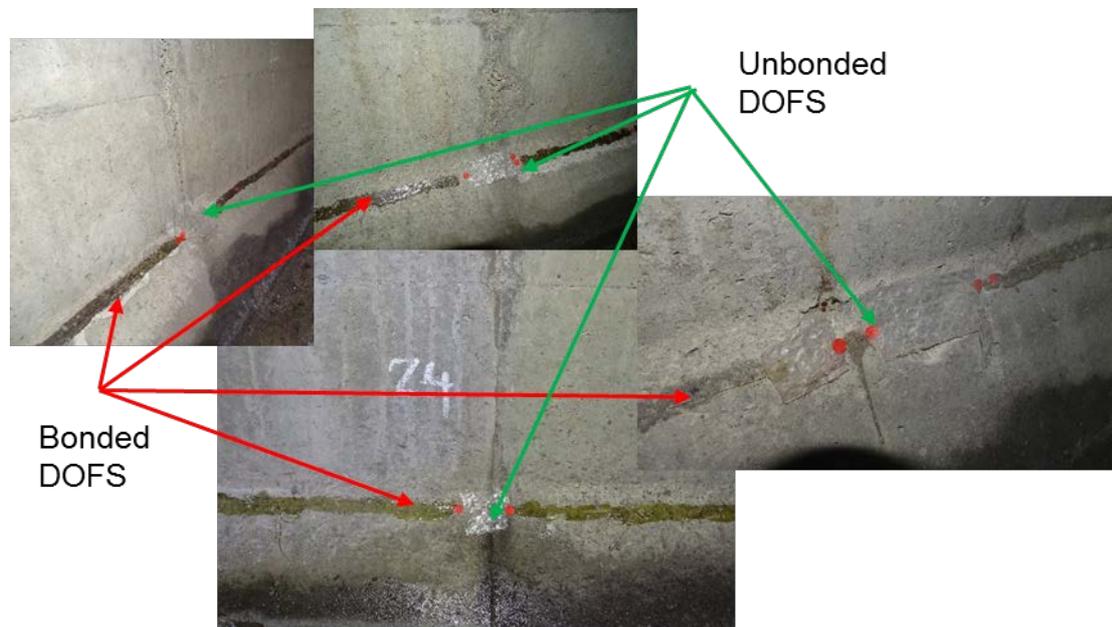
Figure 30. Some examples of unbonded points of the DOFS in the Sarajevo bridge application

The peaks and discontinuities in the data measured by the DOFS are representative of the joints between the prefabricated beams where the distributed optical fiber suffers from lack of bonding and other locations where due to the roughness or small cavities present near the surface, as a result of the heterogeneity of the concrete itself, the full and proper bonding between the sensor and the structural surface was not completely achieved, as seen in Figure 30. To not be confused with the emergence of new cracks, the peaks, although presenting variations in their magnitude,

remain stable in terms of their location. These variations of magnitude in their turn are a consequence of possible vibrations which are transmitted from the operational loads.

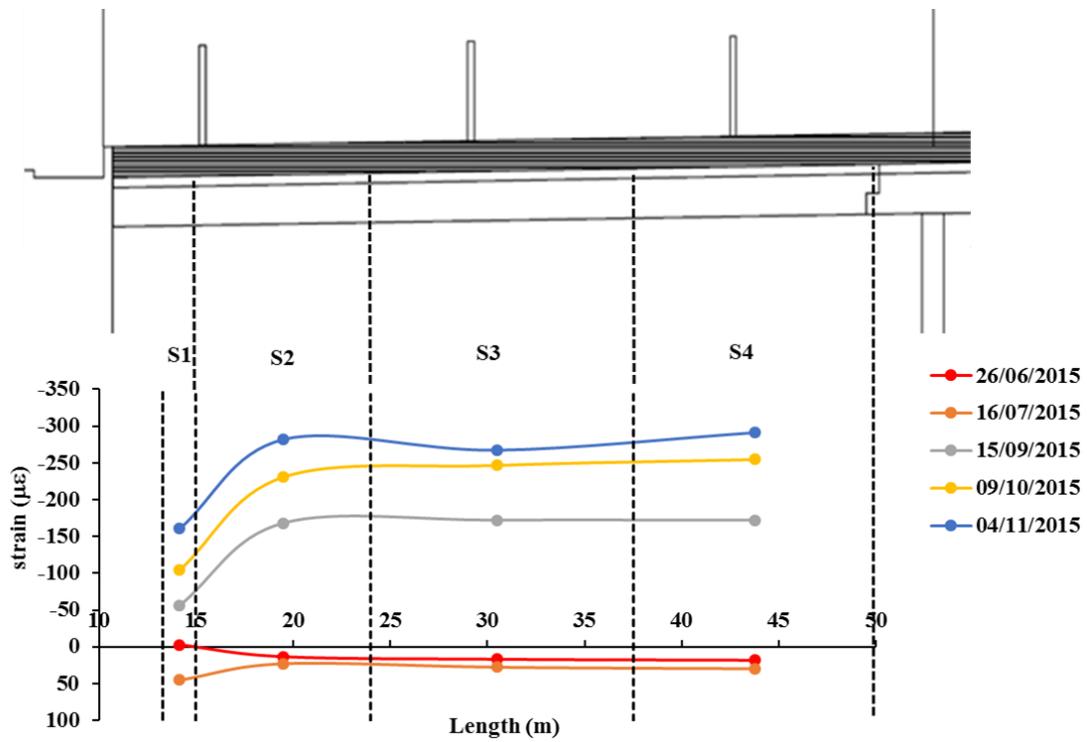
Figure 31. Mean mechanical distribution for DOFS1

distribution, a spatially averaging only of the mechanical strains for S1, S2, S3 and S4 segments was performed and plotted in and Figure 32. These are the values also present in Tables 5 and 6.

In segment S1, mean mechanical strain values lower than those generally present in the rest of the DOFS length can be shown. This decrease is due to the influence of the support system (elastomeric bearings) on the bridge kinematics. The mean mechanical strain distribution is almost uniform in the rest of the box-girder. This means that the applied forces in the deck that could produce variations of strain along the bottom part of the bridge were very small at the time of measuring the sensors, being therefore the strain mainly due to the uniform shortage of the box-girder associated to the decrease of temperature from summer to winter. Note that the difference in strain between August and February in the order of 500 microstrain (Figure 32) is very much plausible for a bridge like this and the climate in Barcelona.

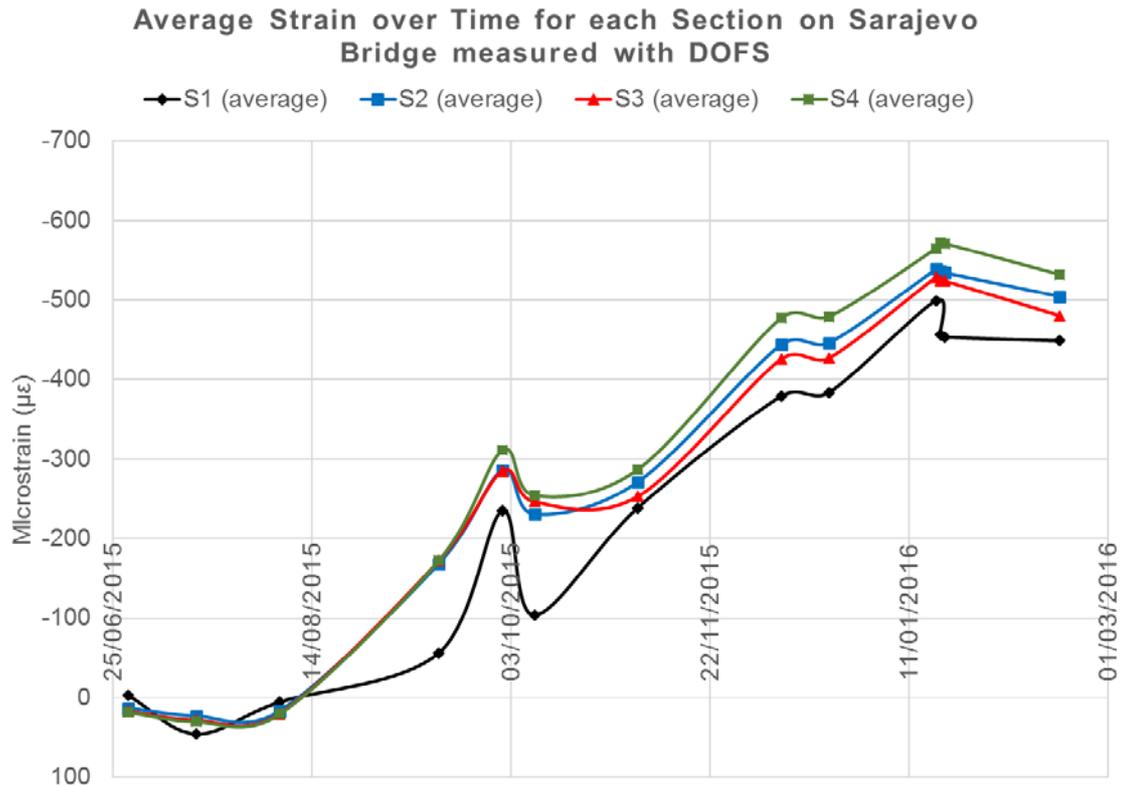
Figure 33. Evolution of average strain measured at each section over time

This is also perceived and validated by analysing Figure 33 which plots the evolution of the average strain at each section over time for both instrumented DOFS.

In Figure 33, as expected, the increase of compressive strains is observed from the summer to the winter period. It is also possible to observe some specific and short-term variations that correspond to the global effect of introduction and withdrawal of construction equipment to the deck and the variation of the applied load that is inherent to the deck widening procedure.
