Heave of a Building Induced by Swelling of an Anhydritic Triassic Claystone

This paper describes the conditions leading to a sustained, low-rate, heave phenomenon affecting a building founded on hard Keuper anhydritic rock. The building was located in an abandoned gypsum quarry. Monitoring data as well as vertical profiles of gypsum and anhydrite content indicate that swelling was associated with the presence of a shallow level of anhydritic clay rock. This paper concludes that the initial quarry excavation as well as the additional building foundation work modified the original stress state and contributed to opening fractures at depth. It also resulted in a facilitated access of water to the upper rock levels, immediately under the foundation footings. Measured heave rates are substantially lower than other rates recorded in a few recent cases. An explanation is provided for the difference. This paper describes a comforting solution for the building.

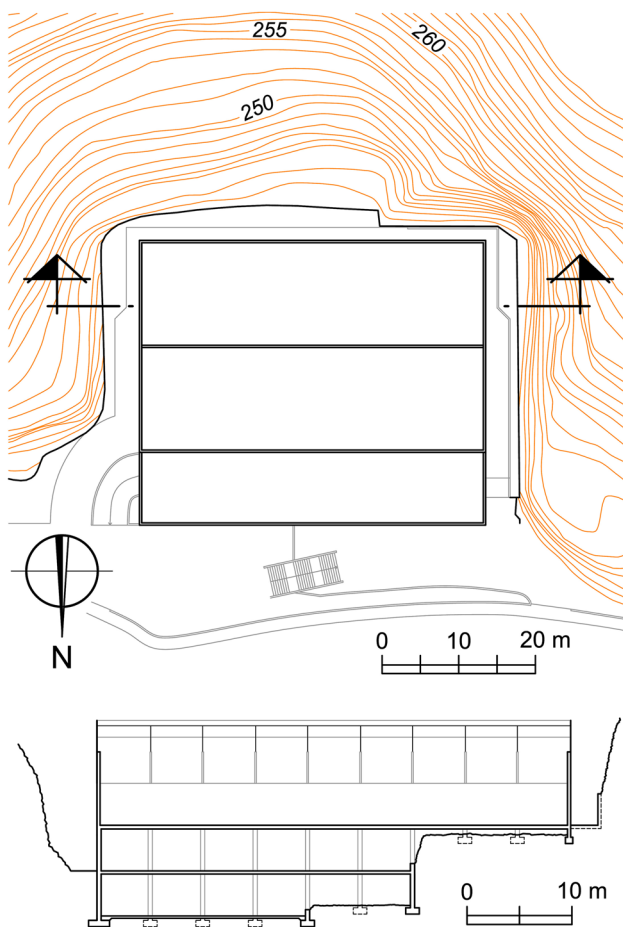
Fig. 1 Plan view and East–West representative section

The interior building columns are supported by isolated footings, braced among them. The footings lay at different elevations, as indicated in Fig. 1. Three foundation platforms are distinguished. Their elevation increases from East to West, as a result of the variable excavation mentioned before. The sub-vertical slopes between platforms did not present instability symptoms; they were not protected or supported by retaining walls; the natural excavated rock surface was essentially exposed.

Slopes surround the building with a high inclination facing North, East and West (Fig. 1). The construction is located in the emplacement of an ancient quarry, which mined gypsum for construction and cement manufacturing applications. The quarry was located in a Keuper rock, characterized by the presence of sulphates (gypsum and anhydrite) and clays. Keuper materials are often associated with high deformations, of tectonic origin, that contribute to their intense folding and the presence of fractures.

The construction of the building in 1991–1992 involved additional excavations over the original topography left by quarry operations. However, most of the excavation observed in Fig. 1 was already in place when the building construction started. Quarries in this type of rock often require the use of explosives for the extraction of the rock, which in turn, introduce a significant degradation and cracking in the rock mass. This comment is based on other known cases of ancient gypsum quarries in similar rock formations. However, no precise data about the quarry operation procedures are available.

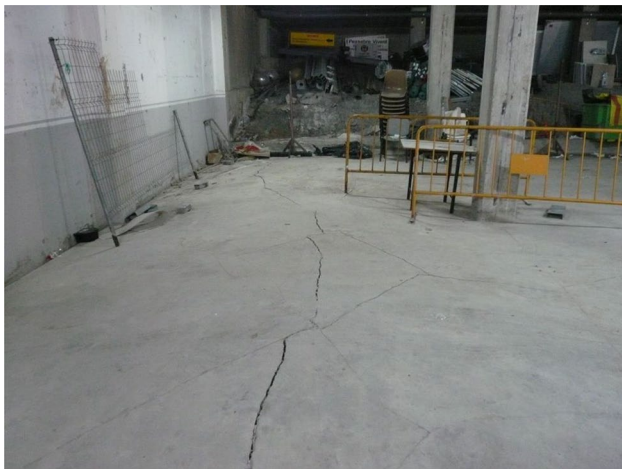
Fig. 2 Cracks and heave of the basement floor

that a non-uniform heave was developing in a large area located at the South-East side of the building (Fig. 3a). The assumption was that the builders had initially levelled the basement floor. It was further accepted that the Northern side of the basement did not experience any movement. It was also noticed that columns and the concrete floor exhibited a differential heave, which manifested in the observed network of fissures of the floor (Fig. 2).

The change of confining stress is a key factor to explain the heave and its distribution in plain view. The heave of the floor between columns (Fig. 2) also suggests that the stress transmitted by the column footings is effective in reducing the swelling generated by the precipitation of gypsum.

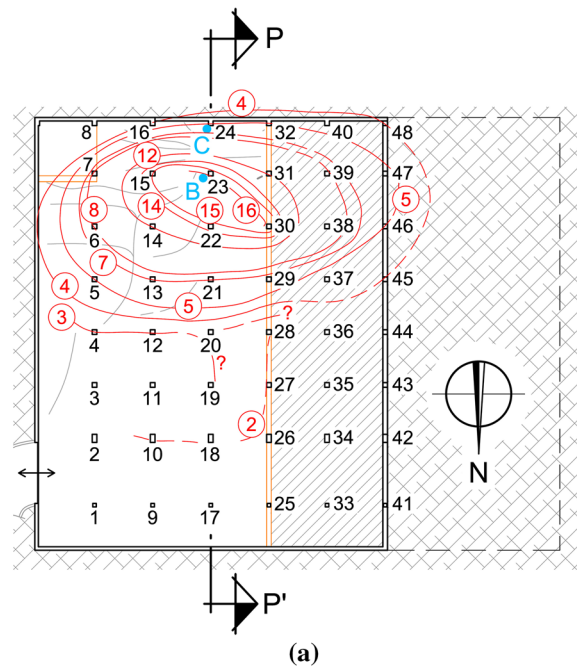
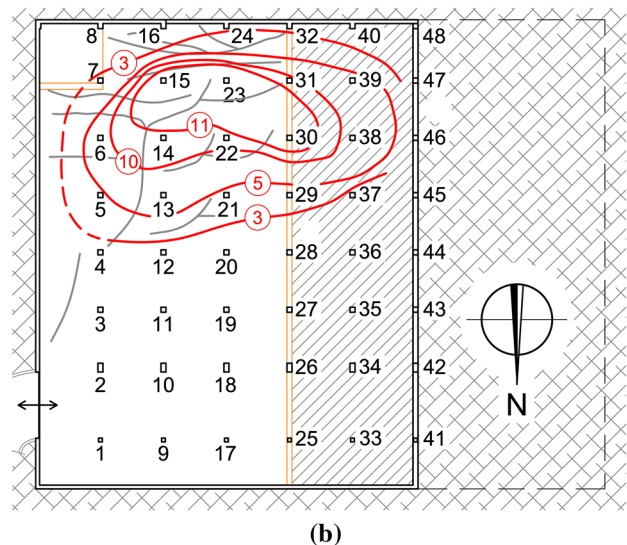
Fig. 3 a Contours of equal surface heave (cm) of the floor of basement and half-basement estimated from topographic levelling (July 2014) and position of surveying boreholes B and C. Profile P–P' is shown in Fig. 12. b Contours of equal heave (mm) measured in the period August 2014–December 2016

The initial reference for the heave measurements shown in Fig. 3a was the levelling carried out in July 2014. The figure shows that the largest measured vertical displacement is located around columns 23, 15, 22, and 30 and that the Northern half of the basement floor of the building exhibited very small movements if compared with the heave experienced by columns located a few meters away from the Southern wall. Measurements also indicated that the magnitude of heave decreases towards the non-excavated area of the basement and half-basement.

Two boreholes 20.4 m long and 101 mm in diameter were drilled with continuous core recovery. Figure 3a shows the position of Boreholes B and C located in the area experiencing the highest floor heave. Borehole B was placed next to a column that had experienced a heave of 16 mm after the construction of the building according to the initial levelling of pillars (Fig. 3a). Borehole C was drilled next to a column, belonging to the rear wall, which had suffered a small heave (5 mm) according to the initial levelling.

It was also verified that the total heave measured by standard levelling techniques at the beginning of the study, shown in Fig. 3a, display the same spatial heave pattern of column heave found when plotting the contours of equal heave after 29 months of systematic monitoring (Fig. 3b). This result shows that the set of columns experienced a continuous heave rate that has decreased slightly during the building life. The average heave rates measured during the 29 months of monitoring differ, at most, in 2.6 mm/year from the estimated average heave rate that occurred along 21.6 years, from the building construction to the first topographic levelling performed at the basement and sub-basement floor.

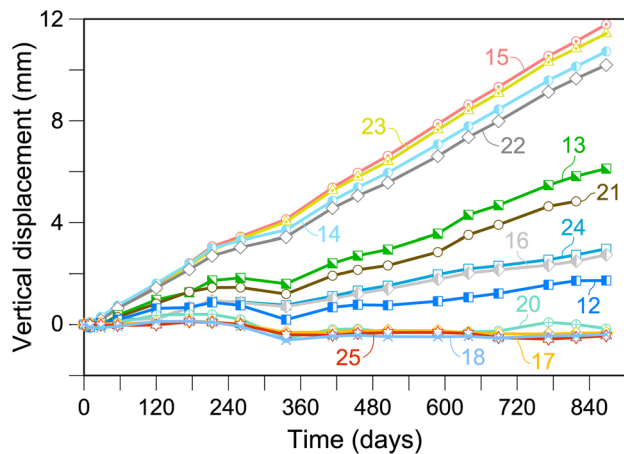
Fig. 4 Evolution of vertical movements measured in topographic marks installed on columns P12–P25 (see column position in Fig. 3)

Figure 4 shows the evolution of vertical movements measured in columns during 29 months in the period July 2014–December 2016. The measurements show that some columns are experiencing a slow but systematic and

continuous heave. The distribution, in plain view, of the vertical movements measured in columns during the 29 months of topographic control is consistent with the distribution of heave obtained from the initial levelling of the columns (Fig. 3b). The maximum heave recorded after 29 months of measurements was 11.8 mm and values close or slightly higher than 11 mm were measured in columns: 14, 15, 22, 23, 30, and 31. These columns are located inside

Figure 4 shows that building columns experience a sustained uplift motion at a low rate (0.013–0.004 mm/day) which is proportional to the total displacement heave. Most probably, heave phenomenon started during quarry

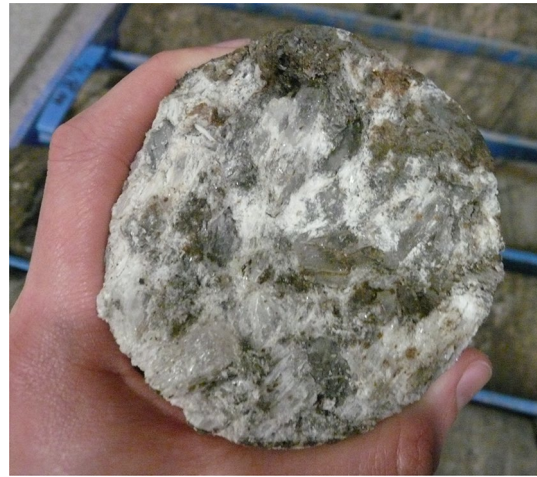
Fig. 5 Detail of crystals in a core recovered in borehole B

Boreholes were drilled in the vicinity of the columns with the purpose of crossing the column footings. The idea was to investigate the nature of the footing-ground contact. The two boreholes crossed, in a downwards direction, a 10 cm thick layer of concrete with steel reinforcement corresponding to the floor basement, a layer, 10–15 cm thick, fill of fine sands and a 80 cm thick layer of concrete without steel reinforcement, which was identified as a column footing. The recovered core indicated that the footing had been founded directly on the natural rock. The cores in the rock mass identified a sulphated rock with interbedded carbonated and grey dolomitic layers. Figure 5 shows dense accumulations of gypsum and anhydrite crystals, observed in rock cores.

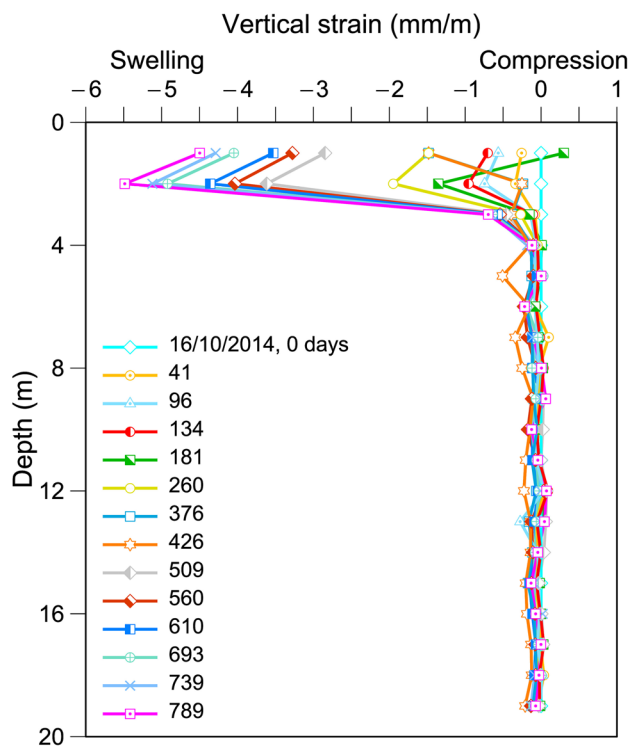
Fig. 6 Vertical strains along depth measured by sliding deformer SLD-01 installed next to column 23 (see column position in Fig. 3)

Both boreholes were instrumented by means of a telescopic measuring tube that allows the measurement of vertical deformations along the borehole by means of a sounding line (sliding deformer, Solexperts AG). Figure 6 shows the incremental vertical deformations measured, in a 26-month period, in sliding deformer SLD-01, along borehole B. Significant vertical deformations concentrate in the four upper meters.

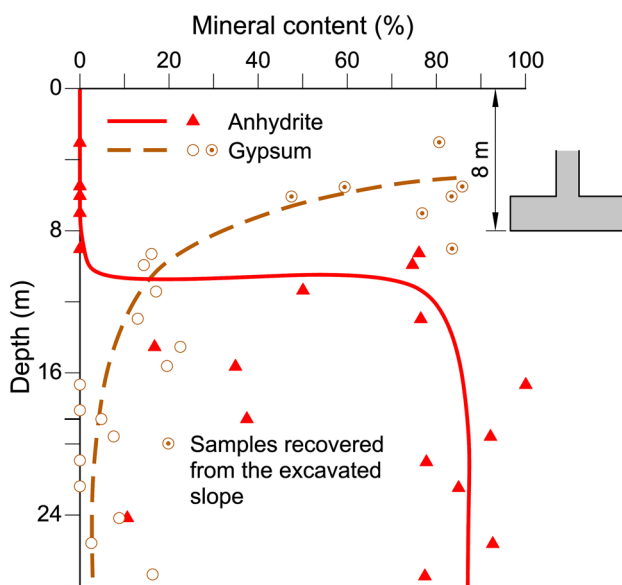
Fig. 9 Distribution of gypsum and anhydrite in depth

Figure 9 shows, in a common depth scale, the distribution in depth of the proportion (% by weight) of anhydrite and gypsum identified in the samples obtained from the boreholes and the excavated rock slope. The origin of the depth scale in Fig. 9 is the surface of the original natural slope before the quarry excavations. Point “O” in Fig. 12 indicates the position of the original soil surface, before quarry excavations, which is the origin for depths in Fig. 9 for the rock cores recovered in boreholes. Figure 9 points out that anhydrite is present in massive proportion in the rock mass at relatively shallow depths: 9 m below the natural ground surface. The figure shows the position of a sharp gypsum–anhydrite transition. Building foundations were almost exactly located at this transition front.

Figure 9 shows that anhydrite was essentially absent in the upper 9 m of the profile. Below this depth, a very rapid increase in anhydrite content is measured. The anhydrite concentration reaches often values in excess of 70–80% and remains approximately constant with depth. In contrast, gypsum dominates in the upper 4–8 m and decreases continuously with depth. The resulting distribution of gypsum and anhydrite contents is similar in qualitative terms to other distributions found in cases involving deep gypsum-related heave. This was the case of Lilla tunnel (Alonso et al. 2013; Ramon et al. 2017) and Pont de Candí viaduct (Alonso and Ramon 2013a; Ramon and Alonso 2013).

The presence of gypsum is explained by the “transformation” of anhydrite into gypsum via the mechanism described above. In our case, there is a marked front for the transformation process at depths of 9–13 m. Foundation footings were resting on the natural rock at a depth of 8 m (Fig. 9), and therefore, the swelling process directly affected them.

The sulphate mineral distribution represented in Fig. 9 is the result of a slow reaction at the time scale of geologic processes. However, the quarry excavation and building construction activated a slow swelling mechanism (but very rapid in geological terms) because of the changes introduced: unloading, and most likely, an improved access of water to the upper anhydrite levels. The construction of the building may impair the direct infiltration of rainfall water but the evolution of free water observed in boreholes after a period of rains, during the drilling operations, indicated that water is present in the rock mass and, in addition, they suggest a reasonably high hydraulic conductivity dominated by the presence of fractures and a hydraulic connection between the building foundation rock and the outside land. Figure 11 shows the cores recovered in boreholes B and C from the upper 6 m. The examination of the recovered cores indicated an intense disintegration at some depths. This favours the presence of water and the possibility of water circulation through the rock mass. It was concluded that the mechanism of expansion induced by the growth of gypsum crystals

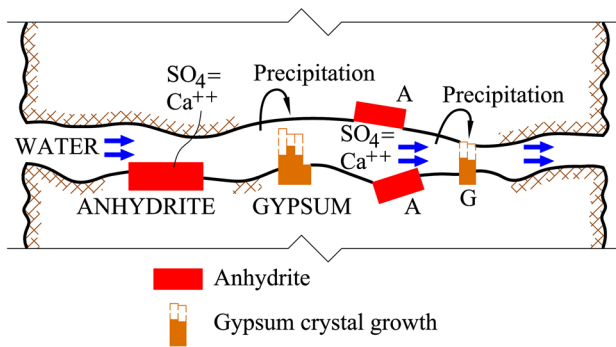
Fig. 10 Conceptual representation of gypsum precipitation on discontinuities. Ramon et al., 2017

Expansions are the result of precipitation of gypsum crystals from a supersaturated aqueous solution in rock discontinuities. Gypsum precipitation in fractures exerts pressure against the faces of the discontinuities, which is capable of pushing them apart and generating the swelling pressures and strains observed in the rock mass (Alonso et al. 2013; Ramon and Alonso 2013). Figure 10 sketches a conceptual representation of the development of expansion due to crystal growth in the rock mass. Gypsum crystals originate from the precipitation of calcium and sulphate ions (CaSO_4) dissolved in water supersaturated in sulphates with respect to gypsum. The solubility of anhydrite is higher than the solubility of gypsum at the temperatures existing in the rock mass. Therefore, the presence of anhydrite and water availability in the rock will provide the conditions for supersaturation, which are necessary for the precipitation of gypsum (Ramon and Alonso 2013).

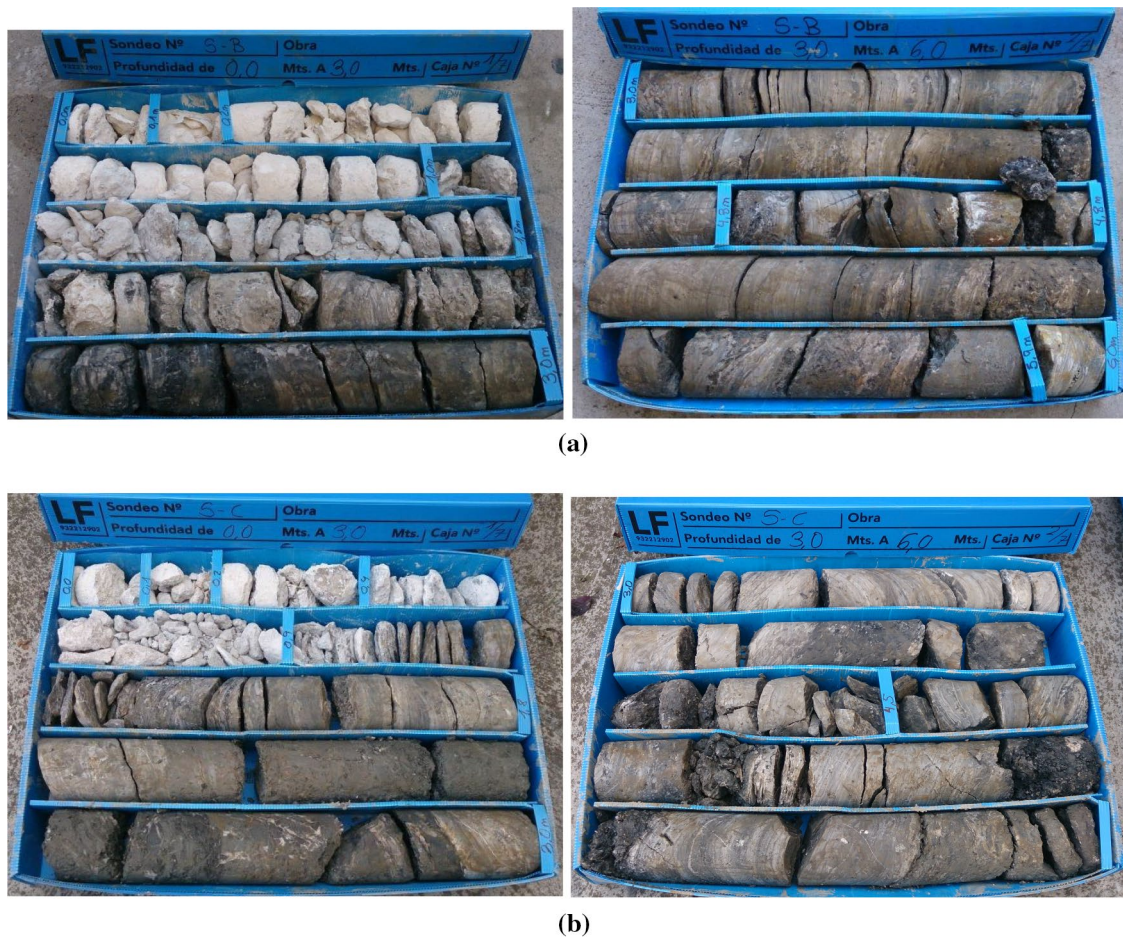
Fig. 11 Cores recovered from the six upper meters in **a** borehole B and **b** borehole C

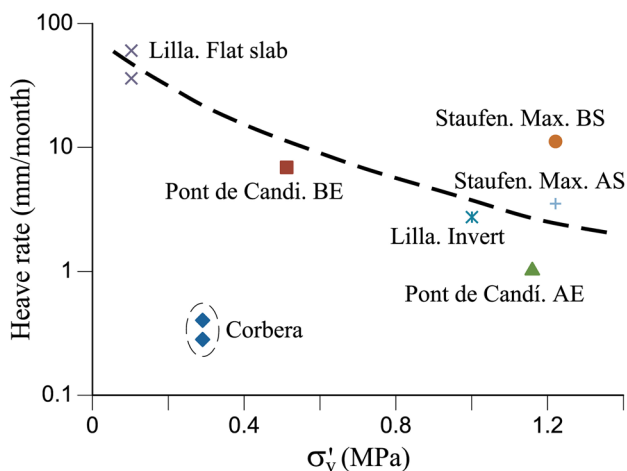
Fig. 13 Rates of heave measured in different locations. *BE* before embankment construction, *AE* after embankment construction, *BS* before borehole sealing, *AS* after borehole sealing

If compared with other known cases of anhydrite-induced swelling, measured heave rates in Corbera are small. Figure 13 shows this comparison. The heave rates of known

cases: Pont de Candí bridge (Alonso and Ramon 2013a); Lilla tunnel (Alonso et al. 2013; Ramon et al. 2017); Staufen village (Sass and Burbaum 2010; Ruch and Wirsing 2013) are significantly larger than the measured rates reported here (note the log scale of the heave rate). The plot shows the relationship between heave rate and applied effective stress at the source of swelling. The references cited describe how an increase in confining stress reduces the heave rate. Figure 13 shows also a tentative relationship illustrating the effect of stress on heave rates. However, the case described here departs from this approximate trend and shows a very small heaving rate if compared with the remaining cases represented.

Heave rates in the three reference cases in Fig. 13 were estimated at early stages, i.e., shortly afterwards the swelling process was identified. It may be argued that as time increases the swelling rate should decrease. This may be a consequence of the exhaustion of anhydrite content. In fact, Ramon and Alonso (2013) show how the calculated long-term heave, in the case of Pont de Candí Bridge, becomes asymptotic to a constant value. It may be thought that the

shown in Fig. 13 suggests, in view of the preceding comments, that a combination of the following factors: difficult access to water, low overall rock permeability and a low exposed surface of anhydrite to percolating waters explain the low heaving rate observed in Corbera. Some induced fracturing or damage of the rock may also have a direct influence on the heave rate. On the other hand, the phenomenon is expected to develop during a long time under the current boundary conditions and, in particular, under the hydrological conditions of the building emplacement.

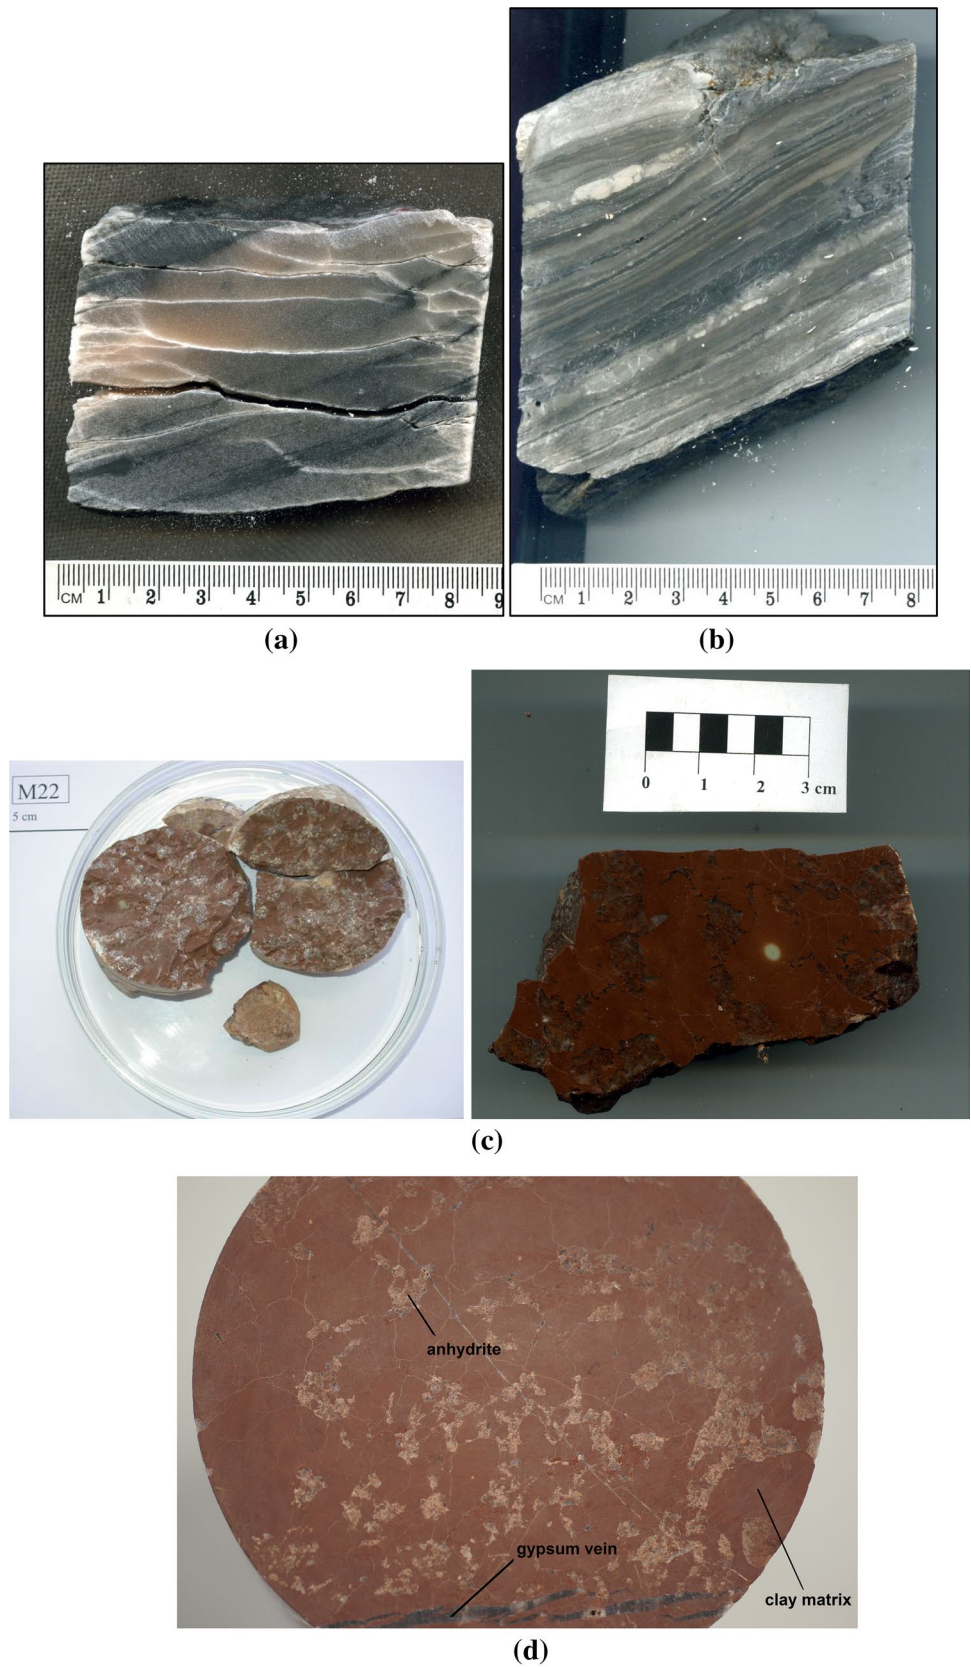
Fig. 14 Samples of anhydritic rock recovered from boreholes from different locations. **a** Depth of sample, 9.6 m, **b** depth of sample, 5.9 m. Cuts performed on cores recovered from the foundation rock of the building in borehole B. Measured anhydrite content by weight in cores: **a** 100%, **b** 76.5%. **c** Sample of a red clay matrix with anhydrite aggregates recovered at a depth of 31.8 m under Pont de Candí bridge foundation: Anhydrite content: 42.2% by weight. **d** Sample of a red clay matrix with anhydrite aggregates and a gypsum vein recovered at a depth of 2.4 m under Lilla tunnel floor

Some rock cores recovered under the foundation level were sawed and polished. Two examples are shown in Fig. 14a, b. They show the aspect of massive anhydrite. In fact, the measured anhydrite content of the cores shown in Fig. 14a, b was 100 and 76.5%, respectively. This is a very impervious rock. If the observation scale is increased, to include discontinuities or clay veins, one may expect a small anhydrite surface area exposed to water dissolution. This is in sharp contrast with the anhydrite claystones identified in other cases mentioned here [Lilla tunnel (Alonso et al. 2013; Ramon et al. 2017), Pont de Candí (Alonso and Ramon 2013a; Ramon and Alonso 2013)]. In these cases, a clay matrix dominates the rock microstructure. Figure 14c shows one sample from the active layer in Pont de Candí bridge and Fig. 14d shows one sample from the expanding zone in Lilla tunnel. These microstructures imply a much larger exposed specific surface of anhydrite and, in addition, the clay matrix, easily fissured, facilitates the access of water. The presence of clay minerals in the foundation rock below footings 23 and 24, which experienced a significant heave (see Fig. 3a) was investigated by determining the content by weight of smectite and illite in cores from borings B and C. Results are plotted in Fig. 15. It was found that clay minerals concentrate in a band located at depths of 6–10 m below the basement floor. Above and below clay minerals were not identified. Swelling takes place in the upper 3 m approximately (see extensometer records in Fig. 6), where clay is absent. The minerals accompanying anhydrite above and below the clay band are magnesite and dolomite (Fig. 16). It is concluded that an additional factor, probably quite significant, to explain the low rate of heave detected in Corbera building, is the massive nature of the anhydrite, which reduces the surface exposed to water circulation. In addition, the presence of clay matrix (Pont de Candí bridge and Lilla tunnel cases) seems to favour higher swelling rates because of the clay matrix role to increase the exposed anhydrite surface to water action.

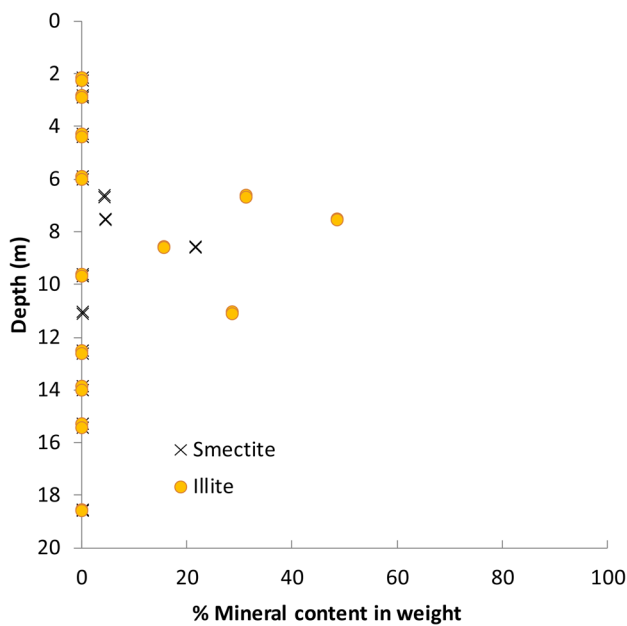
Fig. 15 Weight content of smectite and illite determined by means of X-ray analyses in cores recovered from boreholes B and C. The origin of depth corresponds to the borehole head

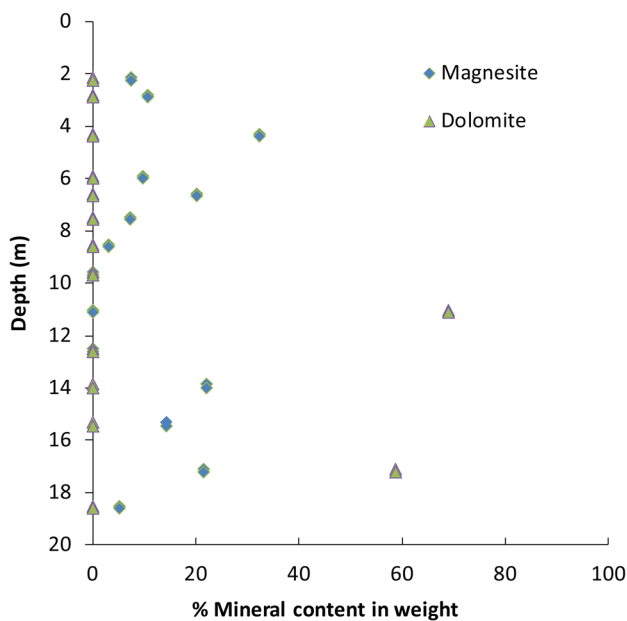
Fig. 16 Contents of magnesite and dolomite (% by weight) determined by means of X-ray analyses in cores recovered from boreholes B and C. The origin of depth corresponds to the borehole head

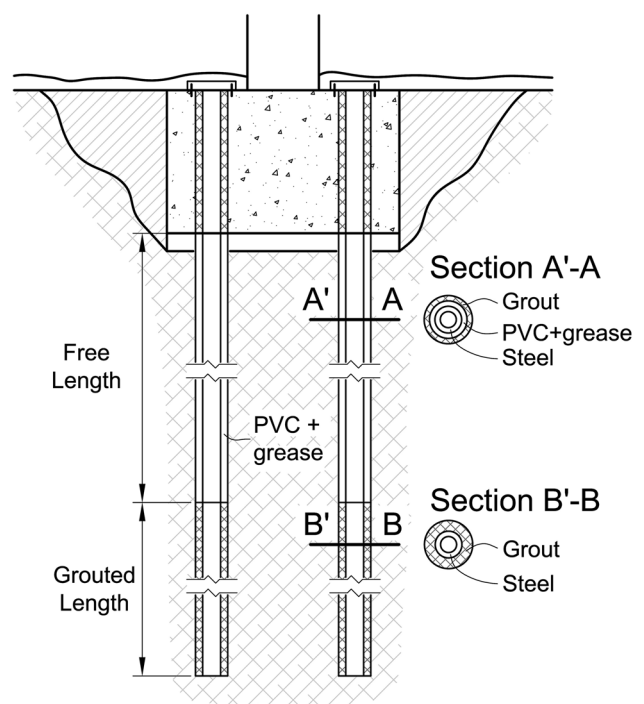
Fig. 17 Design of the micropiles with free stretch, disconnected from the ground (Alonso and Casanovas 1991)

The design of the proposed comforting solution is shown in Fig. 17. Footings are to be supported by micropiles injected at depth in zones not affected by the swelling process. The micropiles are isolated from the upper active layer, conservatively estimated to have a thickness of 6 m, by means of a frictionless system shown in the figure. The tubular micropile is encased in a tube grouted to the rock in the upper active zone. A grease layer between the micropile and the casing eliminates any friction resulting from rock expansion. The micropiles are injected in the stable ground at depths in excess of 6 m. The excavated rock surface along the micropiles will be sealed with grout to avoid the activation of deeper expansions (Fig. 17).

This design is based on the solution described in Alonso and Casanovas (1991). The remedial measures also called for the excavation of the ground below the footing of columns after the construction of micropiles to prevent any upwards thrust of the heaving ground against the column footings. An open gap of 10 cm was suggested to owners. At the current rate of average heave rate, this gap may be closed in about 20 years. Alonso and Ramon (2013b) describe a related case of isolating a railway track line against the heave of an embankment of compacted sulphated soils. Figure 18 shows two photographs taken during the construction of

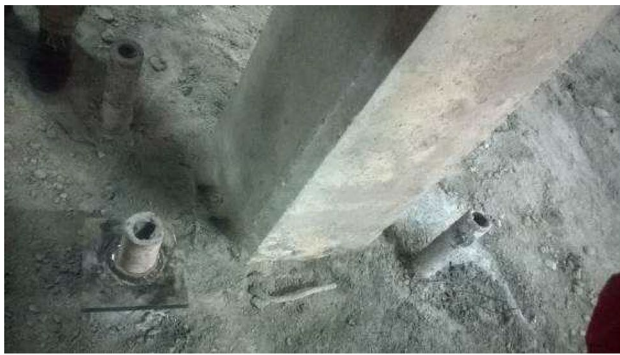
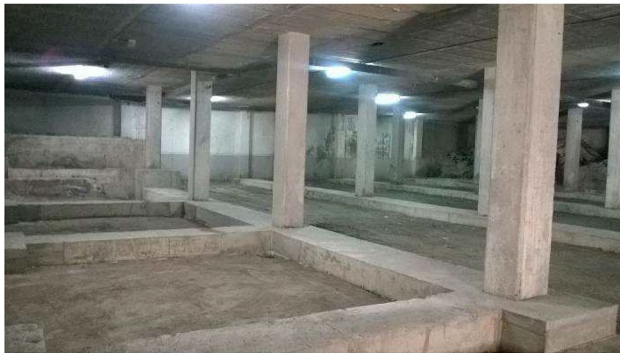
Fig. 18 Photographs taken during the construction of the works of underpinning of existing footings. **a** Column footing stabilized by four micropiles. **b** View of the building basement after repair works

micropiles for the underpinning of footings of the building columns.
