The use of mortars in Palau Güell by Antoni Gaudi

Ricardo Gomez-Val¹, Judith Ramirez-Casas¹, Antonia Navarro-Ezquerria¹

(1) Universitat Politècnica de Catalunya, ricardo.jose.gomez@upc.edu, judith.ramirez@upc.edu, antonia.navarro@upc.edu

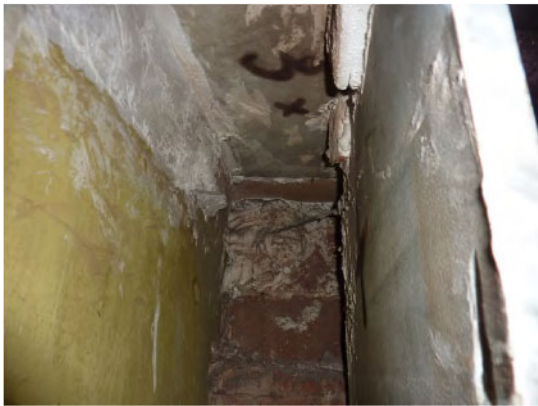
Figure 3. Collection area sample 1

In order to begin the research we chose two different elements in the same area of the building, the noble floor where it was the living room of the building. We took one sample from the mortar used in the ceiling (Figure 3) and another from the mortar used in on the ground in this area (Figure 4). We chose two small areas that we were sure they hadn't been restored, the ground of the inner part of the chimney and the ceiling of a small staircase that begins in the living room.

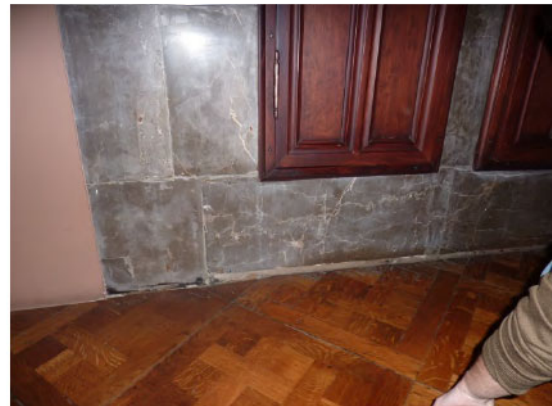
Figure 4. Collection area sample 2

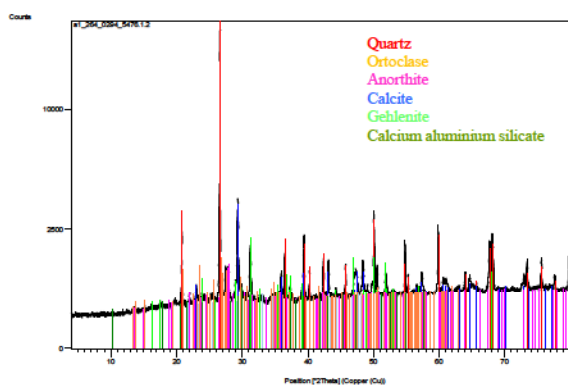
Figure 7. DRX spectrum of the binder

The mineralogical composition of the binder was established using X-ray diffraction analysis (Figure 7). The following components were identified:

- The quartz, the anorthite and the orthoclase are due to the thin section arid size (size under 0,063 mm)
- The calcite is due to the carbonated part of the binder.
- The gehlenite and the calcium aluminium silicate are the definite elements to show that the cement used is natural cement. There are still some non-hydrated areas.

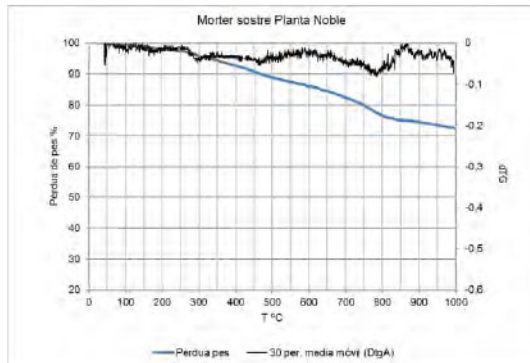
Figure 9. Shows the termogravimètric line in blue and black represents derivation of termogravimètric.

Differential Thermal Analysis allows checking that with a difference of temperatures of 950°C a 28% of the sample is lost. This fact means that there are few composites that are decomposed in this range of temperatures (Figure 9). The highest peaks are found at 300°C, which it fits with the loss of water of some clay and at 800°C matches with the calcite decomposition.

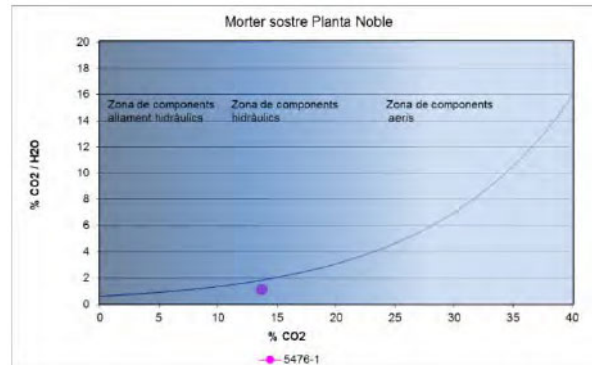
Figure 10. CO₂ to structurally bound water ratio in relation to % CO₂

If we compare the loss of weight produced by the decomposition of calcium carbonates (decomposition of CO₂) at more than 600°C and the quotient between this loss and the water that decomposes between 200 and 600°C, we can determine the degree of hydraulicity of the analysed mortar [8] (Figure 10). So we can conclude that it is a mortar

with hydraulic binder, of the type of the roman cement totally carbonated. There are nodules of gehlenite hydrate, and silicic aggregate, maximum size of 3 mm.

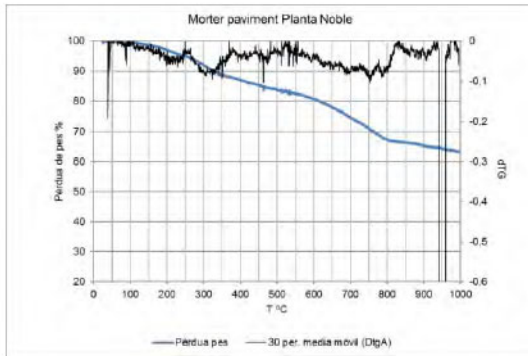
Figure 14. Shows the termogravimètric line in blue and black represents derivation of termogravimètric.

Differential Thermal Analysis allows checking that with a difference of temperatures of 950°C a 38% of the sample is lost. This fact means that there are more composites that are decomposed in this range of temperatures than in the ceiling one (sample n°1) (Figure 14). The highest peaks are found at 300°C, which it fits with the loss of water of some clay and between 750°C and 800°C that matches with the vaterite decomposition (first peak) and calcite.

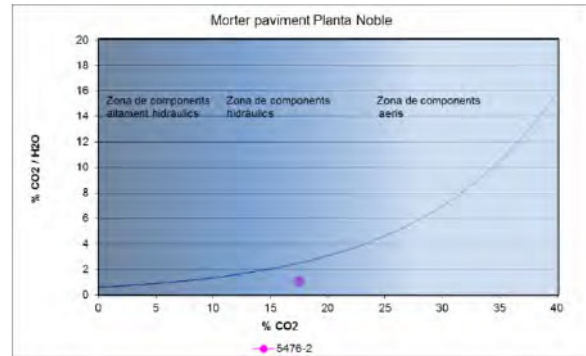
Figure 15. CO₂ to structurally bound water ratio in relation to % CO₂

If we compare the loss of weight produced by the decomposition of calcium carbonates (decomposition of CO₂) at more than 600°C and the quotient between this loss and the water that decomposes between 200 and 600°C, we can determine the degree of hydraulicity of the analysed mortar (Figure 15). So we can conclude that it is a hydraulic binder mortar, cement type naturally carbonated by now, but no nodules gehlenite hydrate, and silicic acid, maximum size of 2 mm.
