Apply safe flooring in housing environments related to elderly (Evaluating suitability technologies to absorb impact in the event of a fall)

II Jornada de doctorado del programa TAEU. 2019

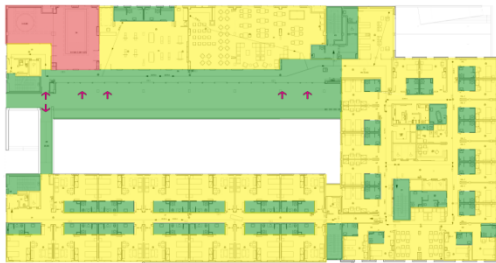
All the areas in all levels of the center were classified according to the defined norm. Here is the second floor of the Mutuam de collserola which classified all the areas with three colors of yellow, green and the red color which respectively described as class one, two and three according to the probability of slipperiness in these areas(Tab. 1).

Table 1. classification of floors according to their slipperiness-ENV 12633:2003- By author

Classification of floors according to their slipperiness	
Slip resistance Rd	Class
$Rd \leq 15$	0
$15 < Rd \leq 35$	1
$35 < Rd \leq 45$	2
$Rd > 45$	3

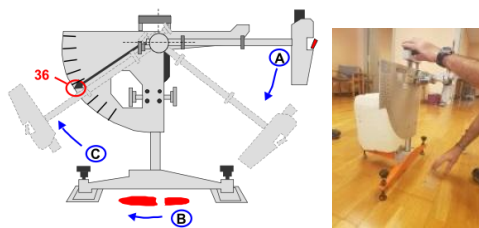
Figure 6. Slip resistance pendulum testing

Slip resistance test performed on current flooring of the center by specific pendulum device (fig. 6) demonstrated that, except the vinyl flooring in gym, parquete in one of the dining room in the first floor the rest of the interior floorings did not pass the standard test and they are not a safe environment for seniors interms of anti-slip.

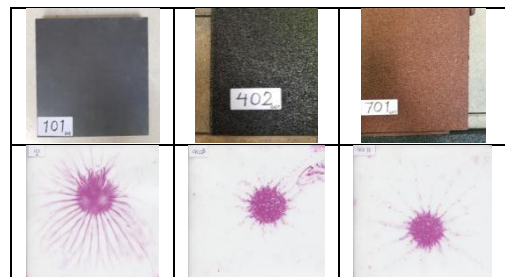
Figure 9. Result of prescale Fujifilm pressure distribution- By author

With this test we try to use a different method which can be visually distinguished the same result (Fujifilm, 2019) . the final sheet will be scanned and analyzed by specific software called FPD-8010E (fig. 9).

Prescale films_presented by Fujifilm, with different levels of sensitivities and functions can precisely measure pressure, pressure distribution, and pressure balance visually by the color density.

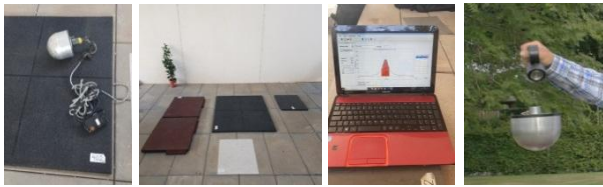
Figure 10. HIC meter Wireless Impact Test-1177-2018- By author

For each flooring new data (temperature, material, weight ...) must be added in Ludometer software (fig. 10). The floorings under test was hit with the metal head provided with the instruments of the test equipment from different drop heights. Signals emitted by the accelerometers of the test head are processed during each impact, to determine the severity derived from the measured impact measure, defined as the head injury criterion (HIC), and to determine the acceleration peak of (g_{max}) experienced.

This European standard specifies a method to determine the impact attenuation of the playing surface. It defines a "Head injury criterion -HIC" for the surface, which represents the upper limit of its effectiveness in reducing head injuries when game equipment is used in accordance with EN 1176 (Sanpeingenieria, 2019).
