## INVESTIGATIONS INTO THE LONG-TERM BEHAVIOUR OF FABRICS

**Key words:** Coated woven fabric, tensile strength, weathering, long-term loading, top coat

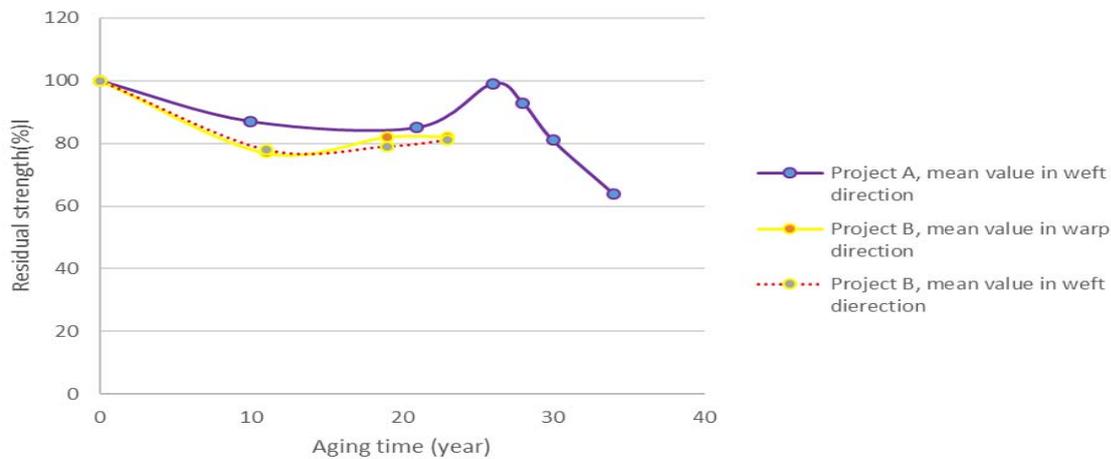
**Figure 1:** Residual strength-ageing time curves of projects A and B

Architectural PES/PVC membranes applied in two membrane buildings are evaluated in this chapter, see also [5]. Table 1 gives details about these materials and their background. After each interval of inspection a sample was taken and the mechanical performance was assessed using a CRE (constant rate extension) tensile testing machine according to EN ISO

With curves in Figure 1, the  $A_2$  factors (strength reduction factors) of two projects could be calculated for different ageing duration. But for the designer, the  $A_2$  factor for a specific material considering its typical lifetime is decisive. Presuming a typical service life of 15 years for PES/PVC it results  $A_2 = 1.18$  for material (A) in weft direction and  $A_2 = 1.32$  for Material (B), both in weft and warp direction.

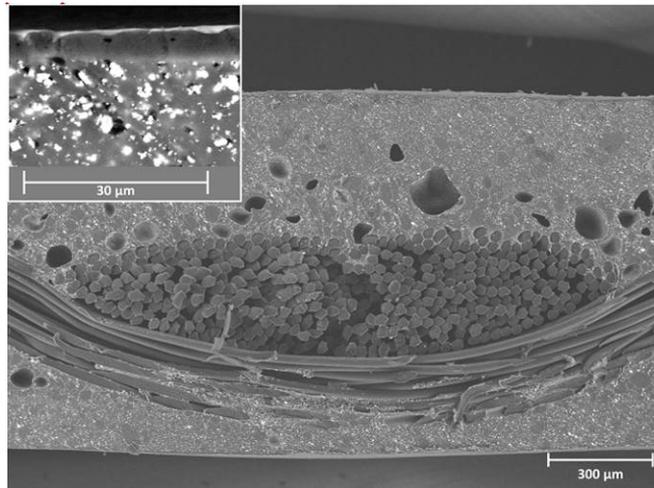
**Figure 2:** SEM cross section of a PVC coated PES membrane. Enlarged detail shows PVC coating and PVDF topcoat. Bright particles are inorganic fillers in PVC.

In Figure 2 the cross section of a PVC coated membrane is depicted showing the foamy, porous structure of the soft PVC coating. The PVC hardly infiltrates the PES-yarn. The PVDF-topcoat is 15-20  $\mu\text{m}$  thick. In general, the wicking process can be distinguished according to the transport direction in transverse or in-plane wicking[8].

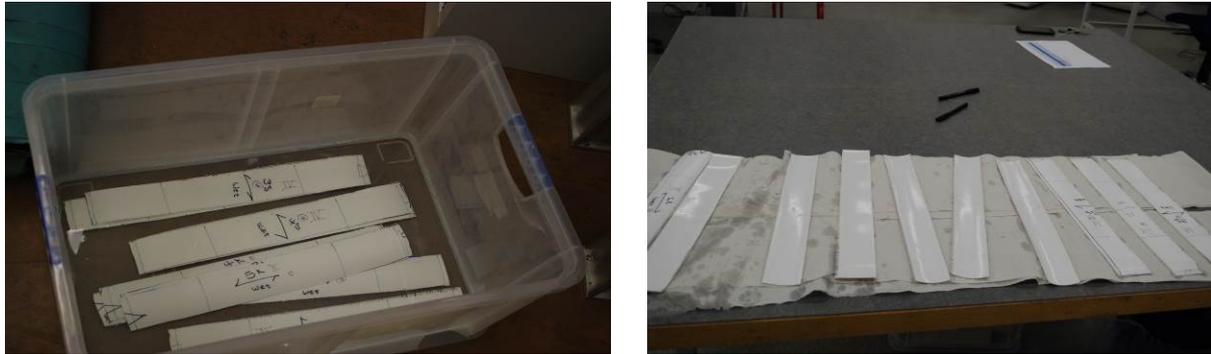
**Figure 3 :** Wet test procedure, bath of water and surfactant (left) and drying with paper towel (right)

The changes of tensile strength due to the influence of water penetration has been examined through wet tests based on EN ISO 1421 [6], carried out on virgin and aged, dismantled PES/PVC fabrics and on virgin glass/PTFE fabric. The dismantled PES/PVC fabric investigated was given from a three-year old inner layer of a biogas plant. The inner layer of biogas plants is affected by some aggressive chemical gases such as hydrogen sulfide. In these tests, test specimens were placed in a bath of water and surfactant for 24 hours, see Figure 3. The surfactant was used in order to lower the surface tension. Comparison samples were kept dry. Dry and wetted test specimens were subsequently tested with the CRE tensile testing machine at the ELLF. Table 2 shows the change of weight after the water bath. With the exception of the dismantled fabric, which has some micro cracks, the average changes in weight of the samples investigated after wetting are almost the same for both PES/PVC and glass/PTFE fabrics.

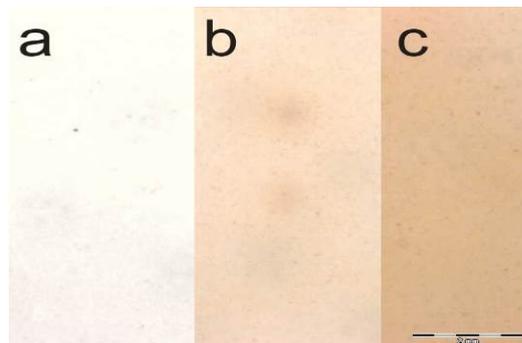
**Figure 4:** Microscopic picture of material (a) and in condition after 20 days of aging (series 1, b / series 2, c)

A weak yellowing appears on the membrane surfaces from series 1. The edges of the samples show a stronger yellowing effect, which indicates that humidity and noxious gases which penetrate into the laminate along open laying fabrics and layers are more responsible for the yellowing than the UV-radiation.

According to the visual appearance the chosen environmental treatment conditions cause external alterations of the membrane but keep the material functionally intact. This is in harmony with the typical observation that changings in color appear on membranes much earlier before serious material destruction takes place.

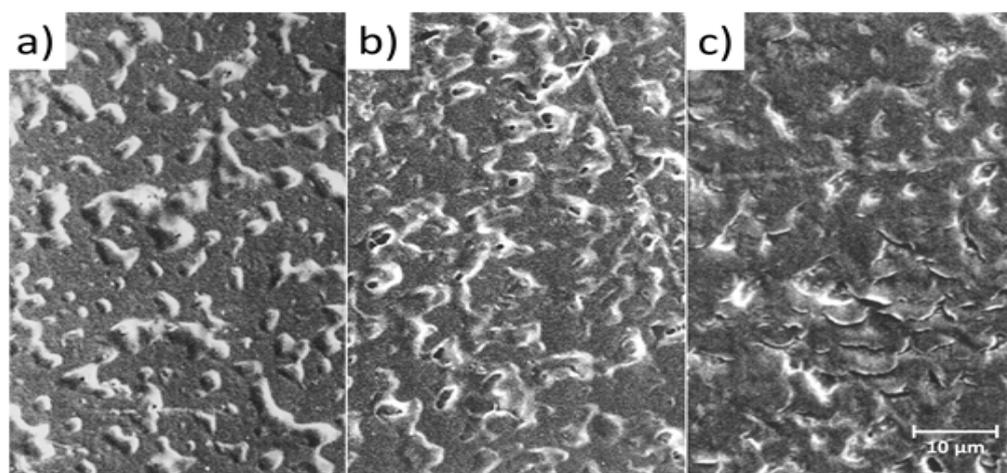
**Figure 5:** SEM picture of material as-received (a) and in condition after 20 days of aging (series 1, b / series 2,c)

Blisters in the top coat or in layers beneath tend to open up during ageing. This causes pores in the top coat which reduce the function of the top coat as protecting coating and diffusion barrier.

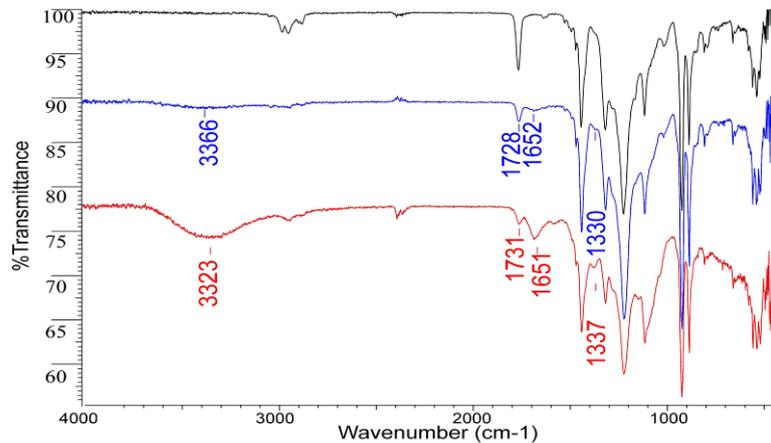
**Figure 6:** IR spectrum of Membrane PVDF-topcoat surface: as-received (top, black) and in condition after aging (series 1, middle, blue / series 2, bottom, red)

The IR spectroscopic examination of the top coat surface containing PVDF has been conducted with a Biorad FT60 spectrometer, a Specac Golden Gate single reflection ATR accessory and a germanium crystal. The high refraction index of the Ge-crystal limits the penetration depth of the IR ray into the material to approximately 1  $\mu\text{m}$ . Thus the chemical information is from the very top layer of the PVDF-top coat. The PVDF coating contains also acrylic binder which results in relatively strong C=O vibration at 1728  $\text{cm}^{-1}$  in the IR-spectrum. After the artificial ageing, especially the samples in series 2 display strong OH-vibrations at 3300  $\text{cm}^{-1}$  and signals at 1640 – 1660  $\text{cm}^{-1}$  in the IR-spectrum of the PVDF-coating. This can be explained with hydrolytic degradation of ester groups. Furthermore, one can recognize that the intensity of the carbonyl vibration at 1728  $\text{cm}^{-1}$  decreases during ageing. Apparently this goes together with an increasing signal at 1660  $\text{cm}^{-1}$ . A decreasing signal intensity means that chemical alterations take place with a non (or slow) diffusing component. This might assume that the PVDF coating acts as an efficient diffusion barrier for PVC plasticizers.

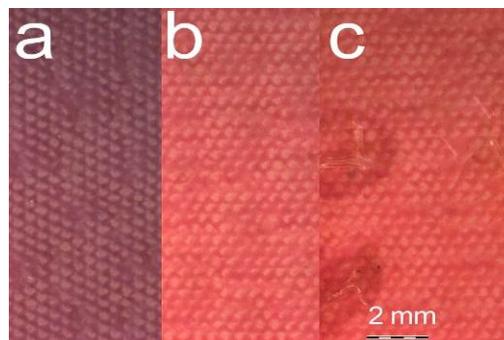
**Figure 7:** Microscopic picture of dyed material as-received (a) and in condition after 20 days of aging (series 1, b / series 2, c)

The varyingly aged membranes were afterwards treated with a dye in the Neocarmin TA process. After the dyeing procedure the surface was investigated with a stereo-microscope, see Figure 7. The penetration of the colored fluid uncovers capillary capabilities of the material and differences in color intensity and color shade depict differences in material and thickness as well as changes in chemical composition during ageing.

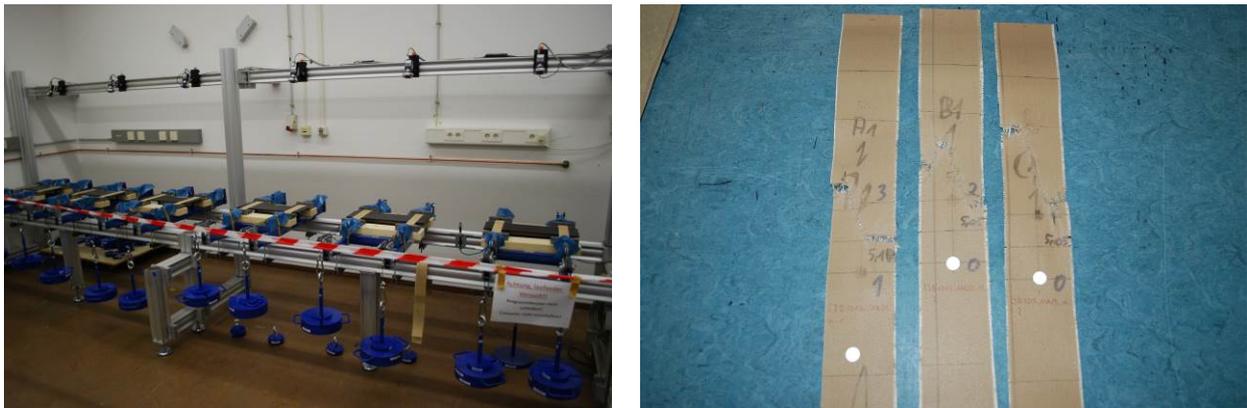
**Figure 8:** Installation situation of the long-term loaded test specimens in the creep test stand (left), examples of the kind and position of fractures during the tensile tests after long-term loading (right)

In total, 12 test specimens were tested, six warp and six weft specimens. They were mounted on the ELLF creep test stand as shown in Figure 8 on the left.

In phase 2, every single test specimen was demounted from the long-term test stand individually and mounted immediately in the tensile testing machine within a time period of less than five minutes. Figure 8 on the right gives an example of material fractures obtained in these tensile tests. No clamping fractures occurred. For comparison reasons, also virgin material was tested in the tensile testing machine. Table 8 shows the results of the measured residual strengths after three months of full design stress and in comparison the virgin state strengths. The strength did not decrease after three months loading, but instead increased by 4-5 % regarding mean values. Only the 5%-fractile in weft direction shows a constant level. This is due to a slightly higher coefficient of variation after the long term loading in weft direction. But it should be mentioned that the coefficient of variation was generally low with max.  $V_x = 3.2\%$ .
