## ISSUES WITH MANAGEMENT, MAINTENANCE AND UPKEEP IN ETFE ENCLOSURES

**Keywords:** ETFE, Maintenance, Building Management

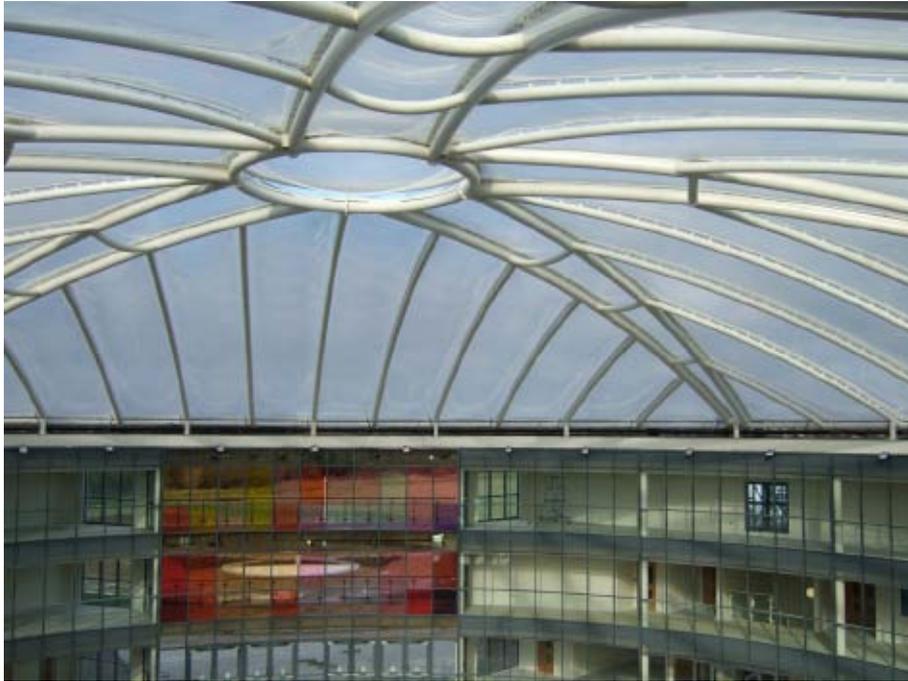
Figure 1. ETFE cushion roof covering atrium of Nova Hreod College courtyard

An installation by Architen Landrell Associates in the UK, the Hreod Dome is an open structure in the South of England which covers the courtyard of Nova Hreod College (A new development in 2005 to relocate Hreod Parkway School). The dome comprises a radial array of fritted (printed) 2-layer ETFE cushions with a centre ‘oculus’ cushion. The ETFE cushion roof, located 15m above ground level, was chosen to cover the courtyard and provide a sheltered communal space for students as well as allow trees and plants to grow in the covered area.

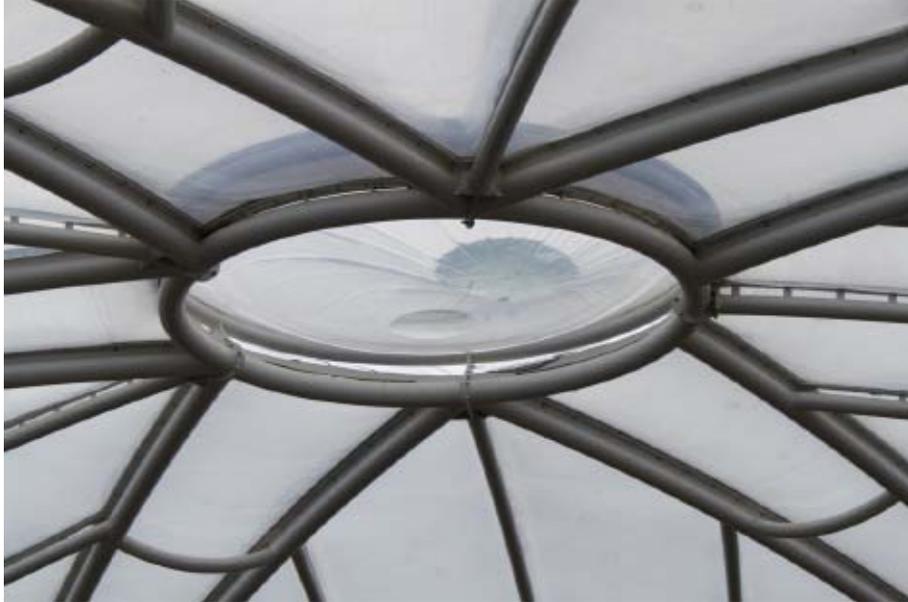
Following the unusually cold winter with a large amount of snow, emergency work was necessary due to water ingress through a puncture in the cushion. In this case a site inspection revealed that the oculus cushion had deflated due to the size of the puncture. This resulted in the cushion inverting under the weight of snow and allowing water from the melted snow to enter the cushion. After the cushion was drained of water the hole could be patched using adhesive ETFE tape. The root of the problem was the unusually large volume of snow over the early months of 2010. This had caused the bird wire (used to prevent birds from landing

on the aluminium extrusion) to be pulled from the holders, enabling birds to then land on the perimeter of the cushions. This also provoked a redesign of the bird wire holders to ensure they were more resilient to the load imposed by sliding snow.

Figure 2. Water pooling on and inside centre oculus cushion of ETFE roof

In this instance the access and repair of the ETFE cushion took no more than 2 hours; also including a routine inspection of the air handling unit (AHU) to ensure that the system continued to perform optimally.

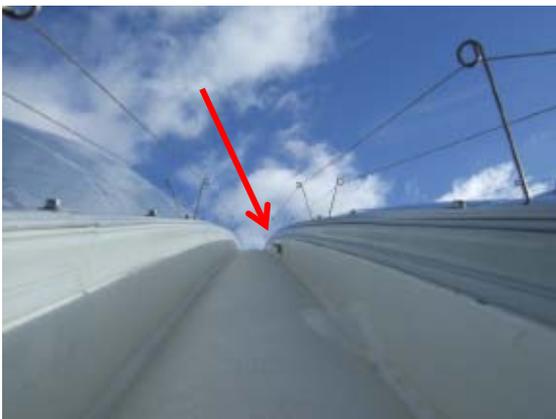
Figure 3. Steelwork with hanger plate anchor (indicated) designed for installation and maintenance access

A channel in the steelwork allows safe contractor access to the oculus (Figure 3). Hanger plate anchors were applied at regular intervals on the steelwork channel to provide access to

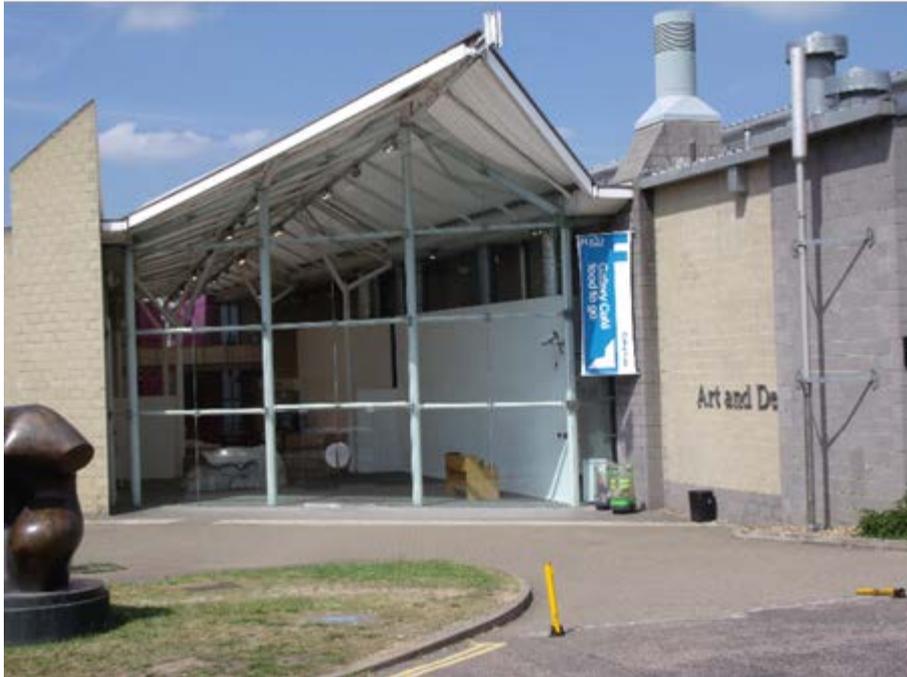
Figure 5. ETFE cushion entrance walkway at Hertfordshire University's Art & Design department

Approximately 10 years old and having had few inspections and very little maintenance in that time, the structure consists of a series of nine ETFE inflated cushions (with an area of nominally 225m<sup>2</sup>) covering the general public access space to the Art and Design building. The walkway comprises three ETFE cushions forming the North face of the structure, and six inflatable cushions forming the South face; all cushions are constructed from translucent white ETFE.

Architen Landrell Associates was called to site to perform general maintenance on the structure due to a steady decline in pressure in the system due to apparent damage to the cushions. The maintenance brief involved repairing any damage to the cushions, an inspection of the air supply, cleaning of the top side of the ETFE cushions and cleaning the aluminium extrusion at the perimeter of the cushions.

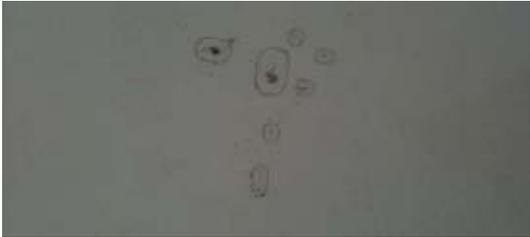
Upon closer inspection of the cushions, it was found that some remedial work had previously been undertaken for small punctures that had been caused by birds pecking at the surface (Figure 6 & Figure 7) however since the system was last inspected there was a

Figure 6. Existing repairs to ETFE surface

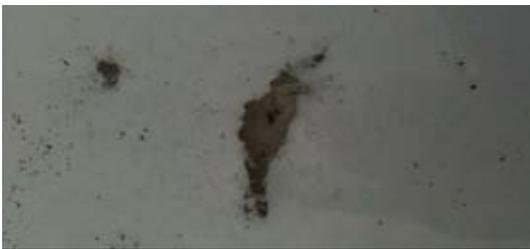
significant amount of additional damage to the surface. This was potentially the cause of the pressure drop in the cushions (the symptom being the fans running more than normally) and additionally allowing dirt deposits in the cushions through water ingress (Figure 8).

Figure 7. Additional damage as a result of birds pecking at surface

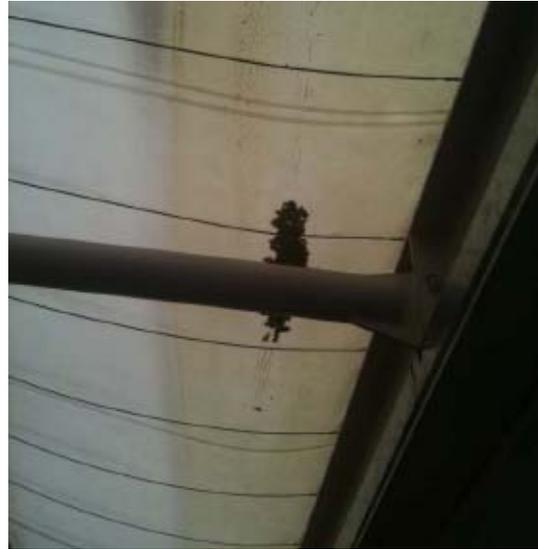
Figure 8. Dirt deposits as a result of water ingress

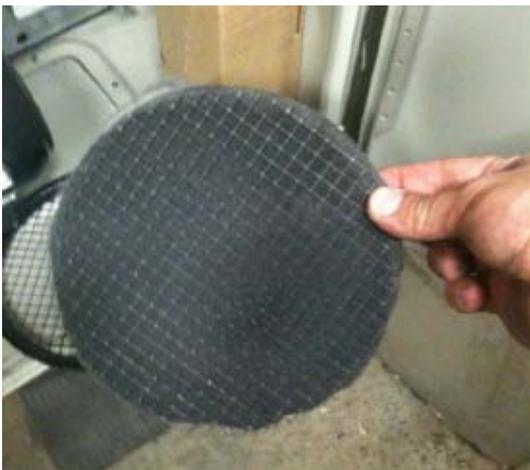
Figure 9. Clogged filter contributing to restricted air flow

Dust and particles in the air drawn in to the air handling unit and caught in the filter (in place to prevent these particles from entering the cushion) had clogged up the air intake, reducing the amount of air that was able to be pumped into the cushions and contributing to the drop in pressure. Figure 9 shows an image of one of the filters before it was replaced with a new one (Figure 10). This not only highlights the need for regular maintenance inspections by the installer to ensure continual satisfactory operation of the system, but also the need for repair kits to be located on site to enable building management services to diagnose and remedy simple maintenance issues with the ETFE systems. Good practice at hand-over of the structure would be to include information on regular maintenance of the roof within the Operation and Maintenance (O&M) manual (including topics such as frequency of filter changes) that can be performed by building services. This will aid in diagnosing and remedying simple matters that arise over the life of the structure.

The air handling unit was serviced in order to ensure the cushions could achieve their full inflation pressure (nominally around 300 Pa) and to reduce the necessity of having the fans running constantly. This process involves ensuring the air supply manifolds have sufficient sealing, a check on the electronics and replacement of filters (if any) to ensure satisfactory continued operation. In this case a suspected cause of inadequate pressure in the cushions was that the filters did not appear to have been changed for a considerable time.

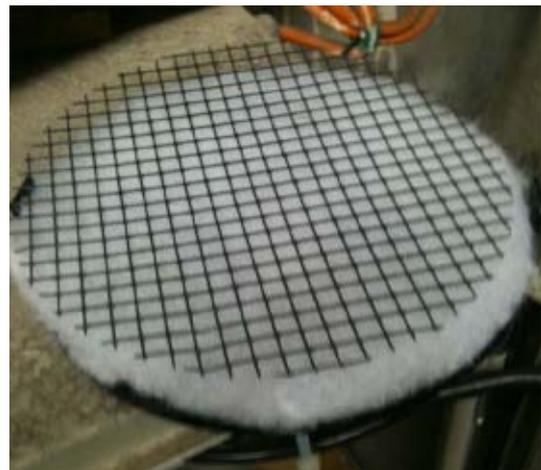
Figure 10. New filter to replace old

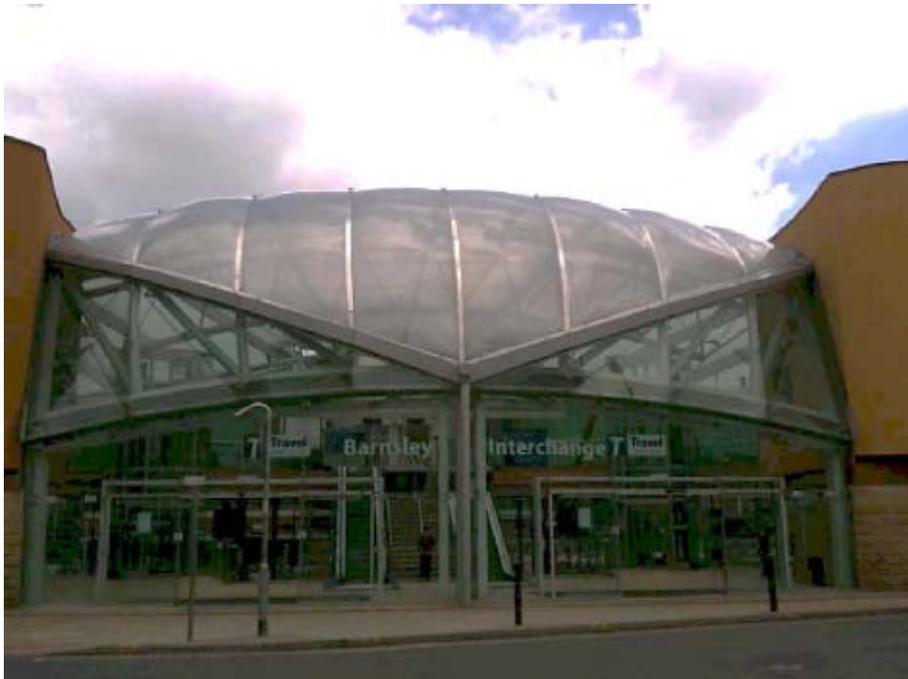
Figure 11. Entrance to Barnsley Interchange Station showing externally visible array of ETFE cushions

In December 2010 a problem was reported with an ETFE structure at Barnsley interchange railway station; a cushion was not inflating and there was concern over snow and ice build-up. It was also reported on site that following a recent air inflation pump change full inflation had not been achieved in the two cushions which had suffered ponding due to the weight of snow.

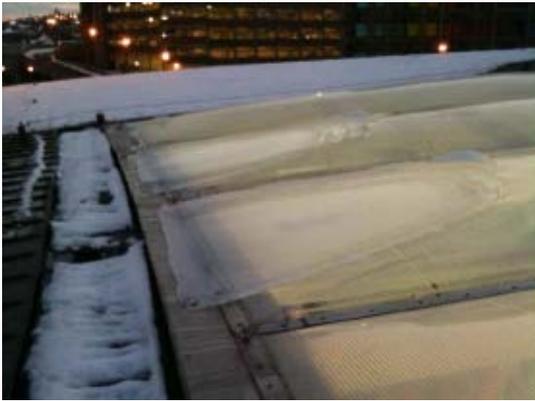
A site-visit showed that a combination of sunlight and warm air in the cushion had melted the snow and with subsequent sub-zero ambient temperatures the water had frozen in the inverted cushion and become sheets of solid ice (Figure 12 & Figure 13).

Figure 12. Image of ice build-up on cushions as a result of ponding

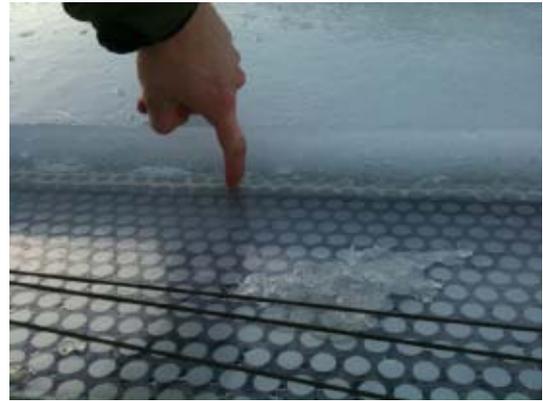
Figure 13. Image showing ice build-up of approx. 3”

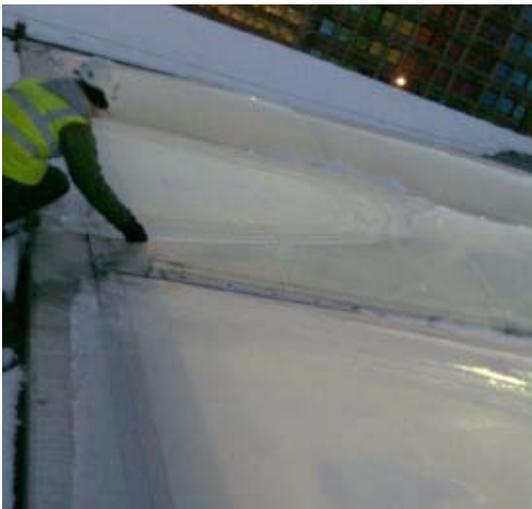
Figure 14. Ice sheet being removed from ETFE cushion

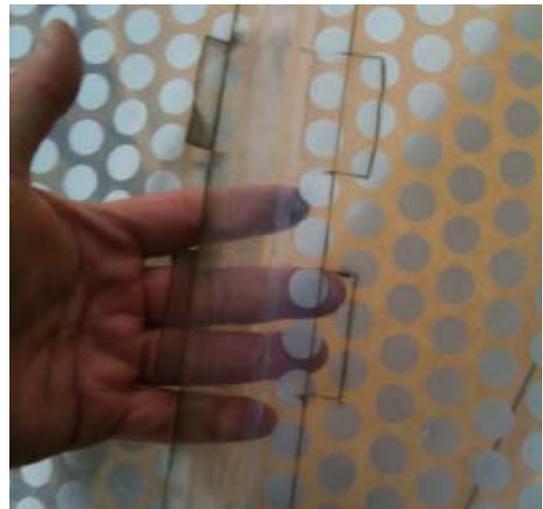
The resulting weight of the ice that had pooled on one of these cushions also appeared to damage a previous repair, detaching a seam that was held with ETFE repair tape. Opening of this seam seemed to be the cause of the pressure loss in the cushions, and not (as was initially thought) the service that was performed previously on the air handling unit.

Figure 15. Previous repair of split weld possibly due to weight of ice

These symptoms might possibly be attributed to the initial design of the structure in particular the patterning of the cushions, the design of which builds in sufficient cushion rise to reduce the lateral forces on the supporting steelwork. Comparing a cushion with a higher radius of curvature than the cushions shown here (under equal pressure) the lateral loading on the steelwork will be higher. This is often visually desirable as it can produce a pleasing aesthetic to the building; however this could result in the issue discussed above in addition to increasing the amount of supporting steelwork which will have to be more substantial to allow for the higher loads.
