3.1 FROM SINGULAR, ACCIDENTAL BUILDING PROBLEMS TO EARLY DEFECTS OF A CONGENITAL NATURE

(Joan Lluís Zamora i Mestre)

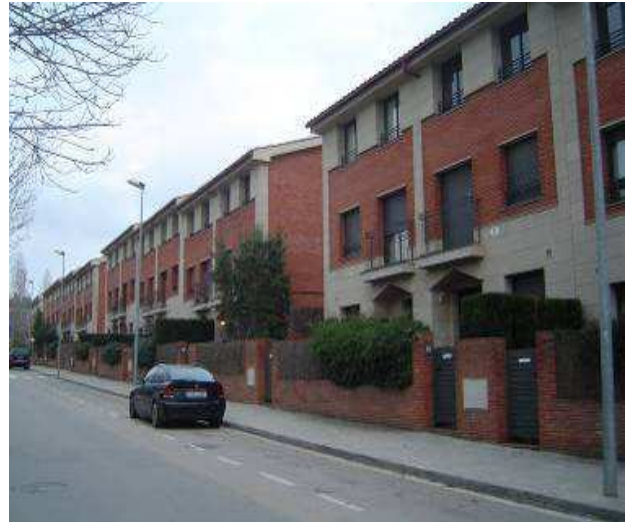
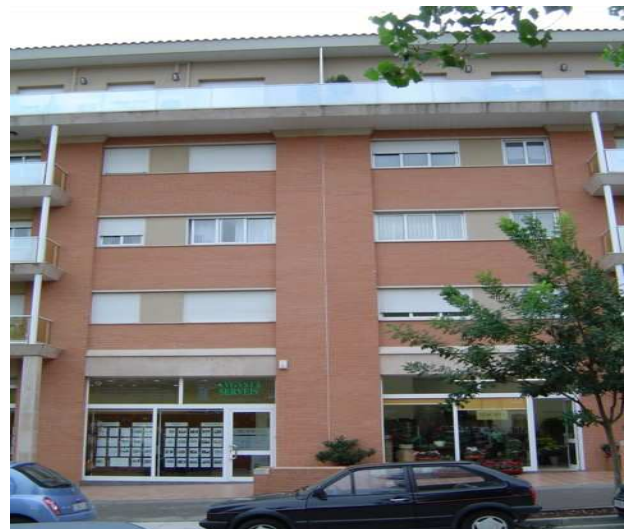
Figure 15 – View photo of a set of newly constructed residential buildings in urban peripheries

Buildings constructed in the second half of the twentieth century will most likely be characterized by the fact that they were mass produced as just any other consumer good. These recent buildings have been produced by specialized companies, which have put them on the market for sale or rent. However, at the time of their production, it was not known who would how they would be lived in (Figure 15).

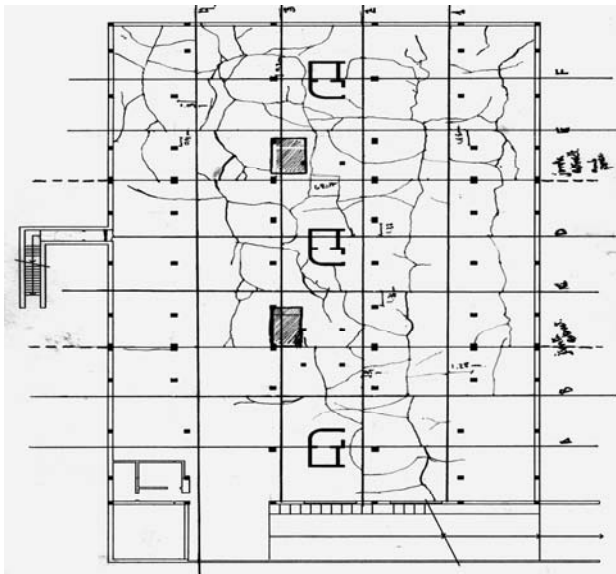
Figure 16 – Planimetry of a large crack in the floor of underground parking of vehicles in an apartment building

- Synchronous: all of the defects are recorded in a short period of time, with their most relevant descriptive parameters (photographs, dimensions and description) as well as their position (x,y,z) in the geometry of the building (Figures 16, 17 and 18);
- Diachronic: all the defects must be recorded at different stages to assess their evolution over time. They may get worse (increase in the size or severity of the problem) or stay the same. In some cases, a diachronic record should be used to assess whether or not a repair has been successful (Figures 19 and 20).

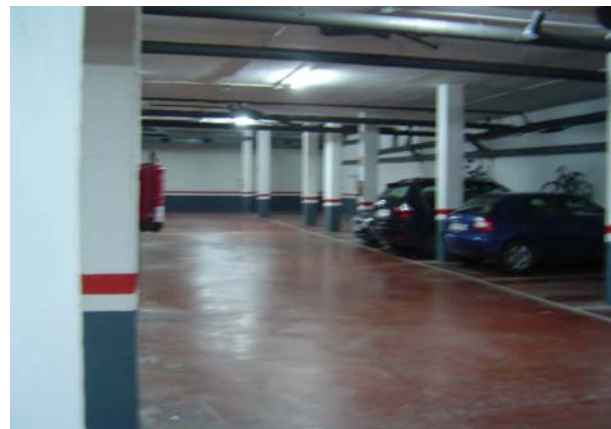
Figure 17 – General view photo of underground parking of vehicles in an apartment building

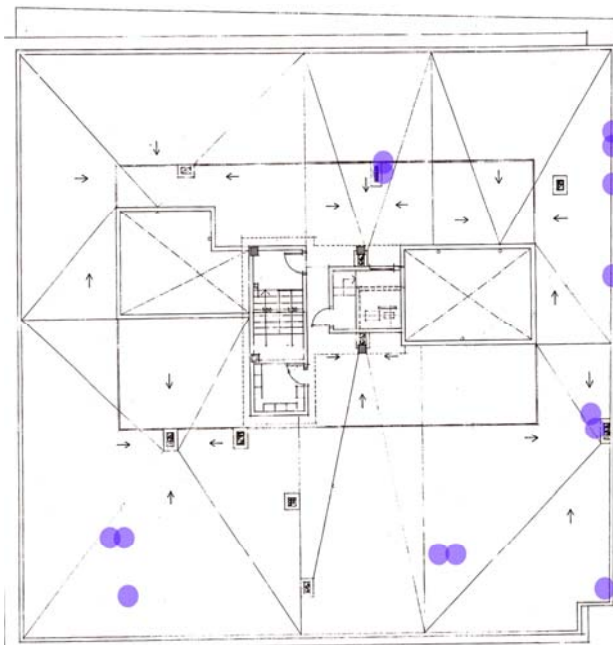
Figure 19 – Planimetry of the points of infiltration of rainwater on the roof of an apartment building

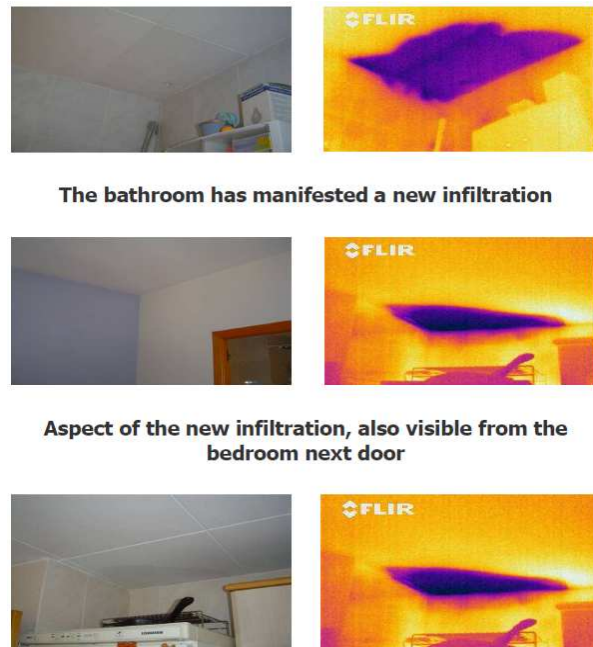
The bathroom has manifested a new infiltration

Aspect of the new infiltration, also visible from the bedroom next door

New moisture infiltration that has appeared in the kitchen

Figure 20 – Thermographic and visible photography points of infiltration of rainwater under the roof of an apartment building

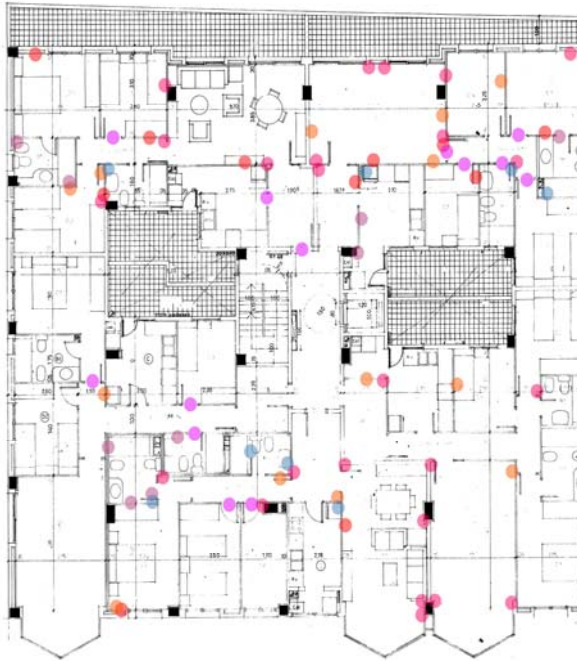
Figure 21 – Planimetry of the points of infiltration of rainwater on the roof of an apartment building

However, all arguments must be based on the preliminary records report (Figures 21 and 22).

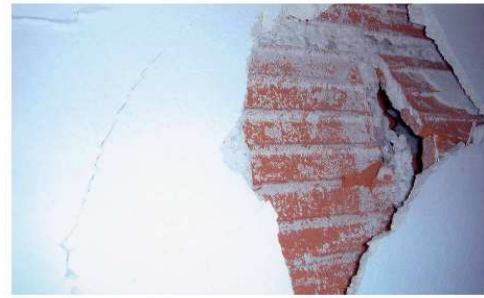
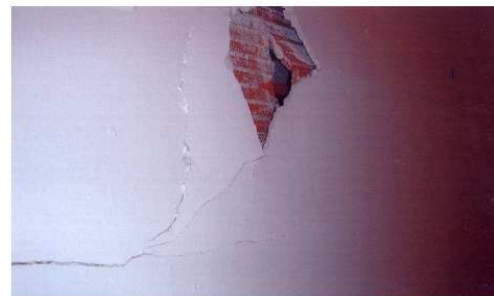
Detail view of an area of the crack: the plaster has separated cleanly from the ceramic brick without existing prior grip

Figure 22 – view detail photo of cracking in the walls of masonry of ceramic pieces in an apartment building

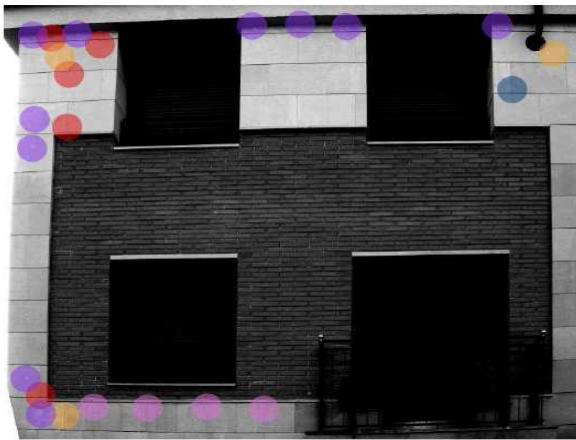
- 01. NICKS
- 02. EFFLORESCENCES
- 03. SCRATCHES
- 04. BREAKAGES
- 05. STAINS
- 06. REPAIRS
- 07. DISCOLORATIONS
- 08. IMPACTS

Figure 23 – Planimetry based on photographs to facilitate identification, census and classification of anomalies detected in the natural stone façade placated by a group of single houses

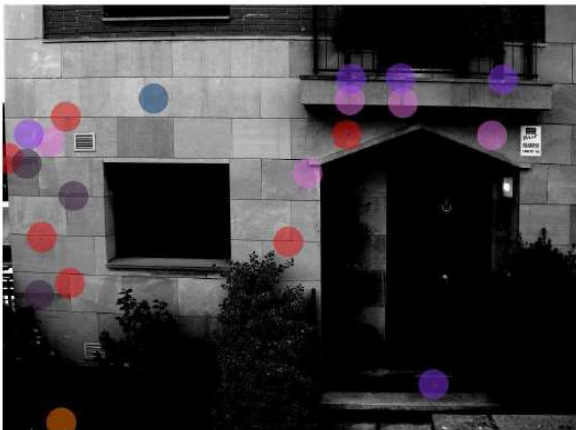
Anomaly 01. Nicks		
Description: We talk about the existence of an anomaly nicks when stone plates have notches (loss of material) because of impacts on certain points of its perimeter. This anomaly usually appears at the edges of the plates but is also present in some corners.		
Some graphic examples:		
Valldaura nº22	Valldaura nº 24	Valldaura nº28
J. Coromines nº21	J. Coromines nº17	J. Coromines nº13

Figure 24 – Proposal for classification of the anomalies detected in the natural stone façade placated by a group of single houses
