UAV, Digital Processing and Vectorization Techniques Applied to Building Condition Assessment and Follow-up

Abstract: The aim of the paper is to explain the basic principles of carrying out an inventory and follow-up of buildings and their condition assessment, by using the Full Interactive Visualization Method for Building Condition Assessment platform. It is a platform enabling the implementation of construction inventory based on the remote cooperation of many specialists in the field of, among others: building construction, architecture, civil engineering, photogrammetry, CAD, UAV. This type of cooperation is of particular importance especially in the context of the current epidemiological situation related to COVID-19. The idea of the presented platform fits into the broadly understanding of Building Information Modeling. After introducing the methodology, stages of the inventory and follow-up process carried out within the platform are illustrated and discussed on the basis of a case study.

Keywords: BIM; building condition assessment; GIS; monitoring; UAV

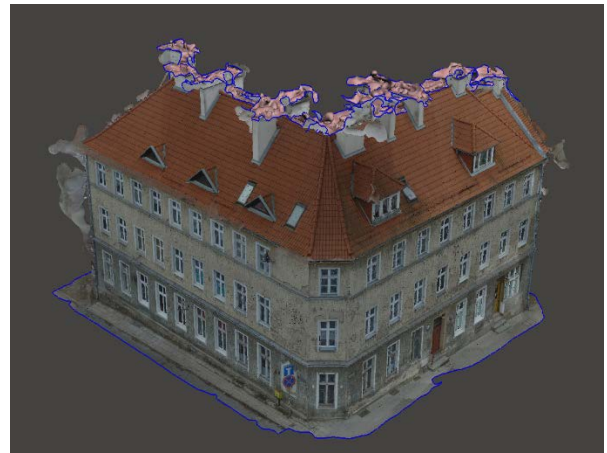
Figure 3 Visualization of the generated model in 3D space

In order to generate a 3D model devoid of artifacts, it was necessary to carry out manual cleaning and classification of the point cloud (Fig. 3 and Fig. 4). The process took almost 6 hours and resulted in the generation of a model practically free from contamination. The model allows it to be used for the visualization of selected, inventoried phenomena in 3D space in a natural way for the user. The carried-out process of cleaning the point cloud additionally influenced the quality of the generated orthophotoplanes of the facade and roof. As part of this stage, an orthophotoplan separation was generated for each of the elevations (Fig. 5).

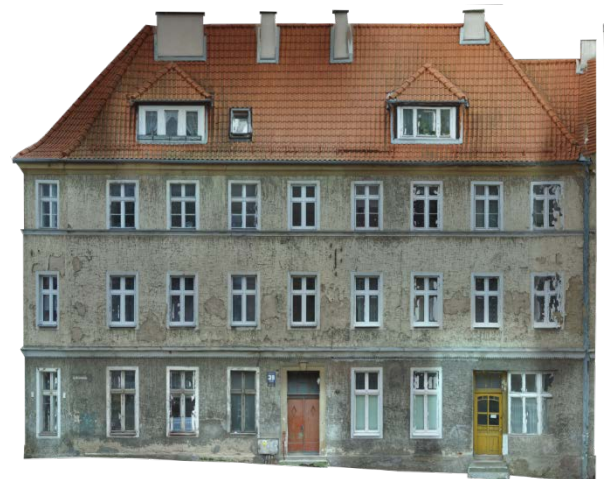
Figure 5 Ortofotoplan of North-East elevation

Work on orthoplanes takes place in a local system, the accuracy of the GPS module used for geotagging photos (accuracy of determining the position ± 2.5 m), which is standard UAV equipment, does not affect the usability of the generated material. In the local system, the distortion recorded inside the system is important, and not the external error of the point position in the selected coordinate system (UTM zone 34N). Due to the above, the quality of the generated orthophotoplanes is described by the GSD

coefficient, which is 0.36 cm, and the length measurement error, which is 0.50 cm. The length measurement error was determined by performing control measurements on an inventoried object using the Leica Disto D810 laser rangefinder. For the control purposes, about 50 measurements were made in different planes.

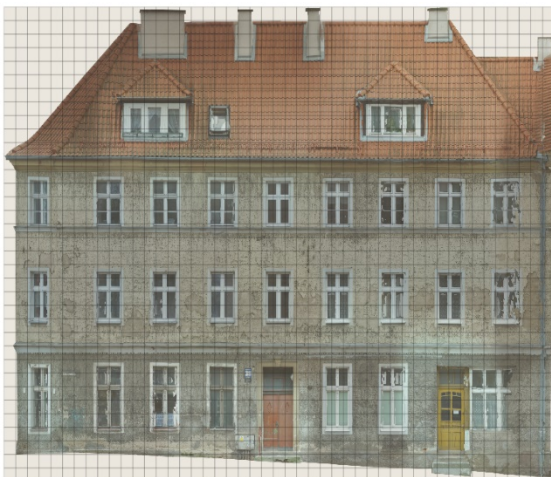
Figure 6 Orthophotoplan with a squared grid

Based on the conducted analyses, a matrix made of squares with a side of 0.4 m was considered optimal (Fig. 6).

The matrix was created in 2 stages. The first stage consisted of creating a square grid using the QGIS tool: vector / research tools / create a grid, resulting in a linear vector layer. In the second stage, linear objects were transformed into polygonal objects using the tool: vector / geometry tools / lines into polygons. As a result, an attribute table was created with the number of records equal to the number of polygons. A total of 1,645 polygons were generated based on the created 47x35 matrix. At this stage, the table contained only 5 attributes: polygon ID and top, down, left, right - coordinates of the polygon corners.
