Classifying System for Façades and Anomalies

Katia Gaspar¹; Miquel Casals²; and Marta Gangolells³

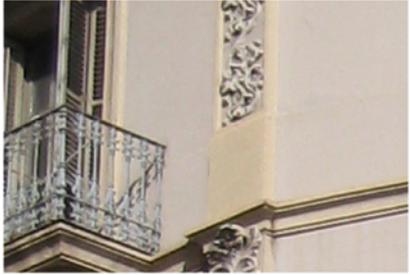
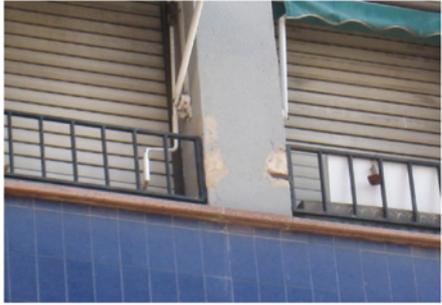
Fig. 2. Samples of technical reports provided for the case study (photographs by the UPC's building laboratory)

Location:	Main facade, Side facade1 and Side facade 2				
	Description:	External wall covering				
	Typology:	Continuous				
	Material:	Stucco

Photographic reference:	_01
	Location:	Main facade
	Element:	Mortar render
	Defect:	Detachment
	Magnitude:	Isolated
	Intervention:	2

reports generated by the UPC's Building Laboratory. The reports give textual descriptions of damage affecting buildings and a set of pictures illustrating the anomalies (Fig. 2). The case study included 154 public housing buildings located in Barcelona and erected between 1800 and 2005 (Table 4). Residential buildings erected after 2006 were not inspected, since they are relatively new and should not have any anomalies resulting from the passage of time. The buildings were grouped by year of construction (built before and after 1980). Residential buildings that were built before 1980 in Spain did not have to comply with any thermal requirements, and therefore most buildings from this period do not have any insulation. Residential buildings built between 1980 and 2006 fall under the thermal requirements established by NBE CT 79. The use of cavity walls with thermal insulation in the cavity was very common in this period. Façades are usually rendered and painted. Table 1 shows typical *U-values* for these buildings (Gangoells and Casals 2012). New residential buildings added to building stock between 2007 and 2010 were built under the new thermal requirements established by the TBC (Table 1). Construction techniques and systems used during the previous period are still very common. However, a thicker insulation layer and higher performance insulation materials are used to meet the higher requirements (Gangoells and Casals 2012). Table 4 describes the main characteristics of the analysed buildings. A total of 216 types of façades were identified in the 154 public housing buildings, as some buildings were found to have more than one type of façade. The types of façades in residential buildings were identified through visual inspection and knowledge of traditional building techniques used in the construction period (City Council of Barcelona 2002). The sample of buildings analysed included all the types of façades that had been identified in the section "Classification of façades in existing residential buildings". Single-skin façades without an air cavity and with external insulation and continuous covering (code F.1-AC.1-I.3-WC.2), and single-skin façades with an external ventilated air cavity, external insulation and non-continuous covering (code F.1-AC.2-I.3-WC.3) were types of façades that resulted from the refurbishment of buildings' envelopes. By the end of the case study, all of the analysed façades had been classified.
