Aznalcóllar dam failure. Part 1: Field observations and material properties

E. E. ALONSO* and A. GENS*

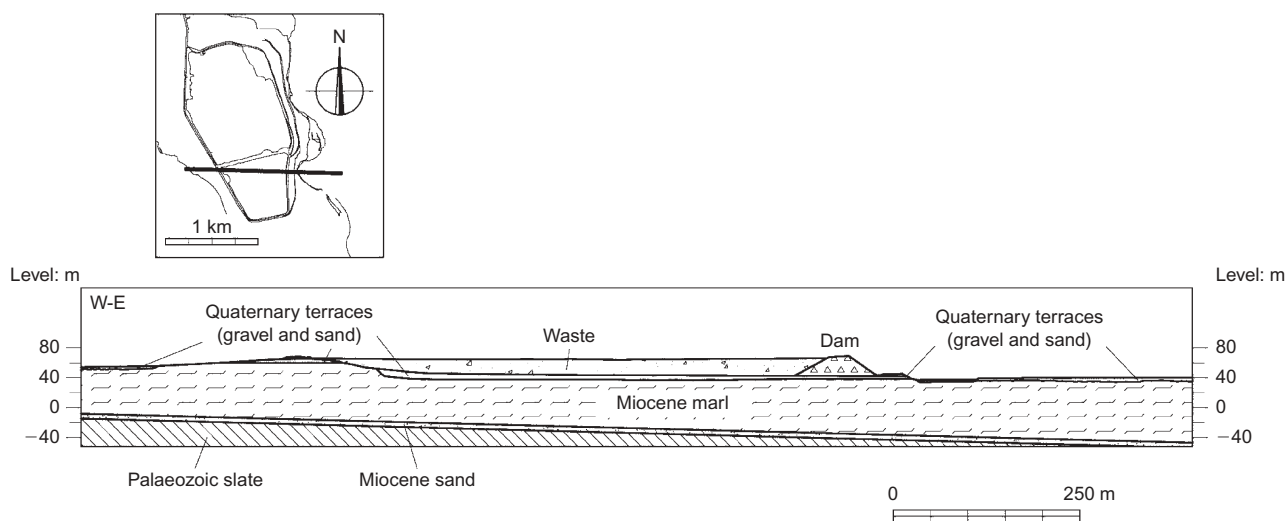
A geological cross-section of the tailings lagoon in a west-east direction is given in Fig. 5. Table 1 summarises the geology of the site. The substrata are Palaeozoic shales

Fig. 5. Cross-section of tailings lagoon. Two stratigraphic discordances are observed: a lower one (high angle) between the Palaeozoic substratum and the upper Miocene deposits, and an upper one (low angle) between the Miocene clays and the Quaternary deposits

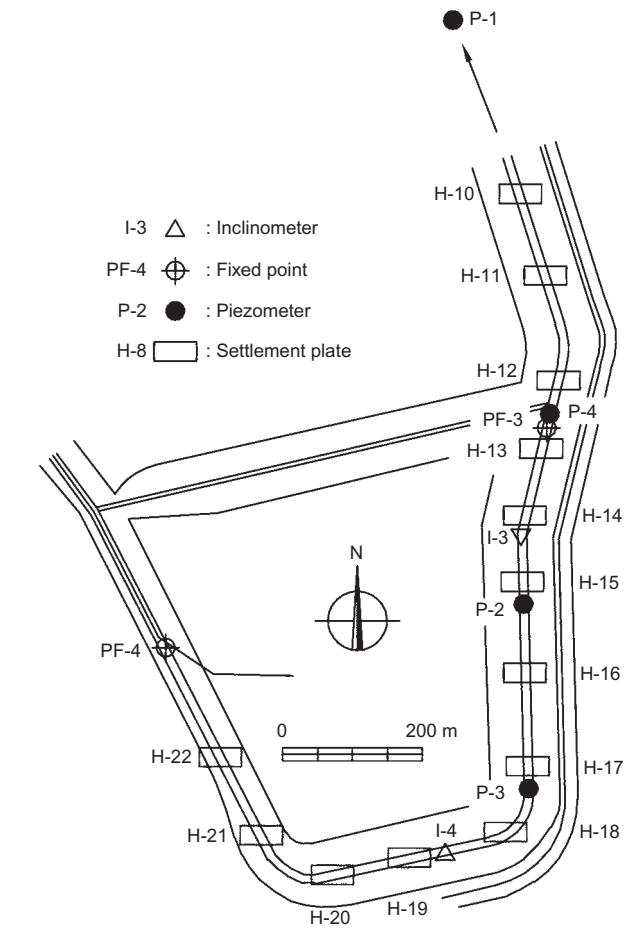
Following the recommendations of an evaluation, in 1996, of the dam safety, a monitoring programme was set up. Fig. 13 shows, in plan view, the position of the instruments in the length of the embankment later affected by the failure. Settlement plates, piezometers (in fact observation wells) and a few inclinometers were located along the crest of the embankment (a few fixed points, shown as PF in Fig. 13, were used as a reference for plate levelling). Great significance was assigned to piezometer readings, and a safety procedure was established in the event of piezometers indicating a rise in water pressure or in the case of abnormal outflow. The 'piezometers' were slotted open tubes penetrating 2 m into the foundation clay. It is clear that they were not intended to measure pore water pressures in the clay, but rather any water pressures developing in the granular alluvium or in the pervious rockfill.

Fig. 13. Position of monitoring instruments: south-eastern side of Aznalcóllar dam

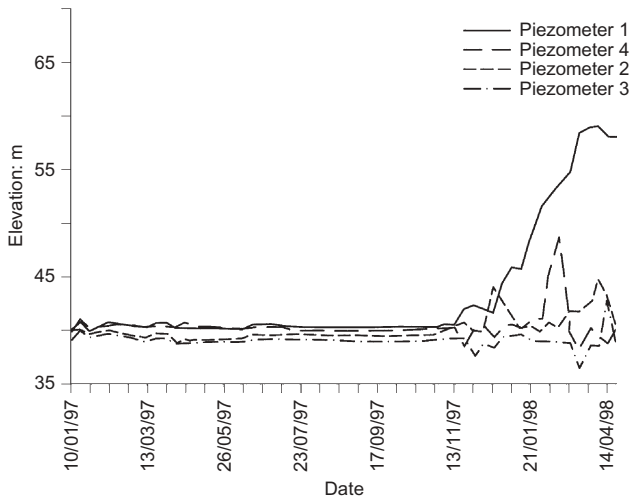
The recorded water heights of the open tube piezometers P-1, P-2, P-3 and P-4 are shown in Fig. 15. The behaviour is fairly regular during the first 10 months of 1997 and the

recorded water elevation (level 39 m) corresponds to the mid-point of the alluvial layer. After November 1997 the measurements show a more irregular pattern difficult to interpret. The last available readings, in April 1998, indicate that the water level was again within the limits of the pervious granular alluvium. No abnormal settlements were recorded. Horizontal displacements of the embankment, however, were not measured. The behaviour of the dam was always considered normal, and the regular monitoring reports did not express any special concern.

Fig. 15. Evolution of water elevation in piezometers P-1, P-2, P-3 and P-4

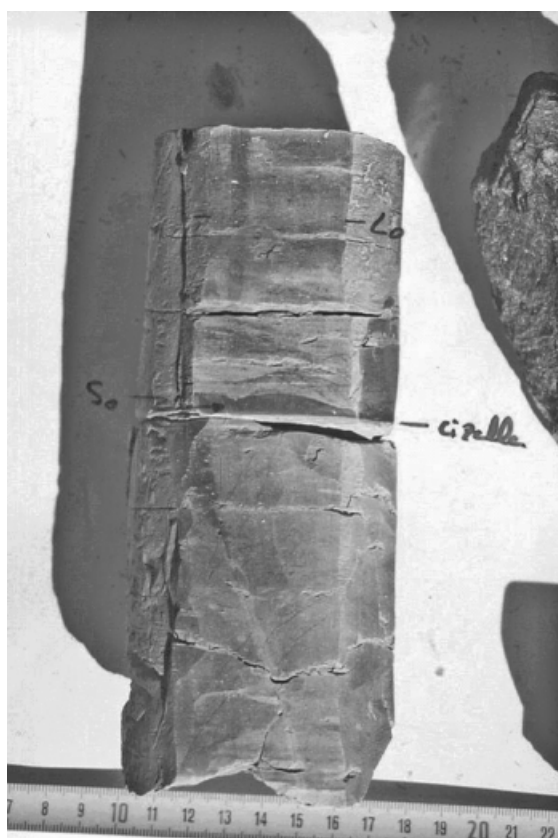
found in direct contact with the clay in some of them (e.g. Boring ES3-0e in Fig. 17). In several boreholes it was also possible to identify the position of the sliding surface where a highly polished surface could be found. This is the case for the plane shown in Fig. 18.

Fig. 18. Highly polished and striated shear plane that follows a bedding plane (S_0). Borehole 2-1 at 33.8 m depth. It was interpreted as belonging to the sliding surface

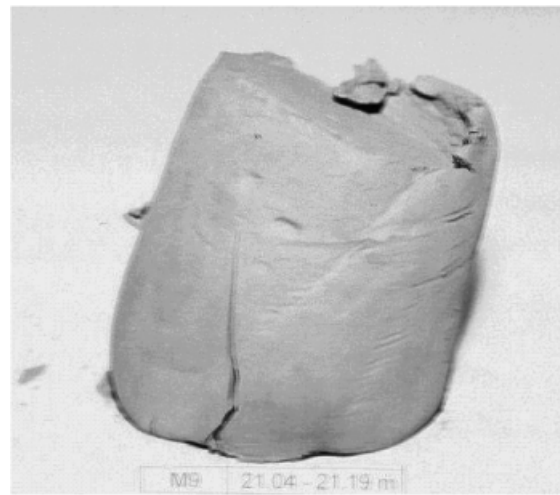
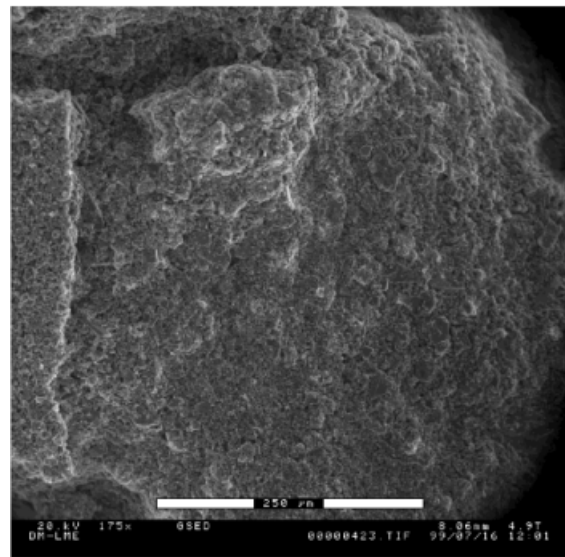
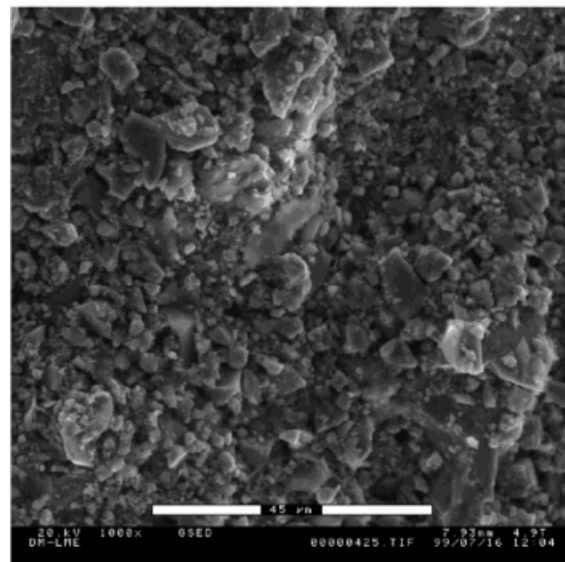
Fig. 26. (a) Specimen of pyrite tailings after triaxial testing; (b) view at $\times 175$ scale; (c) view at $\times 3000$ scale

response and a rapid generation of pore pressure, indicating a collapse of the granular structure. However, as failure conditions were approached, a strong dilatancy changed the trend of pore pressure generation, and the path followed the strength envelope at increasing effective confining stress. When the test was stopped, at very large strains (24%), positive pore pressures were again recorded, although they may not be very significant in view of the large strains reached. Failed specimens, especially those coming from the pyritic lagoon, showed distinct shear planes.

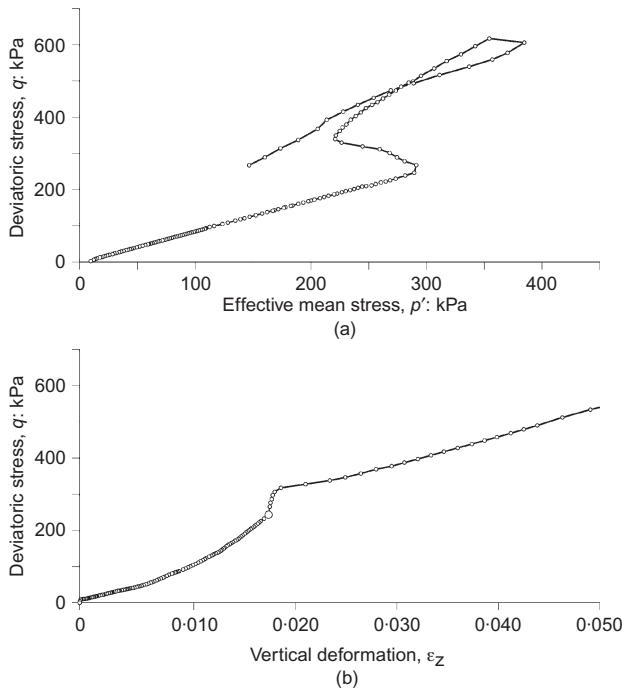
were performed on specimens belonging to the two deposits (pyroclastic and pyrite). Static liquefaction was never observed in triaxial compression tests, a typical example of which is shown in Fig. 27. This shows the stress path (Fig. 27(a)) and the deviatoric stress-strain behaviour (Fig. 27(b)) recorded in a test of a specimen taken at a depth of 20-90-

22.00 m in borehole S5-2 (southern pyritic lagoon). The initial void ratio, e_i , was 0.733. Specimens were consolidated to the estimated effective initial stress. The undrained application of the deviatoric stress resulted in an initially stiff

Fig. 27. Undrained K_0 consolidated ($K_0 = 0.5$) triaxial test on specimen M9 from borehole S5-2 (southern lagoon): (a) effective stress path; (b) deviatoric stress–vertical strain response

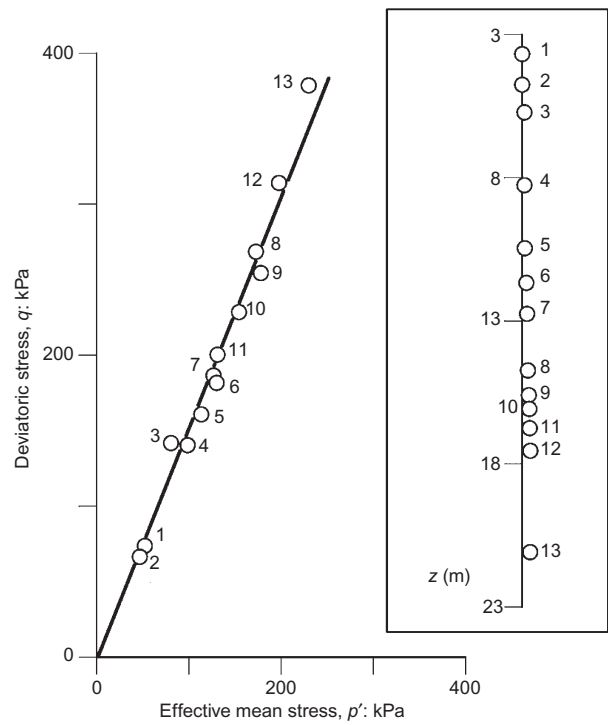
Failure conditions were homogeneous with depth. Fig. 28 shows the strength, q_f , found for specimens taken in borehole S5-2, within the southern lagoon. Also shown is the position of all specimens recovered. Undrained strength of the pyritic waste increases at a rate $q_f/\sigma'_{\text{initial}} = 0.8$, where q_f corresponds to the maximum value of generated pore water pressure. The range of effective friction angles determined in tests on both pyritic and pyroclastic materials is $37\text{--}42^\circ$. No correlation with grain size (D_{50}) or void ratio could be identified.

Fig. 28. Variation of undrained shear strength with depth of pyritic waste

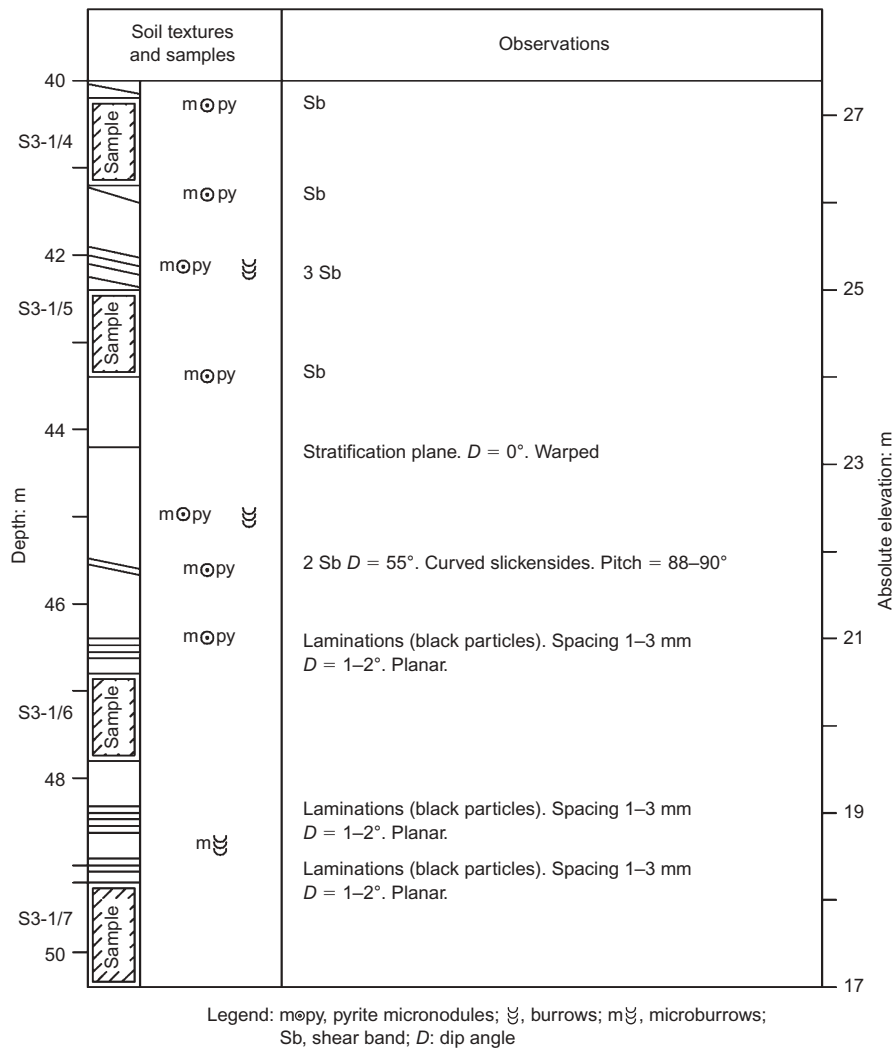
Boring S3-1 (Field record from z = 40 to z = 50 m)

It was decided to test in some detail two ‘soil columns’: boreholes S3-1 and S4-1 located in the slide area (Fig. 6). These two boreholes encountered first the embankment rock-fill, then the alluvial layer and finally the blue clay. The detailed stratigraphy of a portion of the blue clay, from borehole S3-1, is shown in Fig. 33. The sliding plane was estimated to be located at elevations 26–27 m. In one location a warped bedding plane was identified. Subhorizontal laminations (dip $1-2^\circ$) presumably parallel to bedding planes were also observed. Shear bands were also detected at non-regular intervals. They are often inclined at a significant angle. Pyrite micro nodules are scattered throughout, often showing linear arrangements parallel to bedding or lamination planes.

Fig. 33. Portion of stratigraphic column of borehole S3-1 between depths $z = 40$ m and $z = 50$ m (location of borehole shown in Fig. 6)

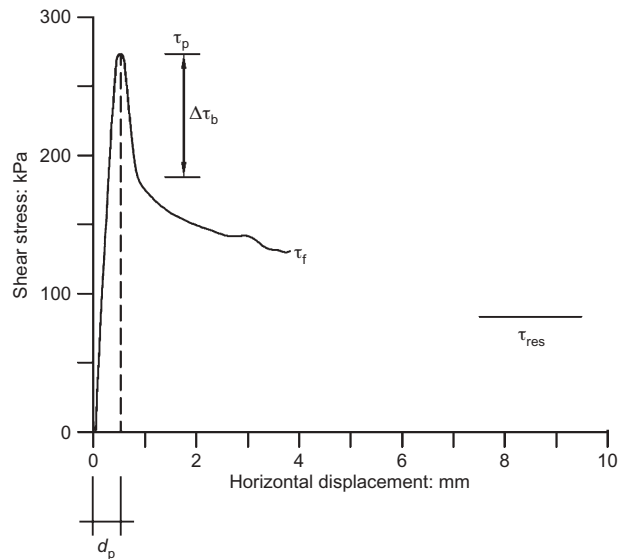
(a) All the specimens exhibited a brittle behaviour. Peak strength was found for displacements of 0.5–1.5 mm (for a range of vertical stresses of 100–400 kPa). Beyond peak the strength initially drops rapidly, then more gradually. This behaviour is illustrated in Fig. 36 for one of the specimens tested. This behaviour will be described by the following parameters: peak strength, τ_p ; displacement to reach the peak, d_p ; strength at the end of the test (for a displacement of 4–6 mm), τ_f ; rapid drop of resistance post-peak: $\Delta\tau_b$. An additional reference strength, the residual strength τ_{res} , may be calculated for a given vertical stress once the residual friction angle is known. As shown later, a representative value $\phi'_{res} = 11^\circ$ was found for this clay. Two brittleness indices are used: $I_f = (\tau_p - \tau_f)/\tau_p$ and $I_B = (\tau_p - \tau_{res})/\tau_p$. I_B is the definition proposed by Bishop (1967). It is clear that $I_B > I_f$. In addition, a measure of the rapid loss of strength after the peak is given by the cementation loss indices, $CL_f = \Delta\tau_b/(\tau_p - \tau_f)$ and

Fig. 36. Direct shear test on specimen of foundation clay from sample M3, borehole S3-1 (depth 39.20–40.1 m): normal effective stress 400 kPa

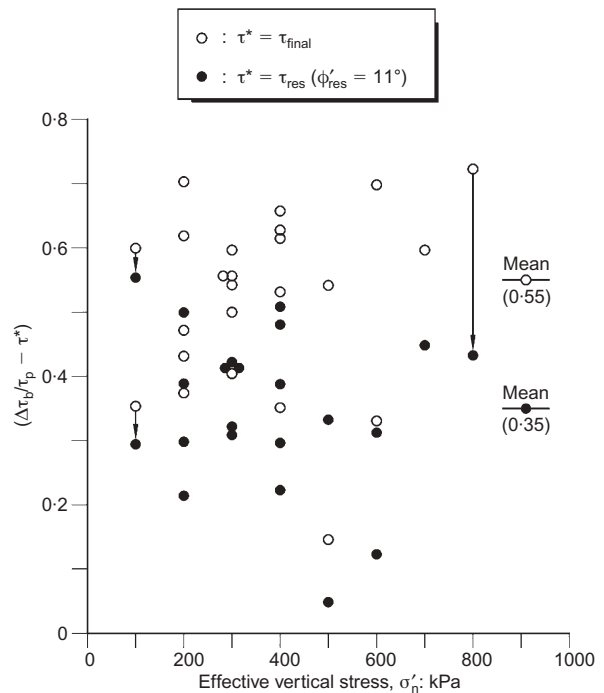
(b) The ‘cementation loss’ indices are plotted in Fig. 37, for all the specimens tested, against the vertical stress. No apparent effect of vertical stresses is observed. Average values are very significant ($\bar{CL}_f = 0.55$; $\bar{CL}_B = 0.35$). They indicate that a large proportion of the peak strength is lost immediately. If the residual strength is taken as the final reference minimum strength value, it is suggested that 35% of the loss of strength after peak is due to the loss of cementation, and a further reduction of 65% is associated with changes of the fabric of the clay (particle reorientation).

Fig. 37. Normalised loss of strength of foundation clay, immediately post-peak, as a function of vertical stress

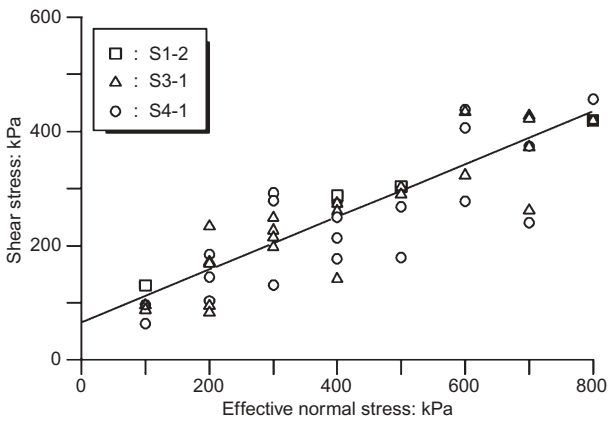
Fig. 41. Drained peak strength envelope for Guadalquivir blue clay

strength on horizontal planes corresponds to the clay matrix. Measured peak strengths are plotted in Fig. 41 in a Coulomb diagram. Some scatter is observed. Average peak strength values correspond to the drained parameters $c' = 65$ kPa, $\phi' = 24.1^\circ$. If the strengths measured at the end of the direct shear test (for displacements of 4–6 mm) are considered, an average limiting curve $c' = 0$ kPa, $\phi' = 20^\circ$ is obtained.

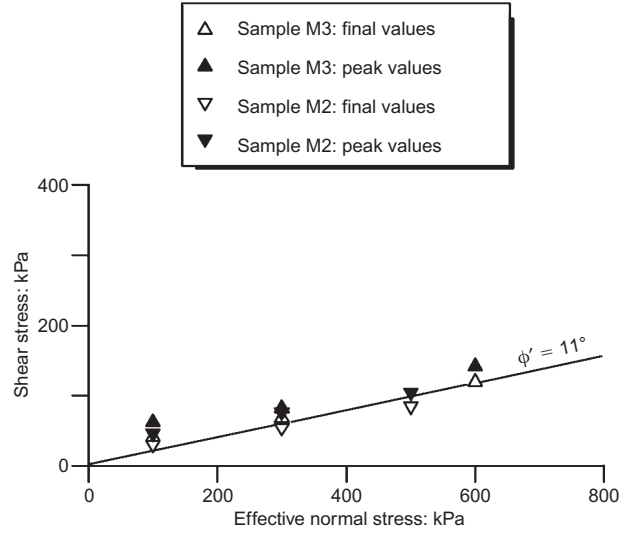
Fig. 43. Summary of direct shear tests performed on two natural discontinuities of the clay

Natural joints found on the large clay blocks deposited by the mudflow (Fig. 12) were tested in the shear box. The discontinuity was aligned with the shearing plane of the box. Several reversing cycles were applied, and displacements in excess of 60 mm were achieved. For vertical stresses in the range 200–400 kPa a friction angle $\phi'_{res} = 11^\circ$ was found (Fig. 43).

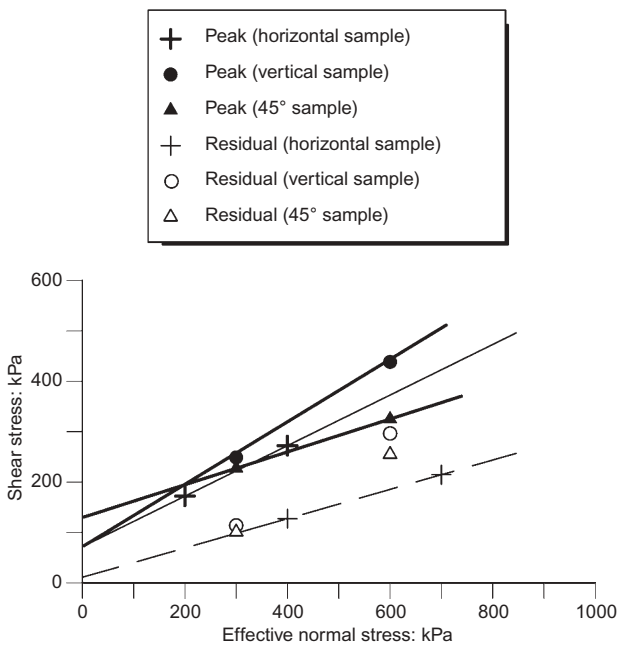
Fig. 42. Shear strength measured in inclined samples of foundation clay

- (e) Several specimens were tested along planes inclined at 45° and 90° with respect to the horizontal. The results are collected in Fig. 42. No clear indication of anisotropy of the clay matrix was found, so it is possible that peak parameters determined for horizontal shearing may represent average peak strength.

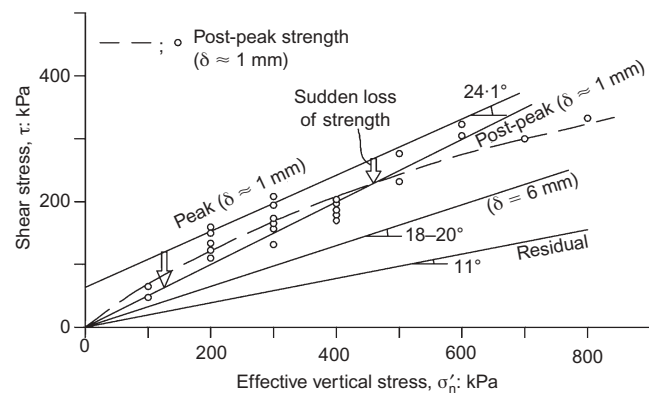
Fig. 44. Direct shear strength envelopes of foundation clay

The results of all direct shear tests performed on horizontal planes are summarised in Fig. 44. The average peak strength is obtained for a shear displacement of 1 mm. The open symbols in the figure correspond to the strength measured immediately after the peak at essentially the same displacement. The curved strength envelope is a reasonable approximation to the measured values. A straight line is also fitted to the points. The important result is that the sudden loss of strength results in a destruction of the effective cohesion. An accumulation of shear displacements of 6 mm implies a drop of friction angle down to $18\text{--}20^\circ$. Finally, the residual friction envelope, associated with further additional displacements, is also plotted in the figure.

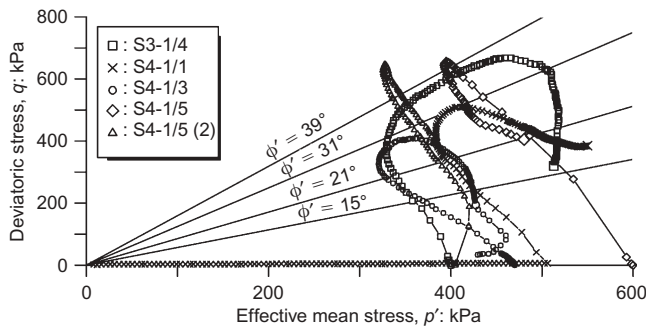
Fig. 45. Stress paths measured in isotropic undrained triaxial tests

Several isotropically consolidated undrained tests were performed in a stress-path cell. Peak strengths correspond to friction angles in the range $\phi' = 31\text{--}39^\circ$ (Fig. 45). For the final conditions (vertical strains in excess of 20%), the friction angle drops to $15\text{--}21^\circ$. The maximum values of Skempton's A -coefficient ($A_{max} = 0.7; 0.45; 0.24; 0.49; 0.8$) reflect a moderate contractant behaviour before the onset of dilatancy. Near the peak some dilatancy develops, and the final A values indicate this change ($A_f = 0.6; 0.35; -0.03;$

0.20; 0.55). The 'elastic' value of $A = 0.33$ is probably a reasonable average value. Elastic moduli measured at relatively low strains ($\epsilon_z = < 2 \times 10^{-3}$) were in the range 55–115 MPa for confining stresses varying from 400 to 600 kPa.
