Aznalcóllar dam failure. Part 2: Stability conditions and failure mechanism

A. GENS* and E. E. ALONSO*

An analysis of the conditions that led to the failure of the Aznalcóllar dam is made in the paper. Pore water pressures prevailing in the foundation clay at the time of the failure have been established on the basis of piezometric observations made after the failure. A simplified consolidation analysis is first presented to interpret pore water pressure generation and dissipation and to evaluate the evolution of shear stresses along the potential failure plane. Both limit equilibrium and finite element analysis are used to back-analyse the failure and to derive representative strength parameters along the failure surface. Three-dimensional effects introduced by the layered nature of the foundation clay are then described. They provide an explanation for the location of the slide, which affected only the south-eastern portion of the embankment. The failure is examined in the final part of the paper from the perspective offered by the current knowledge of the strength behaviour of brittle clays. The significance of progressive failure is discussed, together with other factors that

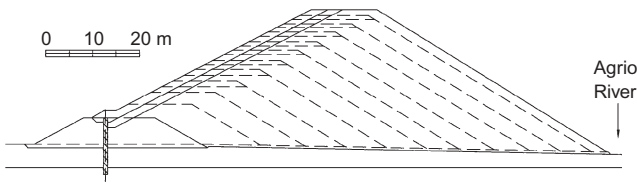
Fig. 1. Original dam design

The dam was initially designed in 1978. A representative cross-section of the initial design is shown in Fig. 1. A small upstream embankment is first constructed. Then a bentonite-cement wall, which penetrates into the blue clay, is built to provide an impervious barrier. The dam was to be built in phases of increasing height, advancing in the downstream direction. The structure is actually a rockfill dam with an upstream impervious blanket of low-plasticity red clay. This blanket is connected with the vertical cement-bentonite upstream diaphragm wall. Upstream and downstream slopes

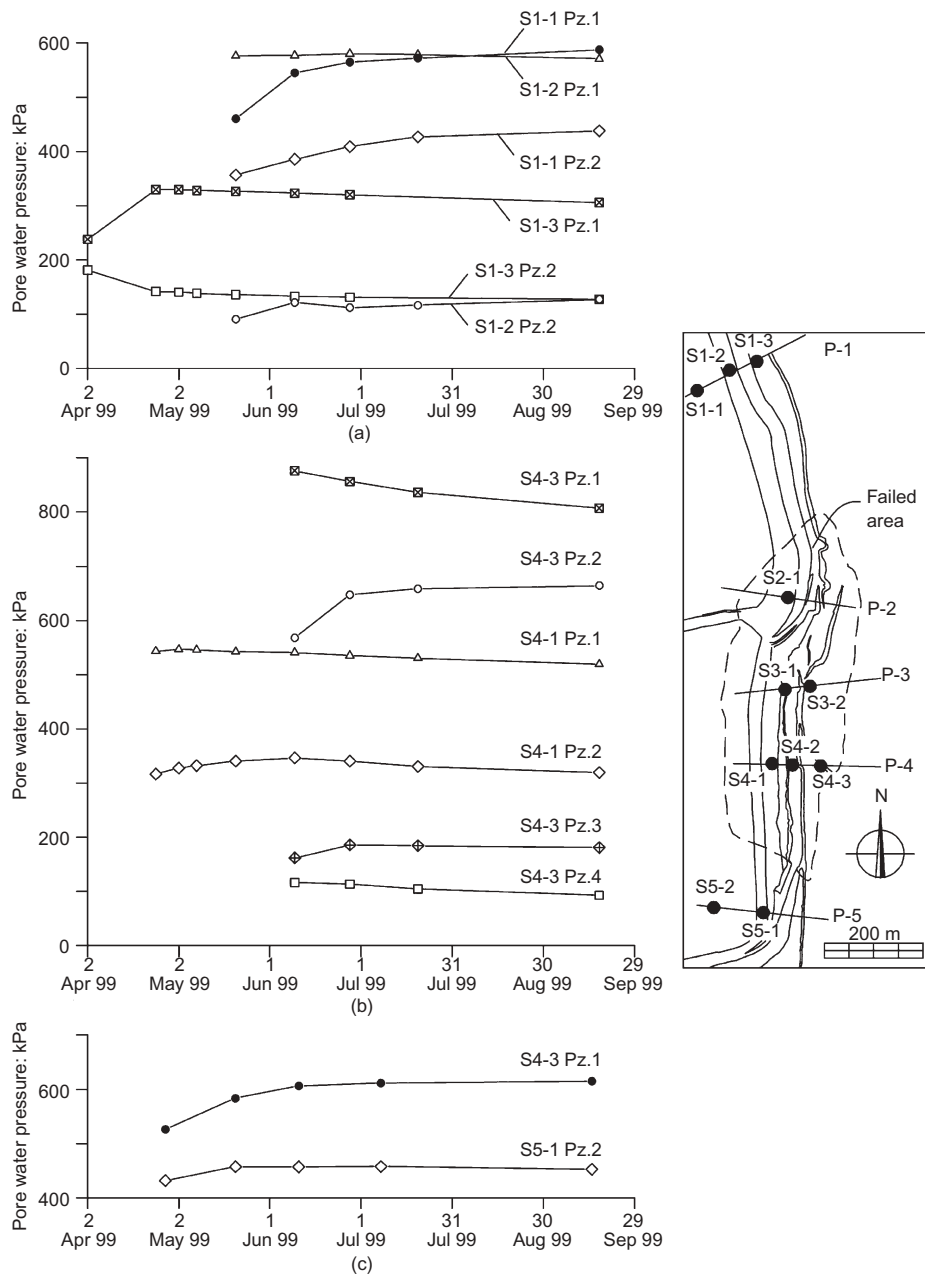
Fig. 4. Evolution of pore water pressure in piezometers located at different depths in boreholes corresponding to: (a) Profile 1; (b) Profile 4; (c) Profile 5

Fifteen vibrating wire piezometers were installed in boreholes drilled after the failure. Readings started in April–May 1999 and rapid equilibration, in general, followed (Fig. 4). Piezometer sensors were located in 1 m long sections of the corresponding boreholes, filled with saturated sand. The

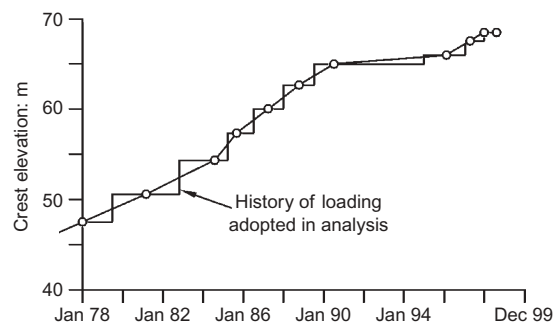
Fig. 7. History of dam construction in terms of elevation of crest and incremental sequence used in calculations

Figure 7 shows the evolution of the embankment at the failed section and the sequence of loading increments adopted in the calculations. The same history of dam elevation applies, with minor variations, to Profile 1, within the unfailed embankment, north of the breach. Data in Figs 3 and 7 define the developing geometry of the embankment from January 1978 to the time of failure, in April 1998. The level of tailings followed the embankment height, the level

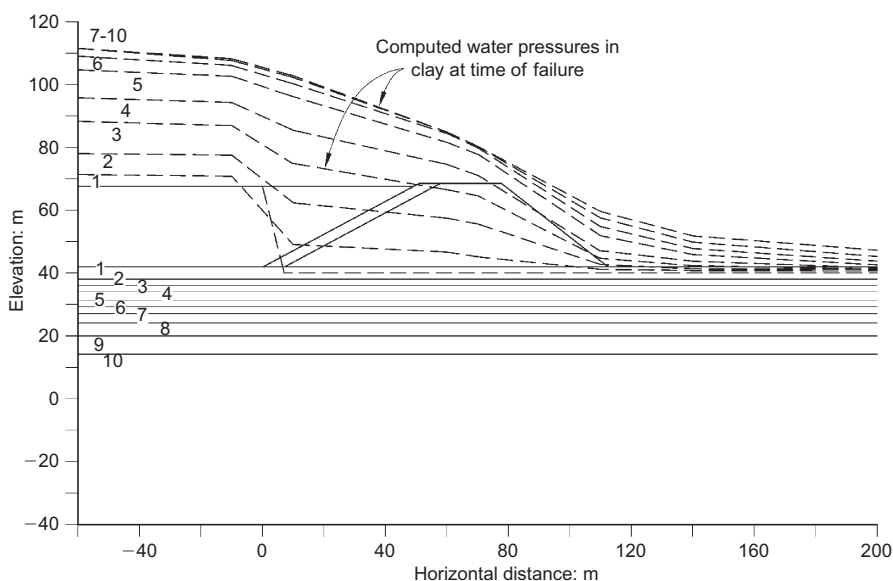
Fig. 12. Embankment geometry and pore water pressures used in limit equilibrium calculations

Despite their limitations, several limit equilibrium analyses were performed with the purpose of gaining additional information on the failure mechanism. In addition, they provide a useful link with engineering practice. Two stability methods were used: Simplified Bishop, for circular surfaces, and Morgenstern–Price, for more general cases. The consolidation analysis reported previously was used to approximate the distribution of pore water pressures in the upper levels of the foundation clay. The impervious cut-off affects the distribution of pore water pressures because it controls the boundary conditions for the dissipation of excess pore water pressures. The program SLOPE/W was used in all cases. The geometry used for the embankment immediately before failure is shown in Fig. 12. A free level of water, 0.5 m in thickness, exists over the tailings level. The clay is divided into a number of horizontal layers to facilitate the definition of different pore water pressure profiles. The water level in the upper alluvium is given by a phreatic level located at the top surface. The rockfill of the dam is fully drained. Soil properties are given in Table 1.

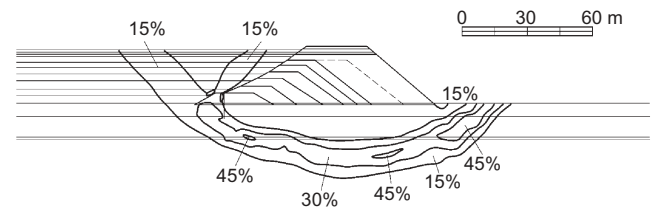
Fig. 13. Contours of equal shear strain calculated at failure in a 2-D elasto-plastic finite element analysis: homogeneous clay

If peak strength parameters are adopted for the clay ($c' = 64$ kPa; $\phi' = 24^\circ$) no plastic points are calculated for the future rupture zone during the whole construction process. It is concluded that, in order to explain the embankment failure, some zones within the clay exhibited reduced strengths. In order to simulate a failure, a progressive reduction of strength parameters is introduced. In this way, the rupture mechanism shown in Fig. 13 is found (contours of equal shear strains are represented). A circular failure is predicted (as in the limit equilibrium type of analysis for homogeneous clay properties).

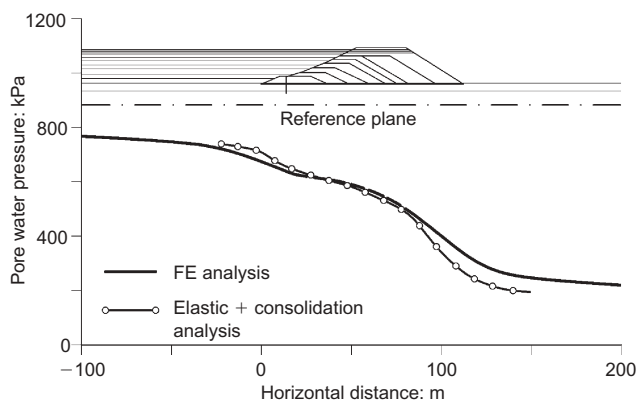
Fig. 15. Distribution of pore water pressures along failure surface (reference plane): comparison of FE and simplified elastic-consolidation analysis

This FE analysis also provided data relating to the evolution of pore water pressures in the foundation. Fig. 14 shows the distribution of pressures at the end of the calculation (just prior to rupture). Note the substantial influence of the heavy tailings and the very limited dissipation of pore pressures. A profile of water pressures along the future failure plane is shown in Fig. 15. The FE prediction is compared with the result of the elastic-consolidation analysis reported before. The correspondence is very good.

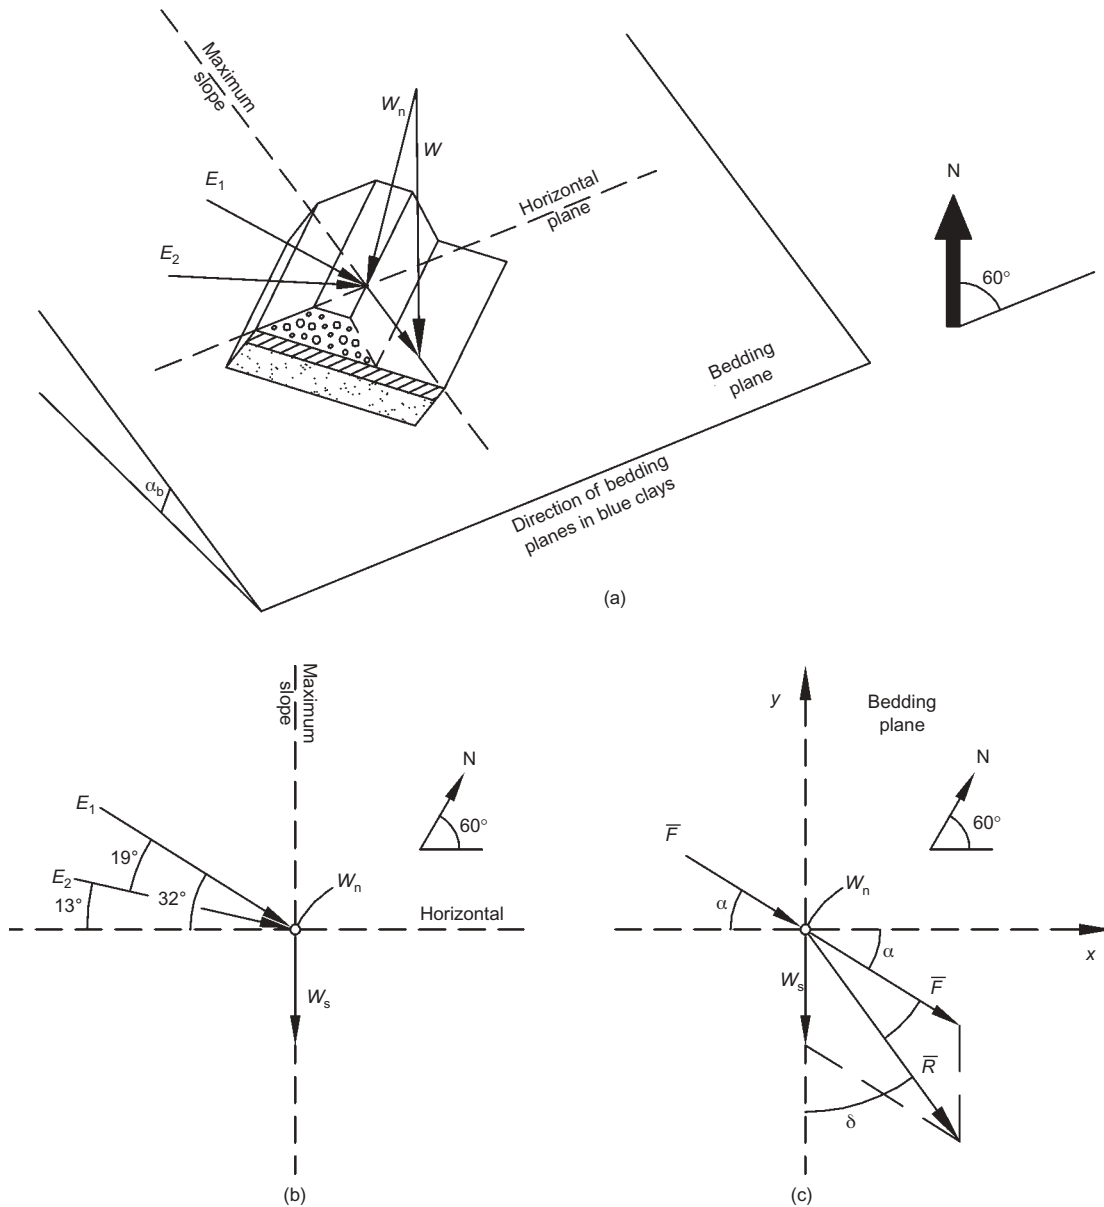
Fig. 19. (a) Three-dimensional scheme of slice of embankment sliding on a bedding plane; (b) forces acting on slice; (c) resultant force

These effects are analysed using a simple three-dimensional interpretation of the slide. Consider in Fig. 19 a free body diagram showing a slice of the failed embankment sliding on the critical bedding plane. The following reference axes need to be considered: the apparent dip of 0°; the true dip; and the normal to the bedding plane. The external acting forces controlling the stability are also shown: the weight, \bar{W} , of the embankment (and the moving foundation soil) and the tailings' thrust (\bar{E}_1 or \bar{E}_2). \bar{W} has two components, \bar{W}_n and \bar{W}_s , in the normal and tangential direction to the bedding planes. \bar{E}_1 corresponds to the southern basin, whereas \bar{E}_2 is the thrust direction in the northern lagoon. In both cases they are assumed to be normal to the embankment direction and parallel to the bedding planes. These forces are plotted in Fig. 19(b). If the resistance offered by the sliding plane is purely frictional (friction angle ϕ'), equilibrium in the sliding plane requires

The direction of the motion may be also obtained. In equilibrium, and given that the sliding mechanism is purely frictional, the motion direction will follow the resultant disturbing force: $\vec{R} = \vec{F} + \vec{W}_s$. The sliding direction is indicated, in Fig. 19, by angle δ .

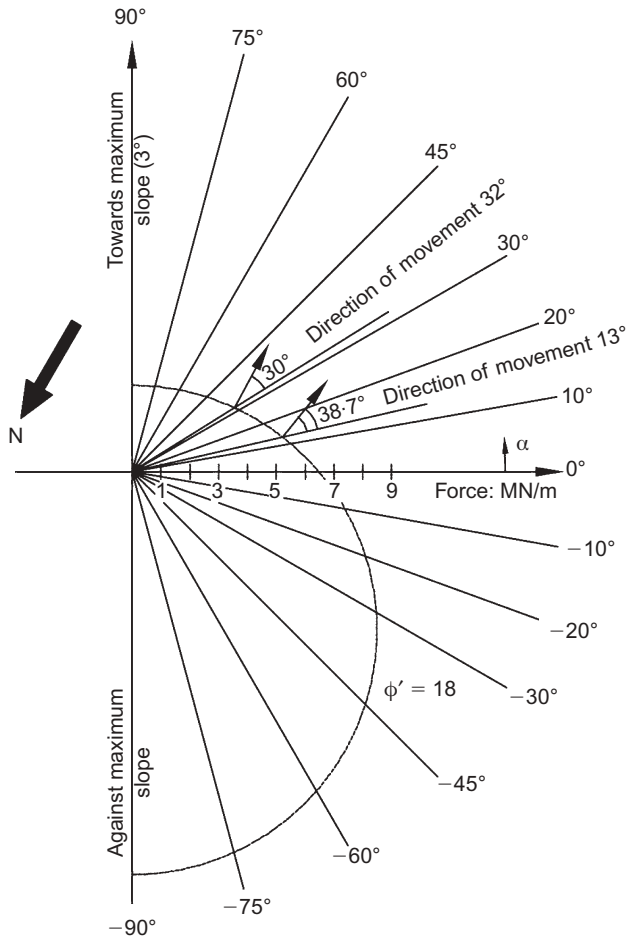
Fig. 20. Polar force diagram for equilibrium conditions

Equation (3) has been plotted in Fig. 20 as a polar diagram showing the variation of the force F in equilibrium as a function of the direction of the force, defined by α . The remaining variables in equation (3) (weight W , dip of strata $\alpha_b = 3^\circ$, water pressure resultant U , and friction angle $\phi' = 11^\circ$) are known. Two directions are particularly relevant in Fig. 20: $\alpha = 13^\circ$, representative of the northern embank-

ment; and $\alpha = 32^\circ$ for the southern basin. The corresponding forces for equilibrium are 5.27 MN/m and 4.11 MN/m respectively. In other words, if the tailings lagoon is pushing the embankment with an overall force of 4.11 MN/m, the southern embankment becomes unstable, whereas the northern embankment still has a 'safety factor' of 1.28 against sliding. This result makes it very unlikely that the northern embankment could have failed first. The displacement vectors, once sliding is initiated, are also plotted in Fig. 20. Note that they do not follow the direction of thrust but are directed towards the true dip direction of clay layers. This is consistent with observations of the sliding direction of the failed embankment. The force diagram plotted in Fig. 20 may also be interpreted as the macro yield locus for the sliding of the embankment on an inclined plane. The radius of the circle is the frictional resistance $(W - U)\tan\phi'$. The yield circle is defined by displacing the purely frictional circle, valid for a horizontal plane, a distance $W\sin\alpha_b$ in the direction of the maximum slope of the clay strata. In other words, the inclination of the strata results in a kinematic hardening in the direction of their maximum slope. The

sliding direction is normal to the yield locus defined in this way, as shown also in Fig. 20.

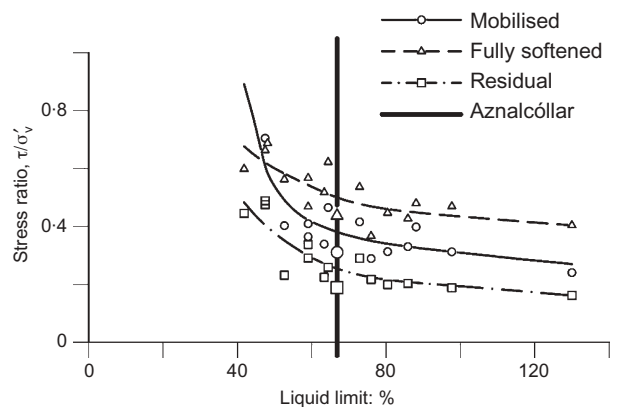
Fig. 21. Mobilised, fully softened and residual stress ratio for field case histories (Stark & Eid, 1994). Also plotted are calculated values for Aznalcóllar failure

Stark & Eid (1994) reviewed case histories involving first-time slides in stiff fissured clays, reported the value of the mobilised strength at failure, and compared it with two strength values: the fully softened and the residual value. Such a comparison is shown in Fig. 21. It can be seen that in most instances the mobilised strength at failure lies about midway between the ‘fully softened strength’ and the residual strength.

The results obtained for the Aznalcóllar embankment yield a value of R approximately equal to 0.76 if the peak strength of the intact material is considered. However, if the failure initiated along a bedding plane, the post rupture strength may be more relevant as the initial strength of the material. In that case, the mobilised friction angle ($\phi'_{mob} = 17^\circ$) lies approximately half way between the post-rupture friction value ($\phi'_p = 24.1^\circ$) and the residual value ($\phi'_r = 11^\circ$). Therefore the value of R is 0.46. The post-rupture, mobilised and residual stress ratios have also been plotted in the graph published by Stark & Eid (1994) in Fig. 21, for the corresponding liquid limit of the Guadalquivir blue clay (identifying for this purpose post-rupture strength with fully softened strength). One should be careful, however, in accepting it as a well-established fact that this average can be used in design, as a number of case-specific factors, already mentioned, control the development of progressive failure.
