Damage survey and collapse mechanisms due to seismicity in Gothic Churches around Catalonia region and Mallorca

Master's Thesis

Supervisor(s): Pere Roca Fabregat

Year: 2010

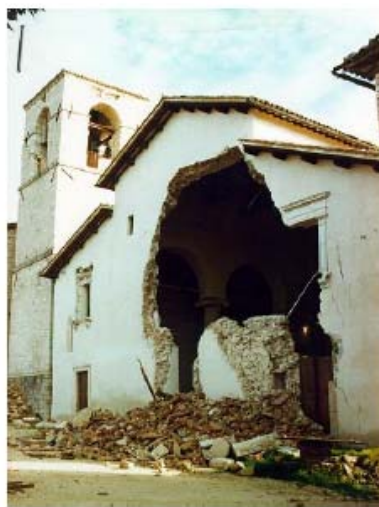
Figure 5 – Collapse of exterior wall of S.Maria Assunta following an earthquake

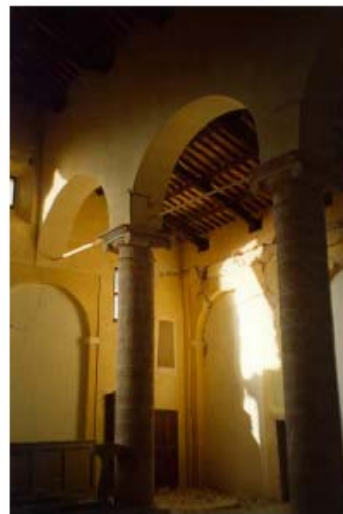
Figure 6 – The cracks due to earthquake in the interior facades of S.Maria Assunta (Lagomarsino, S. 2006)

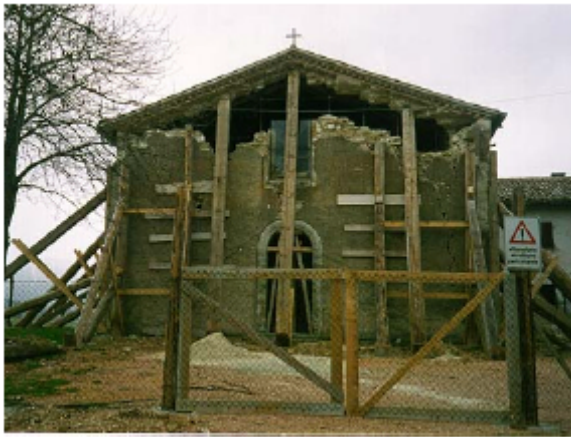
Figure 7 – Collapse of the upper part of the facade in S.Stefano Church in Umbria

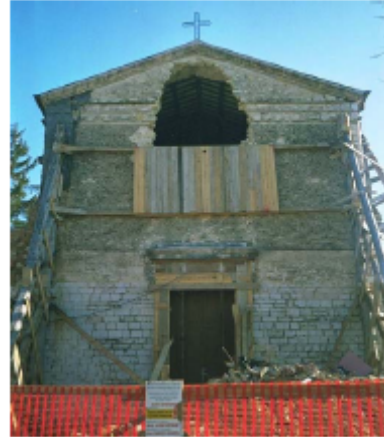
Figure 8 – Damage on the upper part of the facade in S.Silvestro, Sellano (Lagomarsino, S. 2006)

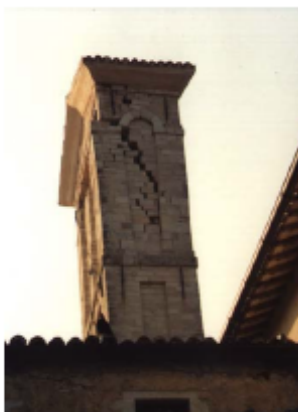
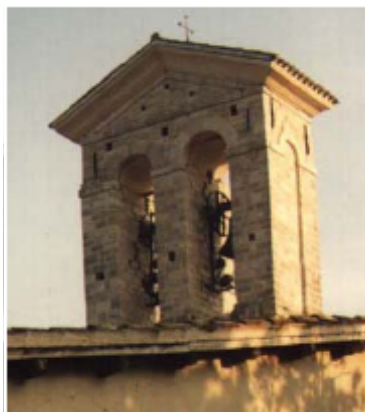
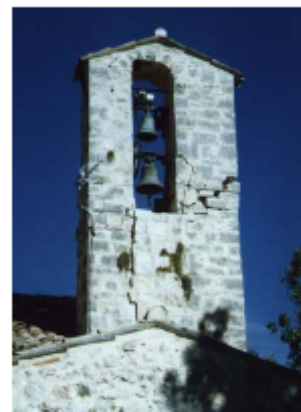
Figure 9 – Damage on the Bell Towers (S.Maria di Constantinopoli, S.Giovanni Battista, Cerreto di Spoleto (G. Augusti, G., Ciampoli, M. and Giovenale, P. 2005)

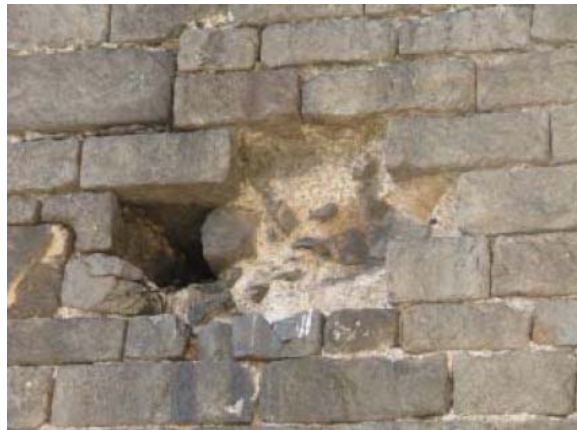
Figure 41 – The holes due to bombing revealing the morphology of the masonry wall

The typology of the bearing walls can be inspected visually without any need of an NDT thanks to the help of the previous damage occurred due to the bombing happened during the war both in 18th and 20th centuries. The exterior leaf of the wall has a thickness of one masonry block (approximately 18 × 13 × 17 cm) while the interior leaf of the wall has the same thickness. The rubble infill is thicker comparing to the exterior and interior leaves (a thickness of 55 cm).

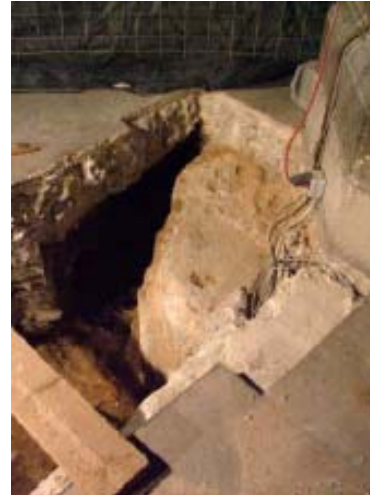
Figure 49 – The pre existing occurrences in the foundations

GPR and similar techniques showed that some existing constructions lay below the ground level of Santa Maria Del Mar Church.

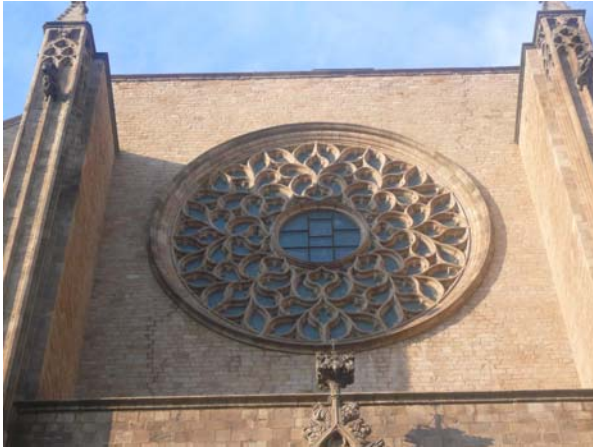
Figure 53 – The rose window which was restorated after the collapse

There is also evidence of an important earthquake in 1428 that caused the partial collapse of the rose window of the façade, killing 25 people. This piece was restored in 1459.

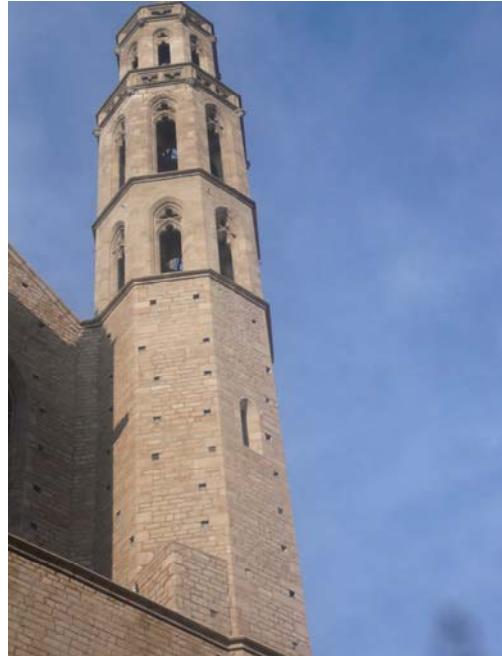
Figure 54 – The bell tower which was reconstructed

There is an evidence of two events causing damage in the structure during construction process. The first one is an earthquake occurred in 1373 caused the partial collapse of the Eastern tower.

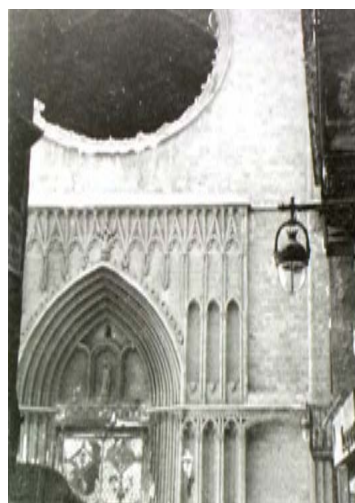
Figure 58 – An old picture showing the damage after fire in 1936

The first construction works started in 1319 and the church which was designed with Catalan Gothic characteristics started to be built. Although some of the components that exist at present especially the interior timber structures are the restored versions of the original ones which were destroyed in the big fire that occurred in 1936, the structure still keeps its integrity.

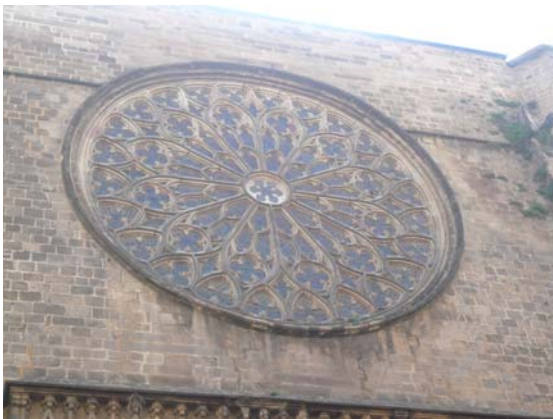
The most important restoration that Santa Maria Del Pi has encountered happened in 1940 right after the big fire that destroyed the rose window in 1936. The restoration process consists of the rebuilding of the rose window again.

The damage still visible on the structure is related to the earthquakes that occurred in the year of 1428.

Figure 72 – The exterior view of the rose window

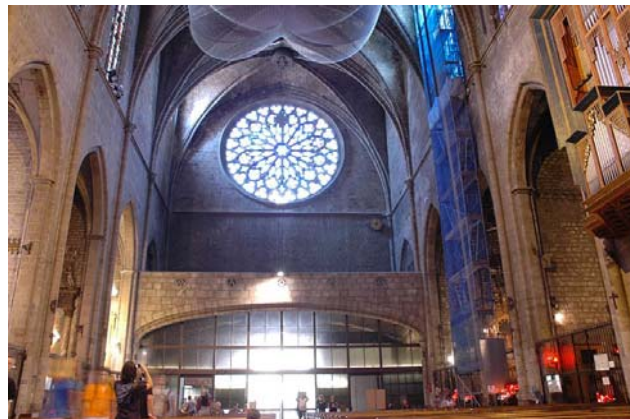
Figure 73 – The interior view of the rose window

Apart from the structural damage which will be explained later, the building has deterioration due to the different reasons. The main deterioration is the discoloration and black crust that are visible especially on the exterior facades. Lack of maintenance and the previous fires are among the possible reasons of these problems.

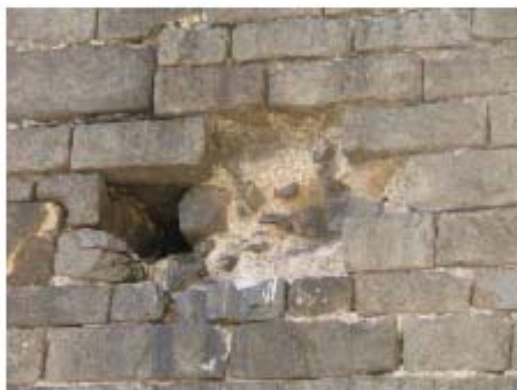
Santa Maria Del Mar still carries the effects of the Civil war period. The holes as a result of the bombing are still visible on the facades. These holes are the results of the years 1714, 1936 and 1939. The vegetation and the small plants with their roots are causing damage on the stone surfaces especially on the buttresses and the upper levels of the facades. Discoloration is also observed as a result of humidity affecting the stone material especially on the facades.

Figure 116 – The view of the holes due to the bombings during Civil War (Caballe, F., Giraldez, P., Gonzales, R., Roca, P. Vendrell, M. 2007)

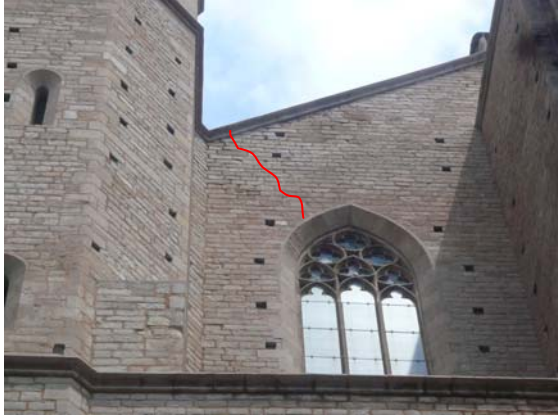
One of the general problems in the cathedral is mainly the vertical and diagonal cracks which can be traced both interior and exterior façades.

Figure 117 – The repaired crack on the main facade

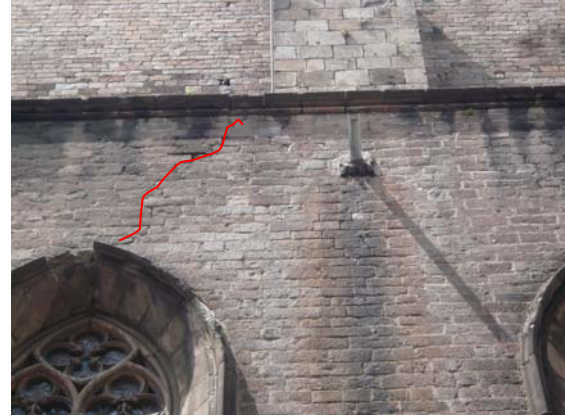
Figure 118 – The inclined crack on the façade

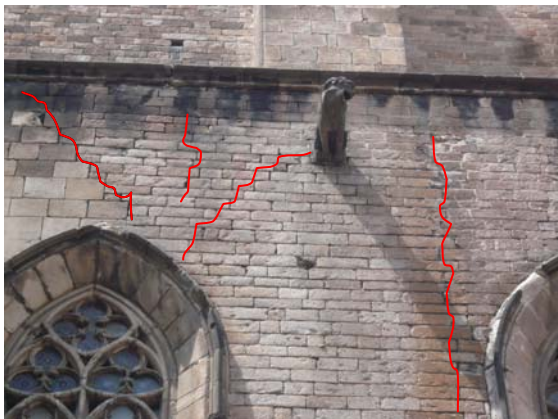
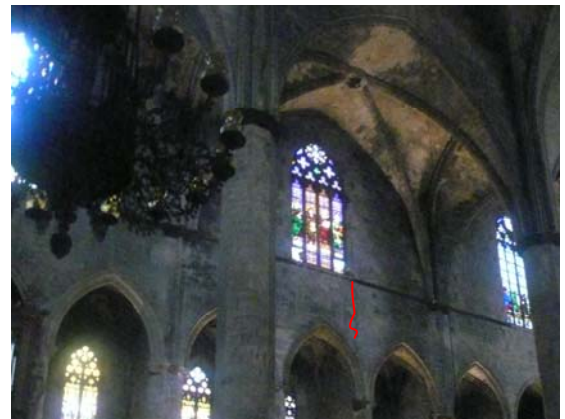
The crack pattern shows a similar behaviour generally in the building. Most of the cracks are usually visible starting from the lower level of the window and extending until the upper level of the arches of the side chapels. The cracks generally tend to appear diagonally following the mortar joints. The damage is more common on the apse part where the construction seems to have experienced some interventions in time. These interventions can be traced by the different construction technique and the material of the walls on the right direction of the apse entrance.

Figure 119 – The cracks following the joints on the exterior and the interior façades

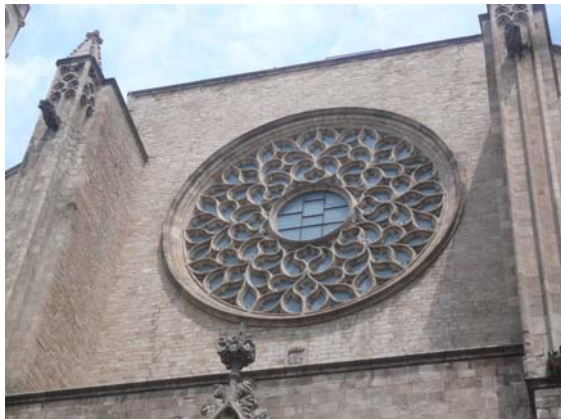
The diagonal cracks concentrate on the main facade where the rose window is located. Two cracks which can be assumed as almost symmetrically corresponding each other are visible starting from the lower part of the rose window extending through and crossing the sill that defines the lower level of the stained glass windows on the upper level. The other crack almost in the same level shows a pattern similar to those two cracks closer to the one on the right finishing on the level of the sill.

The upper crack extends until the centre of the main arch. This crack is also diagonal.

Figure 120 – The cracks around the rose window

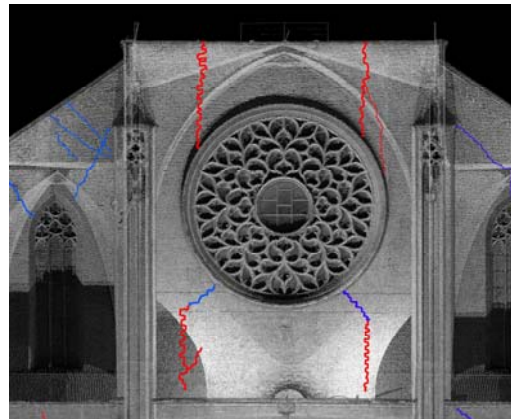
Figure 121 – The crack pattern on the exterior façade around rose window

The vertical or inclined cracks which are visible under and above the openings could possibly be due to the earthquake and it can be explained as they made it possible to dissipate the seismic energy by cracking. If the possible reasons of these cracks are likely the earthquake, these cracks indicate that they prevented further damage in structural components in general.

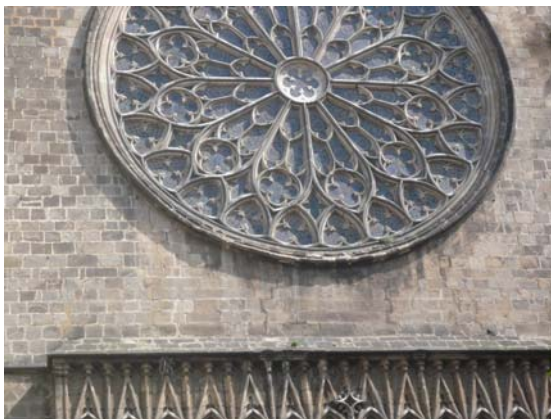
There is a set of cracks on the main façade especially around the rose window. The inclined cracks following the joint mortars are located in the lower level of the rose window. Similar types of cracks are lying on top of the rose window. Some of these cracks are already repaired and it is possible to see the opening of some of these cracks in a low degree. The extending cracks are also visible along the façade between the towers and the main body. This separation is one of the most important problems of the structure.

Figure 130 – The structural cracks under the rose window

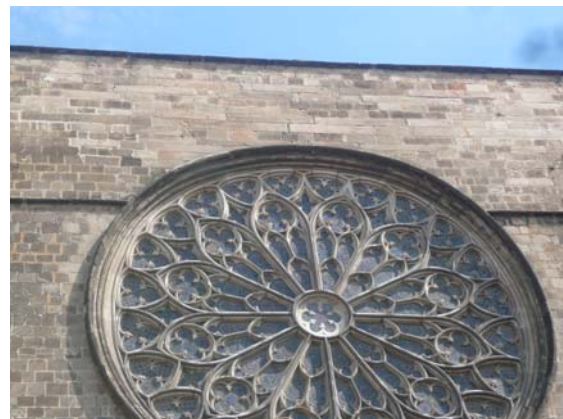
Figure 131 – The reconstructed part and the cracks above the rose window

The upper part of the rose window shows a different pattern. It is obvious from the difference on the stone material that this part has been reconstructed before.

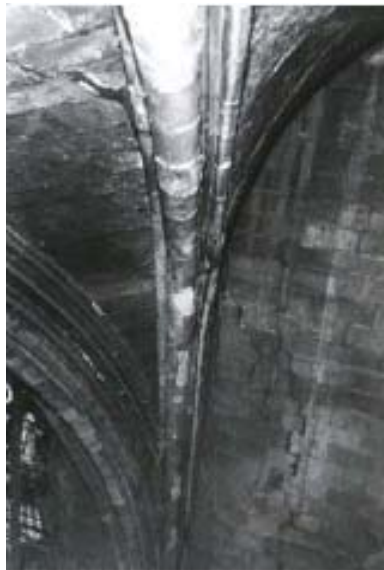
Some of the arches and vaults have in plane deformations. The differential settlement of the two sides of the structure may have a contribution on the asymmetrical deformation of these arches and vaults. Some of the arches have lost the original shape in its plan configuration. The possible reason for these types of deformations may be related to the construction processes.

Figure 134 –The deformation of the arches (Caballe, F., Giraldez, P., Gonzales, R., Roca, P. Vendrell, M. 2007)

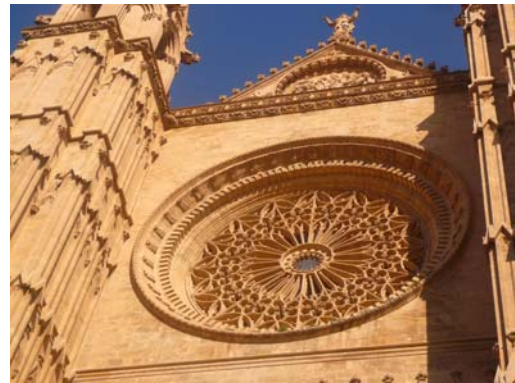
Figure 142 – The rose window on the front façade

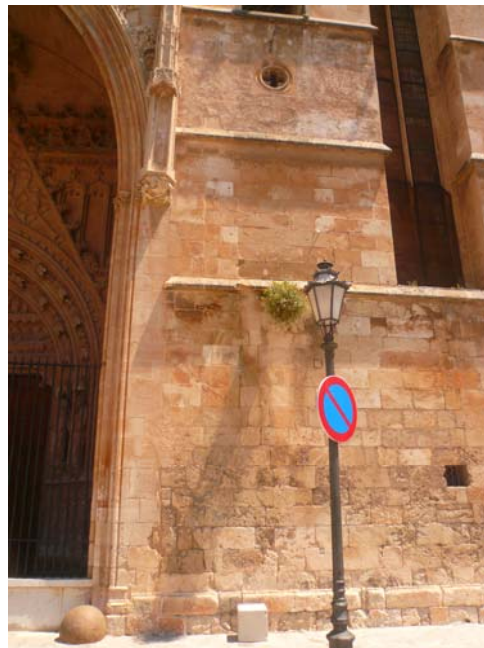
Before mentioning about the structural damage, it can be concluded that there is a general problem regarding the vegetation that especially influence the east and south façades where the restoration works have not been extended to. Discoloration on the stone units and loss of material is also observed.

Figure 144 – The vegetation on the façade

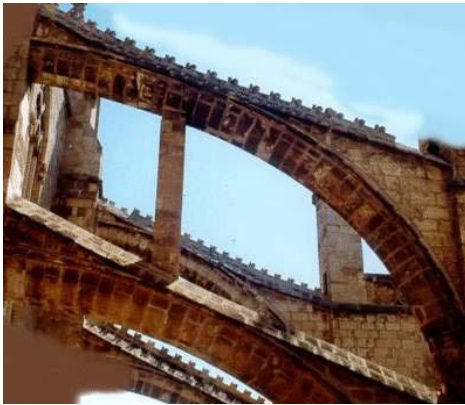
The reports on the previous works show that first significant problem is visible on the piers. The masonry piers show a curvature and lateral displacement in both directions (longitudinal and transverse) of the nave. Some cracks are visible on some piers. These cracks are mainly vertical shaping surface wedges partially expelled from the core of the pier. Significant deformations are visible on the flying arches. There are some signs showing the possibility that some of the flying arches were propped by some masonry columns and walls in order to prevent their possible failure. The cracks developed in the contact area of the transverse arches and the vaults of the central nave separated with each other by wide cracks (Das, K.A. 2008).

Figure 145 – The prop ups between the flying arches

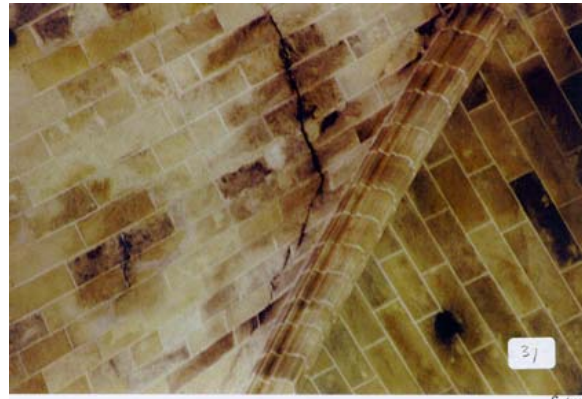
Figure 146 – The cracks on the vaults (Eu India Economic Cross Cultural Programme. 2003)

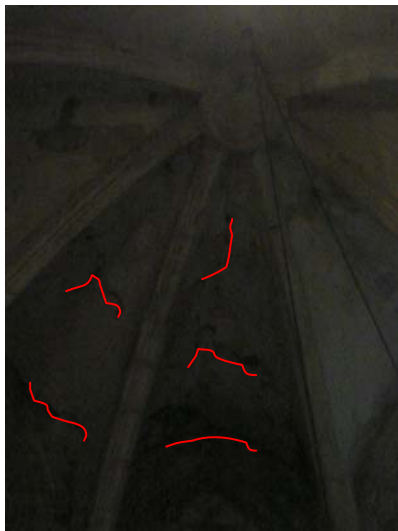
The chapel located next to this entrance shows the signs of the previous alterations. The plastered interior surface of the chapel shows deep inclined cracks in various parts. The plaster seems to have a cement based character.

Figure 147 – The cracks on the plastered chapel

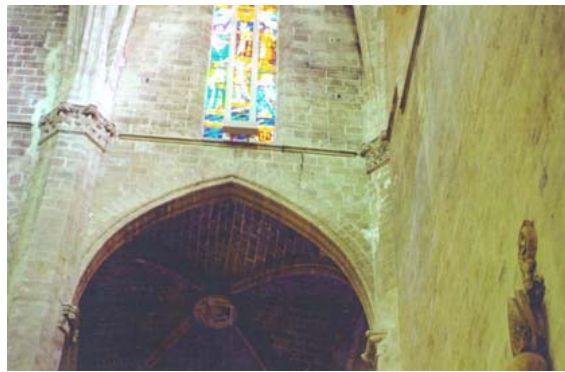
Apart from these problems, the most significant problem of the cathedral is the symmetrical inclined cracks. The cracks are located on the lower part of the stained windows located over the chapels and extend to the frontal lateral wall. On the right side of the entrance, there is also one extending and one repaired crack located on the sides of the stained glass windows between the two first chapels. The deformation regarding the out of plumb of the front façade is visible on both sides of the main entrance from interior. Two extending cracks going up to the rose window are located on both sides of the main entrance door from interior façade.

Figure 150 – The inclined symmetrical cracks extending to the front façade

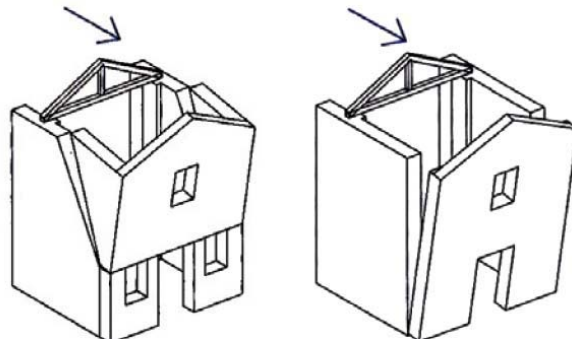
The vertical cracks that are visible on the frontal façade and around the rose window are important to activate this kind of failure mechanism.

These cracks are among the most important reasons why this mechanism should be taken into account. These cracks can activate this type of mechanism. But since the cracks seem like they have not reopened after the restoration in 1994, this mechanism is not the dominant mechanism that is likely to happen.

Figure 156 – Collapse Mechanism- Overturning of the Façade

The main indicatives and the abacus how the collapse mechanism would be expected to occur was shown on Fig. 156

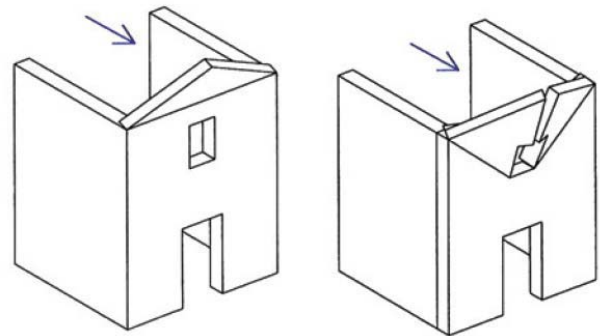
The reasons of these types of damage may be the differential settlements of the lower part of the façade and the superstructure. The differences in thickness of the wall through the height can trigger this phenomenon.

The repaired cracks around the rose window and the historical information regarding the collapse of this rose window after the earthquake of 1428 are the data that leads to the possibility of taking into account of this type of mechanism.

Figure 160 – Collapse Mechanism- Overturning of
the Upper Part of the Façade

already had damaged before are among the arguments to prove that these type of failure should be taken into account. The scheme of the failure mechanism was displayed in Fig. 160

It is possible to see the general view of the collapse mechanism in Fig.160

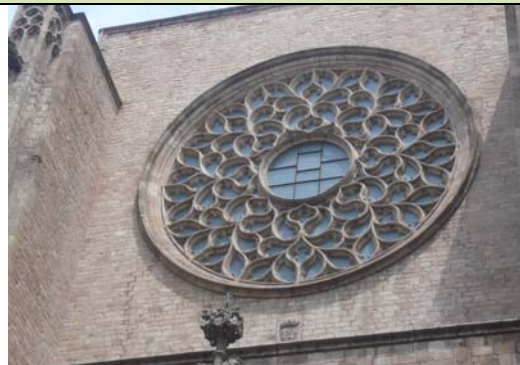
Figure 161 – The damage around the rose window

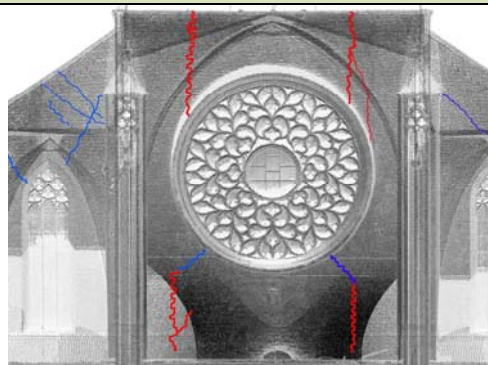
Figure 162 – The crack pattern on the upper part of the façade

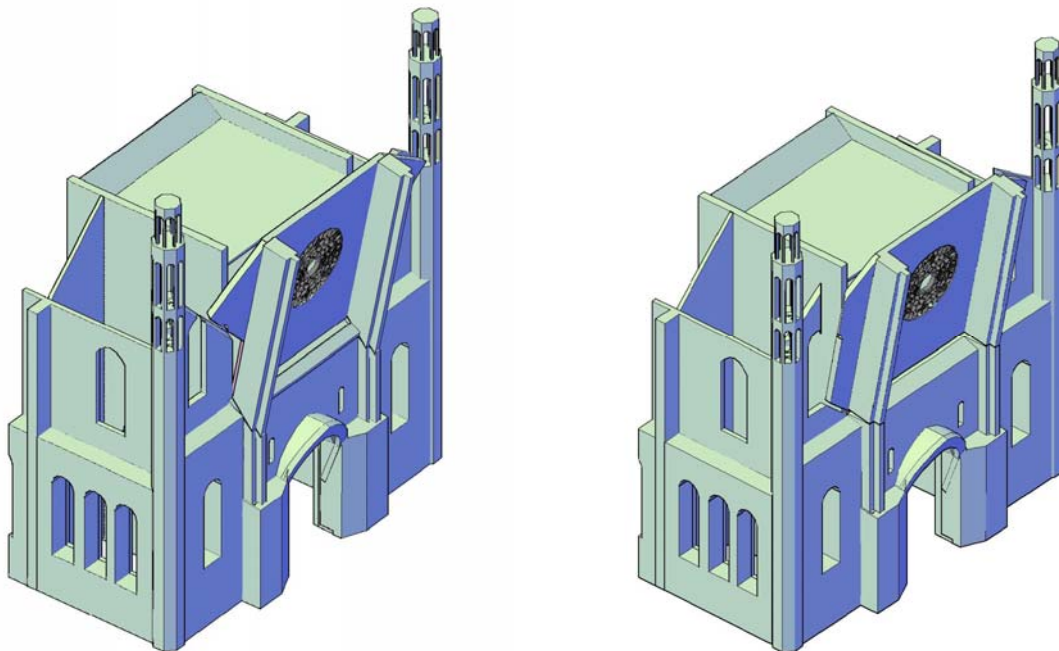
Figure 163 – The model of the collapse mechanism- Overturning of the upper part of the total façade

In the figure 163, the possible collapse mechanisms are shown. The model on the right shows a mechanism more likely to happen in terms of the damage observed.

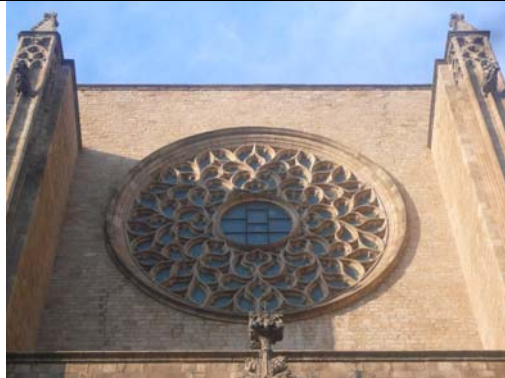
The existing damage pattern shows extending cracks on the upper part of the rose window. These cracks constitute a weak part on the opening and it should be considered among the vulnerable parts in case of an earthquake.

Figure 164 – The damage on the upper part of the rose window

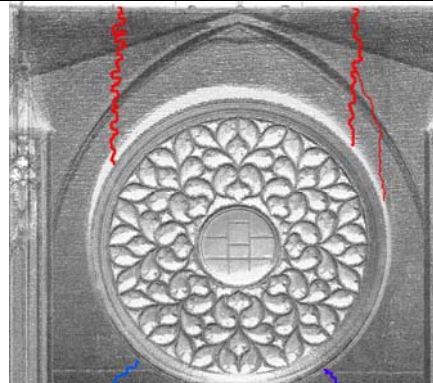
Figure 165 – The crack pattern on the upper part of the façade

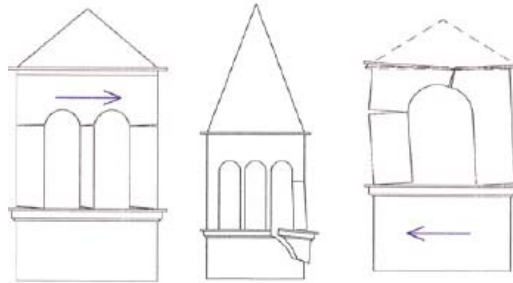
- The historical information about the partial collapse of the bell tower in 1373.
- The crack pattern which can be interpreted as a possible path for the possible tendency of separation of the tower from the part where the cracks are visible around the opening on both sides of the frontal part.

Figure 167 – Collapse Mechanism- Separation of the bell tower

The abacus of the mechanism was shown in Fig. 167

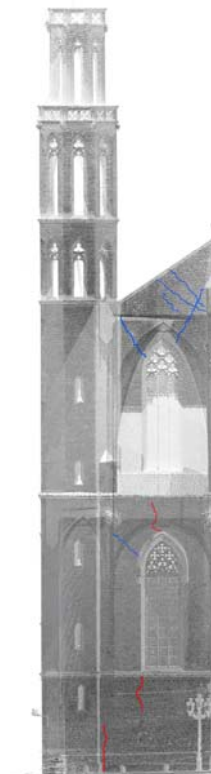
Figure 169 – The crack pattern regarding the bell tower

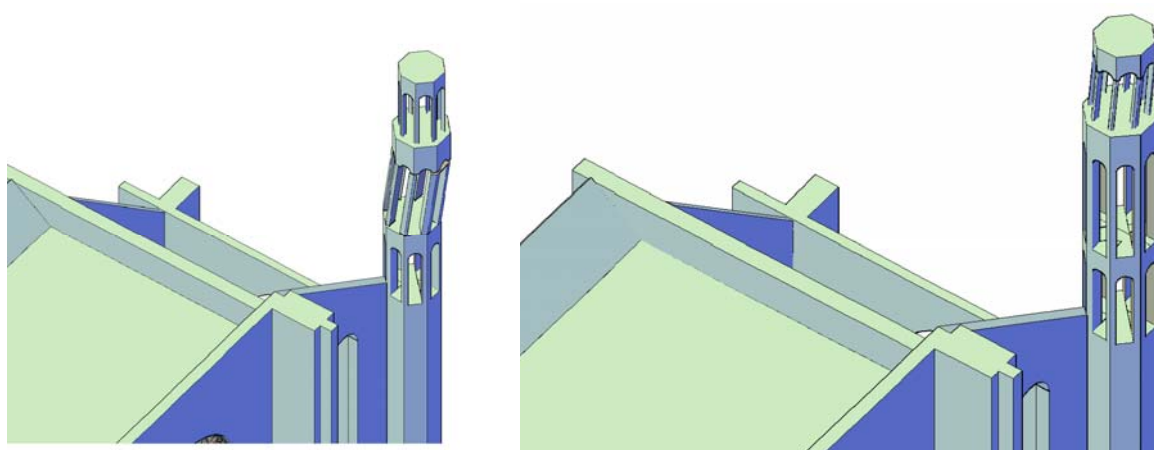
Figure 173 – Overturning and rotation of the upper part of the bell tower

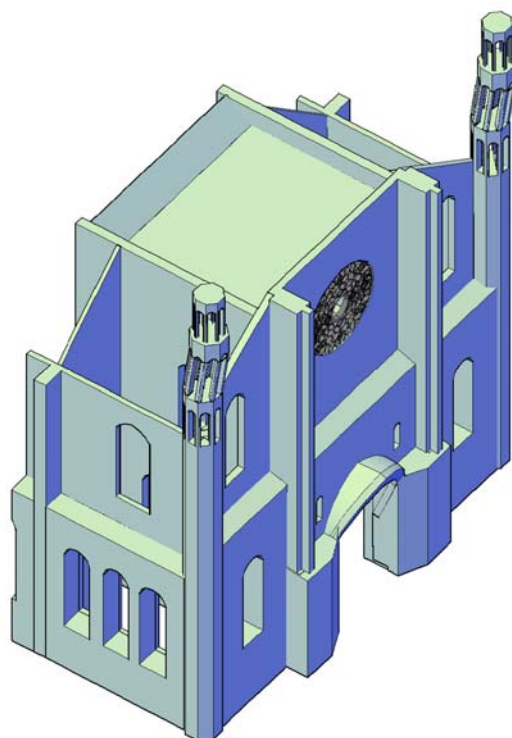
The towers of the cathedral are very slender in the plan shape and they extend to the highest point of the structure. These facts make them among the most vulnerable elements in terms of seismicity.

Figure 174– Collapse Mechanism- Overturning and rotation of the upper part of the bell tower

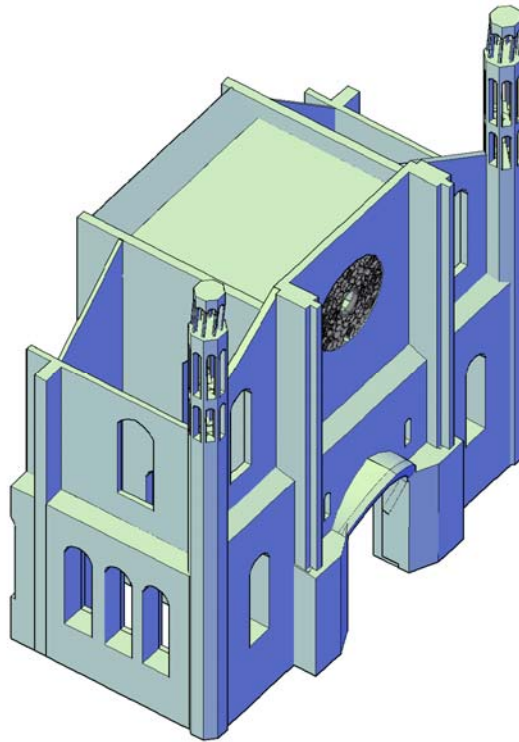
Figure 175 –Collapse Mechanism- Overturning and rotation of the upper part of the bell tower

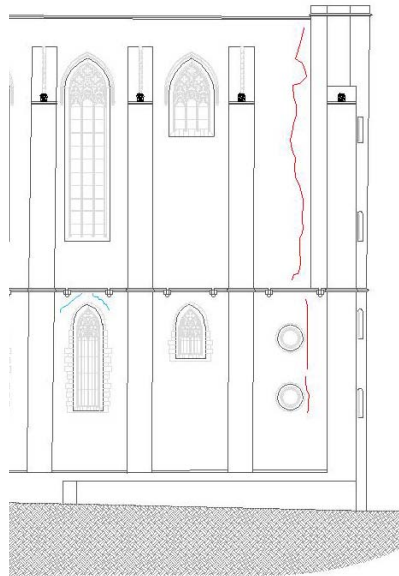
Santa Maria Del Pi has the cracks symmetrically located in the side lateral walls. These cracks are just located adjacent to the front façade. This damage may be a sign of this type of collapse mechanism.

Figure 178 – The extending crack on the side façade

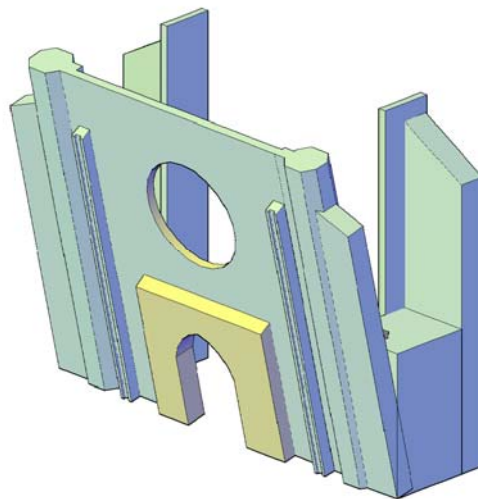
The main crack on the façades and the existing cracks in the connections of the perpendicular walls are the supporters for the failure.

The leaning of the east and west towers and the differential settlements in different extends on the front façade may have a contribution of this type of failure.

Figure 179 – The model of the collapse mechanism-
Out of plane movement of the total façade

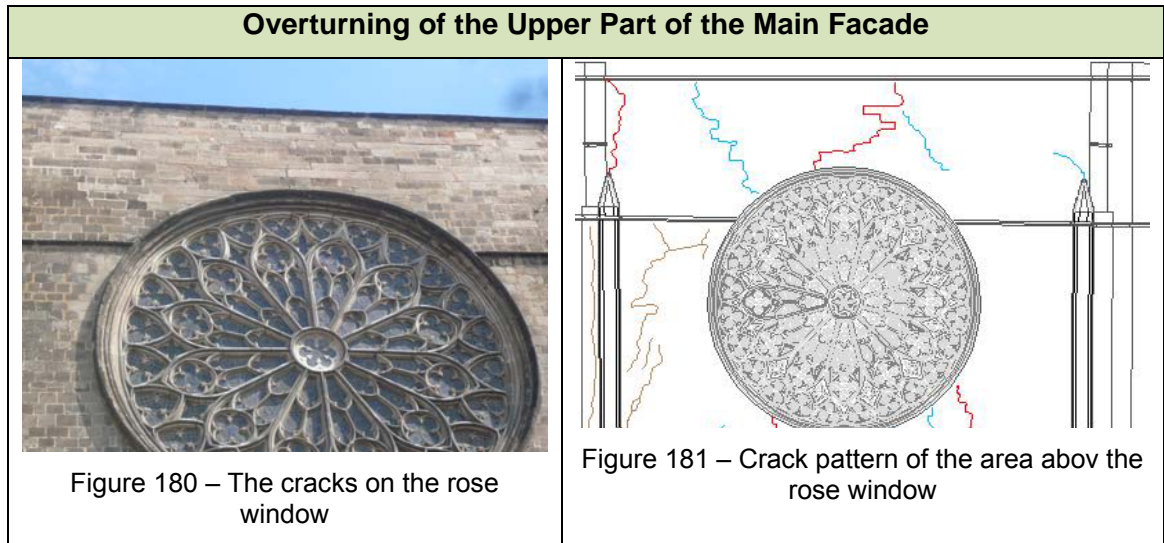
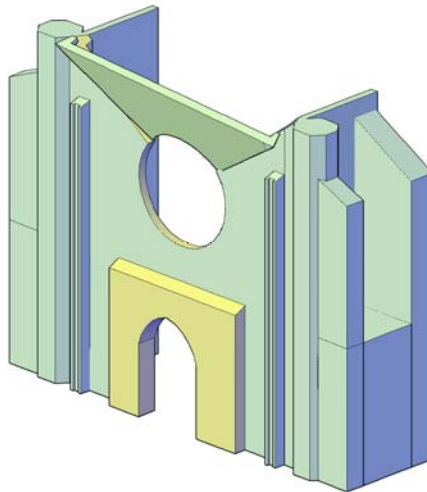
The cracks located on the upper part of the rose window on the main façade are the main reasons of a possible failure mechanism like the collapse of the upper part of the façade. The different stone pattern indicating the signs of the previous alterations, the historical data confirming that this part has

Figure 182 – The model of the collapse mechanism-
Overturning of the Upper Part of the Main Façade

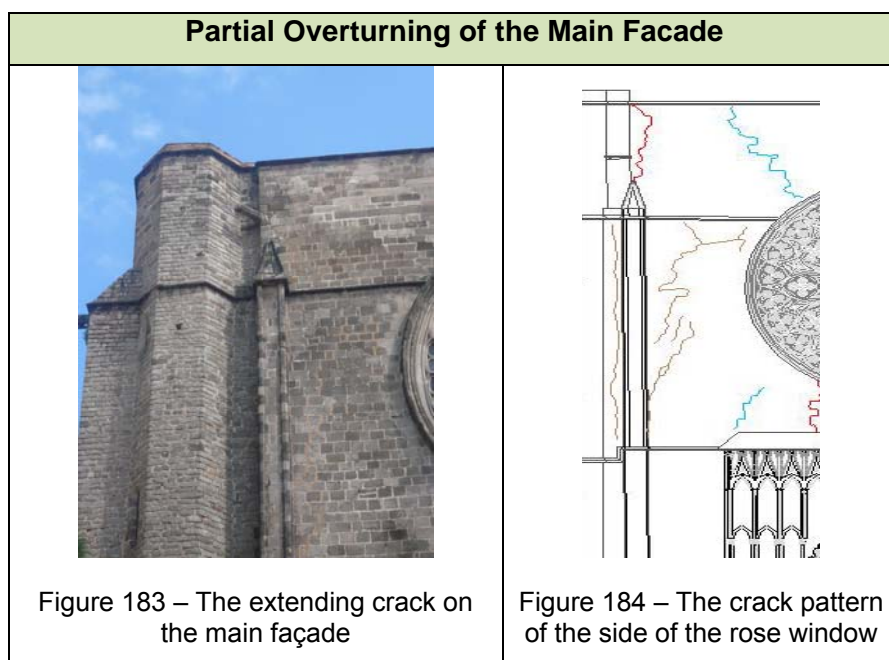
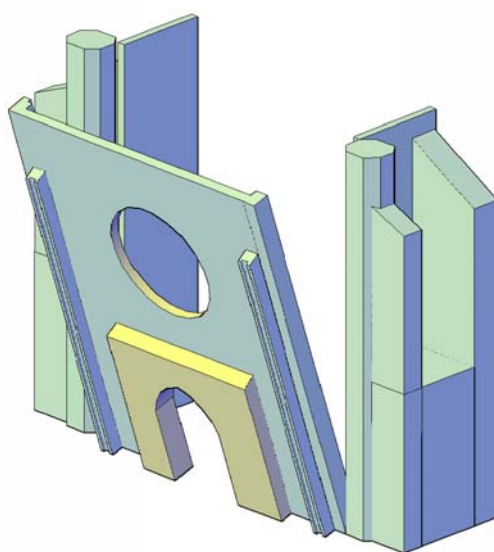
The extending cracks located on the sides of the main frontal part of the façade may have an influence on this type of failure. This damage makes the structure vulnerable against any kind of seismic action.

Figure 185 – The model of the collapse mechanism-
Partial Overturning of the Main Façade

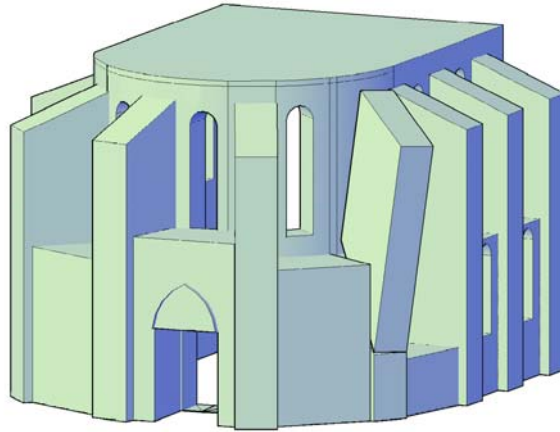
The existing cracks, the inefficient buttresses or the irregularities in the height of different components like the lateral walls of the apse and the buttresses are the possible reasons for this type failure.

The poor connections between the walls and the buttresses are among the possible causes to have this type of local collapse.

Figure 186– The model of the collapse mechanism- Overturning of the Buttresses on the Apse part

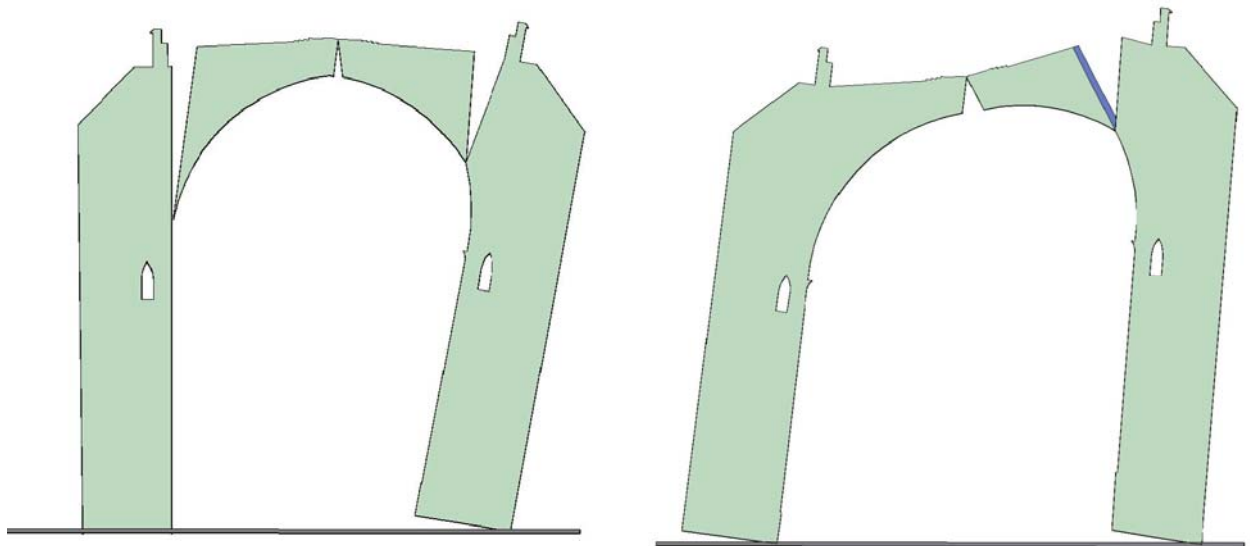
The typical bay of the structure was also considered thinking of the damage and deformation on the arches. This damage is supposed to have occurred due to the previous fires. The structure is a single nave structure and the possible hinges are assumed as the following;

Figure 187 – The models of the possible collapse of the typical bay

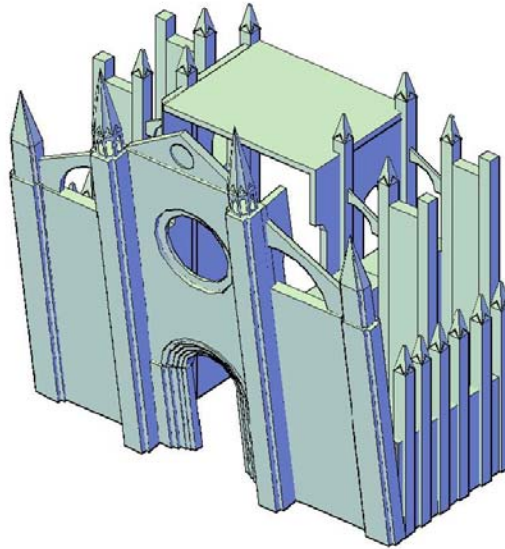
It is not possible to observe any damage on the front façade due to the recent restoration works but on the interior façades, the inclined cracks start on the upper level of the arches of the first chapels extending through the front façade are important in terms of the possibility of this type of mechanism. There is also the cracks start on the upper part of the entrance going up vertically until the lower levels of the rose window on both sides.

Figure 191 – Collapse Mechanism- Overturning of the total façade

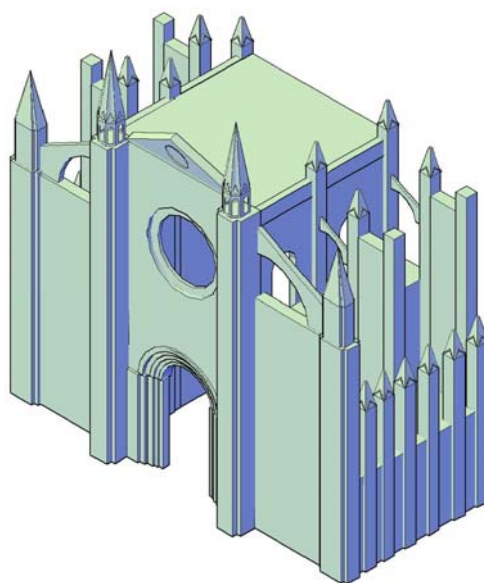
Due to the restoration works which prevent us to point out the structural problems, there is no evidence of any damage that may lead us to consider this type of collapse mechanism. But it is still very important to consider this failure mechanism since the triangular frontal part of the main façade constitutes a weak part in terms of seismicity.

The cracks located on the front façades are usually the main reasons to consider this type of collapse mechanisms. But in this case, the main indicator to take into account this type of failure is different due to there is no information or sign of the previous damage on the façade regarding the time before the restoration works.

Figure 193 – Collapse Mechanism- Overturning of the upper part of the front façade

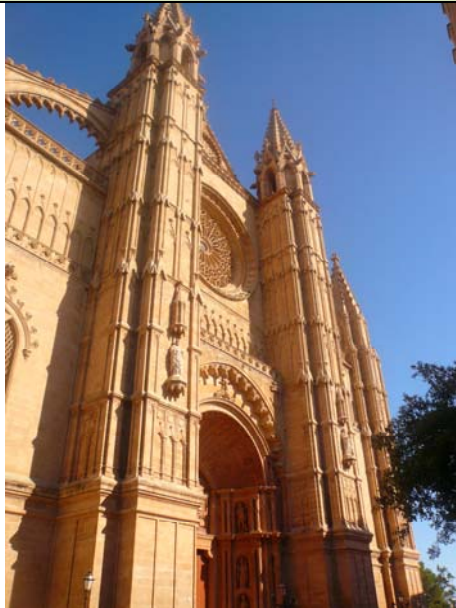
Figure 194 – View of the towers on the front façade

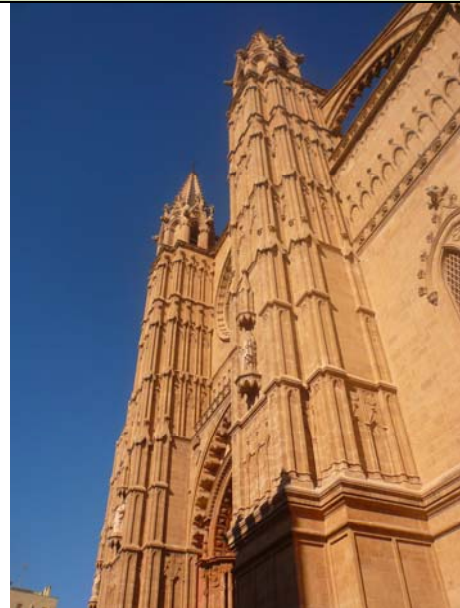
Figure 195 – View of the towers on the front façade

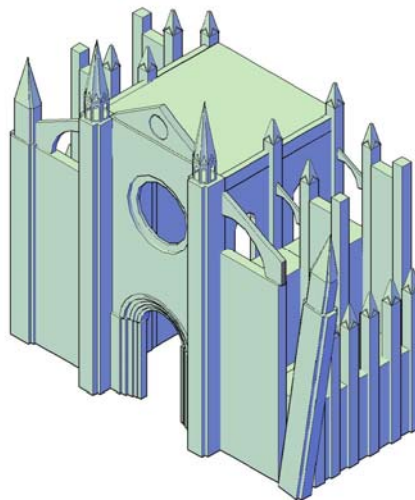
In other cases, the elongated cracks on the connection points of the towers with the lateral walls were the main indicators of the possibility of this type of collapse mechanism. As the height of the tower increases, it sometimes gets more slender as in the case of Santa Maria Del Mar. In this case, the possible collapse of the upper part of the tower is also considered among the possible failure types. These are not the main issues in Mallorca Cathedral but it is still important to highlight as these parts can behave separately under a seismic event since they are among the weak parts of the structure.

Figure 196 – Collapse Mechanism- Separation of the tower

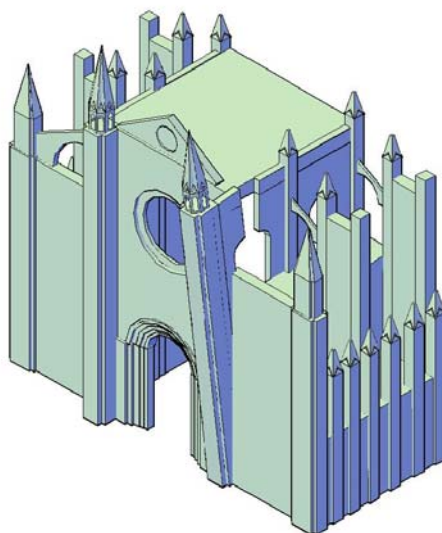
Figure 197 – Collapse Mechanism- Separation of the tower
