12 voids

Twelve spaces of opportunity have been detected inside the factory complex with a strong inherited potential to nest a postindustrial activity.

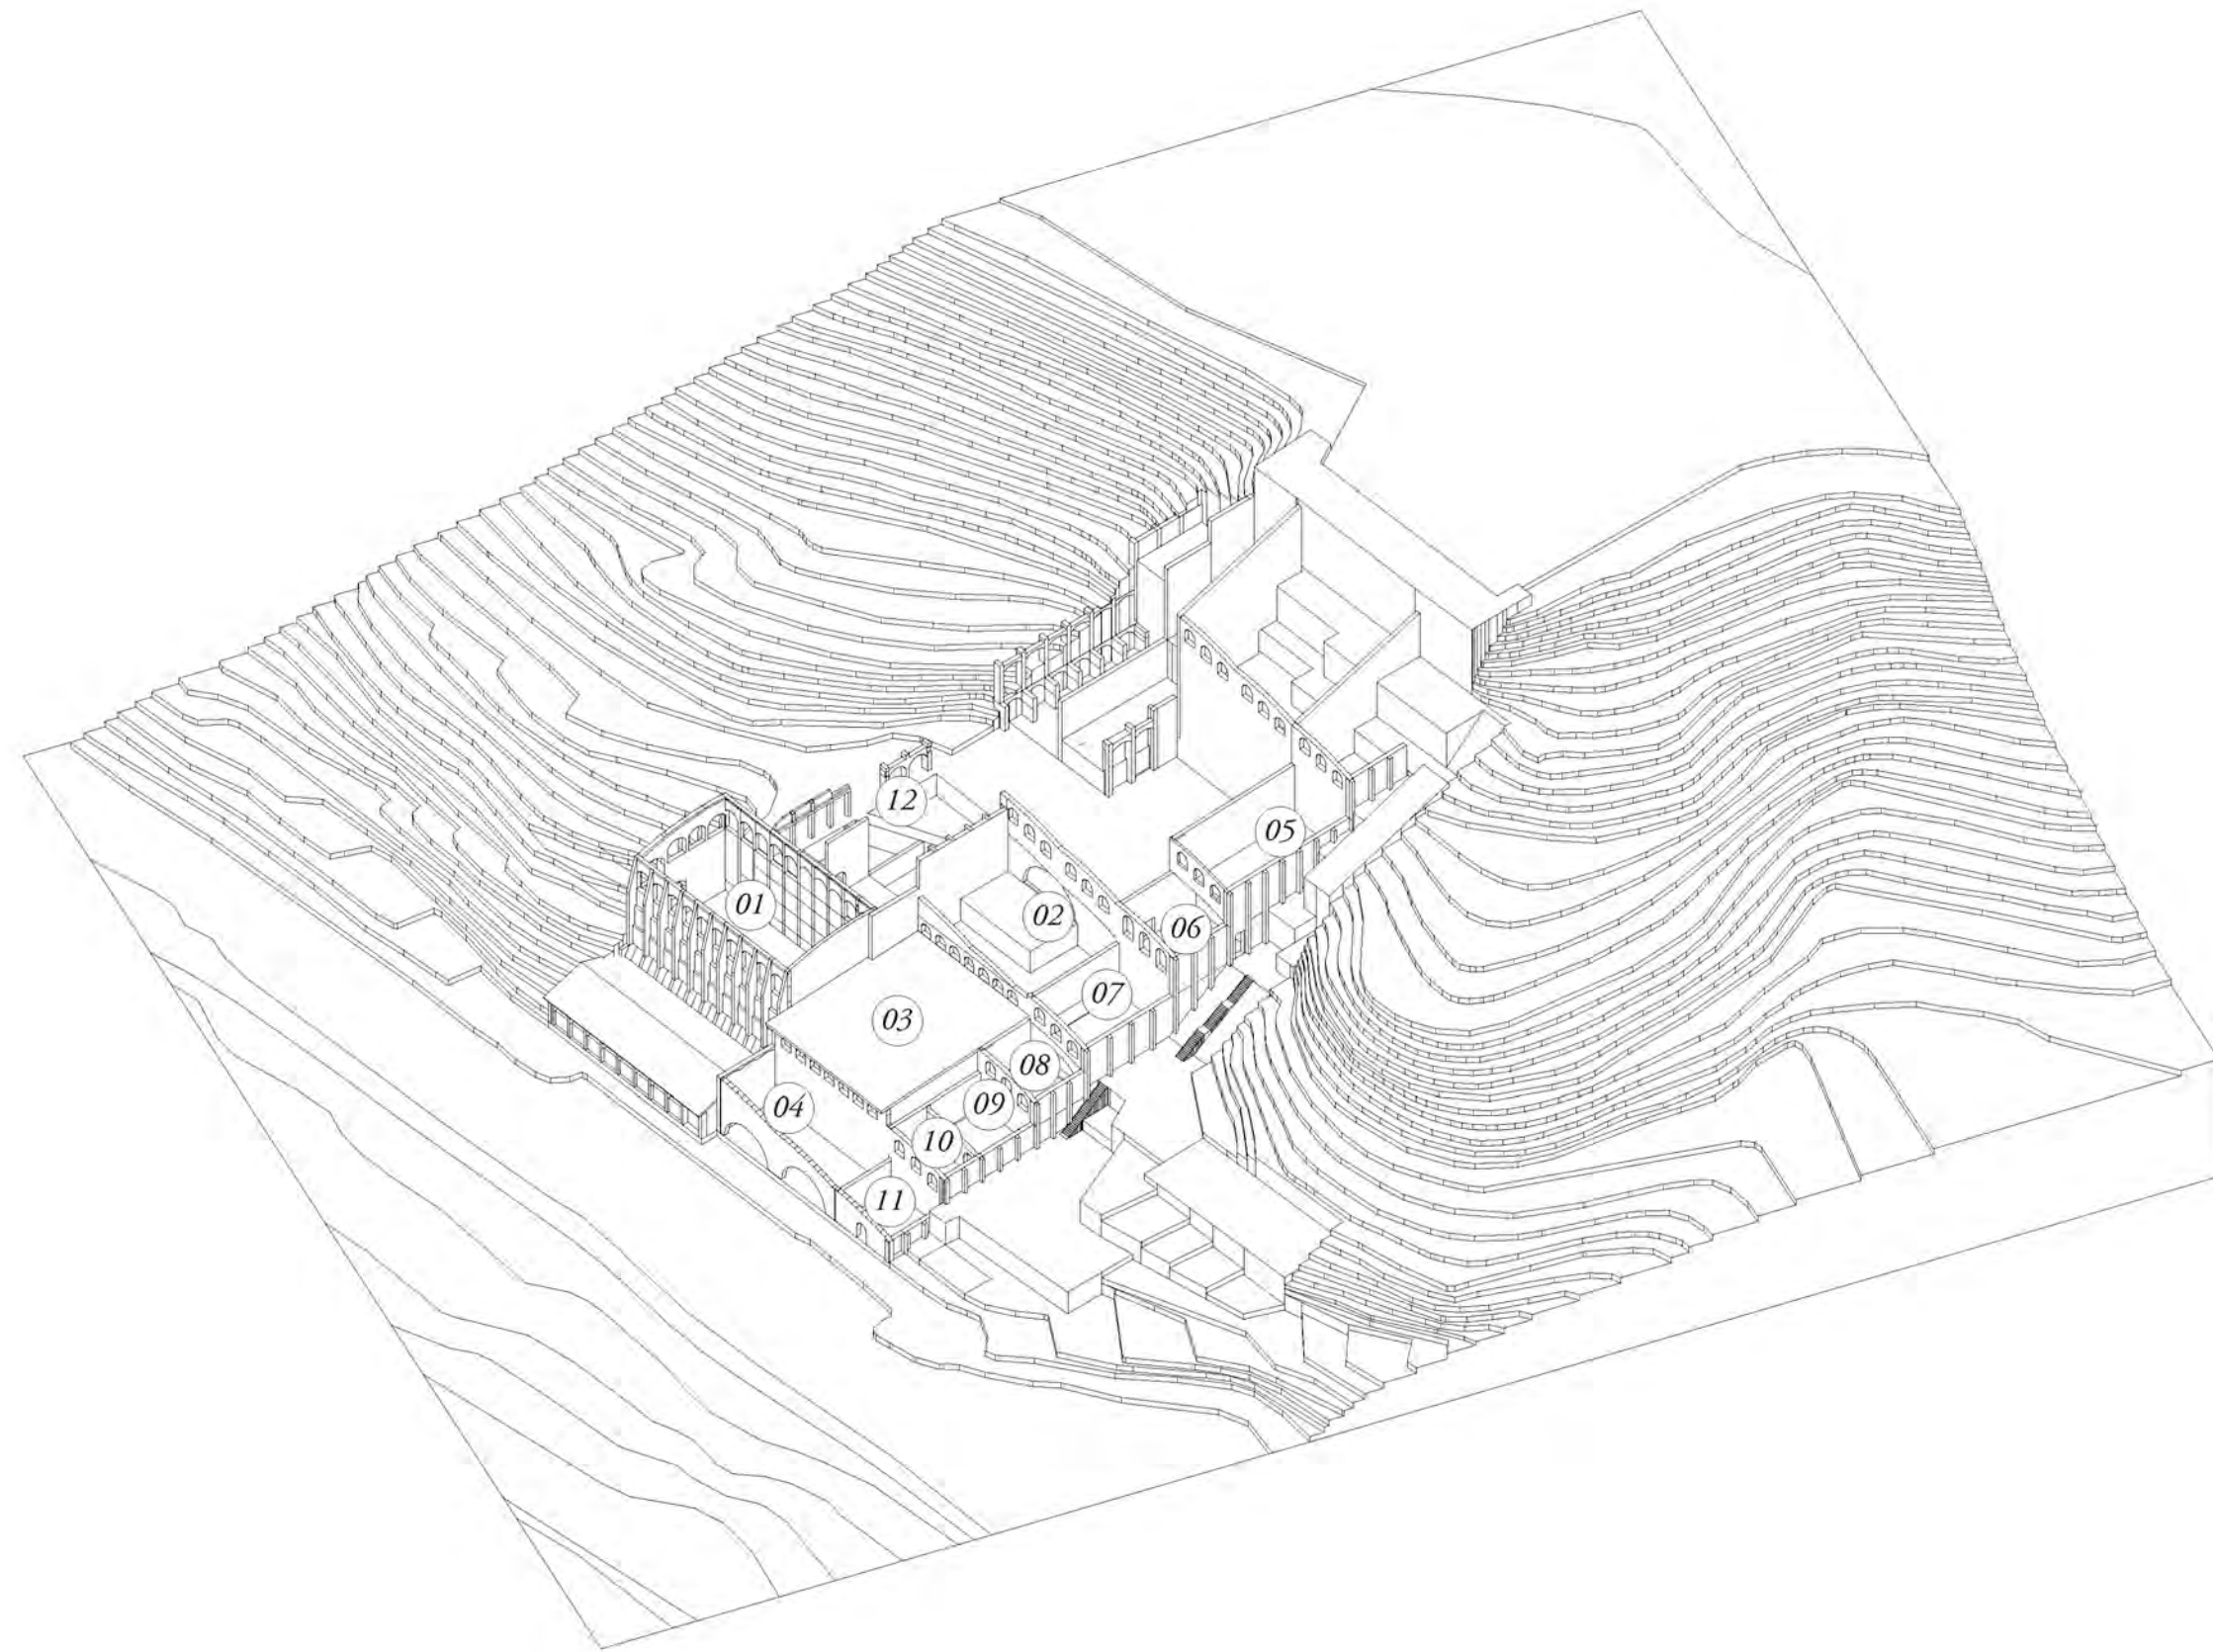
bay code	12
precedent function	rotating ovens
area (m2)	96
relative enclosed coverage (%)	5
relative site coverage (%)	1
aspect ratio (1)	0.9
volume (m3)	287
width (m)	10.1
length (m)	9.47
height (min)	3
base elevation (m)	0
roof elevation (m)	3
relative elevation (%)	0
floor material	original terrain
wall surface (m)	117.42
wall max thickness (m)	0.86
wall min thickness (m)	0.6
wall material	limestone
opening count (n)	1
opening surface (m2)	6.74
opening surface total (m2)	6.74
void/solid ratio (%)	6
access points (n)	2
truss span (m)	10.1
truss count (n)	4
truss max depth (m)	1.6
truss material	cast iron
roof geometry	double curved sloped
roof layering	ceramic triple layer vaulted
roof condition	good
