## Chapter 4

### ROAD SAFETY REVIEW: IMPLEMENTATION

The road safety review process was applied to six roadways in the Town of Natick, Massachusetts. The selected roadways included:

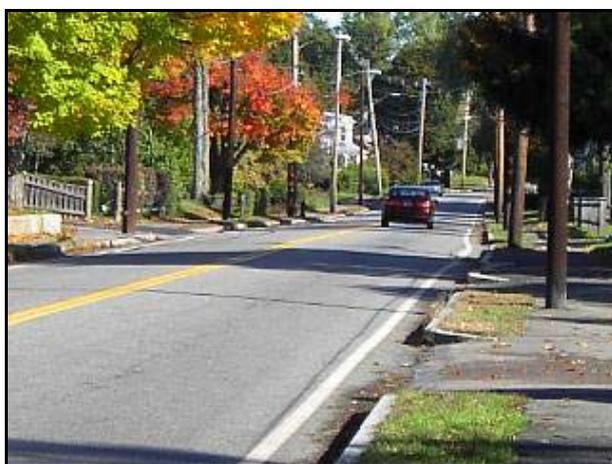
FIGURE 4-21 *South Main Street Typical Cross Section.*

Lane width was typically 12 feet and one foot wide shoulders were provided all along South Main. Figure 4-21 shows a typical cross section of South Main Street.

The typical cross section included granite curbing and sidewalks almost in the entire road segment. The sidewalk was only missed on the northbound side from West Street to Hunters Lane. Utility poles were situated on the southbound side from Cottage Street to Curve Street; from this point to the south, utility poles were placed on both sides. Some of them were located too close to the traveled way (see pictures S3, S4, and S8 in Appendix B).

The pavement was found in good condition as well as the granite curbing and the sidewalks.

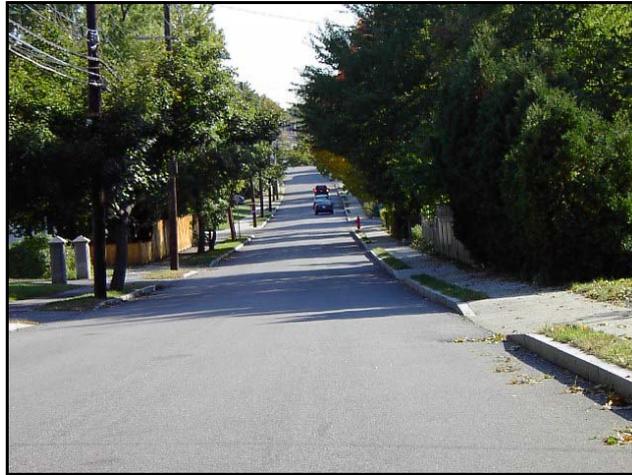
FIGURE 4-27 *Walnut Street Typical Cross Section.*

Granite curbing and sidewalks were provided almost all along Walnut Street. Only on the northbound side from Roundwood Road to Worcester Street sidewalks were missed. The curb measured approximately 0.6 feet wide and 0.5 feet high and the sidewalk width was four feet. Utility poles were placed on the southbound side

from Worcester Road to the curve, and on the northbound side on the rest of the street. A typical cross section is pictured in Figure 4-27. The picture was taken southbound near Shattuck Street.

Travel lane width ranges between 10 feet and 12 feet. From the curve to Worcester Road (Route 9) the lanes are wider (11-12 feet) and on the south side, where no pavement markings were found, they become slightly narrow.

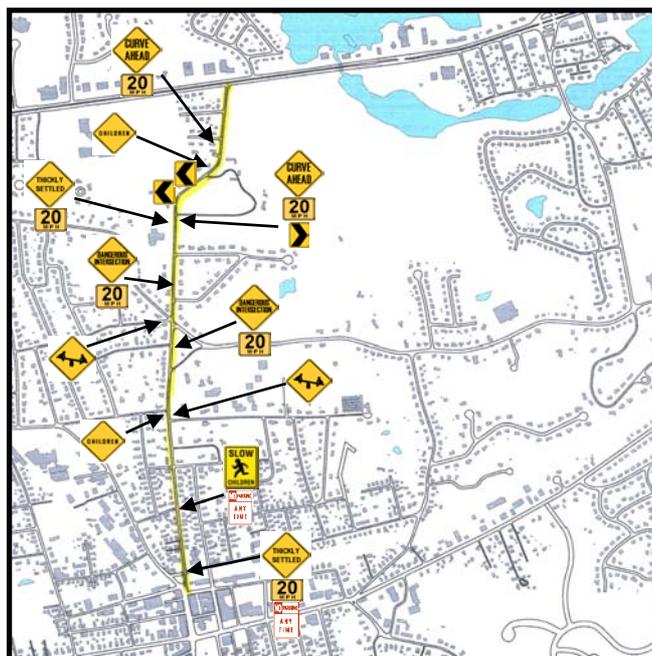
FIGURE 4-28 *Walnut Street Signage.*

No traffic signals were installed on Walnut Street. There were no regulatory signs but frequent warning signs. Walnut Street signage is presented in Figure 4-28.

Even though the speed limit on Walnut Street was 30 mph, various advisory speed signs of 20 mph confused road users who believe the actual limit was 20 mph.

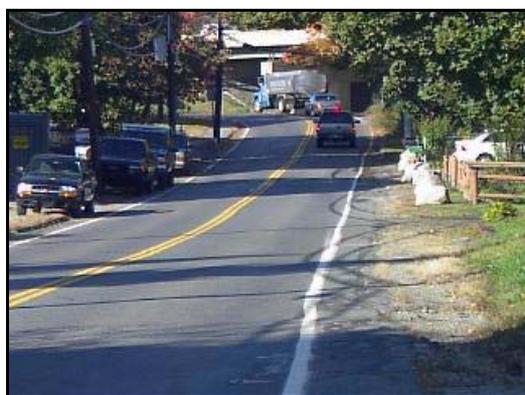
FIGURE 4-30 *Pine Street Typical Cross Section.*

The typical travel lane measured 10.2 feet and curbing and sidewalks were found at irregular intervals along the street.

From Main Street to Darby Court, asphalt curbing and sidewalks were provided on the eastbound side. Sidewalk width was four feet and curb height was 3.5 inches. A short road segment with granite curbing and sidewalk was found between Liberty Street and Pamela Road. A photograph of Pine Street cross section heading westbound is presented in Figure 4-30.

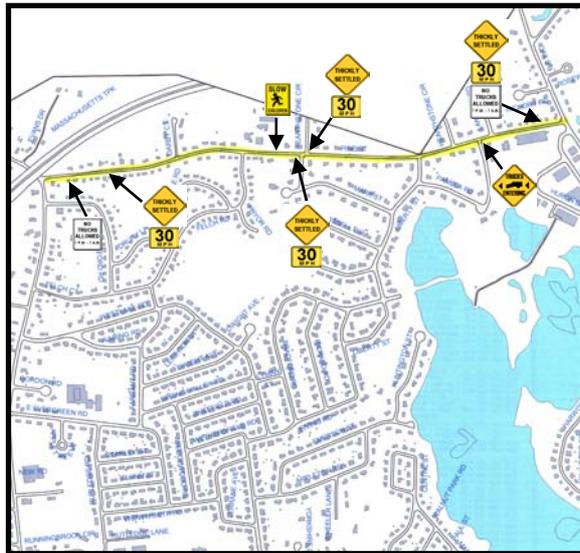
FIGURE 4-31 *Pine Street Signage.*

Pine Street did not contain many signs and any traffic signals. There were thickly settled warning signs with 30 mph advisory speed limits signs, and regulatory signs for heavy vehicles. The signage of Pine Street is presented in Figure 4-31.

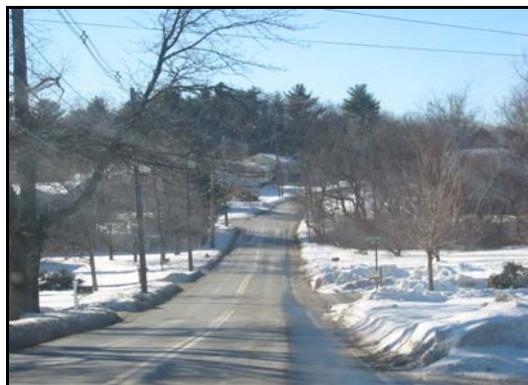
FIGURE 4-32 *Pine Street in Winter.*

The situation on Pine Street is similar to the previous streets evaluated. A picture of the previously cited vertical curve during the winter period is shown in Figure 4-32.

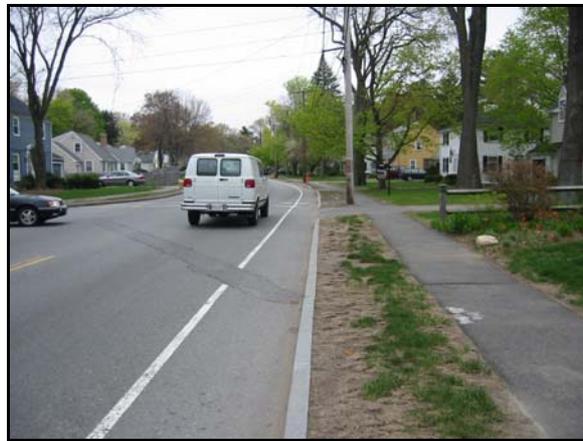
FIGURE 4-33 *Hartford Street Typical Cross Section.*

Utility poles were situated approximately 4½ feet apart from the edge, on the westbound side from Cecil Road to the curve and on the eastbound side from the curve to the end of Hartford Street. Picture in Figure 4-33 illustrates Hartford Street typical cross section. The image was taken near Cecil Road heading westbound.

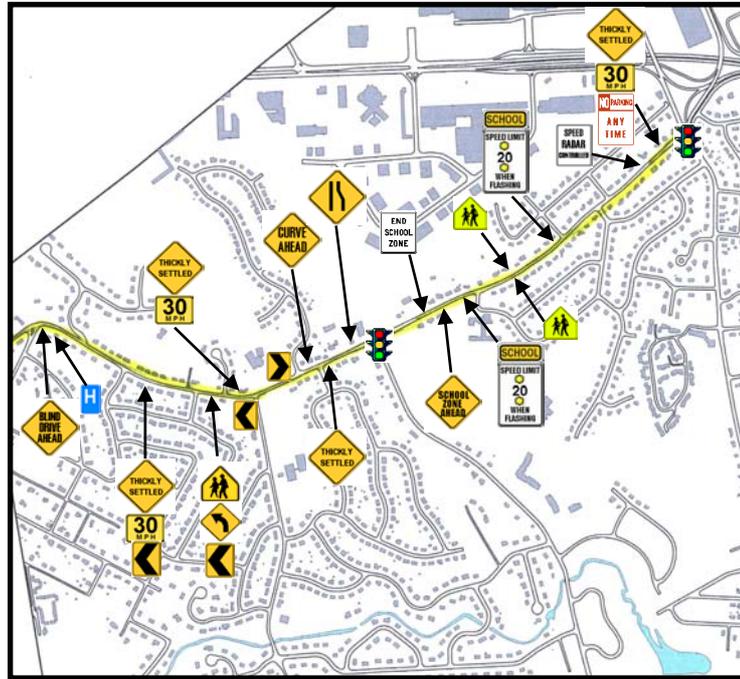
FIGURE 4-34 Hartford Street Signage.

There was a traffic signal at the T-intersection of Hartford Street and Mill Street. The signal was found to operate correctly and was clearly visible to approaching motorists. Picture H6 in Appendix B shows the signalized intersection. Hartford Street signage is presented in Figure 4-34.

The curved segment contained various warning signs alerting vehicles about the curve. Additionally, chevron alignment marking served as complementary delineators.

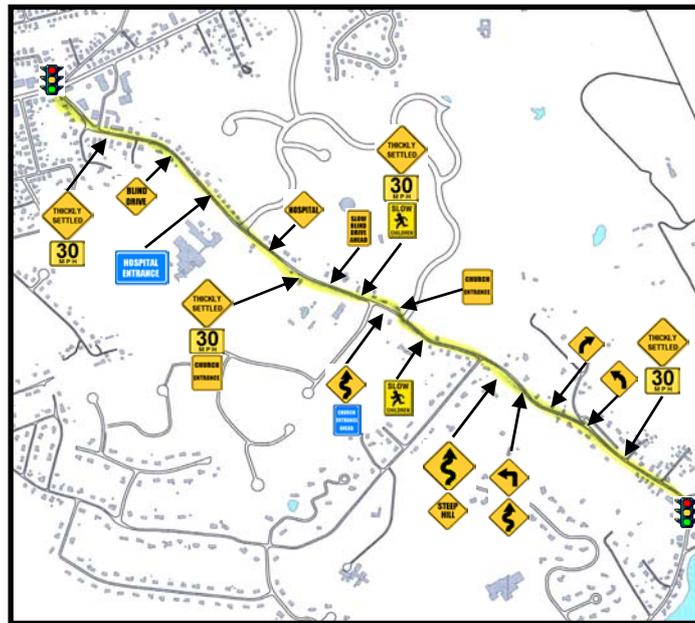
FIGURE 4- 37 *Union Street Signage.*

Thickly settled warning signs posted together with 30 mph advisory speed limit signs were identified four times along Union Street. Figure 4-37 shows the street signage.
