Failure investigation of a Kaplan turbine blade

Abstract

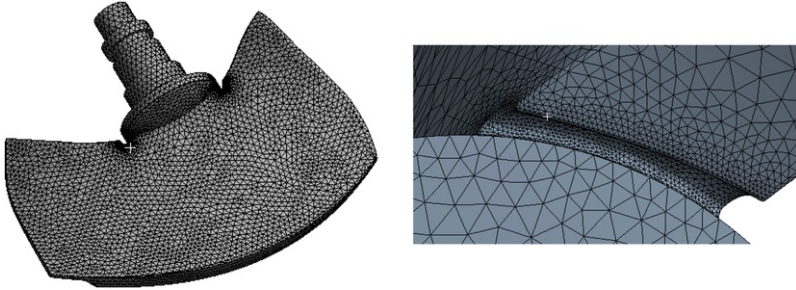
Fig. 9, Fig. 9 View of the mesh.

A numerical model of one blade has been built up in order to simulate the stress distribution in the blade. This numerical model considers the rod, the blade and the tip-lip (see Fig. 9). Ansys Workbench 17 [26] has been used to solve all the simulations in this paper. The material used in the simulation is stainless steel (density of 7750 kg/m^3 , Young's Modulus of 193 GPa and Poisson's ratio of 0.31). The blade is fixed at the rod using a totally fixed support. The mesh sensitivity was strictly checked and the mesh density at the root holes, which are the typical stress concentrator points, was especially increased. Finally, about $1.4 \cdot 10^5$ tetrahedral elements were used, as shown in Fig. 9.

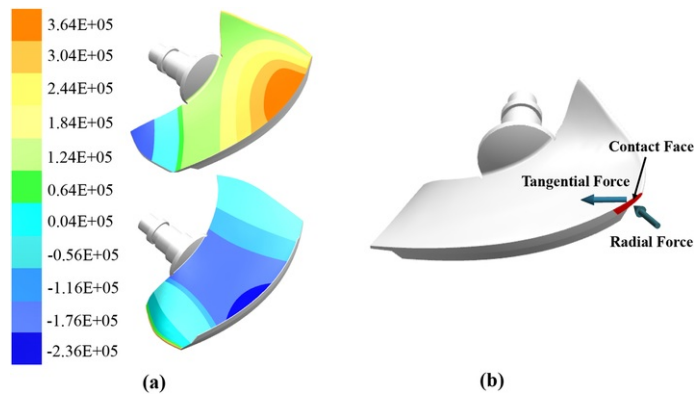
Fig. 10, Fig. 10 Pressure pattern (unit: Pa). b) Contact forces.

First, a modal analysis was performed and the results were compared with experimental values (see Section 5). Once the numerical model was validated, the typical static pressure distribution over a Kaplan blade was applied in the model. This pressure distribution was applied according to the reference [14] (see Fig. 10(a)). In this reference, the pressure distribution was obtained by CFD (Computational Fluid Dynamics). The static pressure distribution in Kaplan blades depends on the operating point because the blades present different angle for every flow rate. In this case, the pressure distribution used corresponds to 67% of guide vane opening, which is a point slightly below the BEP (Best Efficiency Point). The rotating speed was also introduced to the blade to consider the inertia effects. The stress distribution was obtained for this pressure distribution. After that, one tangential force and one radial force were applied in the blade tip, just were it was found broken in the prototype (see Fig. 10(b)). These forces model the behavior of a contact with the stationary wall. As the value of these forces was not known, different values were tested to see the influence of those forces on the stress distribution over the blade.

To model the rubbing, a radial force and a tangential force were applied to the blade (see Fig. 10(b)). The value of these forces is not known, hence different values were tested in the simulation. Fig. 14 shows how the value of these forces affect the maximum stress value located in the root of the blade, where the crack started. The figure shows the stress normalized against the value found without any rubbing (Section 6.1). It is seen that for the contact forces from 10^6N to 10^7N , the stress value increases drastically. From the case of the scratched wall and broken tip-lip, the contact force in this researched case ought to be very high. Therefore, with the appearance of these tangential and radial forces the stress in the root increases and it demonstrates the appearance of the crack in the blade.

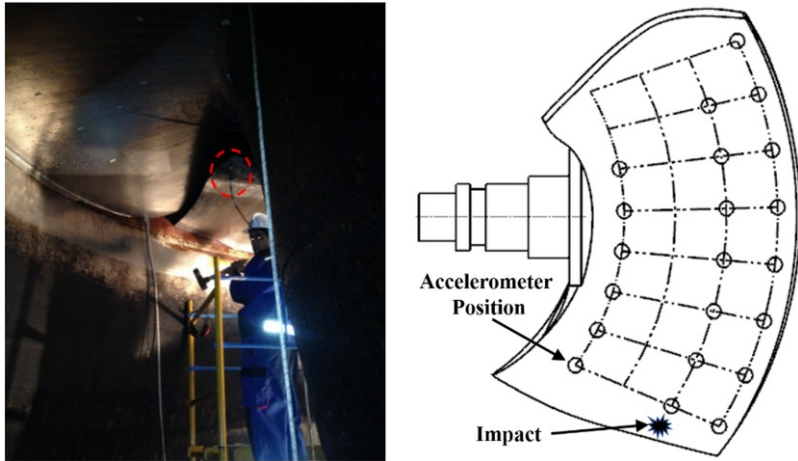
Fig. 11. Experimental Modal Analysis. Not include the radius, not necessary.

The EMA was done on a non-damaged blade of the runner, as shown in Fig. 11. The blade was impacted using an instrumented hammer (Dytran 5802A, 220 $\mu\text{V}/\text{N}$) and the response was measured using an accelerometer (Kistler 8752A, 100 mV/g). Both accelerometer and sensor were connected to a Bruel & Kjaer (LAN XI Type 3053) acquisition system which recorded the signals in the time domain. The blade was impacted always in the same point (see Fig. 11) and the accelerometer was moved to 21 different positions in order to represent the mode-shape of the blade for every natural frequency. This method is called roving accelerometer [27,28]. Three impacts were done in every position of the accelerometer in order to compute the average of them. The positions where the accelerometer was placed are shown in Fig. 11.

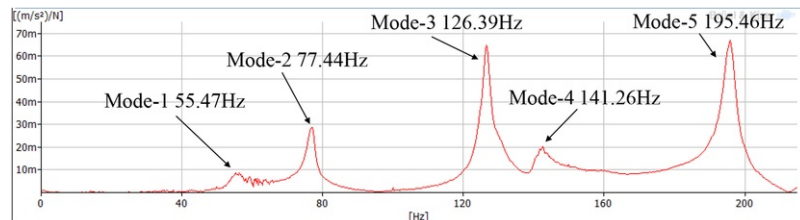
Fig. 12. Frequency Response Function. Change mode-shapes names by Mode 1, Mode 2, Mode 3, Mode 4, Mode 5.

A FRF of one of the points analyzed is shown in Fig. 12. The first five natural frequencies of the blade are observed between 0 and 200 Hz. The mode-shapes associated to every of those natural frequencies are shown in Table 1 and in supplementary videos. In this table, the results obtained by simulation are also shown. It is seen that there is a good agreement between experiment and simulation since both mode-shapes and values of natural frequencies are very close.
