**Introduction**

Heritage buildings are fragile and valuable patrimony of cities and countries. Maintenance and repairing requires efforts and a wide knowledge of the structures. However, in many cases, the constructive methods, the distribution of supporting elements and the materials are unknown. There are two main causes of this uncertainty: the lack of information and drawings due to the age of the buildings, and the misinformation about past restorations, damages and alterations of use and structures. Non-destructive tests are widely used to obtain information since they can be applied without causing any damage [1]. One of the most extended methods in cultural heritage assessment is Ground Penetrating Radar (GPR) [e.g. 2, 3 and 4]. This technique allows a wide and quick evaluation of large parts of the structures. This paper presents examples of data acquisition methods to achieve patterns for further recognition and characterization of structures, materials and damages. The field study was completed in the terraces of *Eixample* of Barcelona, in XIX Century buildings [5 and 6].

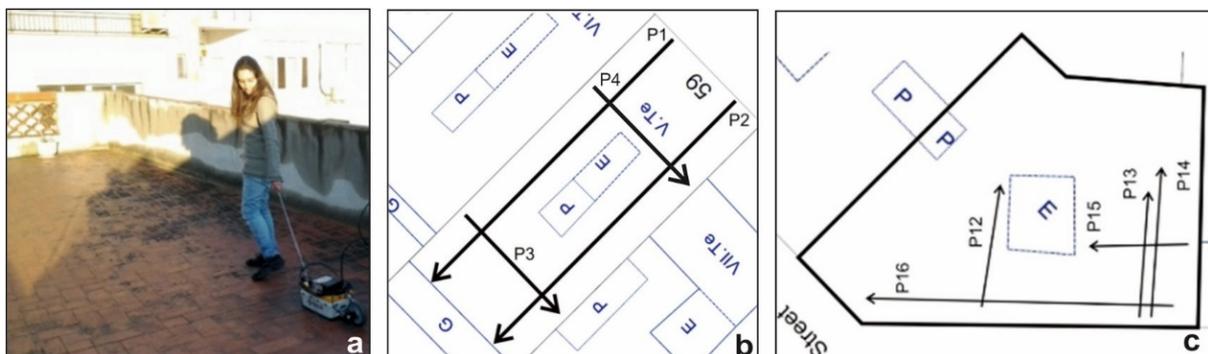
**Figure 1 .a) Radar data acquisition, b) position of radar lines on case 1 c) position of radar lines on case 2.**

In this paper two case studies are presented. One of them, case 1, is showing structural changes as consequence of rehabilitation. The position of the profiles for both cases is shown in Figure 1. The other one, case 2, is characterized by significant variation in the built structural supporting structures, including orientation and material types.

In case 2 the terrace was surveyed through the acquisition of 5 profiles, 2 perpendicular and 3 parallel radar lines to the façade (see Figure 1). The most paradigmatic profile 16 contains chief information about the inner elements present in the terrace (Figure 4). Two walls were clearly identified and half of a third wall is detected right in the beginning of the profile. Above it, it is detected a longitudinal set of parallel elements for the first meters. The following meters GPR data shows an alteration of orientation of the elements. An interesting fact is detected from the middle of the profile towards the end is detection of diagonal walls partition.
