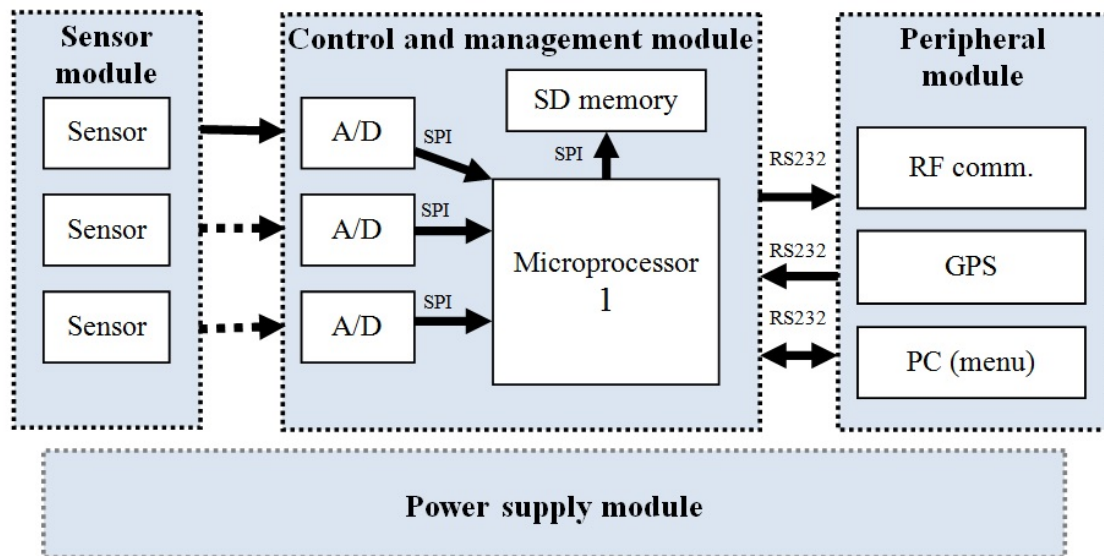
**Figure 1** Block diagram of the seismic acquisition equipment

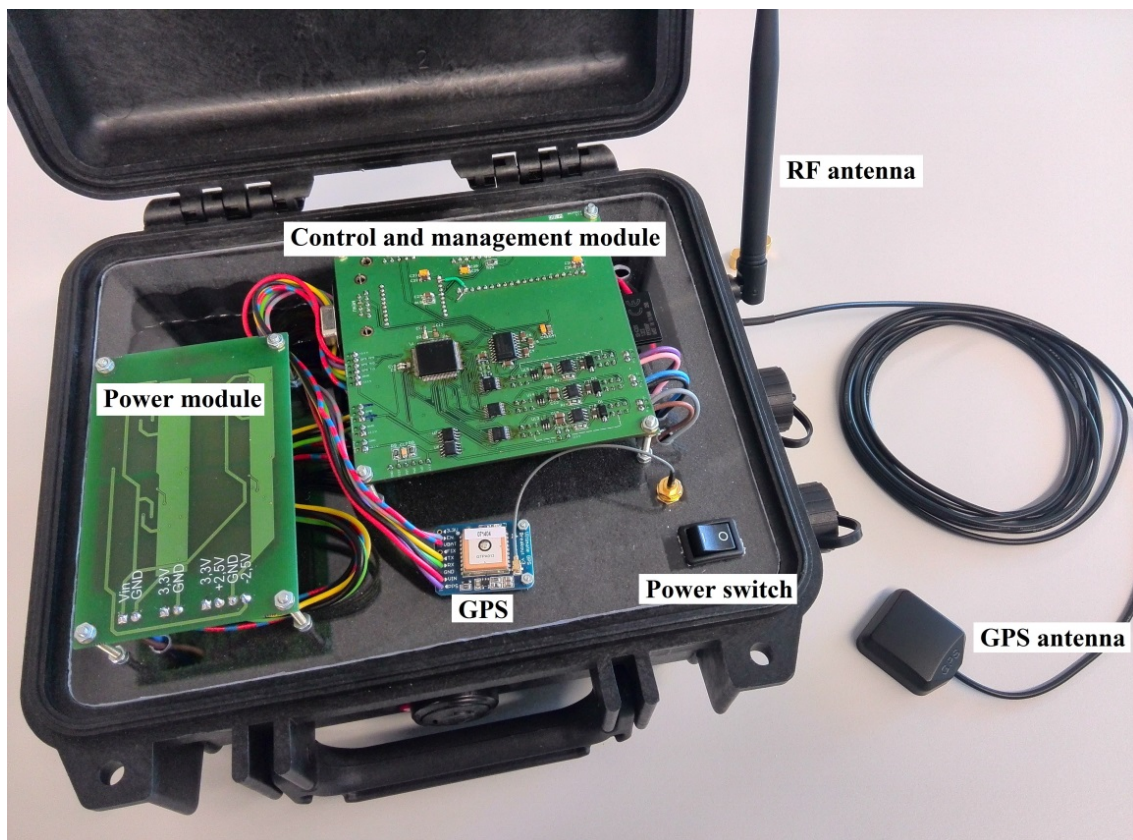
**Figure 2** Volcanic seismic acquisition equipment

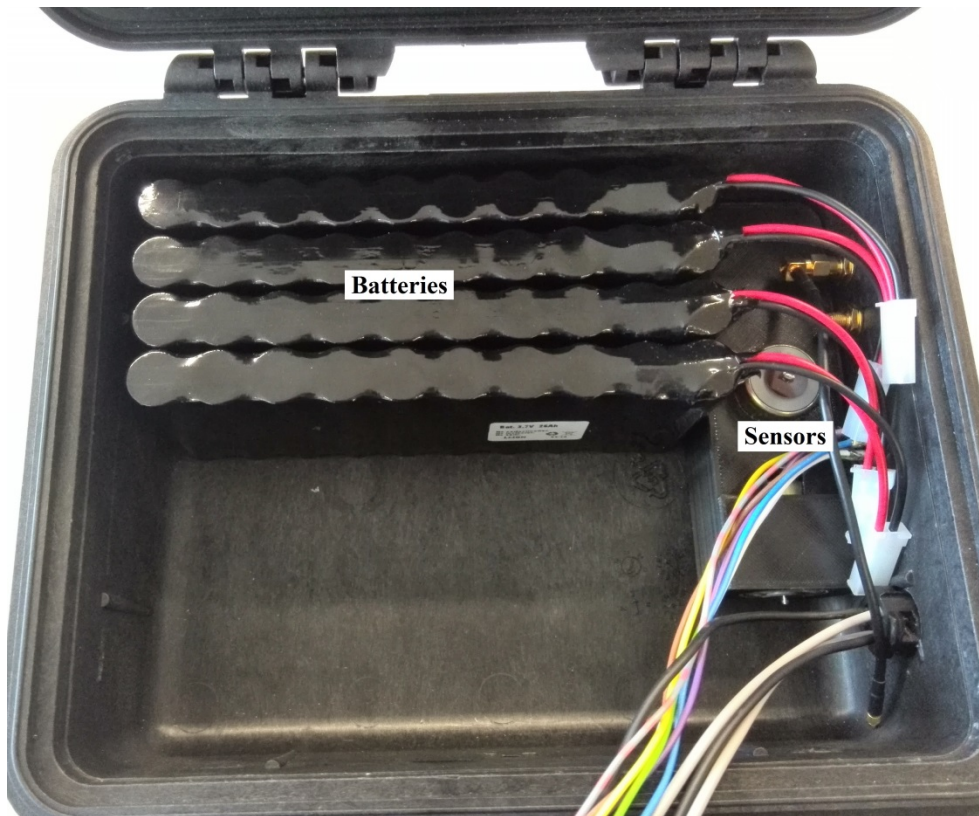
**Figure 3** Location of batteries inside waterproof box

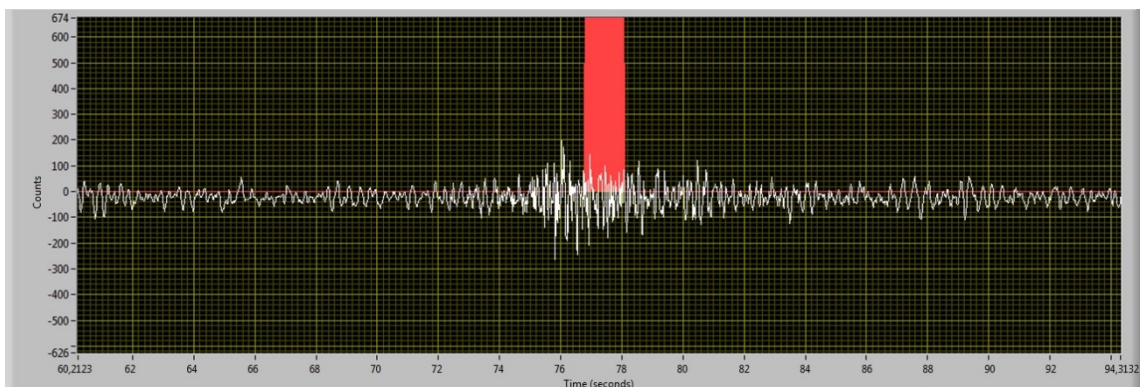
**Figure 4** Seismic event detected in El Hierro on 16/07/2012 at 03:01:09 at a depth of 20km (contrasted data with IGN events catalogue), using the STA/LTA algorithm (Short Time Average / Long Time Average).

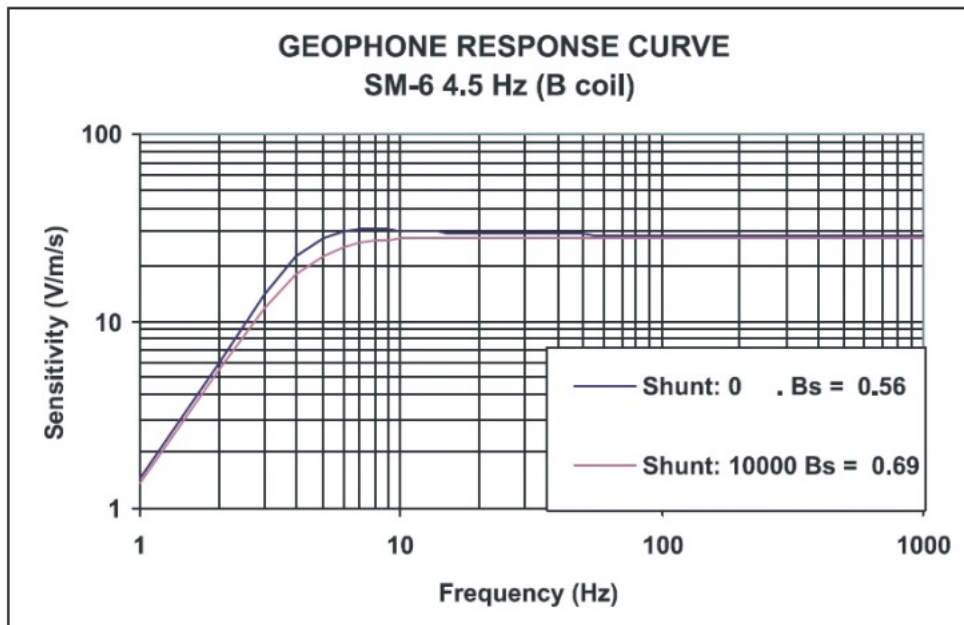
**Figure 5** Response of SM6 sensor according to the manufacturer [22]

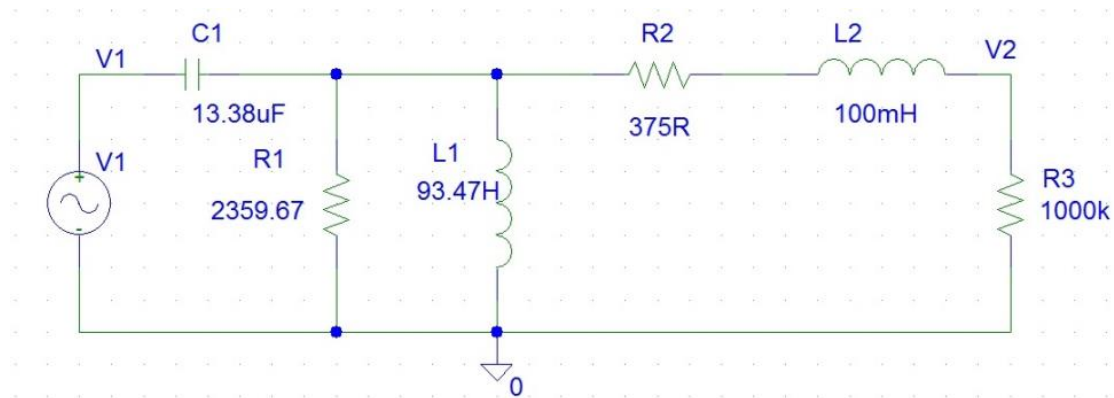
**Figure 6** Equivalent circuit of the SM6 sensor

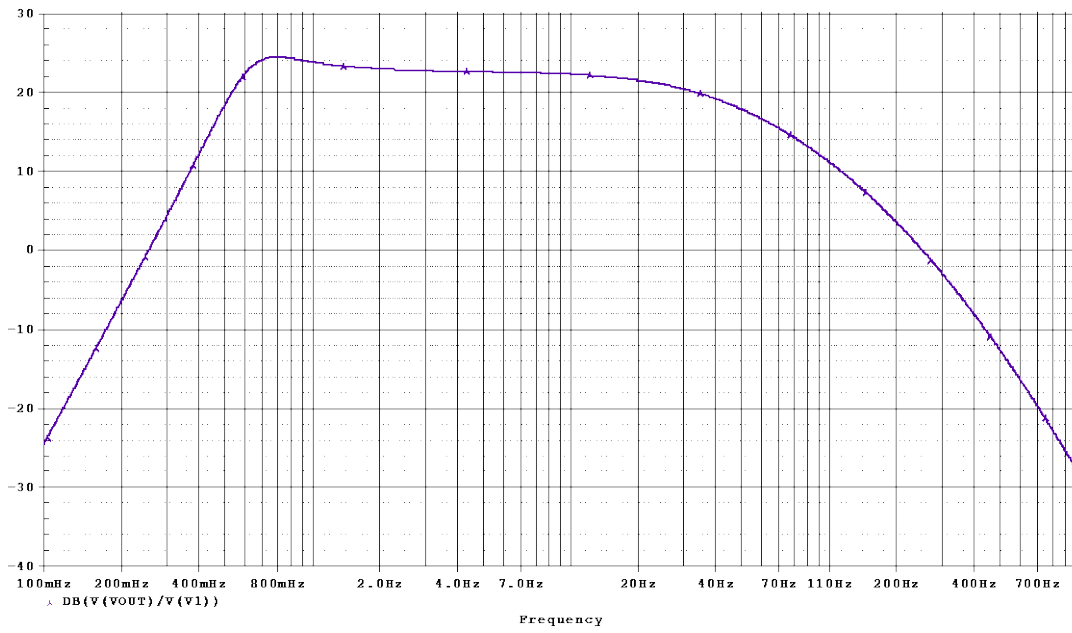
**Figure 7** Electromagnetic sensor responses through the conditioning circuit

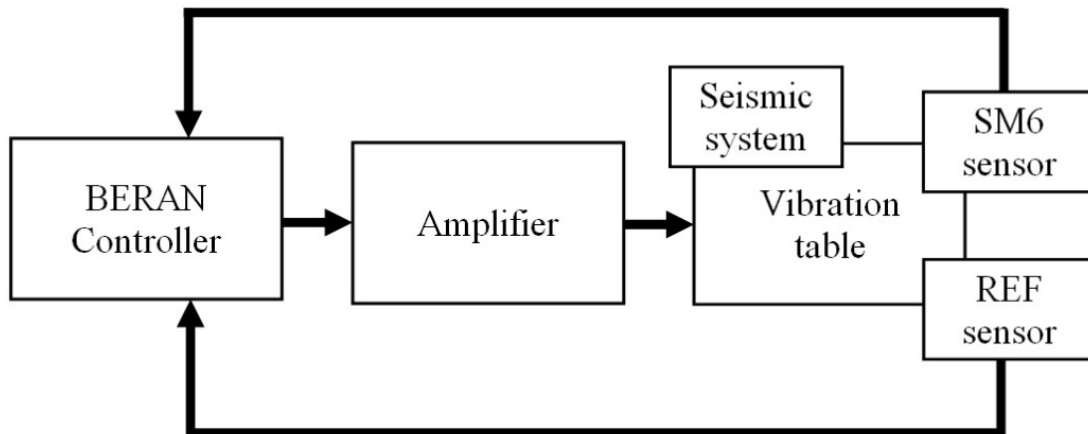
**Figure 8** Test connections in the table vibration

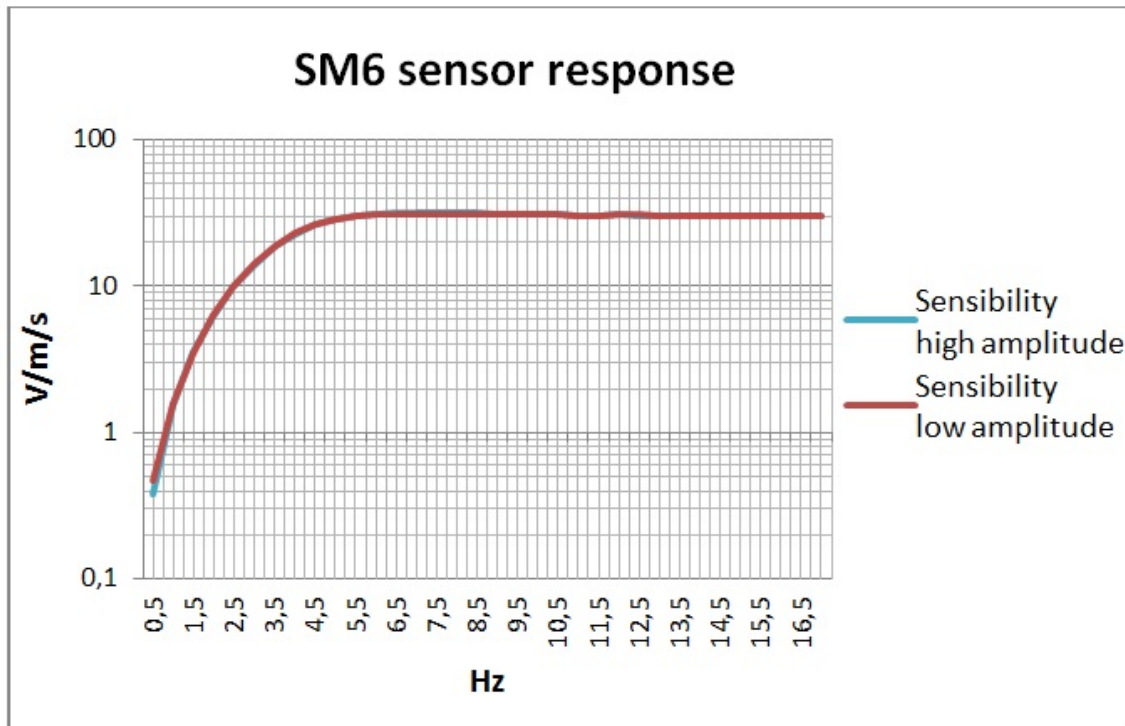
**Figure 9** Response of SM6 sensor in laboratory test

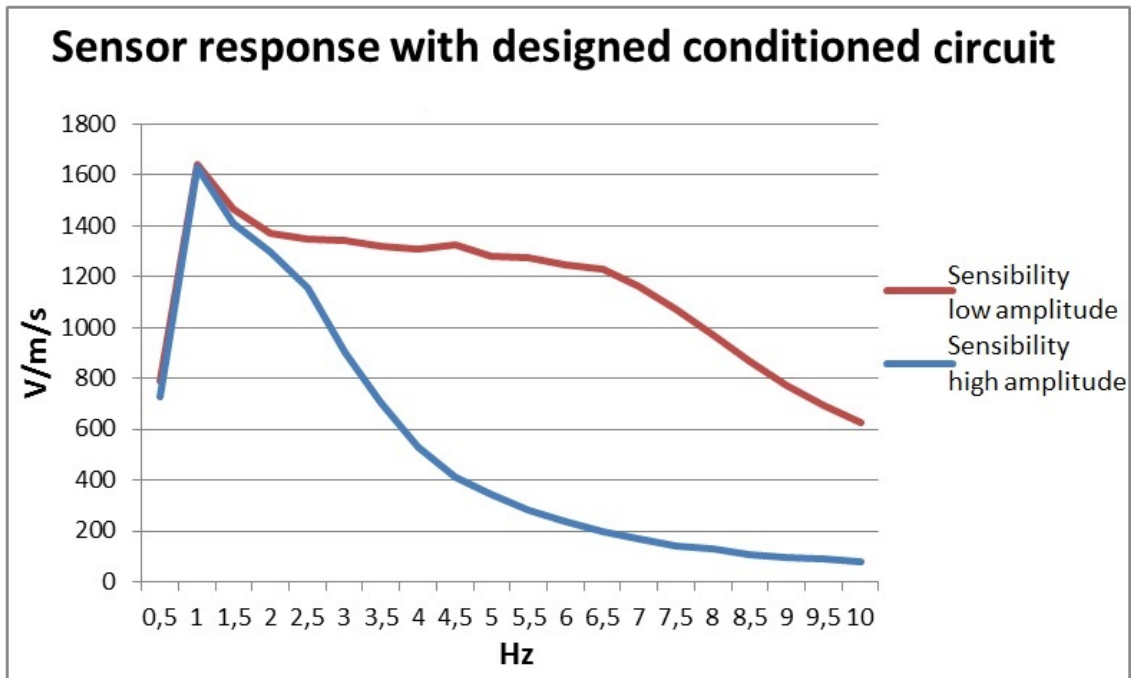
**Figure 10** Graphic results of SM6 sensor with the designed conditioned circuit

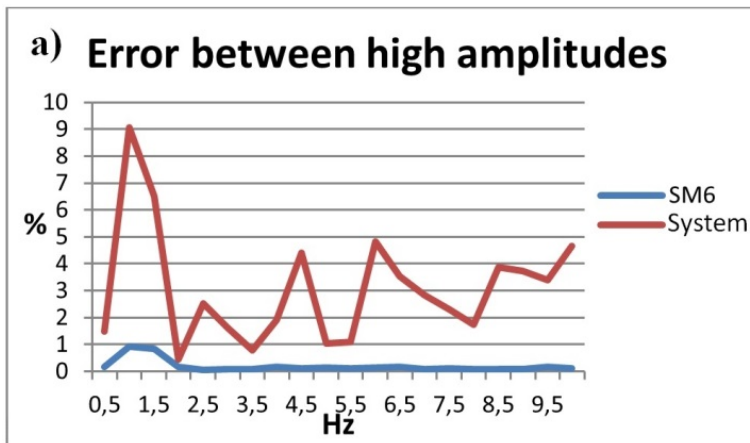
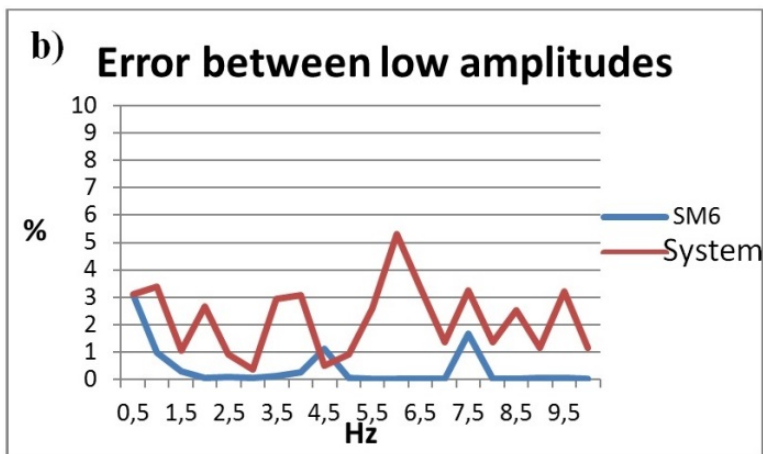
**Figure 11** Relative errors between tests with the same features. (a) Error between high amplitudes test. (b) Error between low amplitudes tests.

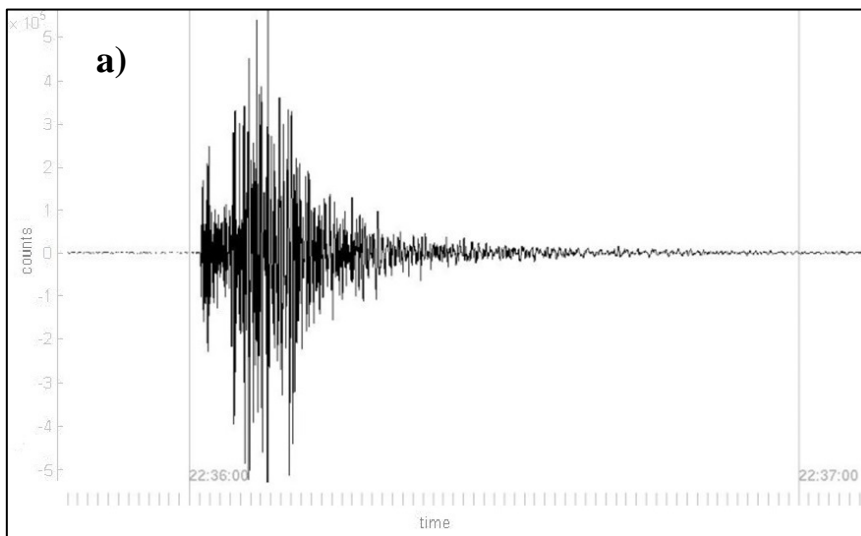
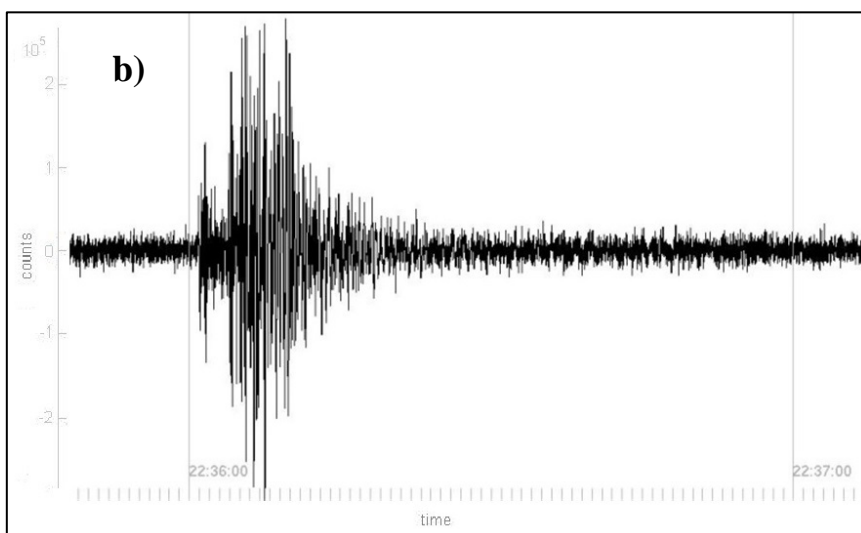
**Figure 12** Obtained events on *El Hierro* Island in Canary Islands, on September 3, 2014 at 22:36.(a) Taurus reference equipment signal (b) Designed equipment signal

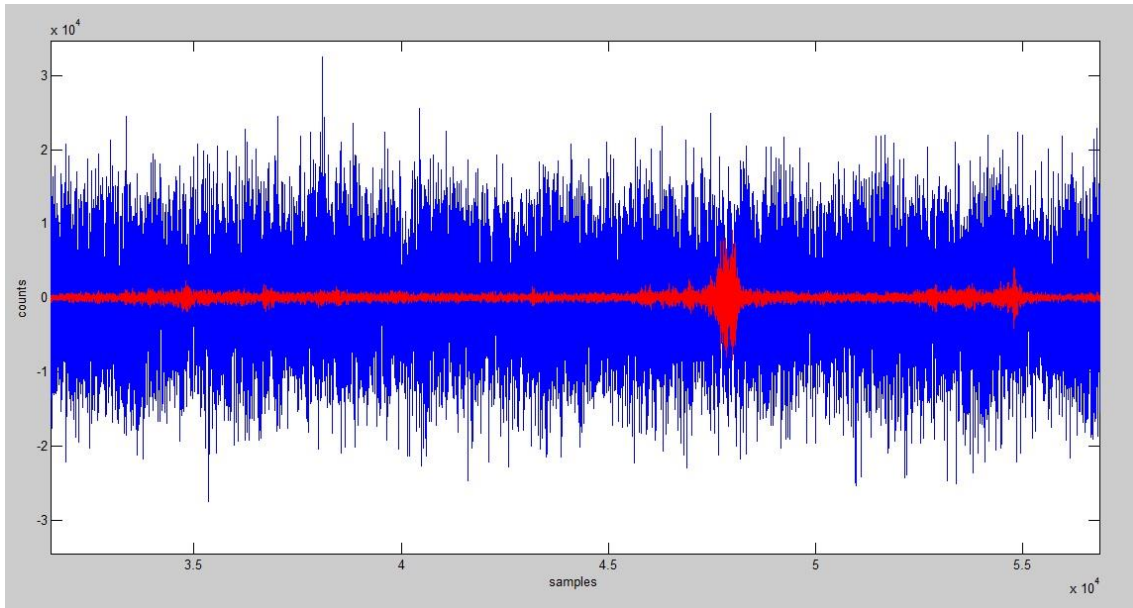
**Figure 13** Comparison of acquired signals. Designed equipment in blue, and reference equipment in red.

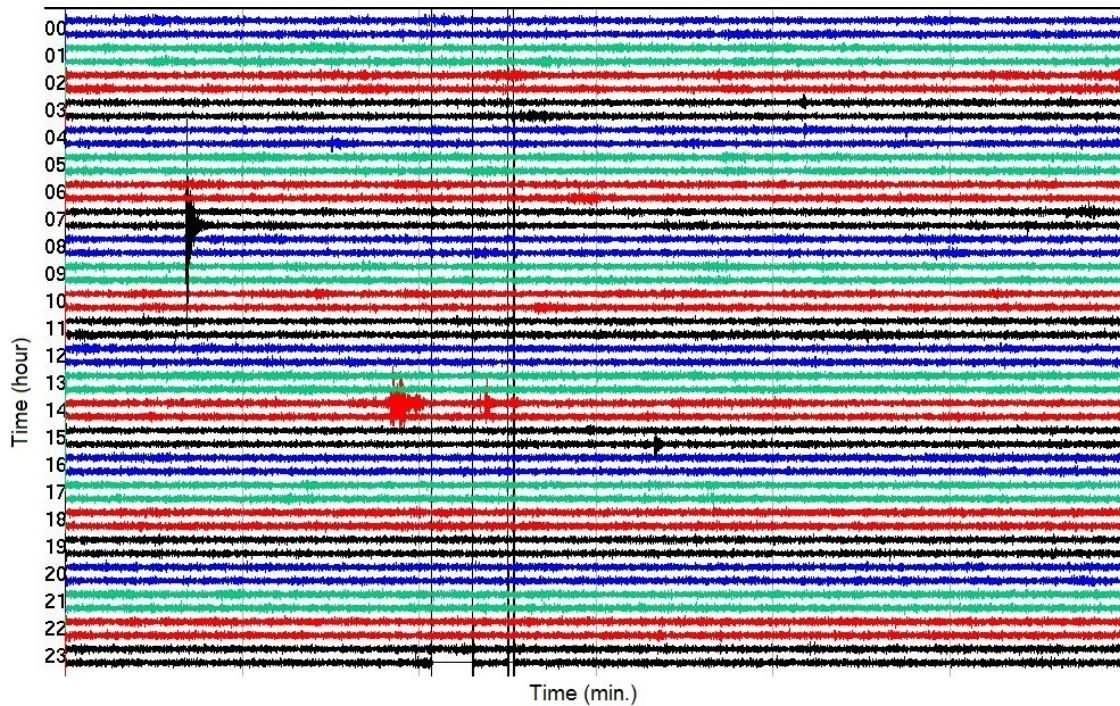
**Figure 14** Signal acquired by reference equipment in a complete day in *Las Cañadas del Teide* in Tenerife, Canary Islands. December 13, 2014.

\* Each data line of vertical axis represents 30 minutes of the corresponding hour.

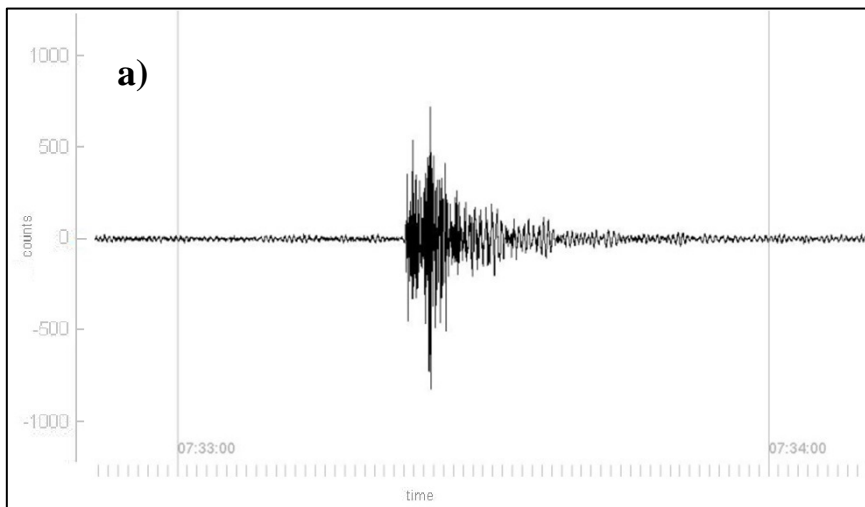
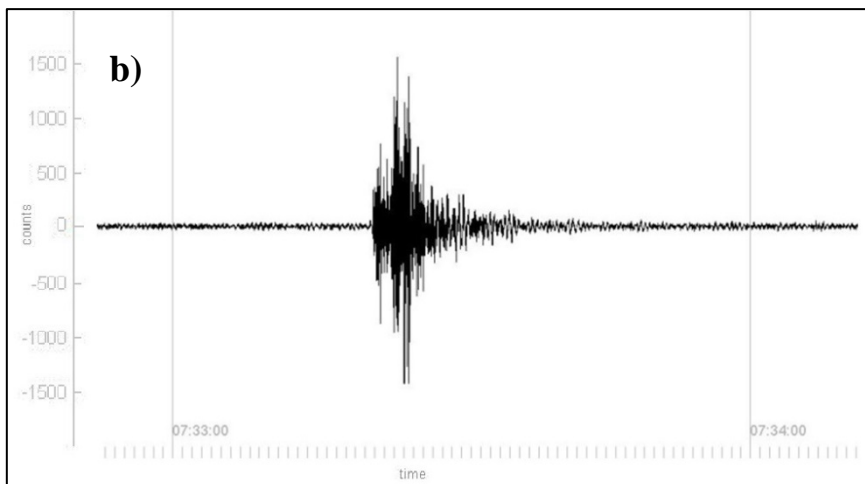
**Figure 15** Obtained events in *Las Cañadas del Teide* in Tenerife, Canary Islands, on December 13, 2014 at 07:33. (a) Guralp reference equipment signal. (b) Designed equipment signal.
