MASTER THESIS

Experimental Investigation of Fatigue Behavior of Curved Composite Laminates

Universitat Politècnica de Catalunya
Master in Aerospace Science & Technology
July 2016

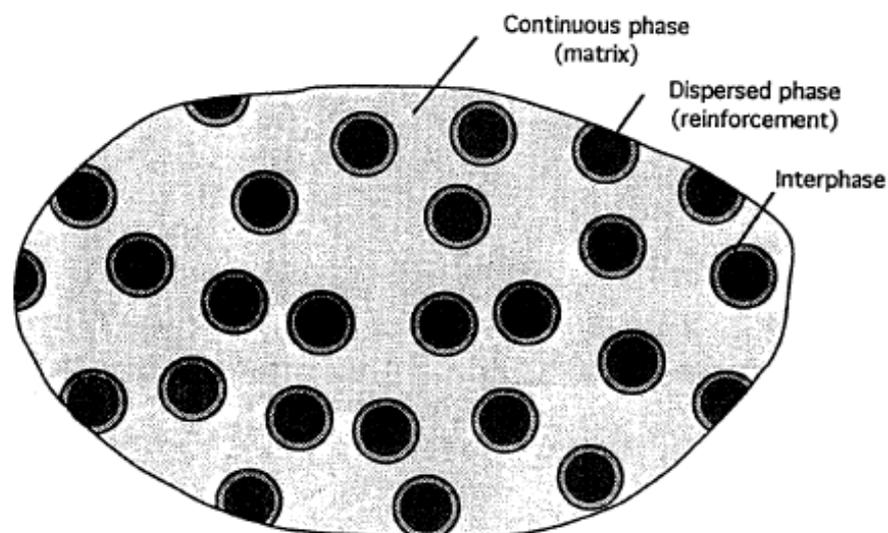
Figure 1.1 Illustration of phases forming composite materials [1]

Composite is a material which consists of two or more phases on a macroscopic level, in order to achieve superior designs by using independent mechanical performance of the forming materials. One of the phases of composite materials is reinforcement and the other is matrix (**Figure 1.1**). The reinforcement may be in the form of fibers, particles or flakes. The matrix phase materials are continuous and provide protection and support [1, 2]. Desired properties are obtained by stacking reinforcement phase in the appropriate direction.

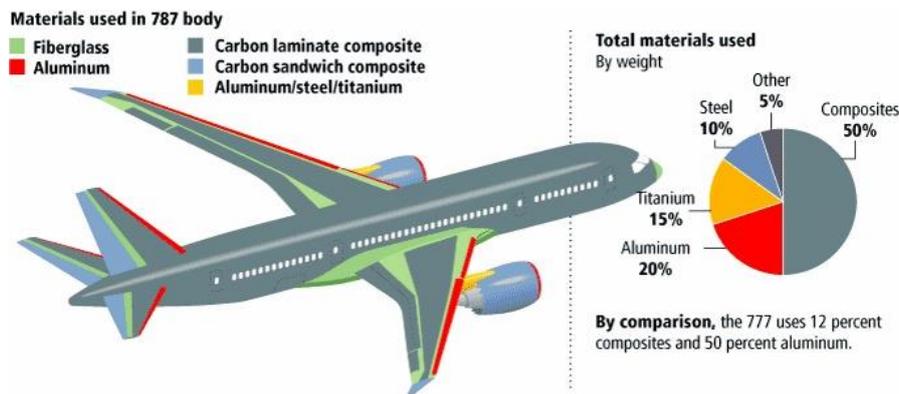
Figure 1.4 Types of materials used in 787 aircraft structure in weight percent [9]

The first composite aircraft in history is accepted the British two-seated small airplane Bristol Scout in the 1910s, however, the usage of composites in large transport aircrafts was not seen until the early 60s [5,6]. In the last decades, there has been an increasing trend in using composite materials in aerospace industry. In **Figure 1.2** the evolution of composite materials in aerospace industry is presented. In 1970s only 5% of airframe weight was manufactured by composite materials. Airplane manufacturers used composite materials as secondary structures and in control surfaces as can be seen in **Figure 1.3**. In 1988, Airbus introduced A320, the first airplane with tail section made of composite and in 1995 Boeing built B777 with composite tail too [7]. As shown in Figure 1.3 the usage of composite materials in airframe increases year by year and nowadays even fuselage is manufactured by composite. In these days, new aircrafts consist of approximately 50% of composite materials (**Figure 1.4**).

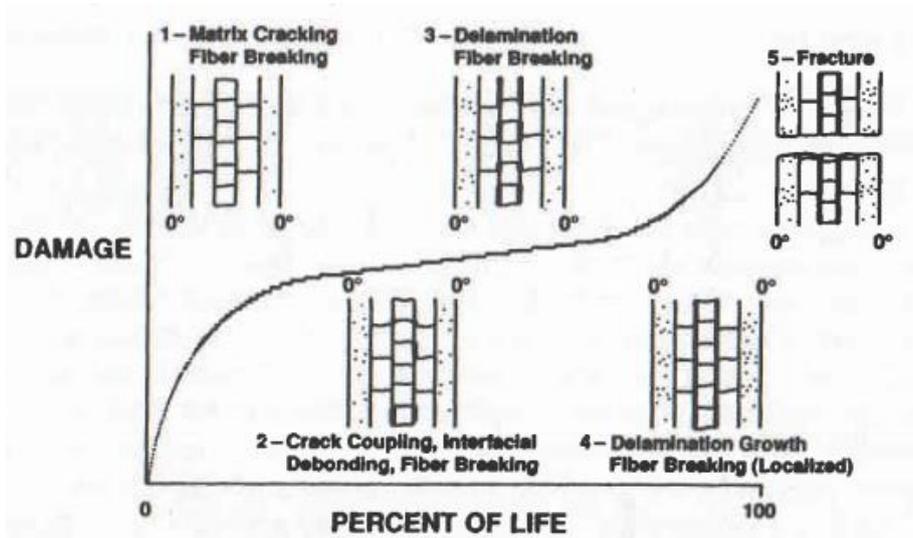
Figure 1.5 Variety of damage modes of composite materials under fatigue loading [15]

Composite materials have taken place of metals in aerospace systems due to their superior properties. Especially, composite materials offer great resistance to fatigue loading compared to metals. Fatigue behavior of composite materials totally differs from that of metals. Predictable crack initiation and growth are observed in metals leading to failure [11]. However, composites have different failure mechanisms such as delamination, matrix cracking, transverse-ply cracking, debonding, fiber failure, etc. It is difficult to predict the damage modes and which mode or modes will dominate the failure [11, 13]. In **Figure 1.5** variety of different damage modes of composite materials under fatigue loading is shown. The early stage of damage development consists of matrix cracking in the off-axis plies. Phase 2 begins by initiation of transverse cracks which is called the secondary matrix cracks leading to the interlaminar cracks. In the following phase, these interlaminar cracks cause separation of the plies locally. In the final phase of damage development, matrix cracking interactions increase and locally

failed regions find a path, then localized fiber failures are formed which rapidly lead to the loss of structural integrity of the material, hence, fracture.

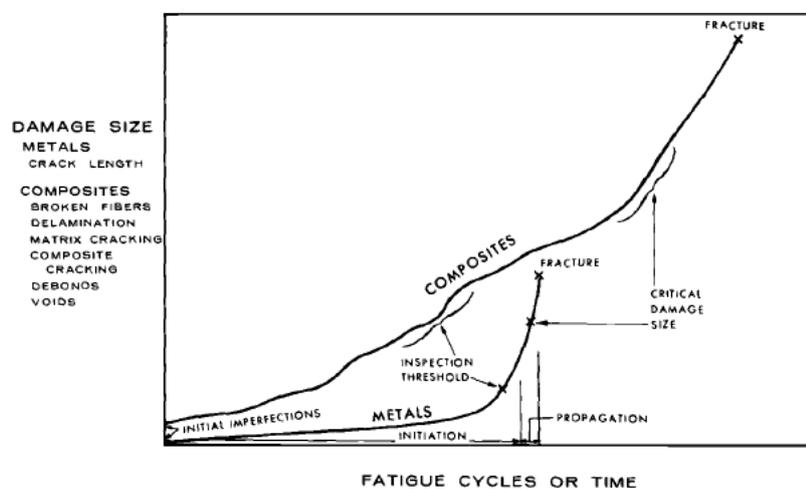
Figure 1.6 Comparison of fatigue behavior in metals and composites [11]

The difference between fatigue behavior of composite materials and metals is shown in **Figure 1.6**. All structures have initial flaws which may eventually cause fatigue crack growth [14]. As illustrated in **Figure 1.6**, the initial damage in composites, as broken fibers, matrix cracking, etc., can be much larger than initial imperfections in metals, which are primarily small cracks. The crack initiation time represents most of the fatigue life of metals. Then the propagation of crack until catastrophic failure occurs suddenly with little warning [13]. **Figure 1.7** shows the fracture surface of a coil spring. The fatigue crack starts at a surface flaw and it progresses in the direction of maximum stress [12]. In contrast of metals, composite materials cracking occupies only the end of the fatigue life. Hence, depending on the fiber orientation, composite materials are more damage tolerant over metals [11, 15].

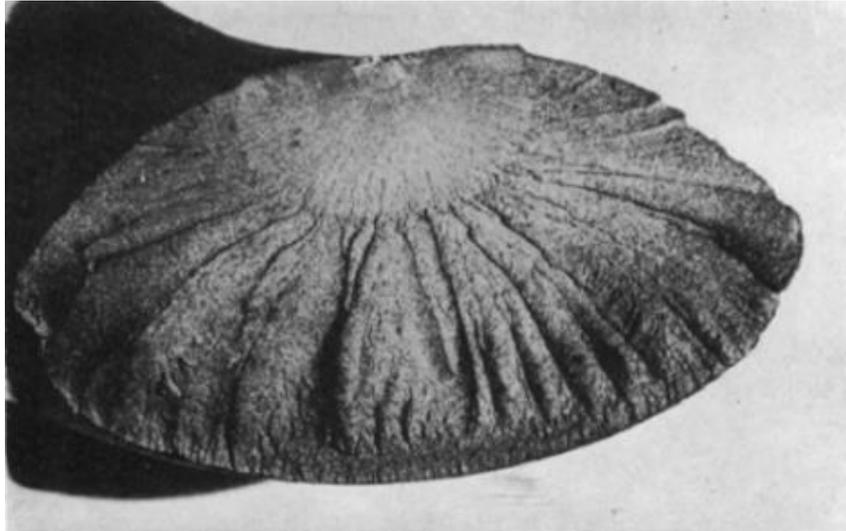
Figure 1.7 Fatigue fracture surface of a coil spring [12]

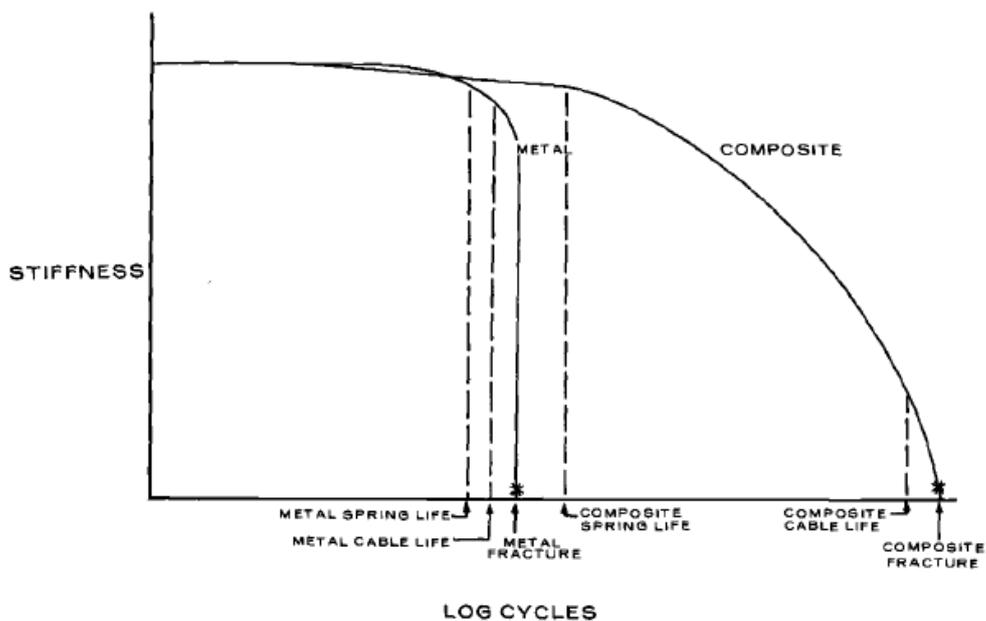
Figure 1.8 Schematic stiffness comparison of metal and composite under fatigue loading [11]

Figure 1.8 shows the stiffness versus life plot of metal and composite materials. Conventional metals hold stiffness until the end of their life, then, stiffness drops sharply. In contrast, composites lose stiffness gradually over the lifetime [15].

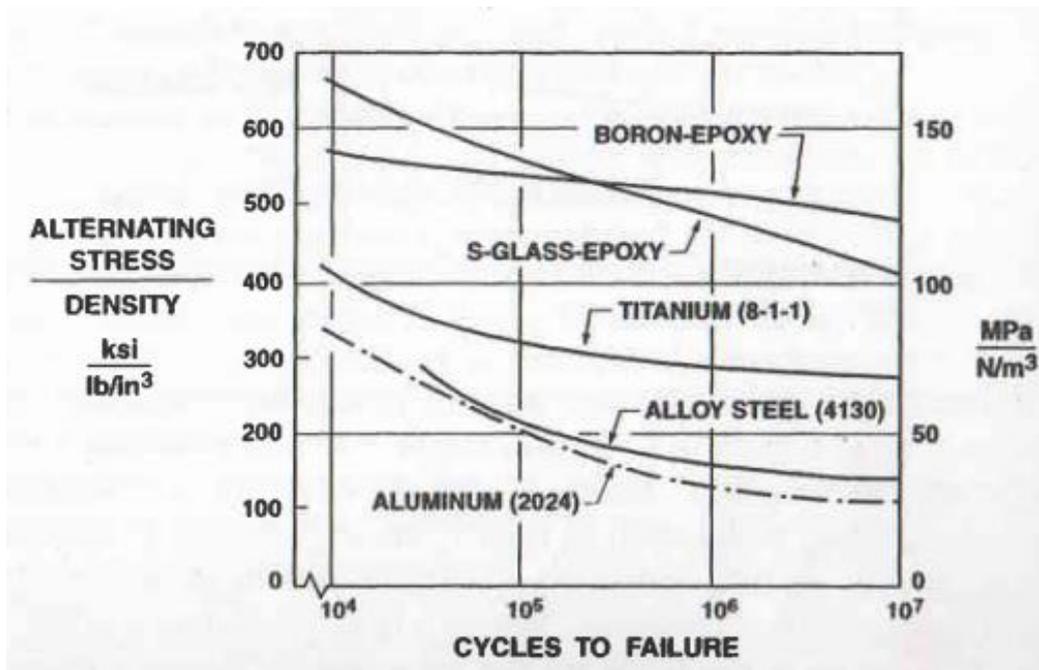
Figure 1.9 SN curves of different metals and composite materials [15]

Typical SN curves for different composite materials and metals are shown in **Figure 1.9**. Curves of composite materials are flatter than those of the metals. The initial advantage of higher strength of composites over metals provides higher performance under high cycle fatigue loading [15]. This advantage of longer life besides specific strength and stiffness over metals is the primary reason to increase the demand of composite materials in aerospace and wind turbine applications.

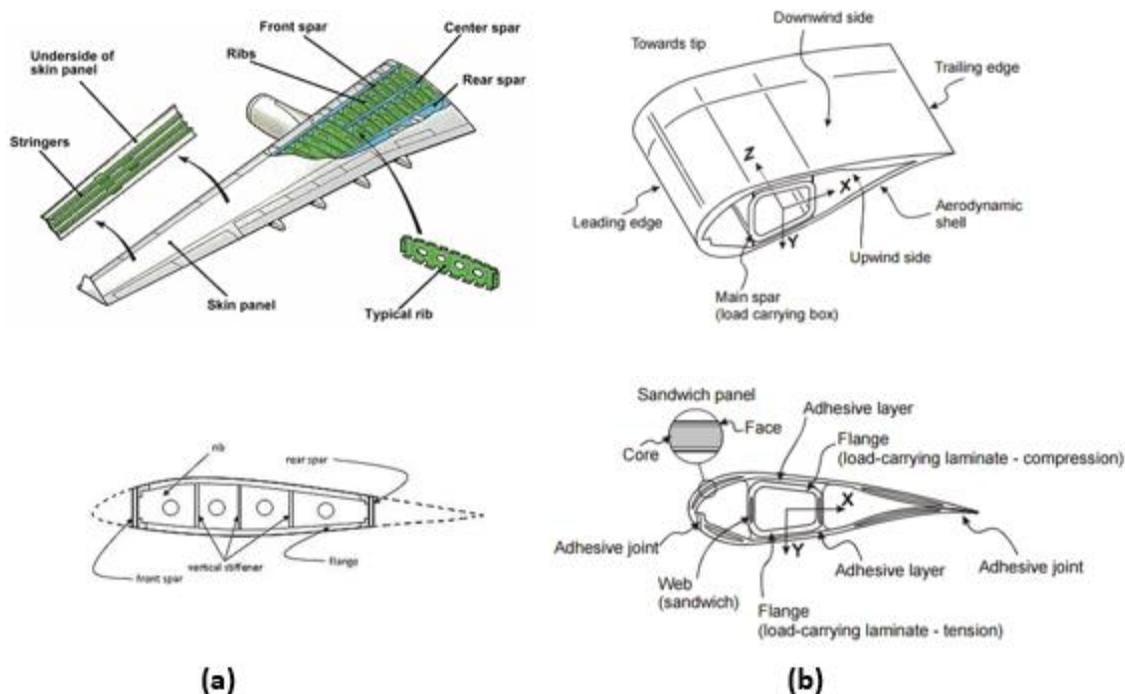
Figure 1.10 Application of curved composite laminates [17] (a) wing internal structure; (b) wind turbine blade structure [18]

The wing is essentially a beam which transmits and gathers the entire applied air load to the attachment to the fuselage. The most critical part of the airplane is wing box which is required to be light and strong enough to endure bending and torsion moment created on the wing [16]. With developing manufacturing capabilities of composites, more complex geometries such as curved composite laminates can be used in aircraft and wind turbine industry instead of metallic structures. These box structures consist of load carrying members as ribs, spars and stringers, which are the main applications of curved composite materials replacing metal components. **Figure 1.10** shows the applications of curved composite laminates in aircraft wings and wind turbine blades.

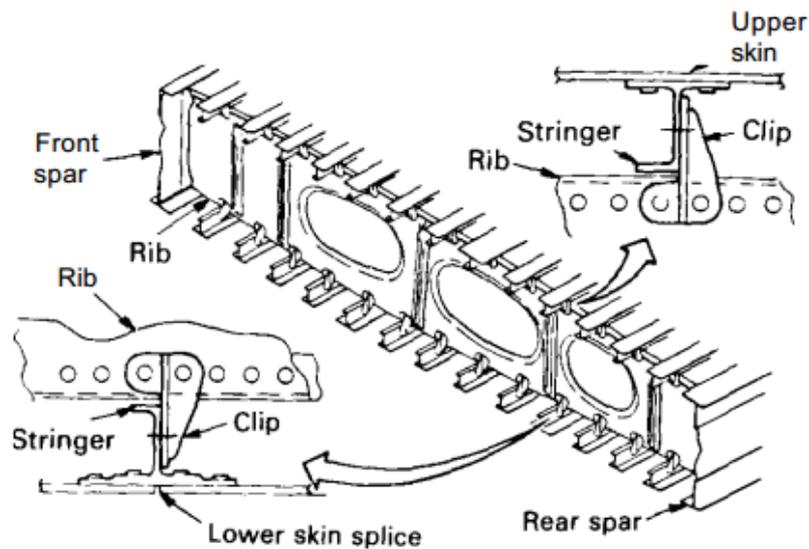
Figure 1.11 Typical rib construction [16]

Ribs: In an aircraft, ribs are forming elements of the structure of a wing. Ribs form the airfoil shape of the wing, and the skin adopts this shape when stretched over the ribs. The ribs need to support the wing panels, achieve the desired aerodynamic shape, add strength, prevent buckling, and separate the individual fuel tanks within the wing [19] as shown in **Figure 1.11**.

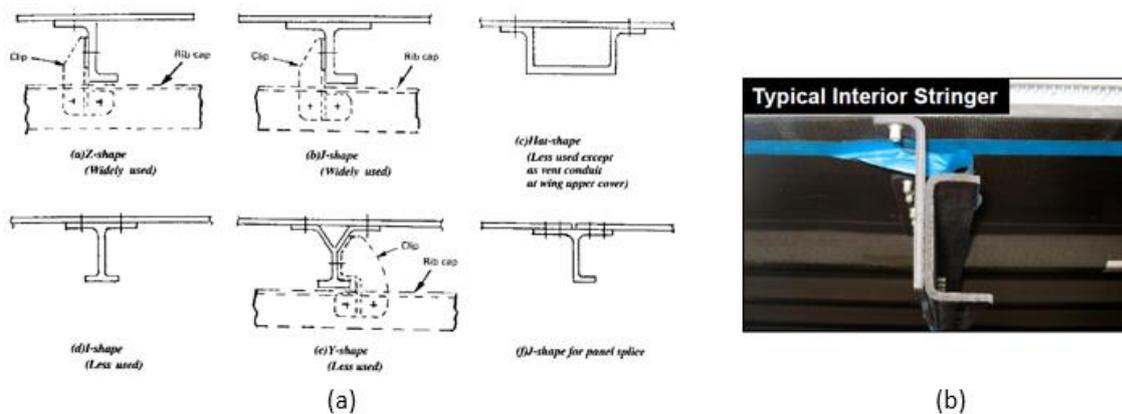
Figure 1.12 (a) Types of stringers; (b) Boeing 787 interior stringer panel [16, 20]

Stringers: A stringer is a thin strip of material, to which the skin of the aircraft is fastened (**Figure 1.12**). Its primary function is to transfer the bending loads acting on the wings onto the ribs and spar [19]. Stringers are the most effective mechanism to save weight [16]. **Figure 1.12b** shows the typical interior stringer of the Boeing 787.

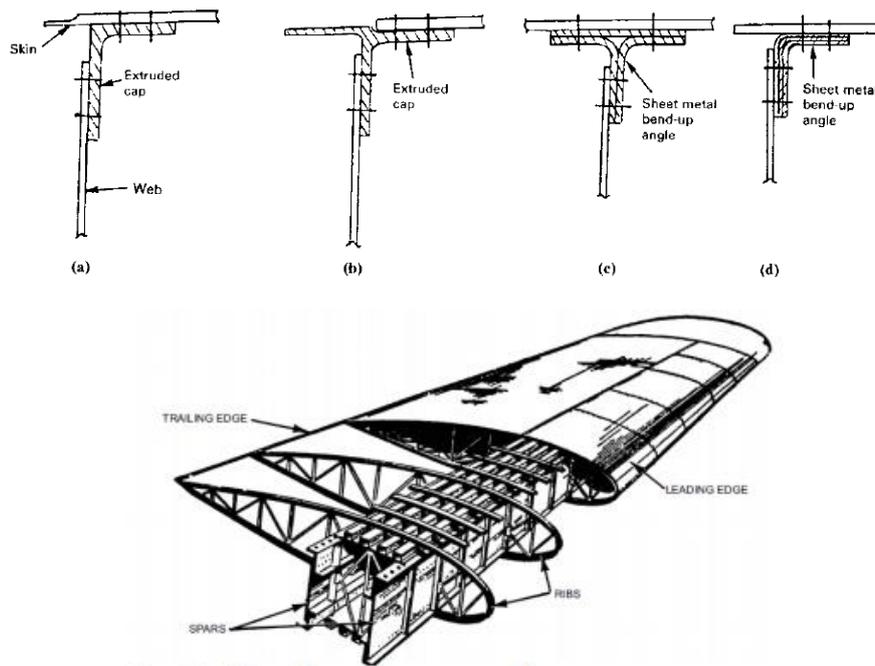
Figure 1.13 Typical spar cap configurations [16]

Spars: Spars are the main structural members of the wing. They extend from the fuselage to the tip of the wing (**Figure 1.13**). The entire load carried by the wing is taken up by the spars. The spars are designed to have great bending strength [21].

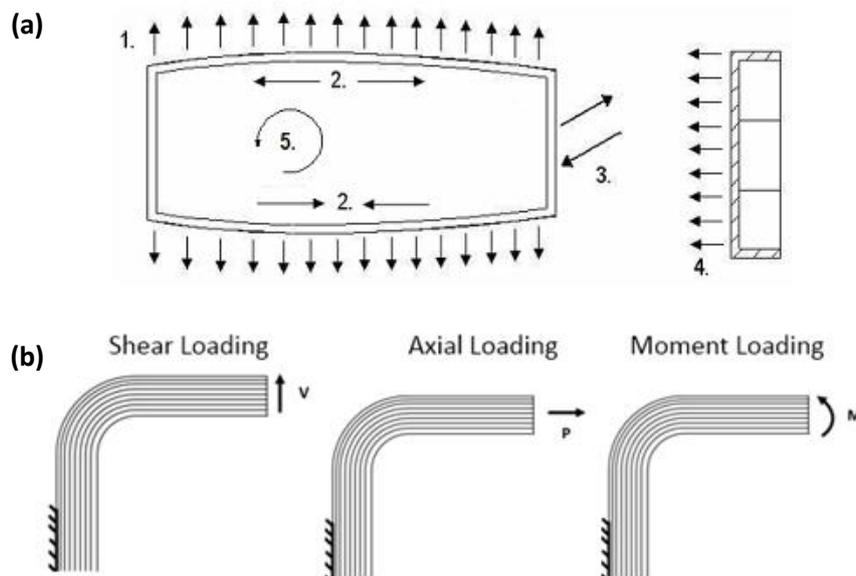
Figure 1.14 (a) Types of loads applied on a typical rib box structure; (b) reaction forces on the curved section of the composite laminate [24]

In every flight, a typical wing rib section located in a wing box is subjected to mainly three types of loads acting on a wing rib section, which are: the axial load (parallel to the arm, P), the shear load (perpendicular to the arm, V), and the bending moment (M) (**Figure 1.14b**). These are the reaction forces to the applied loads on wing rib structure (**Figure 1.14a**). These loads can be explained as follows [24]:

- Shear loads in the web
- Distributed pressure load at the sides due to the air and fuel inside the box structure, resulting in moment load at the curved section
- Compression and tension loads in the chord wise direction due to the Poisson's ratio effect and end load at spars
- Shear flow distribution on a rib bordering a cut-out
- Torsion loads due to the air flow during flight
- Redistributes concentrated loads: such as nacelle and landing gear loads to wing spars and cover panels

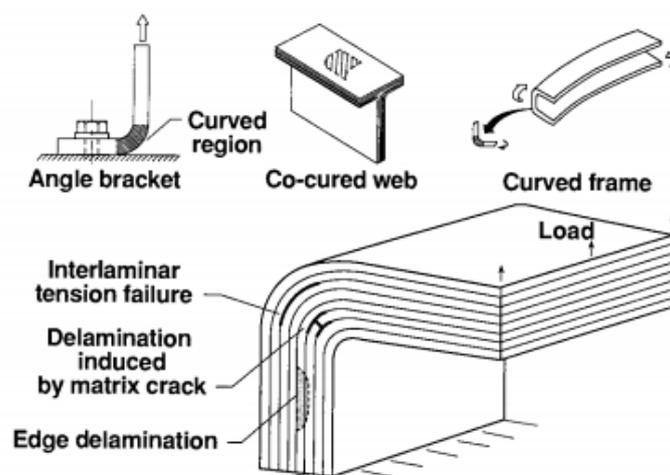
Figure 1.15 Curved composite laminate configurations and failure modes [27]

Delamination occurs due to high interlaminar stresses, which arise from material discontinuities, geometric discontinuities or eccentricities in the load path. Curved composite laminates consist of all of these interlaminar stress sources. Mostly the composite laminates are multidirectional and the difference in material properties between adjacent plies of different orientations also cause singular stresses at the free edges which initiates edge delaminations. Delaminations at the corner of the laminates may initiate due to interlaminar tensile or interlaminar shear stresses which cause radial stresses because of the curvature [27]. Delaminations may occur due to voids and errors formed during the manufacturing process too. **Figure 1.15** presents structural configurations and variable damage modes for curved composite laminates.

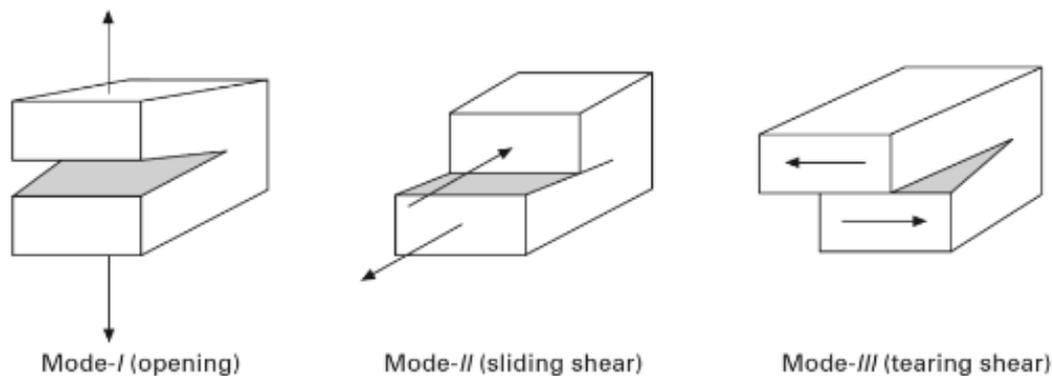
Figure 1.16 The three modes of fracture [28]

The curved region of the laminate is considered as a fatigue critical location. Delamination initiation and propagation occur in combination of the three fracture modes: Mode-I, Mode-II and Mode-III, as shown in **Figure 1.16**. Mode-I represents the opening mode of the crack faces, Mode-II is the sliding mode and Mode-III corresponds to the tearing mode deformation [28]. In order to understand the characterization of the delamination, complete mix-mode failure analysis have to be conducted.

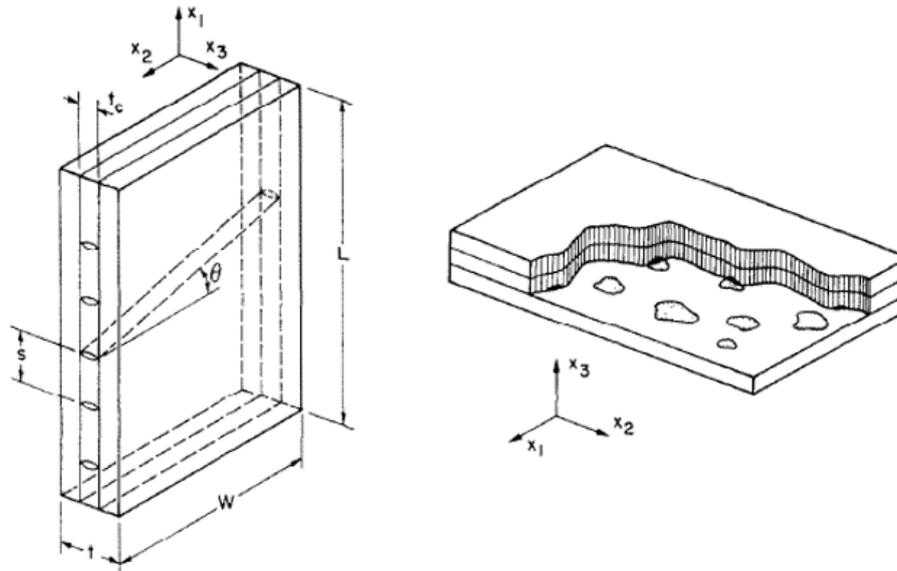
Figure 2.1 Representative volume element of a composite laminate having (a) Intralaminar cracking; (b) Interlaminar cracking [38]

Talreja (1986) focused on two damage modes in composite laminates namely, intralaminar damage (matrix cracking) and the interlaminar damage (interior delamination) in the paper 'Stiffness Properties of Composite Laminates with Matrix Cracking and Interior Delamination'. In this study, the deformational response of the composite laminates to mechanical loads were considered. With this aim, a representative volume element about material point, containing intralaminar cracking was constructed (**Figure 2.1a**). **Figure 2.1b** represents the volume element for interlaminar cracking corresponding to interior delamination. Of a composite laminate. An interlaminar layer was displayed to show the presence of interior delamination. Using these volume elements, vectorial representation of two types of damages were defined and relationship between the overall stiffness properties and the damage in the individual modes were derived from a phenomenological theory.

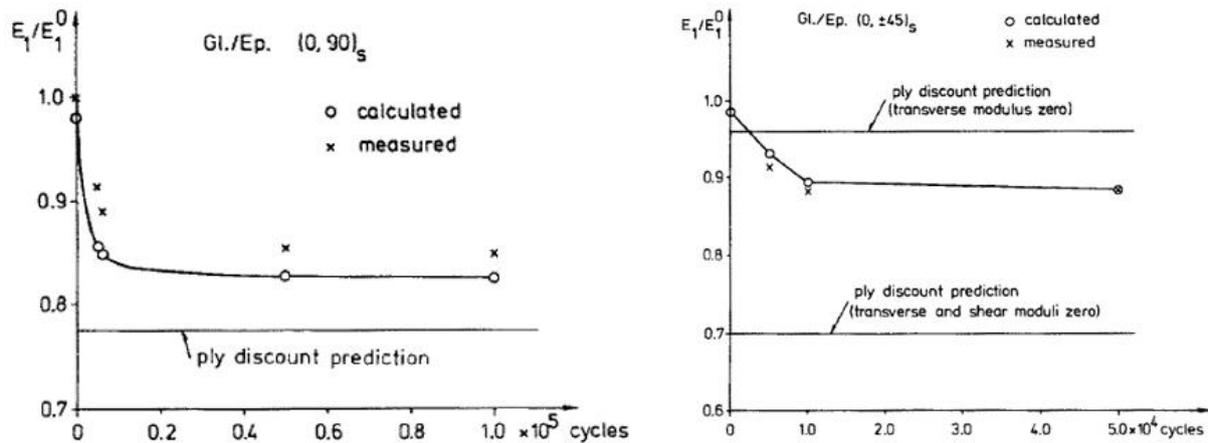
Figure 2.2 Variation of the longitudinal Young's modulus under tensile fatigue loading (a) $[0, 90]_s$ glass epoxy laminate; (b) $[0, +45]_s$ glass epoxy laminate [38]

The calculated relationships showed that the matrix cracking reduced all elastic modulus and changed the initial orthotropic symmetry of a laminate. However, the interlaminar damage did not change the symmetry but reduced the elastic modulus as well. Complete understanding of the damage evolution and changes in the deformational response of the material corresponded to not only the properties in the longitudinal direction but the changes in all stiffness coefficients. The determination of changes in the engineering modulus required knowledge of the phenomenological material constants for intralaminar cracks. Consequently, the required phenomenological constants were determined analytically. These constants were used in the derived stiffness-damage relations and elastic modulus degradation was predicted, then compared with the experimental results as shown in **Figure 2.2a** and **Figure 2.2b**. The results of predictions and the experiments were in good agreement. It was stated that, these modulus degradation typically occurred in the first stage of fatigue damage. A theoretical work was conducted on the effect of interlaminar cracking to the elastic modulus. Significant stiffness degradation was predicted in the second stage of the fatigue damage dominated by interior delaminations. However, the effect of this cracking mode on stiffness properties was not evaluated experimentally [38].

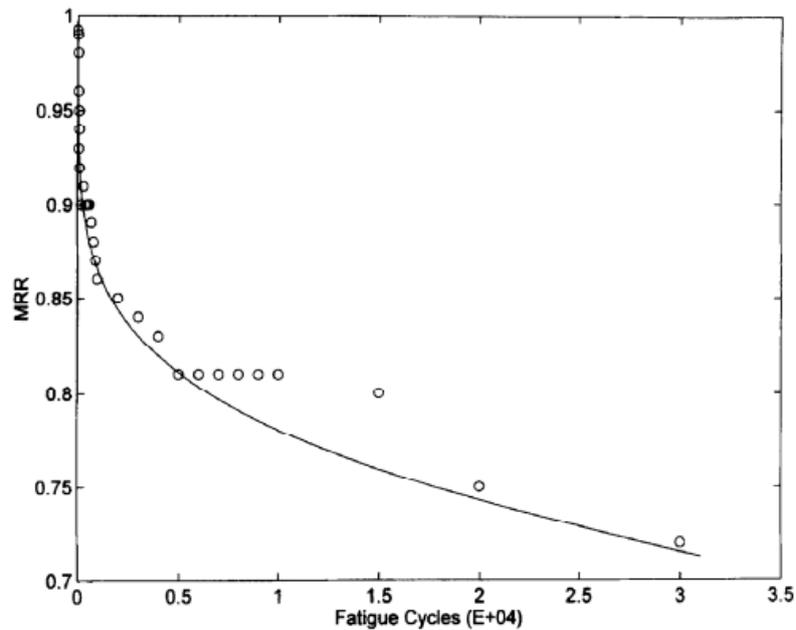
Figure 2.3 Stiffness degradation model and experimental data [30]

Applied stress was calculated with the strain value corresponding to different cycles and modulus reduction ratio (MRR) was obtained analytically. All data and parameters obtained from experiments were used to predict the statistical distribution of the MRR at any applied stress level. **Figure 2.3** shows the prediction and the experimental results of MRR. There was a good agreement between the model and the experiments. The accuracy improved with increasing cycles due to rapid stiffness loss occurrence in the early cycles [30].

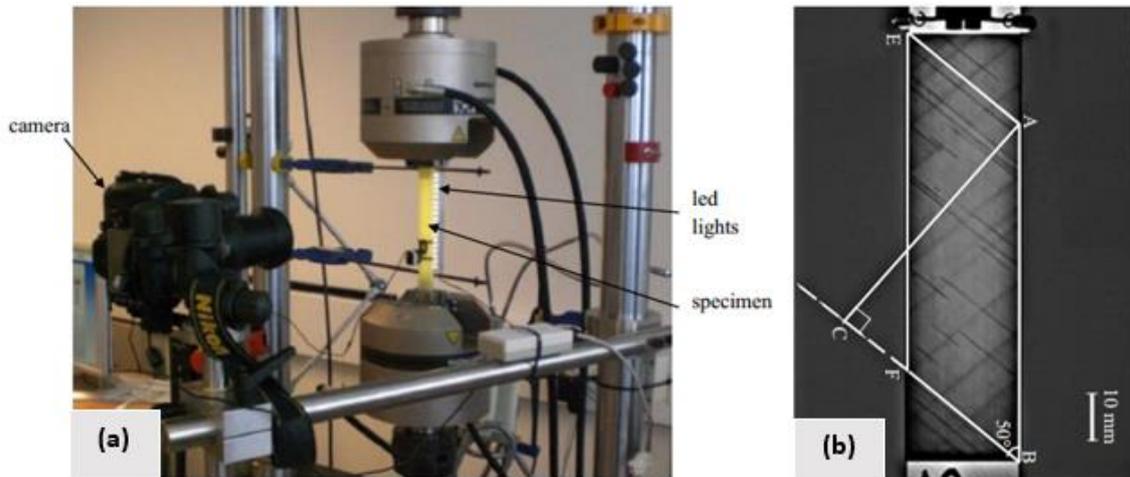
Figure 2.4 (a) Fatigue experimental setup; (b) Damage occurred on flat specimens under fatigue loading [29]

transparent and crack propagation was observed using uniform distributed light source. The experimental setup is shown in **Figure 2.4a**. Cyclic loads were applied with 3-5 Hz frequency and at an R-ratio of 0.1 where $R=P_{\min}/P_{\max}$. P_{\max} value was set for strain values in the range of 0.4% and 1.1% of the maximum strain. As the stiffness of the specimens decreased with the cycles due to damage evolution the applied load was constant while the strain values increased.

As expected, the first crack initiation was followed by multiple onsets through the whole specimen as shown in **Figure 2.4b**. The cycle of delamination onset was recorded for variable σ_{\max} and SN curve was generated. Crack propagation was analyzed and crack locations was found to be far enough that the cycles spent for each crack onset could be considered as independent fatigue results. The increase in crack density in the off-axis plies led to the stiffness degradation of the test specimens. It was easily observed that stiffness reduction in earlier fatigue lifer was strongly dependent on the load level.

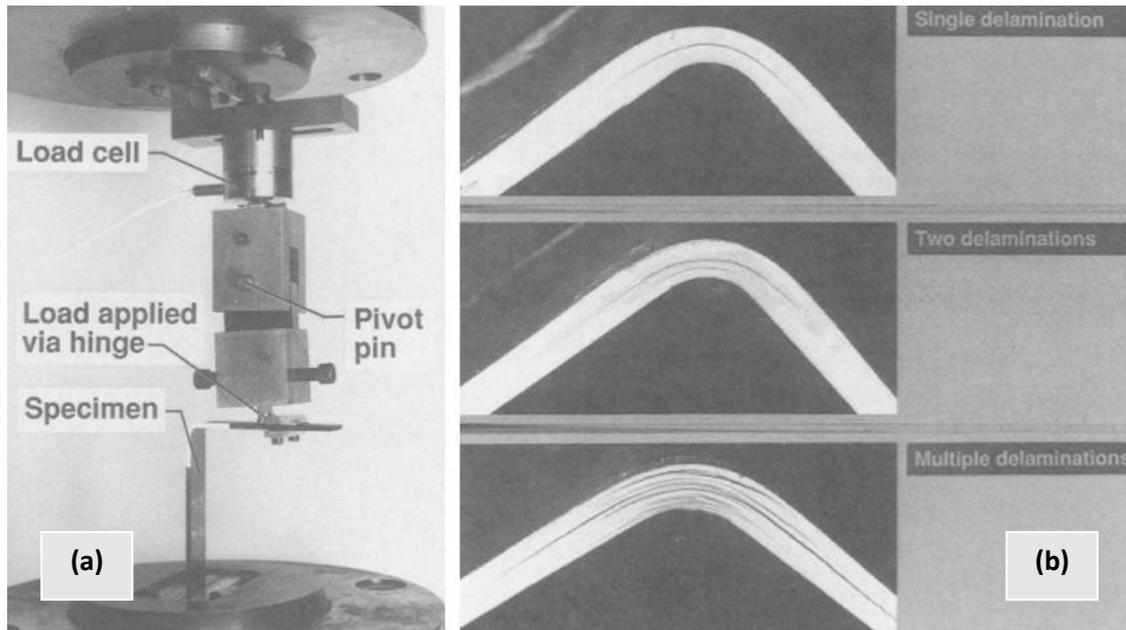
Figure 2.5 (a) Loading fixture; (b) Damage evolution in UD composites [27]

Delamination failure in a UD curved composite laminates was investigated numerically and experimentally in the paper ‘Delamination Failure in a Unidirectional Curved Composite Laminate’ by Martin (1992). It was stated that delamination was the primary failure mode of composites due to their low through-the-thickness properties. This study aimed to predict the maximum load which a unidirectional curved laminate could sustain without any damage. With this aim, simple right-angled 24-ply graphite/epoxy (AS4/3501-6) UD laminates were manufactured. Double cantilever beam (DCB) specimens were also manufactured with 24-ply and [0] UD fibers, as well. Flat specimens were produced also, in order to determine elastic properties of materials. The fracture toughness value, G_{Ic} , was obtained with DCB specimens and the elastic tensile and shear properties were measured using ASTM standards. The fixture for testing the curved composite laminates is shown in **Figure 2.5a**. Load was applied to the specimen at a distance L of 50 mm from the curved region by a hinge, clamped to the specimen. The other leave of the hinge is clamped to the fixture which consisted of a clamp free to pivot. The laminates were loaded quasi-statically under load control and load-displacement data were monitored in order to determine the failure load. The maximum load per unit width and the first delamination location was tabulated in the results. The damage evaluation of the specimens is shown in **Figure 2.5b**. Damage initiated as a single delamination around the curved region in which 46-49% of total thickness and extended through the arm and the leg. Final failure corresponded to delamination at different locations through the thickness of the curved region with the loss of all bending stiffness of the specimen as shown in **Figure 2.5b** (bottom).

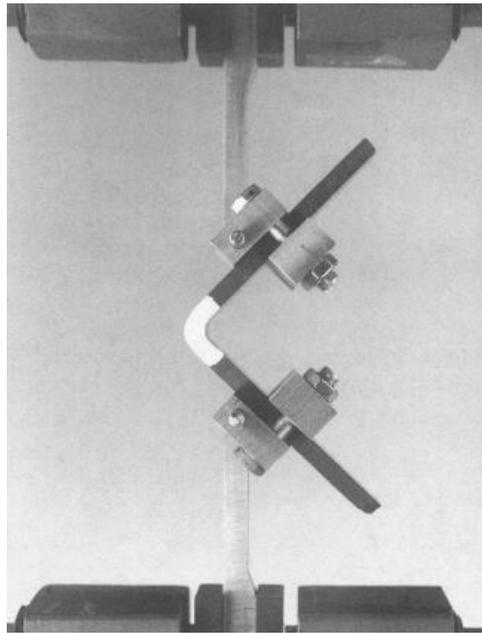
Figure 2.6 Loading fixture and the specimen [31]

lengths and thicknesses namely, 16, 24, 48 plies. The material was AS/3501-6 carbon/epoxy. Initially aluminum hinges were bonded to the tips of the specimens and load was applied through the hinges. However, high loads caused bend or break of the hinges. Thus, loads were applied through a steel loading fixture (**Figure 2.6**) which allowed conducting the experiment in the universal test machine. Experiments were carried out under displacement control with the rate of 0.5 mm/min. load displacement curve was recorded and the initial laminar tension failure coincided with the sudden decrease in load. In order to observe the failure easily, the curved region of the laminates were painted to white.

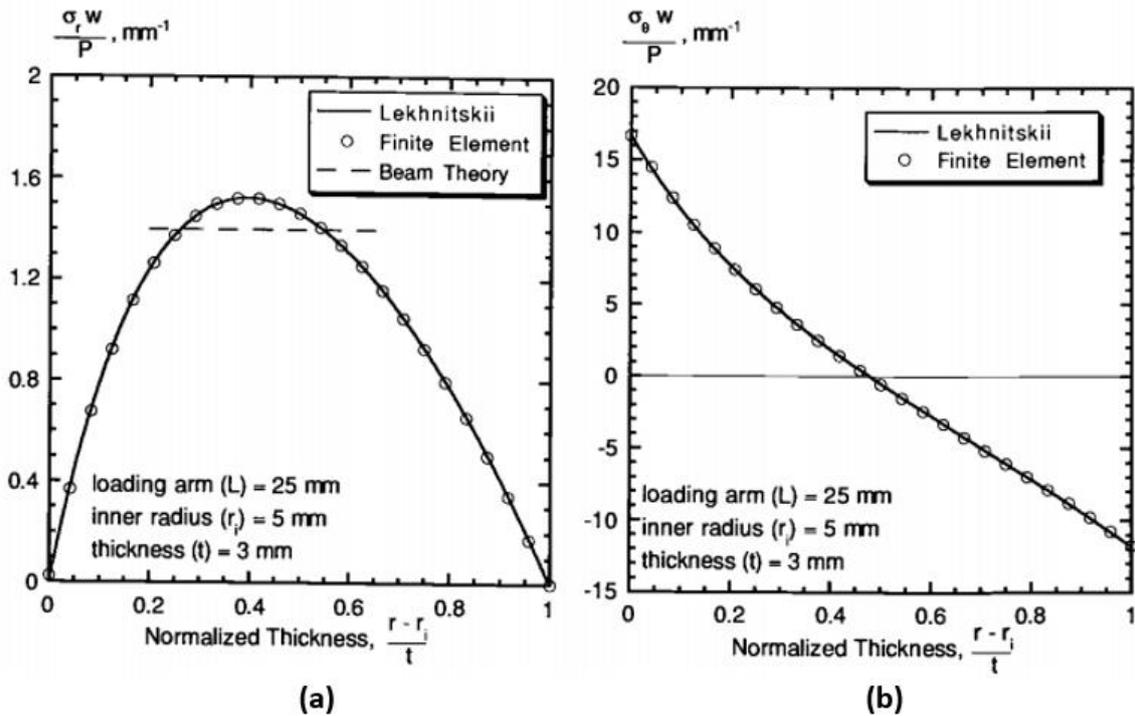
Figure 2.7 FEA results with analytic results (a) Radial stress distribution; (b) Tangential stress distribution [31]

Lekhnitskii solution for a curved beam and beam theory were conducted to determine the radial stresses. Finite element analyses were used to determine the stress state of the laminates, as well. The radial and tangential stress distributions calculated numerically and analytically are shown for 3 mm thick laminate in **Figure 2.7**. Shear stresses were considered as negligible and radial stress increased from zero and varied from tension to compression as the radius increased. The radial stress was maximum at 0.4 of the thickness of the laminates. The failure was dominated by the radial stress alone.

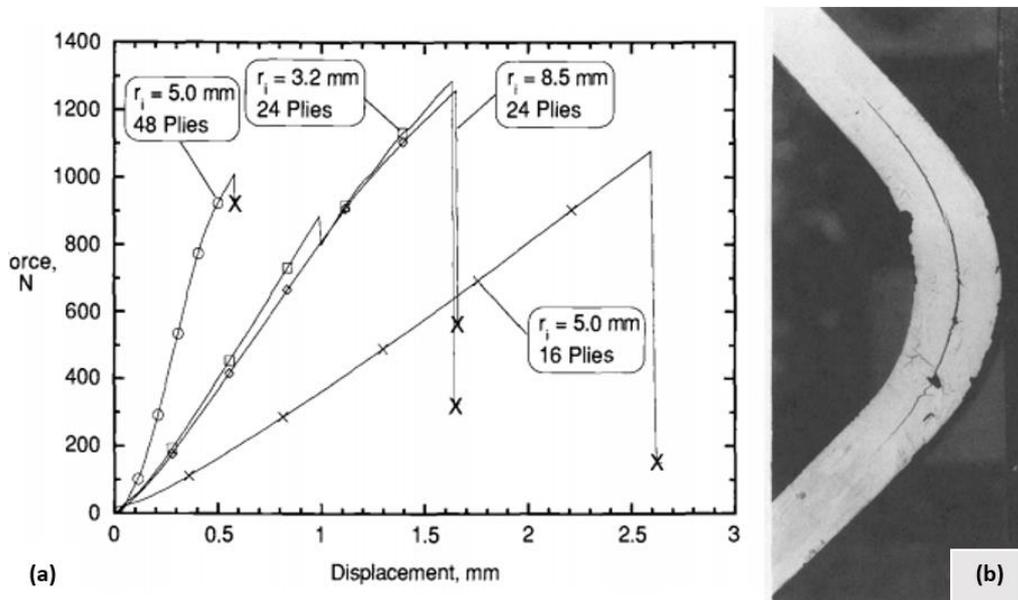
Figure 2.8 (a) Typical load displacement curves; (b) Delamination occurred in the curved region after failure [31]

In the experiments, subcritical damages observed before the catastrophic load drop occurred which corresponded to small load drops resulted in steps the plots. The wider specimens experienced more steps until failure. Failure occurred at the load value which is twice more than the initial damage loads. During the failure the load often drop by 40%. **Figure 2.8a** plots the load displacement of curved laminates with different thicknesses. After failure, circumferential cracks were formed at the curved region. **Figure 2.8b** shows an example of crack existed after failure.

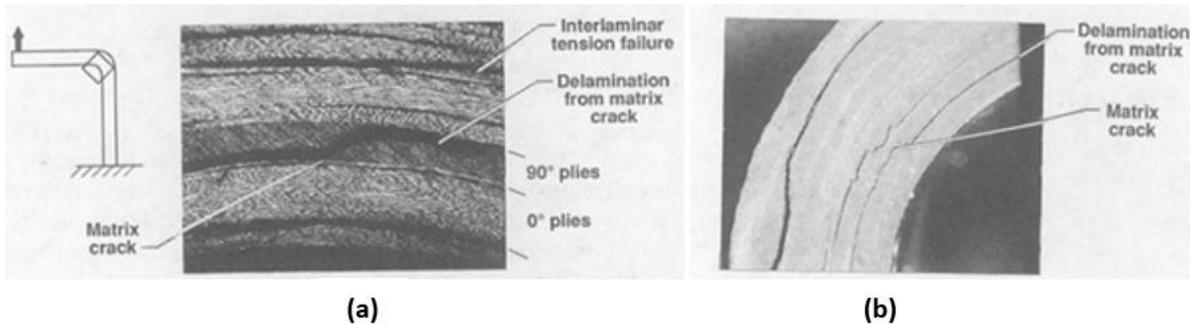
Figure 2.9 Damage in curved laminate (a) Lay-up A; (b) Lay-up B [32]

delamination leading to complete loss of stiffness. As shown in **Figure 2.9a**, an oblique matrix crack occurred in the tension loaded $[90]_3$ plies and interlaminar tension failure occurred in the 0° plies of Lay-up A. Although it was not experimentally proved, it was thought that the matrix crack had occurred before the delamination. **Figure 2.9b** presents two matrix cracking formed in both $[90]_2$ and $[90]_3$ plies of Lay-up B. In analytic calculations, Lay-up A was chosen to be studied due to the second matrix crack formed in Lay-up B created complications. Hence, the maximum load per unit width vs cycles to delamination onset graph of Lay-up A was plotted.

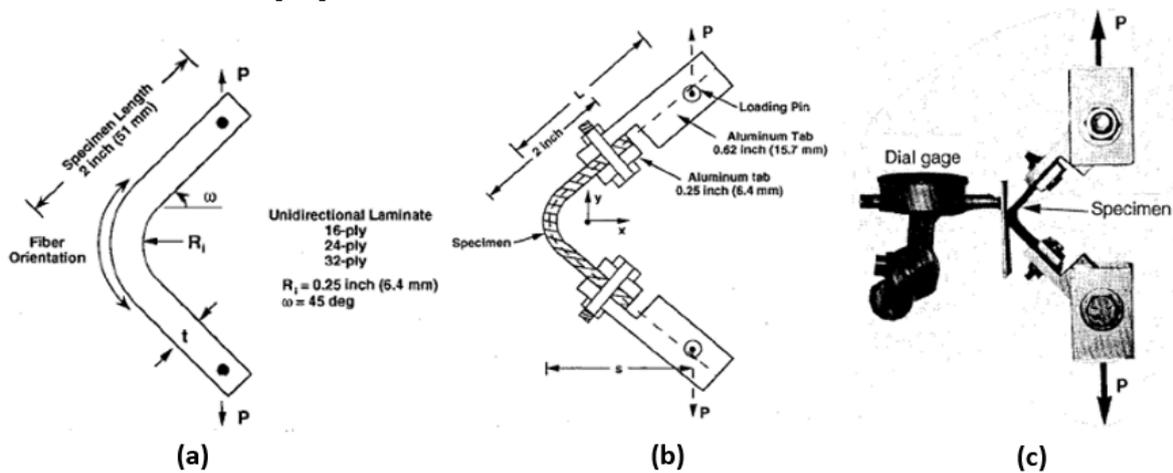
Figure 2.10 (a) Specimen configuration; (b) Illustration of loading fixture; (c) Specimen and the loading fixture [33]

In the paper, 'Interlaminar Tension Strength of Graphite/Epoxy Composite Laminates' written by Shivakumar, Allen and Avva (1994), a tension loading fixture were proposed to measure the interlaminar tension strength of L-shaped curved beam laminated textile composites. The curved specimens had equal legs and three different thicknesses, 16, 24, 32 plies (**Figure 2.10a**) were tested. The material is the AS4/3501-6 graphite/epoxy composite. A special load fixture was designed to test the specimens in a standard tension test machine. **Figure 2.10b** shows the illustration of the specimen attachment and the load case. The specimen and the loading fixture assembly as shown in Figure 2.10c were mounted on a servo-hydraulically controlled tension test

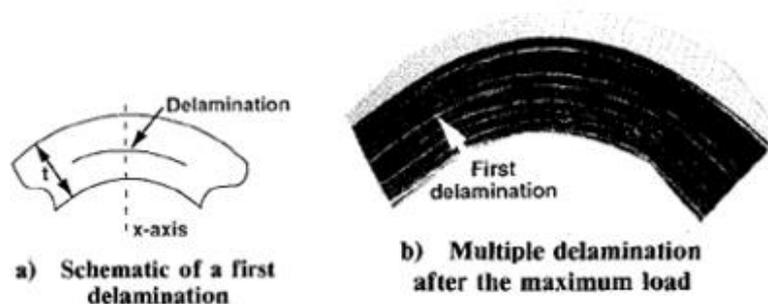
Figure 2.11 Single and multiple delaminations [33]

machine. Tests were conducted under displacement controlled at 1 mm/min. A sudden decrease in load was observed when the interlaminar tension failure load which was used in calculating interlaminar tensile strength and the data was recorded. Delamination corresponding to loss of stiffness occurred near mid-thickness (**Figure 2.11**) where the transverse tension stress was higher.

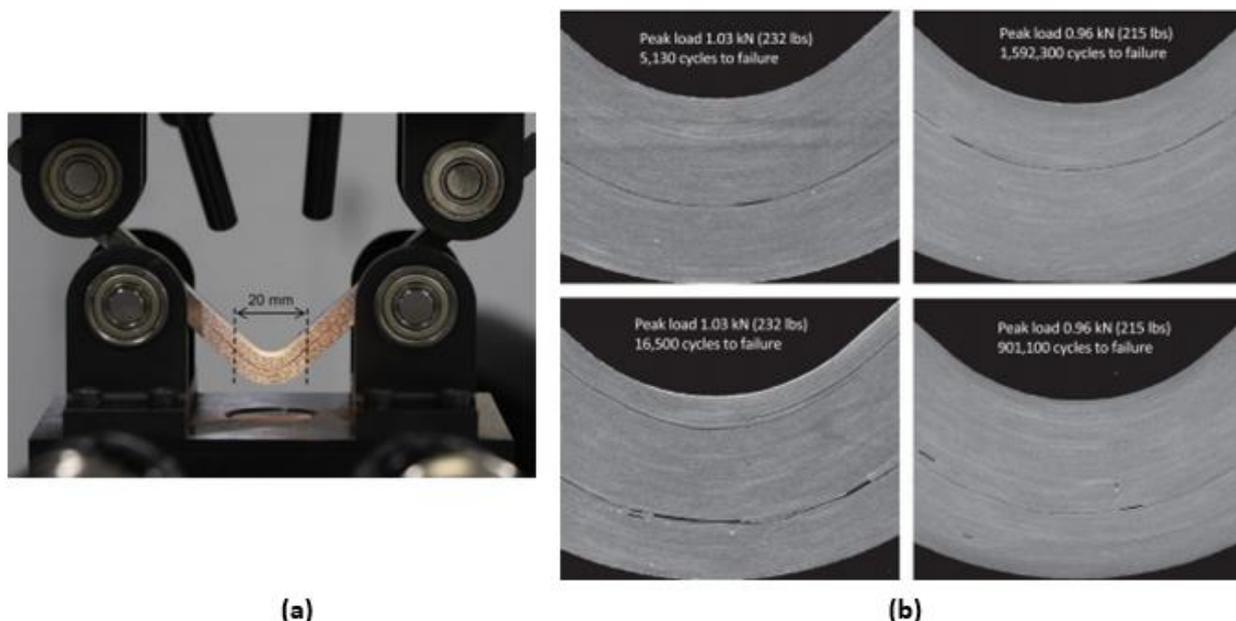
Figure 2.12 (a) 4-point bending test setup; (b) Examples of delaminations on fatigue test specimens [34]

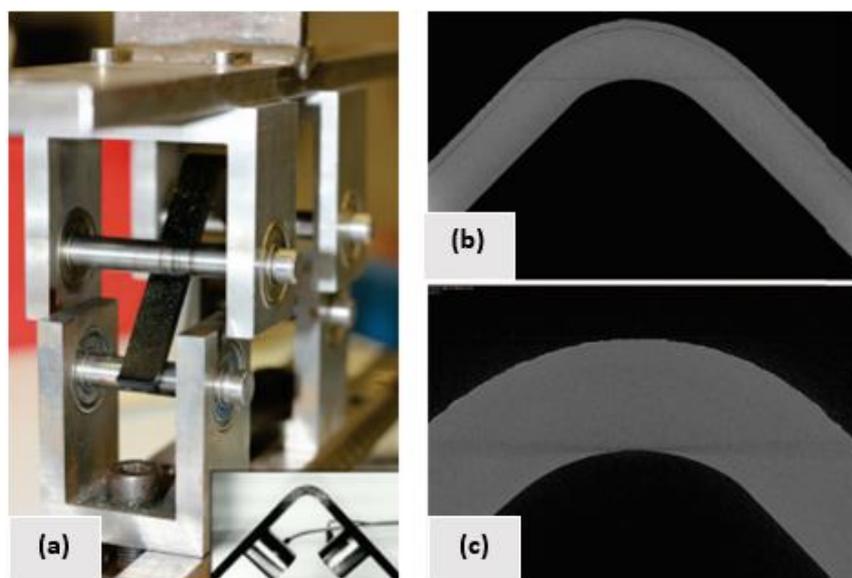
Figure 2.13 (a) Experimental setup; CT scan (a) Before test; (c) After fatigue test [35]

The static strength of the curved composite laminates was obtained from the static tests. CT scans of five specimens were taken after fatigue tests and no damage evidence was found as shown in **Figure 2.13c**. Thus, it was assumed that there was no delamination initiation leading to final failure. Hence, the point of damage initiation was accepted as failure. It was stated that failure occurs where the maximum radial stress arose at 40% of the through the thickness of the curved region. Full SN curves were generated from the fatigue tests and it showed that fatigue endurance increased with decreasing severity. This work had been conducted in order to develop a model to predict Mode-I fatigue delamination growth of this material [35].

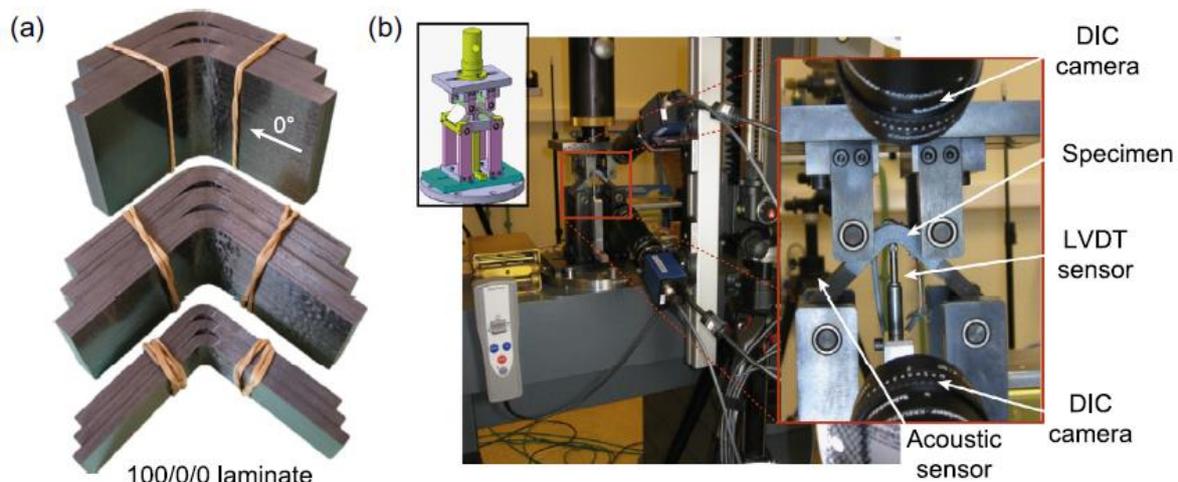
Figure 2.14 (a) Curved composite laminates; (b) Experimental device [36]

and Total Thicknesses', Charrier et al. (2015) focused on the out-of-plane tensile strength of curved beam carbon/epoxy laminates. 4-point bending test was conducted on curved composite specimens in order to obtain out-of plane properties of the material. The specimens were manufactured from T700GC/M21 UD pre-preg plies with different stacking sequences, arm length, width and thicknesses, namely 16, 32, 48 plies. The parameters such as the distances between the rollers of the test fixture were optimized for different specimens. The tests were performed under displacement control. Different measurement techniques were used to record the maximum displacement and load. **Figure 2.14** shows the specimens and the experimental setup. FEA were conducted in order to compare the stress state results with the experiments.

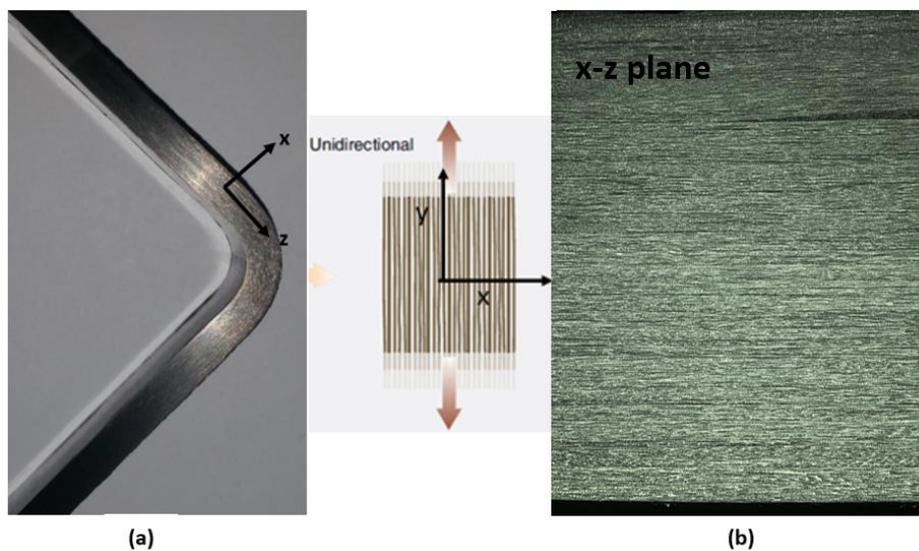
Figure 3.1 (a) [0] UD specimen showing in thickness plane; (b) Micrograph of the side view of [0] UD specimen

$[0]$ UD lay-up consists of 30 plies of 0° positioned UD pre-pregs (**Figure 3.1a**). UD pre-pregs are laid through the thickness. HexPly® AS4/8552 UD carbon pre-pregs are used having 0.184 mm thickness. **Figure 3.1b** shows the micrographs of the side view of the laminates. It can be seen from the figure that UD pre-pregs are laid through the same direction. It is more difficult to hand lay-up UD pre-pregs to manufacture complex geometries, relative to fabric pre-pregs. This lay-up configuration is selected in order to investigate the behavior of the fiber dominated laminates.

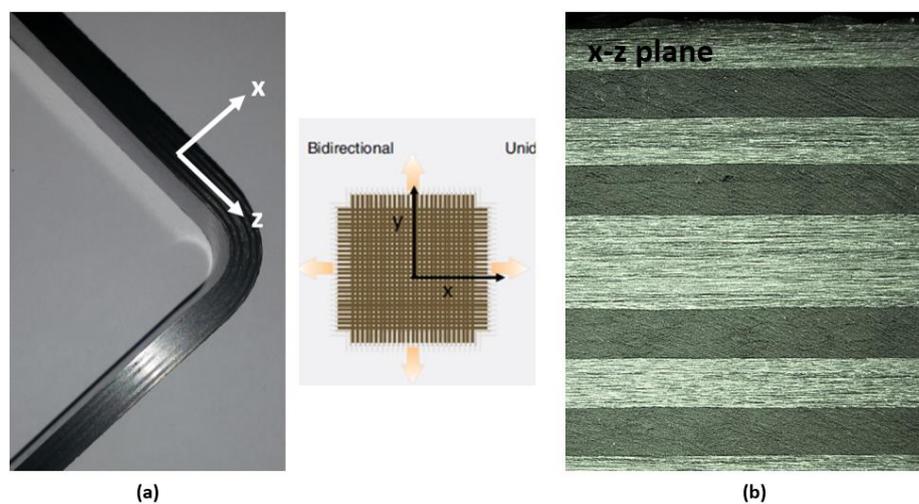
Figure 3.2 (a) Cross-ply specimen showing in thickness plane; (b) Micrograph of the side view of cross-ply specimen

The second lay-up is $[0_3/90_3/0_3/90_3/0_3]_s$, cross-ply laminates. It contains 30 plies (**Figure 3.2a**). HexPly® AS4/8552 UD carbon pre-pregs are used having 0.184 mm in thickness. Different lamina directions can be seen easily. Different orientations of pre-pregs create clear interfaces between the plies. Group of 0° and 90° of plies are laid up since group of plies act as a single ply and decrease the number of interface where delamination may occur [39]. Matrix cracking and delaminations occurring between the interfaces can be observed easier with this lay-up orientation. Cross-ply laminates

have these off-axis plies which provide investigating the behavior of matrix dominated laminates. **Figure 3.2b** presents the micrographs of the side view of cross-ply laminates and the different directions of the laminas. Lamina properties of unidirectional pre-pregs used in both lay-up orientations are shown in **Table 3.2**.
