MASTER THESIS

Experimental Investigation of Fatigue Behavior of Curved Composite Laminates

Universitat Politècnica de Catalunya
Master in Aerospace Science & Technology
July 2016

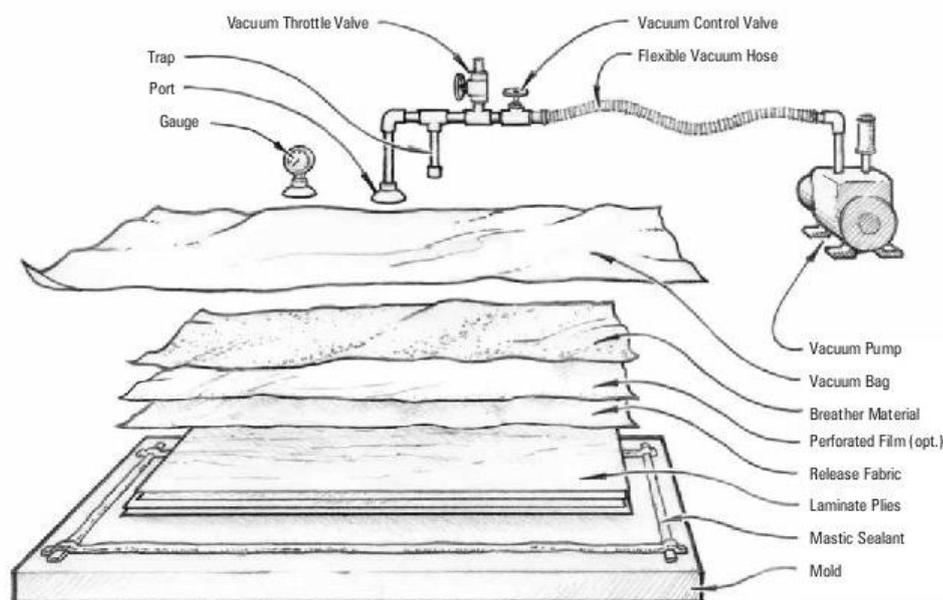
Figure 3.3 The illustration of hand lay-up manufacturing process of composite materials [42]

Manufacturing of the L-shape laminates was carried out using hand lay-up with the vacuum bagging technique. Right angled male tool was used. Vacuum bagging for autoclave curing is the most common method in aerospace industry for manufacturing carbon fiber reinforced epoxy parts. **Figure 3.3** shows the simple schematic of the bagging system.

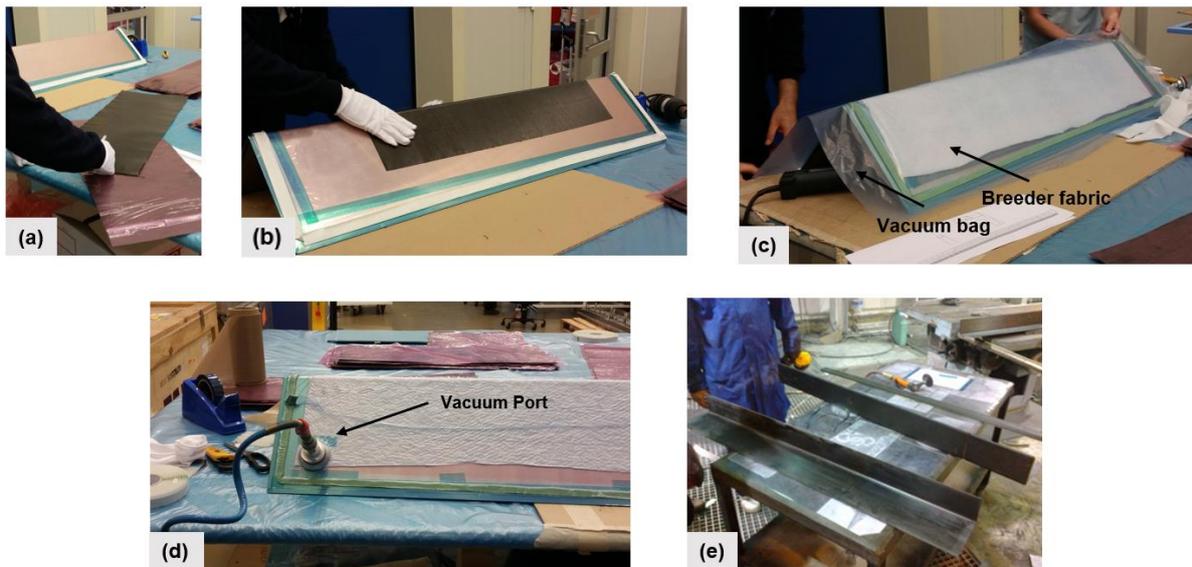
Figure 3.4 (a) Pre-pregs used for lay-up; (b) Hand lay-up over male tool; (c) Vacuum bagging preparation; (d) Vacuum bagging process; (e) Tool length specimens after manufacturing

Pre-pregs were used as a starting material for vacuum bagging to save time and make easier the manufacturing process (**Figure 3.4a**). In order to prevent sticking, the tool was cleaned by polish before the lay-up process. Then, pre-pregs were laid up in the desired sequence and the orientation (**Figure 3.4b**). After the lay-up process was complete, the release fabric and bleeder papers were placed (**Figure 3.4c**). The bleeders were used to absorb excess quantity of epoxy during the vacuum bagging process. Finally, an impermeable nylon bagging was positioned with small holes to place vacuum gage ports (**Figure 3.4d**). A vacuum vent line and a pressure gage were mounted on these ports. The entire assembly was placed inside an autoclave for the curing process where the external pressure was applied to merge individual layers into a laminate [41]. The specimens were cured in autoclave for 8 hours minutes at 180 °C temperature and 6.9 bars pressure. In order to finish the procedure, the autoclave temperature was slowly decreased to room temperature, while the pressure was decreased gradually. The total autoclave curing process was approximately 10 hours. After the process, the cured curved composite laminates were cut into the desired dimensions (**Figure 3.4e**).

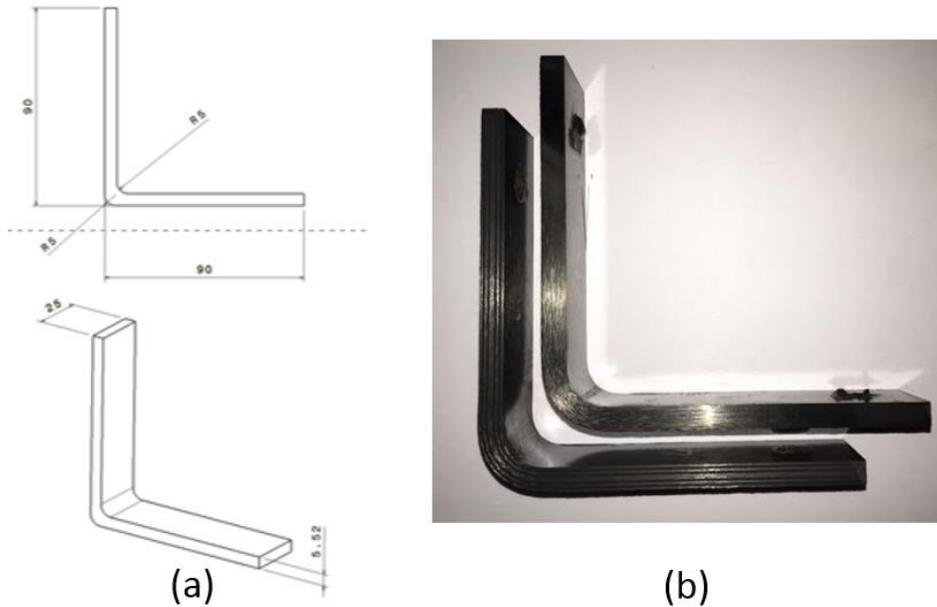
Figure 3.5 (a) The geometry of the specimen; (b) Specimens with different lay-ups

Manufactured L-shaped laminates were in tool size after curing. In this thesis, the experiments were conducted using coupon level specimens. The experimental setup and fixture were appropriate for coupon level testing. To obtain coupons from tool length size L-shape beams, 25 mm-width pieces were cut which refers flanges and brackets of the aircraft. The L-shape composite specimen has 90 mm symmetric upper arm lower arm. The geometry of the curved composite laminate in millimeters are presented in **Figure 3.5a**. The curved composite laminates were formed of 90 mm lower and upper arm, 5 mm inner radius, 25 mm width and 5 mm. 30 plies UD and cross-ply laminates have 5.54 mm thickness. The last version of the specimens after cut and the side view of three different lay-ups are presented in **Figure 3.5b**. In **Table 3.3**, the geometric properties of three different lay-ups are presented.

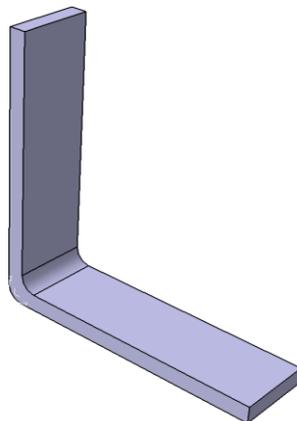
Figure 3.6 Model of the laminate

Using PATRAN software, the geometry and the laminate properties were modeled for three different lay-ups using the lamina properties. **Figure 3.6** shows the modelled geometry and **Table 3.4** present the laminate properties of two different lay-ups.

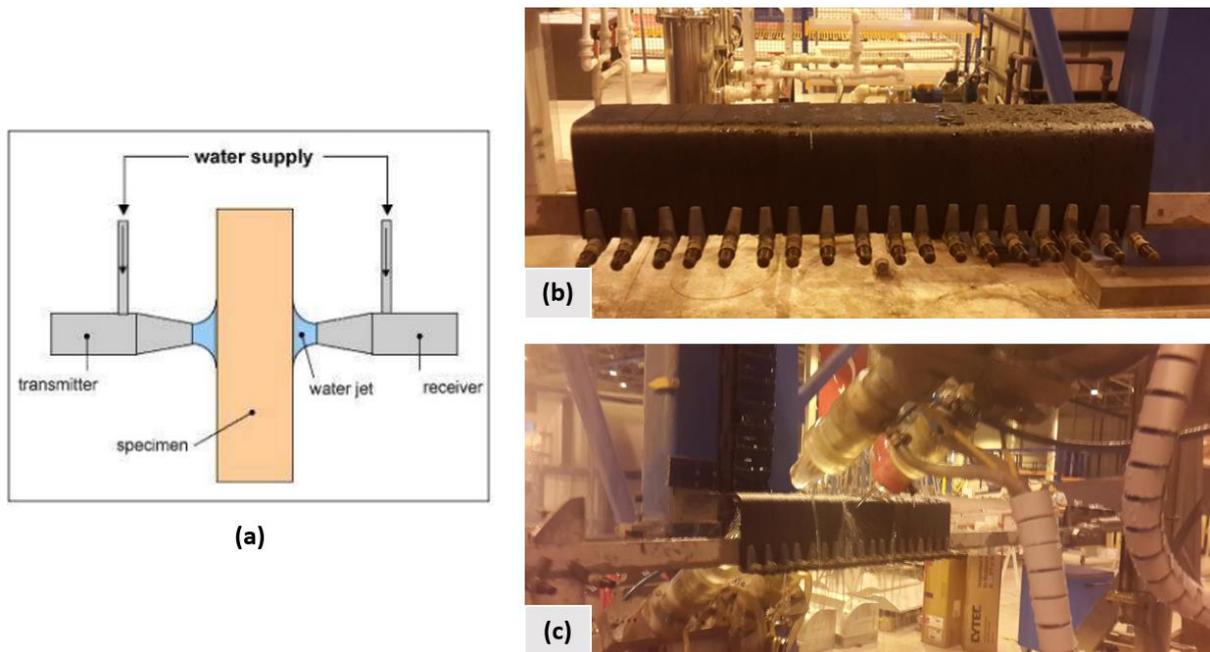
Figure 3.7 (a) Mechanism of through-transmission ultrasound scan [44]; (b) Specimens held by the support structure; (c) Scanned specimens and the water jet

Nondestructive testing is important in this study for detecting initial flaws occur during manufacturing process and investigating matrix cracking and delamination occur inside the specimen after exposed to cyclic loading. The hidden internal cracks may have a significant effect on structural integrity of the specimens and these cracks are not detectable by radiography or other NDT techniques but ultrasonic testing. In this study through-transmission method is used to scan the specimens. Through-transmission typically uses two transducers, one emitter and one receiver. The receiver is placed to the opposite side of the specimen and facing to the transmitter probe. The ultrasound is coupled to the specimen through a jet of water projected onto its surface which provides better conductivity of pulses as well. The pulse passes through the specimen and is bounced to the reflector such as glass plate before passing back through the specimen. **Figure 3.7a** illustrates the mechanism of the through-transmission ultrasound (TTU) scan. **Figure 3.7b** and **Figure 3.7c** presents the specimens held by the support structure anchored to the floor and the water jet during the scanning [44].

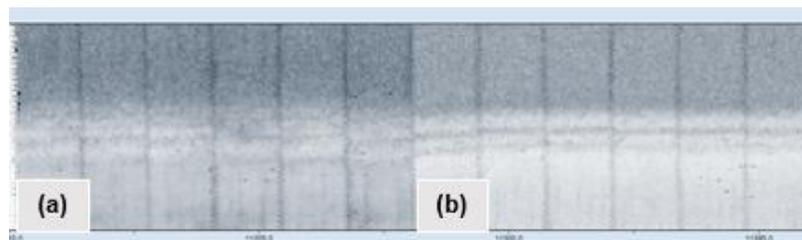
Figure 3.8 Ultrasonic test results of (a) [0] UD laminates; (b) Cross-plyed laminates

Figure 3.8 presents the ultrasonic testing results of 6 specimens of each lay-ups. TTU cannot detect the small size flaws but no critical size flaws were found in the curved region. These results are used as reference images in order to detect the matrix cracking and delaminations in the internal region of the composite laminates after fatigue loading.

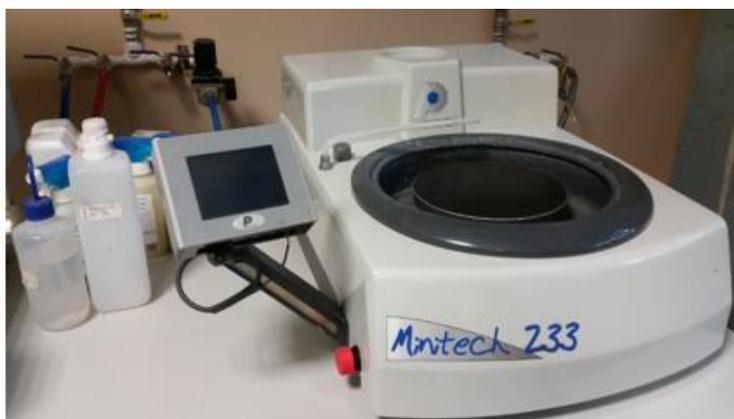
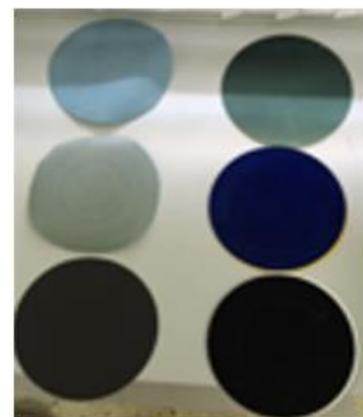
Figure 3.9 (a) Rotating wheel for polishing process; (b) SiC and diamond grinding discs

In order to understand damage mechanisms of static and fatigue failure microstructural investigation and observation during fatigue experiments were vital. Micrographs of specimens were taken using microscope after failure of specimens with the aim of observing the matrix cracking and delamination. After cutting procedure of the specimens to coupon level, there were machining marks through the lateral surface of the specimens. These marks create a rough surface and make the observation of damage mechanisms impossible under microscope. In order to get proper photos and make a complete analysis of fracture mechanism, it was requisite to have smooth and glassy surface. The lateral surface of the test specimens were polished to obtain the surface quality using different steps which are summarized in **Table 3.4**. Grinding procedure was conducted by waterproof circular SiC papers with different grain sizes (**Figure 3.9b**) using a rotating wheel (**Figure 3.9a**). The process was lubricated with water in order to prevent burnt of the surface and remove grinding particles. Then,

diamond grinding discs (**Figure 3.9b**) were applied with diamond particle solutions to obtain smooth and shiny surface. It was critical to clear lubricant from the specimens after polishing procedure. Water marks affect the micrographs, as well. Hence, it was required to use low-density fluid such as alcohol which dries quickly to clean the specimens.

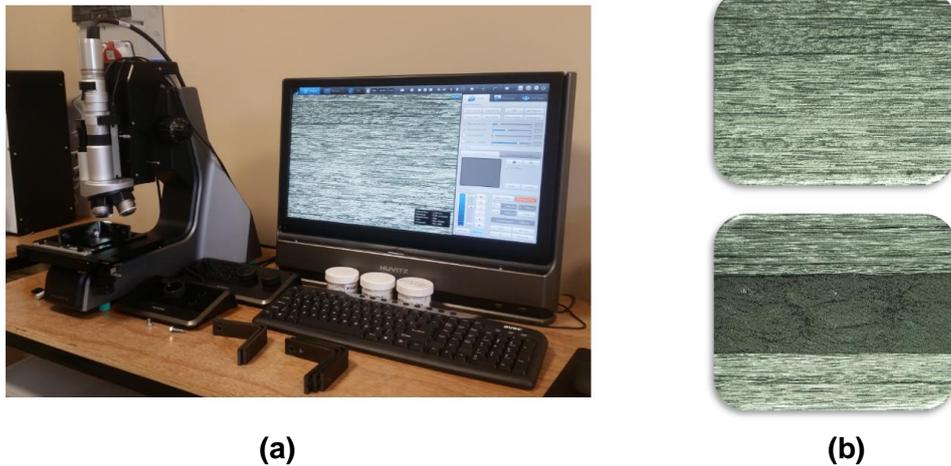
Figure 3.10 (a) Leica DMI1 microscope; (b) Micrographs of the specimens

Micrographs of the specimens were taken before the experiments in order to compare the surface after damage. The specimens were analyzed with Leica DMI1 (**Figure 3.10a**) inverted microscope with 5x, 10x and 20x objectives and 10x camera magnification factor. The aim was to determine crack position in the layers. **Figure 3.10b** presents the micrographs of undamaged specimens with two different lay-ups with 20x magnification.

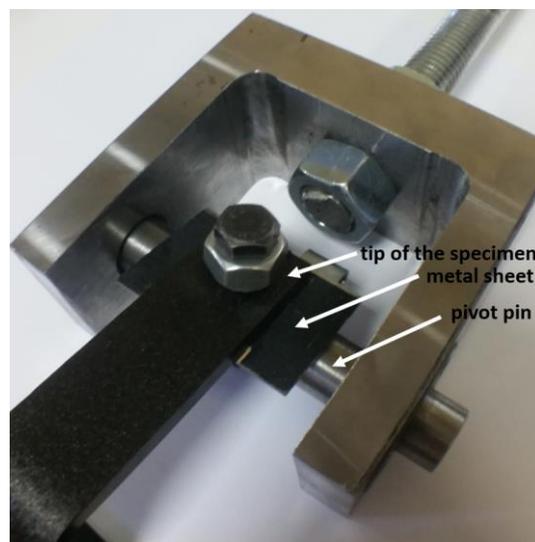
Figure 3.11 Tip of the fatigue tests specimen with metal sheet

Curved composite specimens were ready for fixing after investigating with ultrasonic test and also observing their lateral surface under microscope after polishing process. The test specimens were fixed to the axial loading fixture by bolts. In preliminary tests, 6 mm bolts were used to fix the specimens; however, these bolts experienced fracture under cyclic loading. Then, it was decided to engage the tips of the specimens to the pivot pin of the fixture with 8 mm bolts. With this aim, 8 mm hole was obtained using vertical drilling machine 7.5 mm from the curved region of the specimen. In static tests, the specimen was engaged to the fixture directly. Nevertheless, for fatigue testing, in order to prevent specimen from crack growth starting near the hole, induced by stress concentration due to bolt, metal sheet was glued to the tips of the bottom surface of the specimens. A sand paper was glued to the leave of the hinge in order to prevent slipping. The leave of the hinge was glued to the tip of the specimen and engaged to the fixture together as shown in **Figure 3.11**.

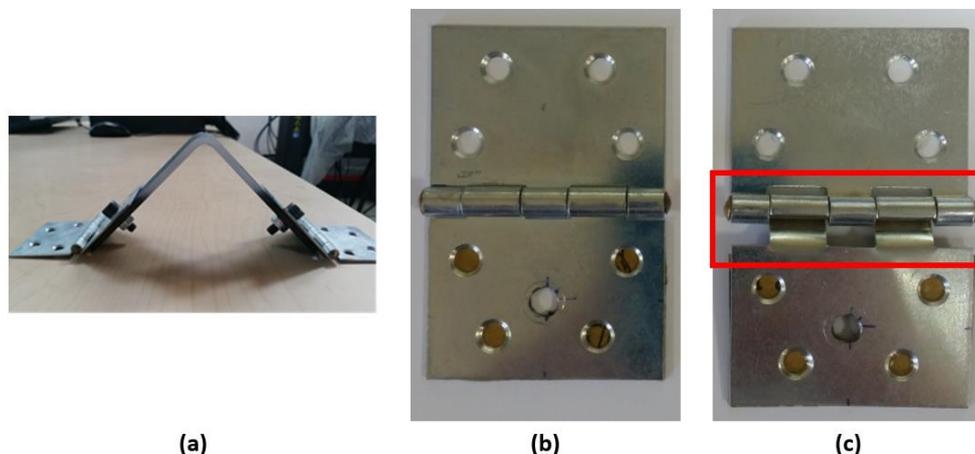
Figure 3.12 (a) Hinge mechanism on the specimen; (b) Original hinge; (c) Deformed hinge under axial loading

At first, hinge mechanism was used in order to apply axial loading to the curved specimens. Two hinges were fastened to the two arms and the load was applied to the specimen through the hinges. Sandpaper was glued to the hinge to fasten the hinge to the specimen without slipping. Hinges were glued to the specimen as well and screwed together so that load was distributed as shown in **Figure 3.12a**. The other leaves of the hinges were held by grips of the test machine. However, after 1000 N the joint of the hinges started to be unfolded. Whereas, **Figure 3.12b** shows the original hinges, **Figure 3.12c** presents the deformed hinges. Then, it was confirmed to design and manufacture a special loading fixture appropriate for axial loading.

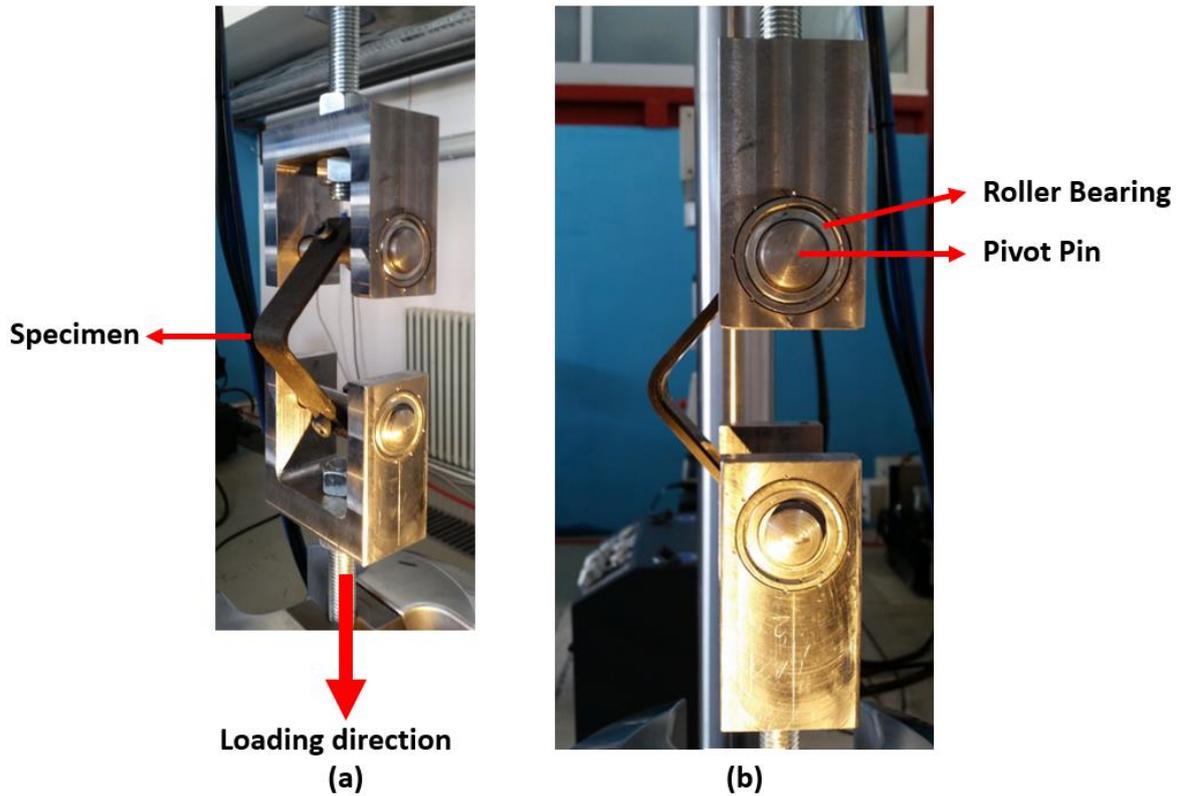
Figure 3.13 (a) Specimen and the loading fixture; (b) Closer look to the fixture and the specimen

In this study, curved composite laminates were subjected to axial static and fatigue loading from both tips using special design fixture. The loading conditions and experimental fixture with the specimen are shown in **Figure 3.13a**. Both arms of the specimen were bolted to a pivot pin bearing system in order to fix the arms on the fixture and provide free rotation around z-axis (**Figure 3.13b**). Axial force was applied to the fixture through the screw located in the middle of the fixture (**Figure 3.13a**).

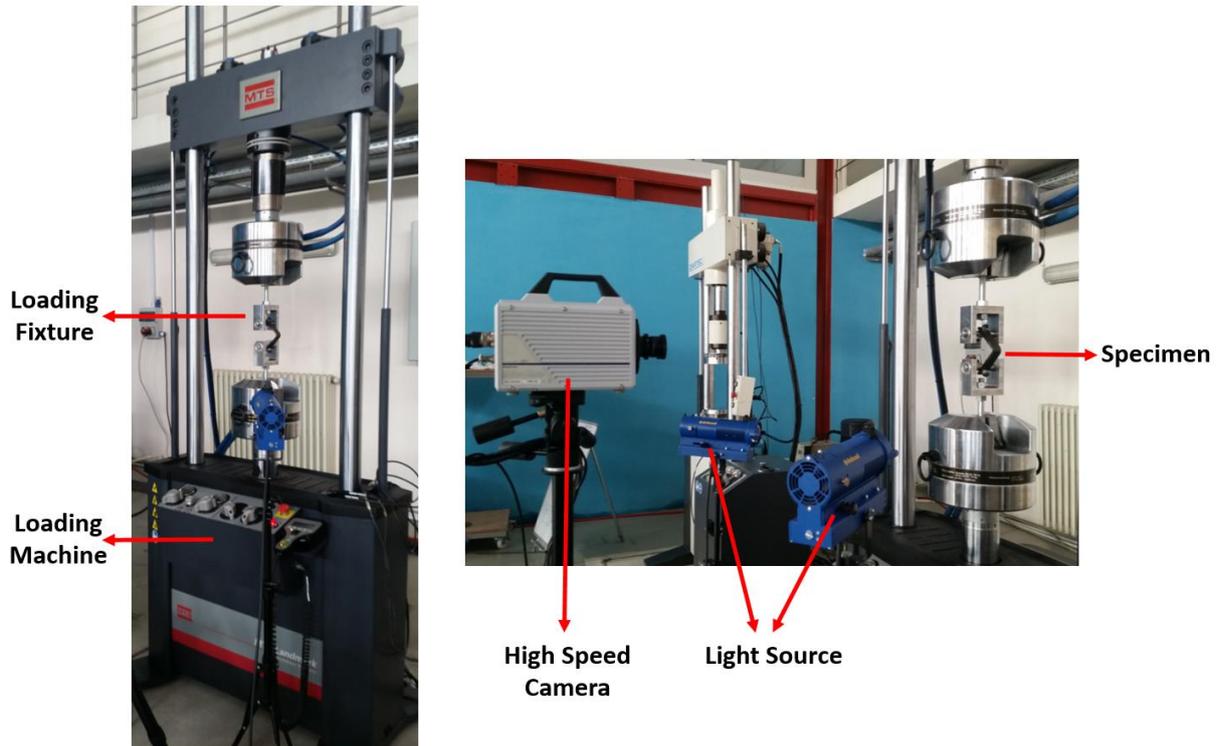
Figure 3.14 Experimental setup

MTS 250 kN axial loading servo-hydraulic test machine was used to carry out static and fatigue tests. All static tests were conducted under displacement control at a rate of 2 mm/min. Multi-Purpose Testware (MPT) module was used to give the displacement command to the test machine and acquire the data. Delaminations were recorded using Photron FASTCAM SA-5 high-speed camera system which recorded the images with framing rates of 150000 fps at full resolution of 1 MP. **Figure 3.14** presents the experimental setup, including the loading fixture, specimen and the high speed camera system.

Fatigue tests were conducted under displacement control as well with the R ratio, $R = \delta_{\min} / \delta_{\max}$, of 0.1 and at 2 Hz frequency. Basic Testware (BTW) module was used to give the command of the parameters used in fatigue experiments and for data acquisition as well. Full process was recorded with DSLR Canon D650 camera with macro-lens and crack initiation and propagation was observed.

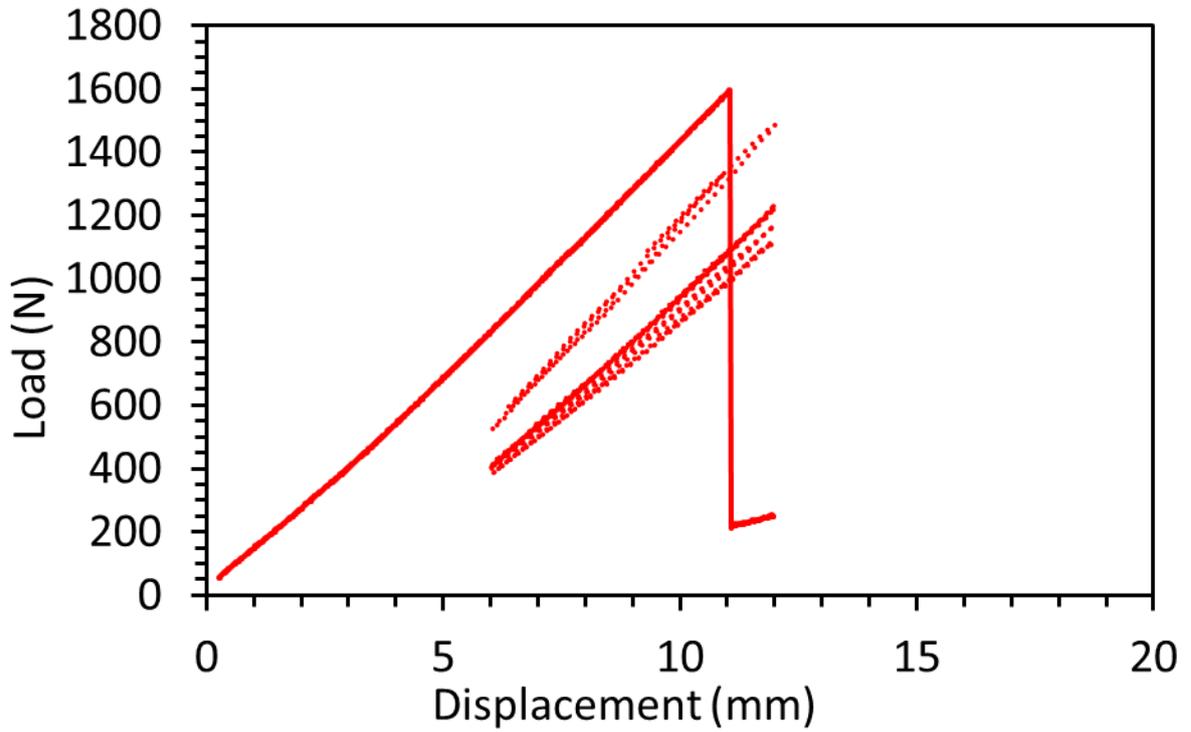
Figure 3.15 Load displacement plot of preliminary static and fatigue tests

Preliminary tests were conducted in order to validate the loading fixture and experimental method. In the preliminary tests, [0] UD 25 ply specimens with R_i equal to 10 mm were exposed to static and fatigue tests. Static test was conducted under displacement control at the rate of 2 mm/min. Fatigue test was conducted under displacement control at R-ratio of 0.5 with maximum displacement of 12 mm and at 2 Hz. In the **Figure 3.15**, the load displacement curves of the static and fatigue tests are presented. Static test is represented with dark red line and the evolution of the fatigue curve is represented with red dashed lines. As seen from the plot, force increased with increasing displacement almost linearly. Maximum load was 1597 N at 11 mm displacement. Then load dropped suddenly to 215 N with the multiple delaminations occurred through the thickness at the curved region. After that point the specimen failed almost completely with critical stiffness degradation. As can be seen in **Figure 3.15**, under fatigue loading stiffness degradation was observed with ongoing cycles. The slope of the load displacement curves was calculated in every 5000 cycles and corresponding compliance value of the material was plotted in **Figure 3.16**. During the tests, the loading fixture experienced no deformation as hinges mechanism. Both static and fatigue tests results were rational and consisted with the expectations. With these preliminary tests, it was proved that the loading fixture had satisfying design and it was ready for further experiments.

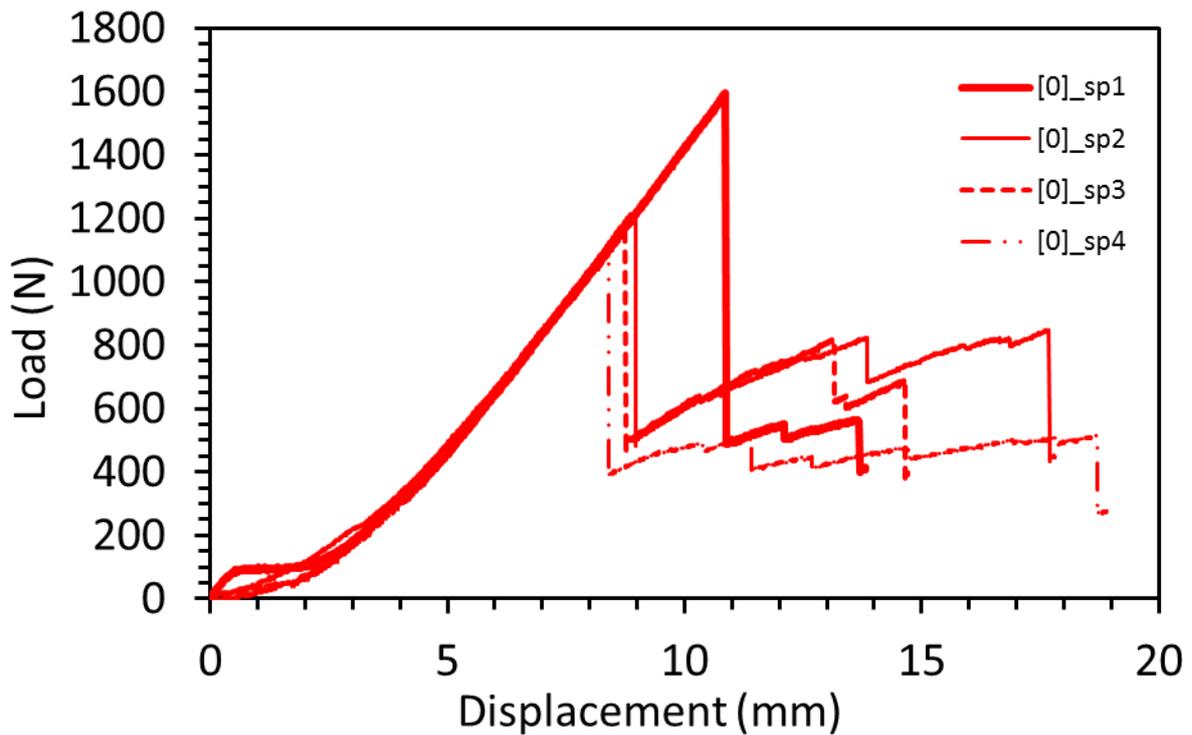
Figure 4.1 Load-displacement plot of [0] UD specimens under static loading

The first results belong to $[0]$ UD curved composite laminates. The lay-up details are explained in the experimental method and material part. **Figure 4.1** presents the load displacement curve of 4 different static tests conducted on $[0]$ UD curved composite laminates. The initial slope of the four specimens are the same which corresponds to the initial stiffness of the material. After reaching to the maximum interlaminar stress, sudden load drop is observed corresponding to delamination. After the first failure, the maximum load capacity of $[0]$ UD curved composite laminates drops to around 40% of the maximum load. All specimens carry load with very low slope with steps in the load displacement plot which corresponded to little load drops due to crack formation leading to the second delamination with multiple cracks through the thickness at the curved region corresponding to complete stiffness loss of the specimens.

Load-displacement curves (**Figure 4.1**) of the four specimen have similar behavior. However, although all specimens have the same initial slope the ultimate strengths of the four specimen are different. The first specimen has higher ultimate strength than the other three specimens. The other three specimens experience the first load drop almost at the same load value. Despite the different maximum load values of the specimens, the first load drop level of all specimens are almost the same, 400 N. Even the damage occurs at different load values the failure pattern of the specimens are almost the same under static loading for $[0]$ UD curved composite laminates. The average ultimate strength of $[0]$ UD specimens are 1100 N at 8 mm displacement in order to use in fatigue loading experiments.

In the preliminary tests, specimens with 25 ply carry 1650 N average maximum load. Since these [0] UD laminates are thicker, it is expected to carry more load. However, as can be seen from the plot, the average maximum load is 1200 N. Besides the thickness, the inner radii are different for two specimen configurations. [0] UD laminates in this study is 5 mm, smaller than the inner radius of preliminary test specimens. According to Kedward et al. [46], the radial stress, σ_r increases with decreasing mean radius, R_m as shown in **Equation 4.1**, so that in this study [0] UD laminates experience higher stress state with lower load level.

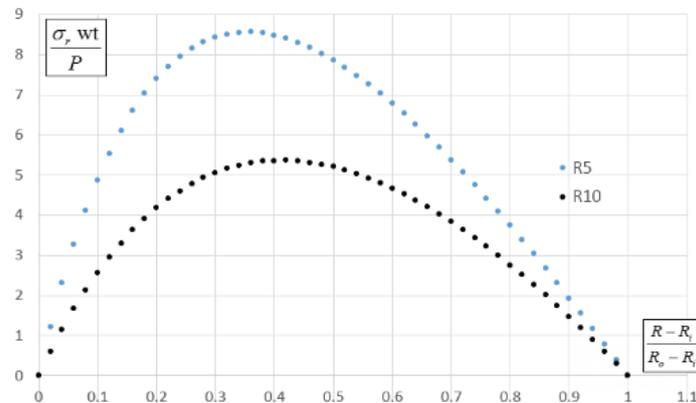
Figure 4.2 Radial stress distribution through thickness [47]

In previous studies and preliminary tests, maximum radial stress and delamination occurs at $0.4t$. FEA shows that decrease in inner radius changes the location of maximum radial stress location [47]. **Figure 4.2** present the maximum radial stress variation with decreasing inner radius. The maximum radial stress occurs at $0.4t$ for R_i equals to 10 mm whereas if inner radius is 5 mm as in this study, the maximum radial stress location shifts to $0.35t$.

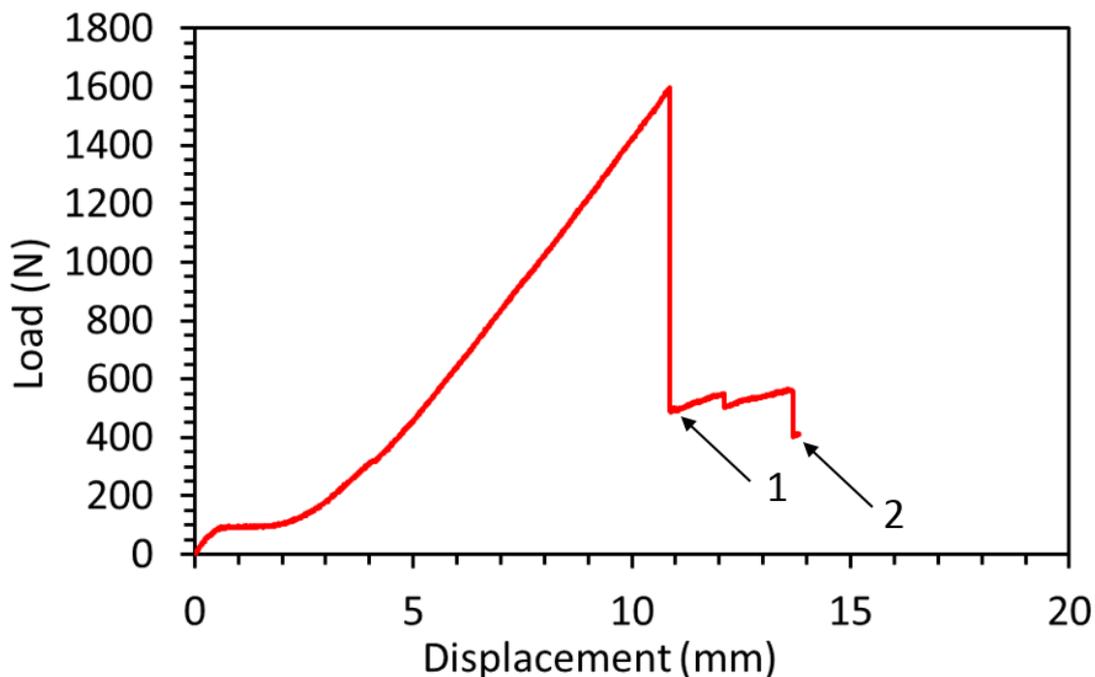
Figure 4.3 Load-displacement plot of [0]_sp1 under static loading

Crack initiation and propagation occur sudden and catastrophic. DSLR camera cannot catch the initiation and the progression of the damage. In order to understand the failure mechanism in detail high speed camera images are taken with 210000 fps. The high speed camera images present the damage evolution of [0]_sp1. The load-displacement curve of the specimen is investigated separately in **Figure 4.3**. The load drops are marked on the load-displacement curve which correspond to the delaminations observed in high speed camera images. **Figure 4.4** presents the high speed camera images and the damage progression of [0]_sp1. **Figure 4.4a** presents the delamination occurring in the first load drop. The first delamination starts suddenly from the middle of the curvature at $0.35t$ near the highest radial stress location. Then the delamination proceeds to the arms instantaneously. The little load drop is observed in the load-displacement plot, however no delamination is observed from the lateral

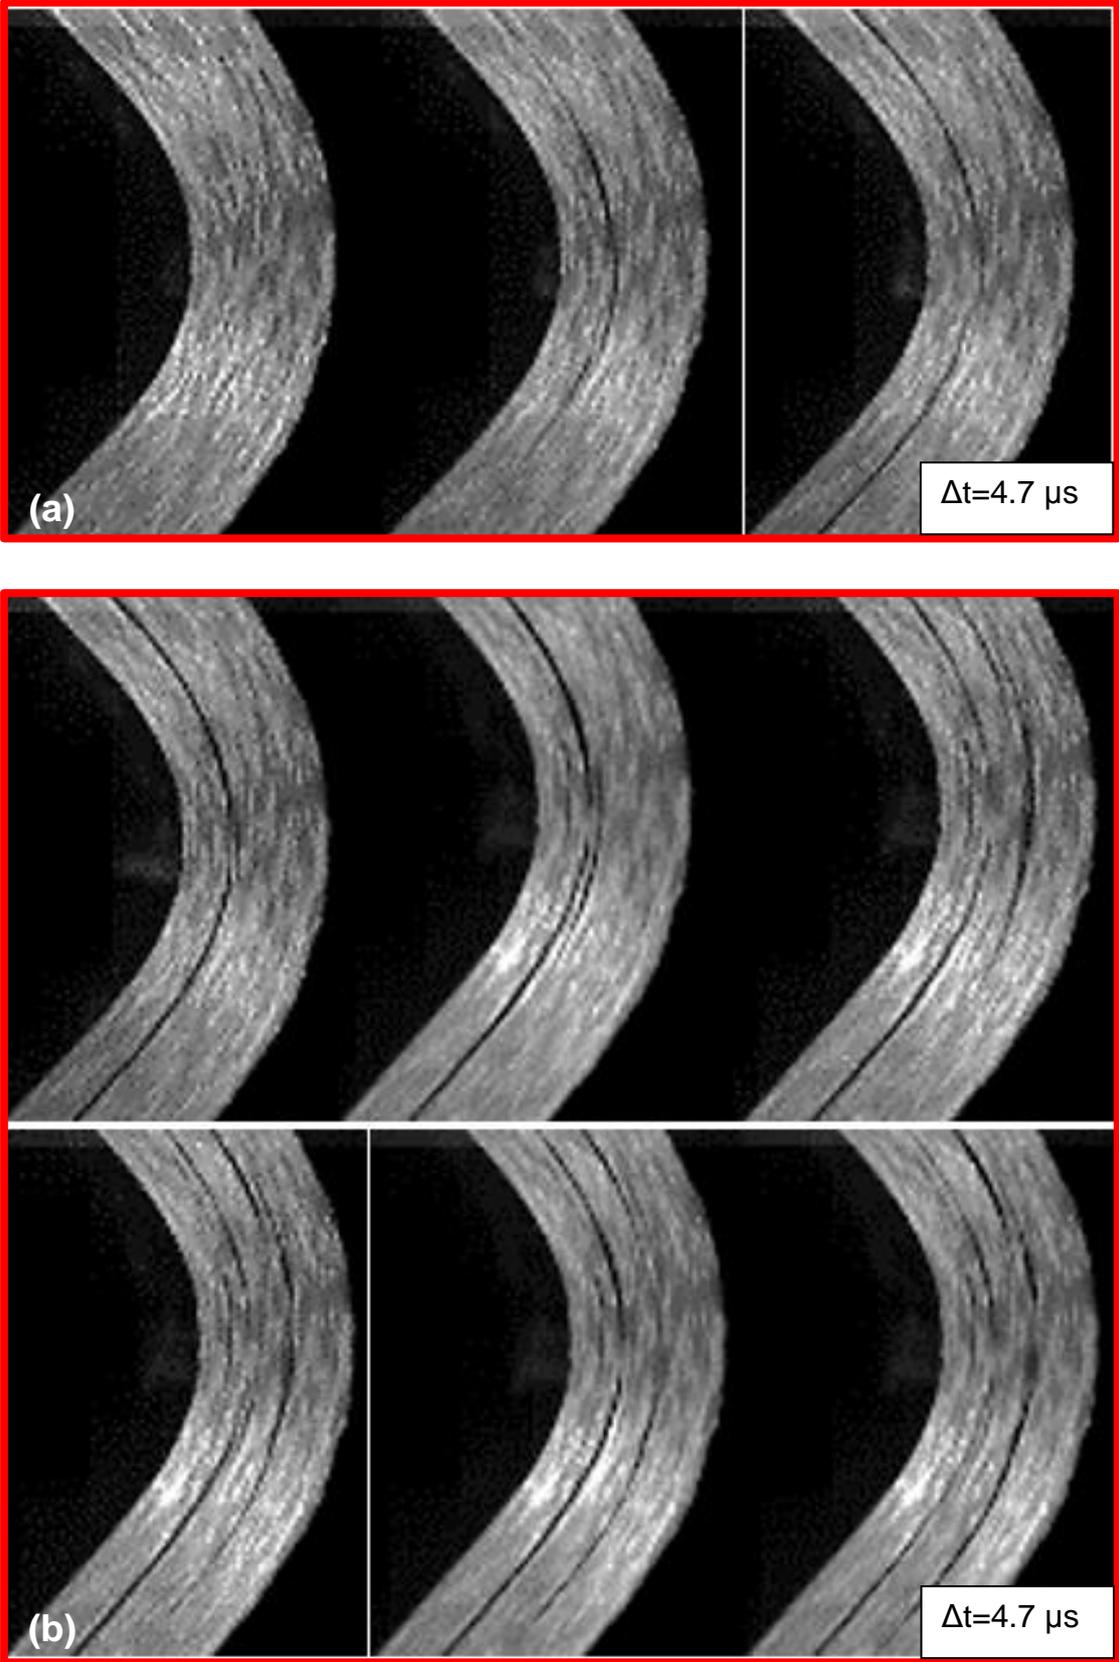
Figure 4.4 High speed camera images of [0]_sp1 (a) The first load drop; (b) The second load drop

surface. **Figure 4.4b** presents the delaminations corresponding to the second load drop. Multiple cracks are formed near the initial delamination with increasing load and the second delamination occurs and grow through the arms instantaneously corresponding to the second load drop. The second delamination occurs at the $0.65t$ of the specimen which corresponds to 0.4 of the remaining beam thickness. At that location the maximum stress in the remaining ligament occurs.

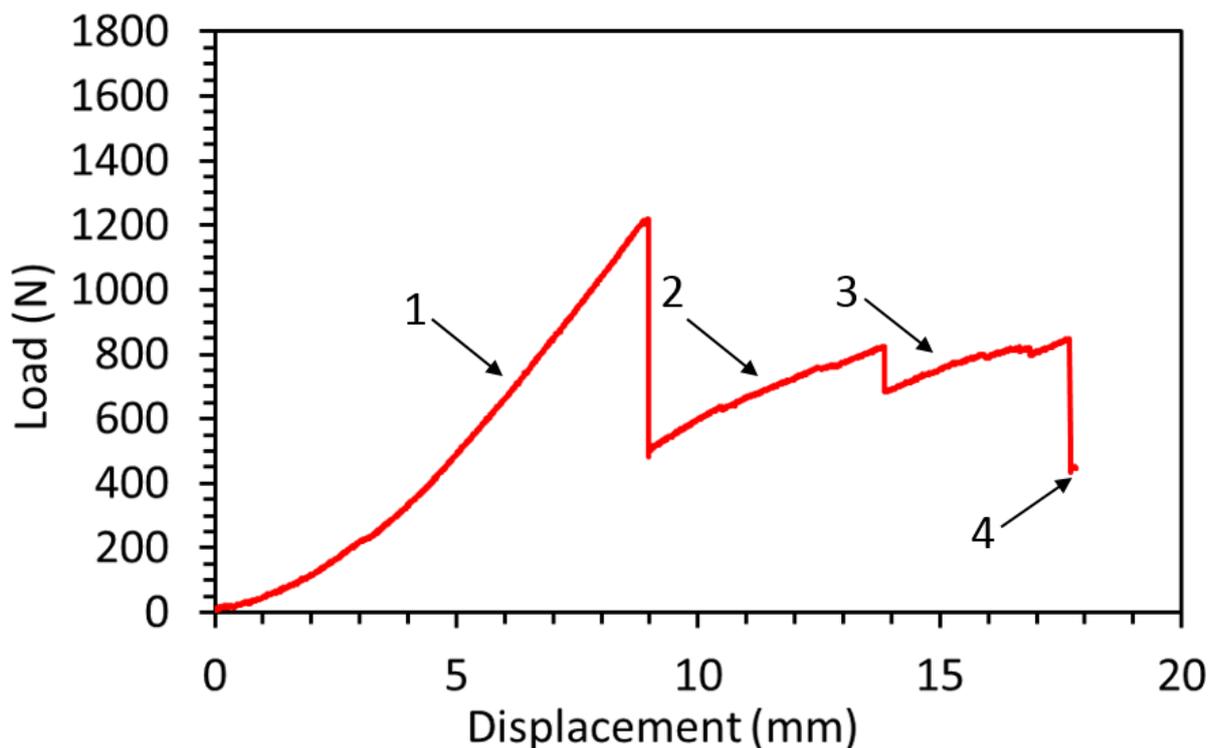
Figure 4.5 Load-displacement plot of [0]_sp2 under static loading

The damage evolution is investigated using DSLR camera as well. The results of [0]_sp2 is examined. The load-displacement curve of [0]_sp2 is presented in **Figure 4.5** individually. The initial state and the load drops are marked and corresponding damage evolution is shown in **Figure 4.6**. **Figure 4.6a** represents the initial form of the specimen without any crack. **Figure 4.6b** shows the first delamination occurred which corresponds to the first load drop. The delamination initiated at $0.35t$ where the radial stress is maximum. In the load-displacement curve little load drop are observed after first load drops which means crack propagation to the arm of the curved laminates as shown in **Figure 4.6c**. The final failure is presented in **Figure 4.6d** corresponding to final load drop. As shown in the figure the final failure occurs with the multiple crack through the thickness which means the complete stiffness loss of the specimen. The second major delamination occurs at $0.75t$ of the specimen corresponding to the $0.4t$ of the remaining thickness where the radial stress is maximum for the remaining ligament. **Figure 4.6e** presents the micrograph of the curved region of the same specimen. Since there is no load on the specimen in the micrograph, the delaminations are more unapparent than the DSLR camera images. However, the path of the delaminations can be seen easily on the lateral view of the specimen.

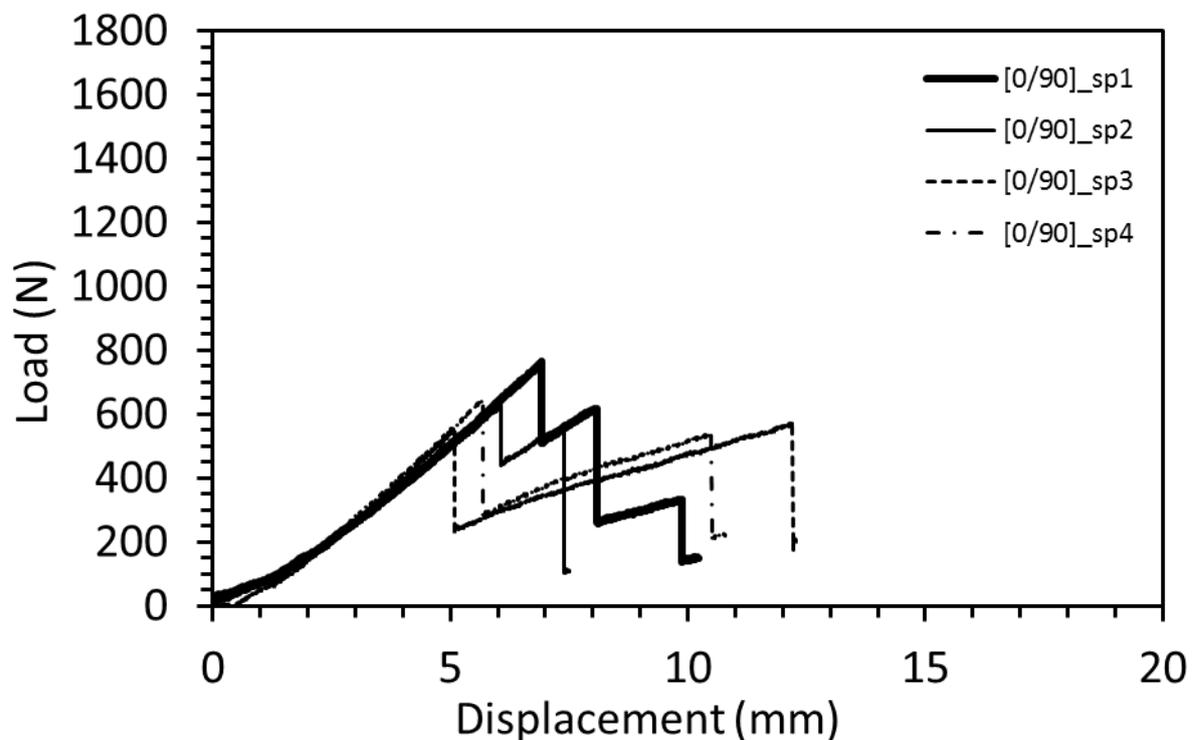
Figure 4.7 Load-displacement plot of cross-plyed laminates specimens under static loading

In this section the results of cross-plyed laminates are presented. The lay-up orientation is $[0_3/90_3/0_3/90_3/0_3]_s$ and the lay-up details are explained in the experimental method and material part. **Figure 4.7** presents the load displacement curve of 4 different static tests conducted on cross-plyed curved composite laminates. The initial slope of the four specimens are the same which corresponds to the initial stiffness of the material. Cross-plyed laminates experience multiple load drops until failure. The first load drop corresponds to the first delamination occurred in the interior off-axis plies where the tensile stress is maximum. The ultimate strength of all specimen varies and the load drops to different load levels after the delamination. The first delamination occurs in the first off-axis ply of the first and the second specimen. Nevertheless, in the third and fourth specimens, delamination initiates from the second off-axis ply. The differences in load drop levels are the consequence of these differences in delamination initiation location. After the first delamination the remaining plies continue carrying load. The slope of the load displacement curve is almost the same with the initial slope of the material. The load reaches almost the maximum value then the second load drop occurs corresponding to the second delamination adjacent off-axis ply. Second load drop corresponds to the final failure for all specimens except the first specimen. The first specimen carries load after the second load drop with lower slope and then experience the third delamination in the off-axis plies corresponding to the final failure. The differences in the load-displacement curves of the specimens from the same batch may occur due to the manufacturing defects.

The average ultimate strength of cross-plyed laminates 650 N at 5.5 mm displacement in order to use in fatigue loading experiments.

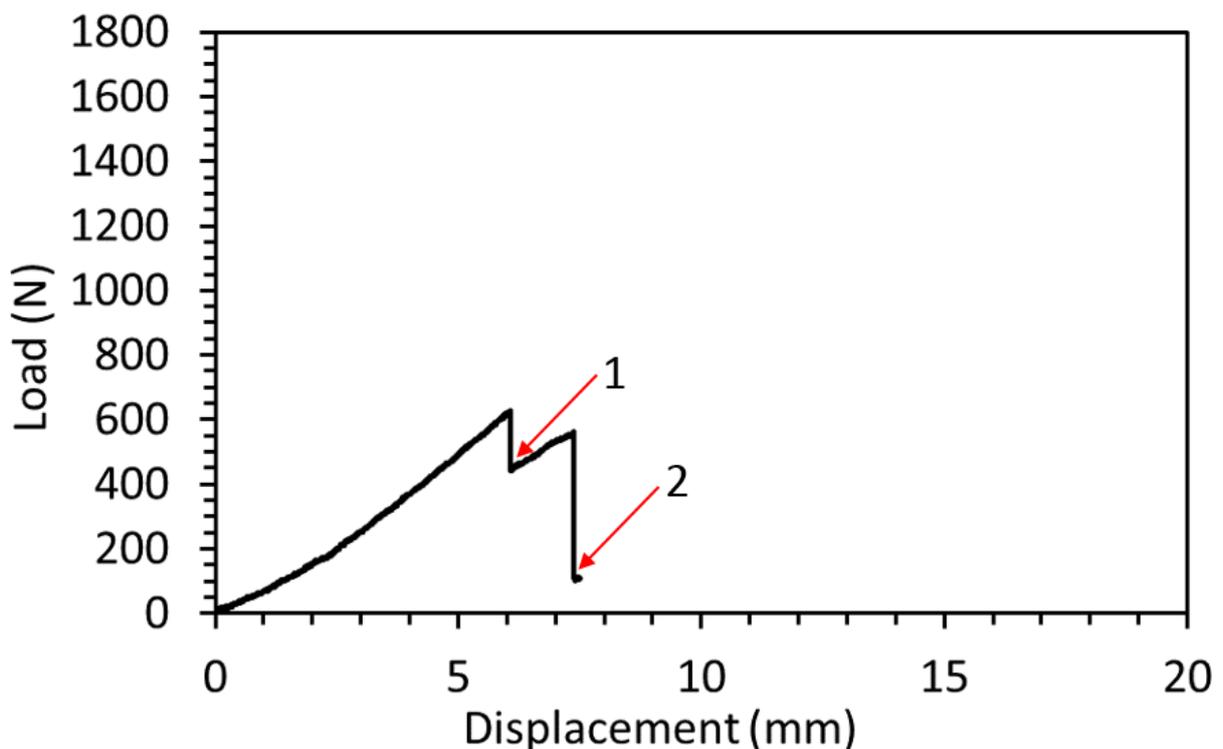
Figure 4.8 Load-displacement plot of [0/90]_{sp2} under static loading

The failure is catastrophic and sudden so that it is impossible to catch the initiation and the progression of the damage. In order to understand the failure mechanism, high speed camera images are taken for [0/90]_{sp2}. The load-displacement plot of [0/90]_{sp2} is presented in **Figure 4.8**. The load drops are marked which correspond to the delaminations observed in the high speed camera images. High speed camera images of [0/90]_{sp2} are shown in Error! Reference source not found.. **Figure 4.9a** shows the evolution of the first damage which corresponds to the first load drop. The first damage occurs suddenly in the interior off-axis ply as matrix cracks starting from the mid curvature then the matrix crack jumps to the adjacent 0° ply and lead the delamination propagation through the arm. **Figure 4.9b** presents the sequence of the damage evolution which occurs in the second load drop. The second and third delaminations occur instantaneously corresponding to the second load drop. However, high speed camera images show that matrix cracks start first in the second 90° plies and lead to the delamination proceeding through the adjacent 0° plies then the failure occurs in the next 90° plies. In the third off-axis plies matrix cracks initiates near the curved region leading to delamination in the interface.

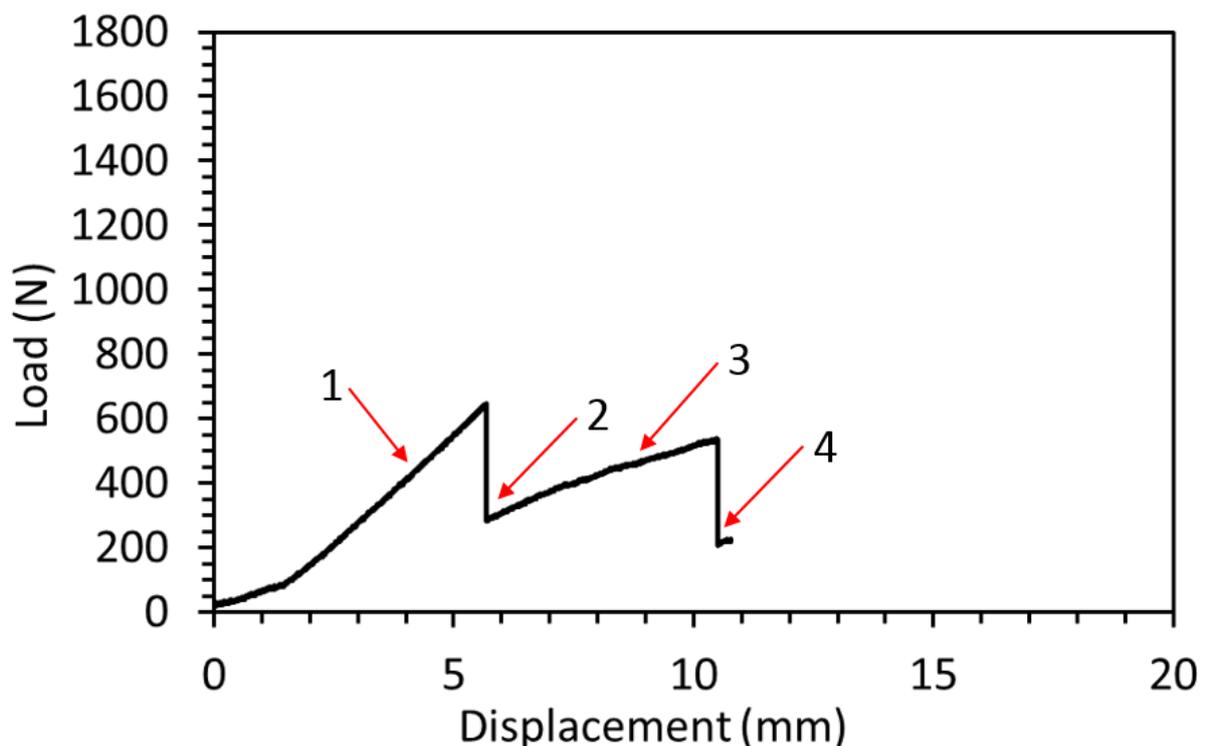
Figure 4.10 Load-displacement plot of [0/90]_sp4 under static loading

In order to investigate the damage mechanism, DSLR camera images are examined as well. The damage evolution on [0/90]_sp4 is presented using normal camera images. **Figure 4.10** shows the load-displacement plot of [0/90]_sp4. The initial state of the specimen and load drops which correspond to the delaminations observed in the normal camera images are marked on the load-displacement curve. **Figure 4.11** presents the damage evolution on the specimen [0/90]_sp4. **Figure 4.11a** shows the initial situation of the specimen without any crack. In **Figure 4.11b**, the crack initiates at the curved region and propagates through the arms. In the middle region the matrix cracks are observed which jump to the adjacent 0° plies and propagate as delamination (**Figure 4.11c**). **Figure 4.11d** presents the second delamination occurred in the next off-axis ply corresponding to the final failure of the specimen. Matrix cracks occurred in the mid of the curvature lead to delamination in the interface of the 0° and 90° plies. The delamination propagates through the arm of the specimen. **Figure 4.11e** presents the micrograph of the curved region of the same specimen. Little defects can be seen easily in the interior and the second off-axis ply. The matrix cracks initiated from the off-axis plies can be observed easily. In the second 90° ply, it can be easily seen that the matrix crack not only proceeds through the interface, but also jump to the adjacent 0° ply and progress as delamination throughout the fibers. In the third off-axis ply, the matrix crack proceed through the interface as well. The damage initiates at different 90° ply on [0/90]_sp2 and [0/90]_sp4. This difference cause the difference in the load level after first load drop. These images shows that despite the differences in the load-displacement curves of the specimens, the failure pattern is similar in cross-plyed laminates. The results and failure pattern is consistent with the study conducted by Uyar et al. [45]
