MASTER THESIS

Experimental Investigation of Fatigue Behavior of Curved Composite Laminates

Universitat Politècnica de Catalunya
Master in Aerospace Science & Technology
July 2016

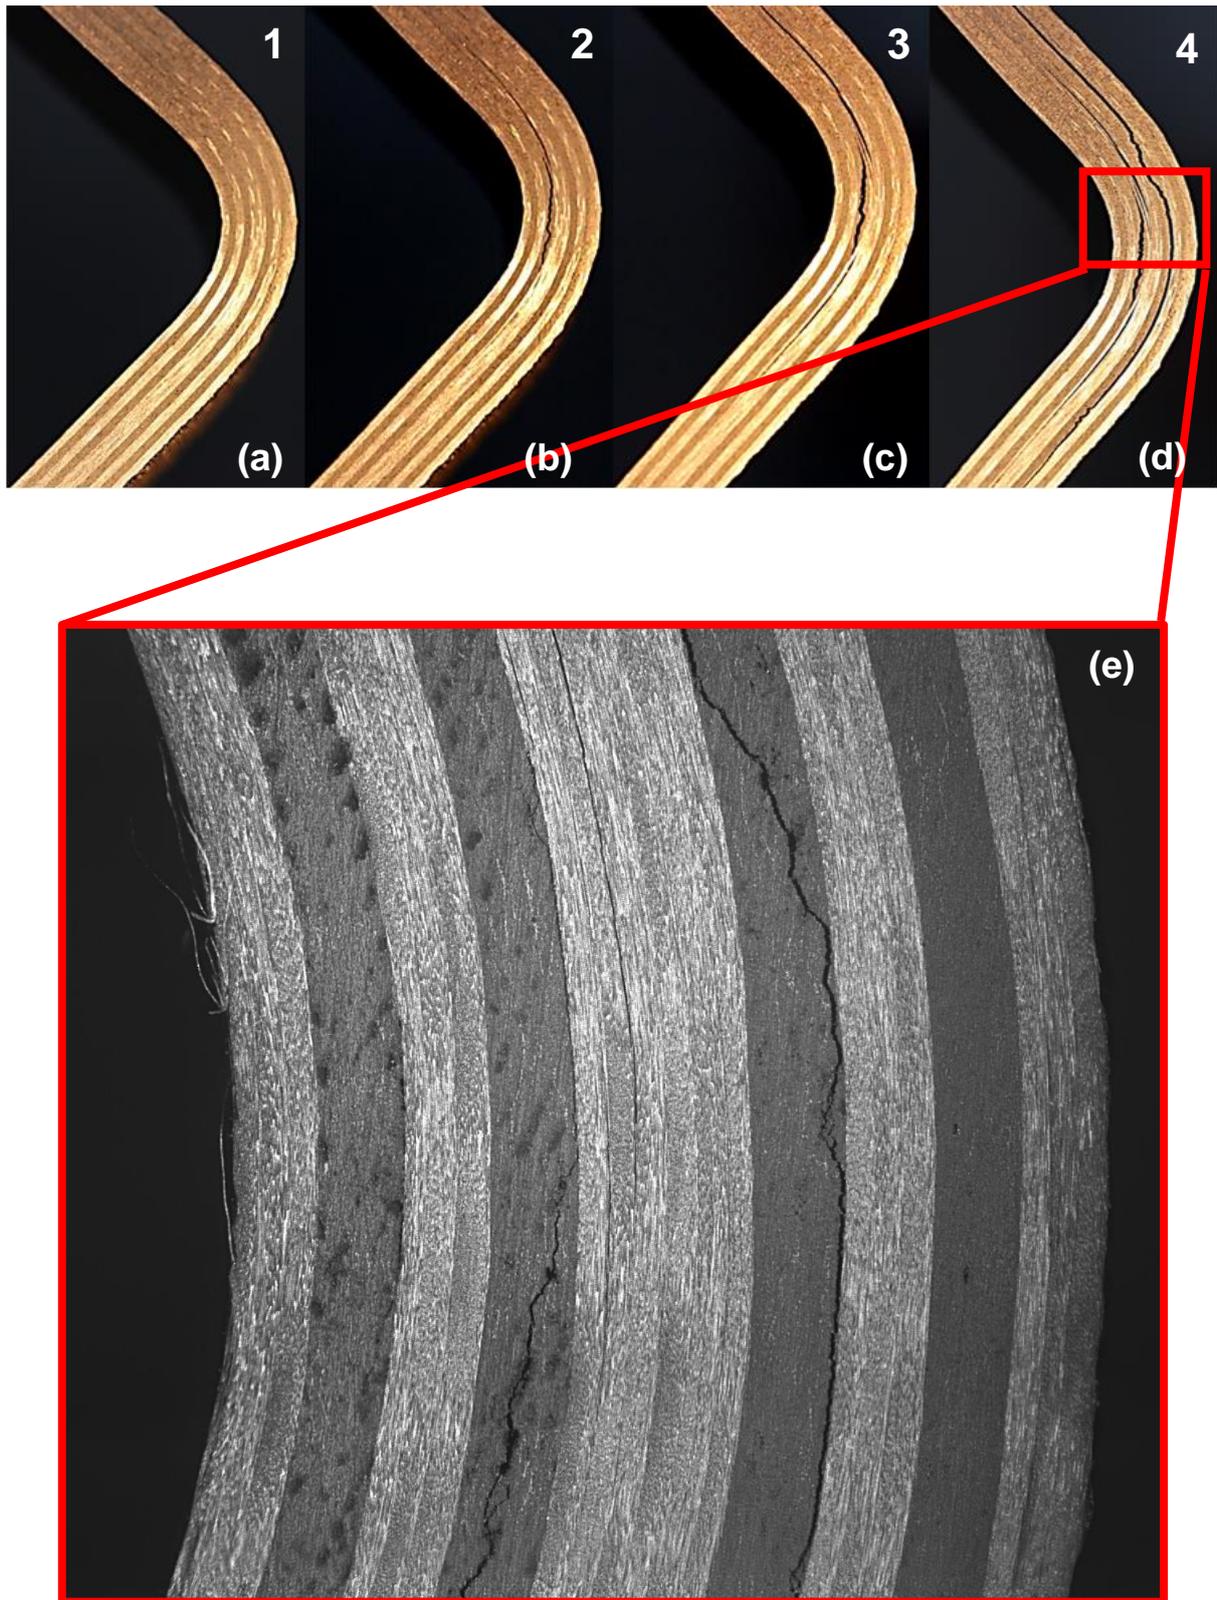
Figure 4.11 The images of [0/90]_{sp4} under static loading (a) Initial state; (b) After first load drop; (c) The crack propagation; (d) After failure; (e) The micrograph of the side view after failure

In order to investigate the damage mechanism, DSLR camera images are examined as well. The damage evolution on [0/90]_sp4 is presented using normal camera images. **Figure 4.10** shows the load-displacement plot of [0/90]_sp4. The initial state of the specimen and load drops which correspond to the delaminations observed in the normal camera images are marked on the load-displacement curve. **Figure 4.11** presents the damage evolution on the specimen [0/90]_sp4. **Figure 4.11a** shows the initial situation of the specimen without any crack. In **Figure 4.11b**, the crack initiates at the curved region and propagates through the arms. In the middle region the matrix cracks are observed which jump to the adjacent 0° plies and propagate as delamination (**Figure 4.11c**). **Figure 4.11d** presents the second delamination occurred in the next off-axis ply corresponding to the final failure of the specimen. Matrix cracks occurred in the mid of the curvature lead to delamination in the interface of the 0° and 90° plies. The delamination propagates through the arm of the specimen. **Figure 4.11e** presents the micrograph of the curved region of the same specimen. Little defects can be seen easily in the interior and the second off-axis ply. The matrix cracks initiated from the off-axis plies can be observed easily. In the second 90° ply, it can be easily seen that the matrix crack not only proceeds through the interface, but also jump to the adjacent 0° ply and progress as delamination throughout the fibers. In the third off-axis ply, the matrix crack proceed through the interface as well. The damage initiates at different 90° ply on [0/90]_sp2 and [0/90]_sp4. This difference cause the difference in the load level after first load drop. These images shows that despite the differences in the load-displacement curves of the specimens, the failure pattern is similar in cross-plyed laminates. The results and failure pattern is consistent with the study conducted by Uyar et al. [45]

The results show that the failure mechanisms are different between two lay-up orientations. **Figure 6.2a** presents the damage evolution of [0]_sp2 from UD laminates and **Figure 6.2b** presents the damage evolution of [0/90]_sp4 from the cross-plyed laminates. In [0] UD laminates the first delamination occurs at near the highest radial stress location, $0.35t$ corresponding to the first load drop where 0° plies are weak at that direction. In the second load drop, multiple delaminations are observed at the $0.4t$ of the remaining thickness again at the maximum radial stress location of the remaining ligament. However, in cross-plyed laminates the failure initiates with matrix cracking in the interior off-axis ply where the highest tangential stress occurs and these matrix cracks weaken the lamina in the angular direction and lead to the delaminations at these points. In the second load drop, matrix cracks and delaminations are observed in the second and third off-axis plies instantaneously. However, the high speed camera images of [0/90]_sp2 proved that the failure is sequential which includes the first failure in the second 90° ply then the third 90° ply (**Figure 6.3**).

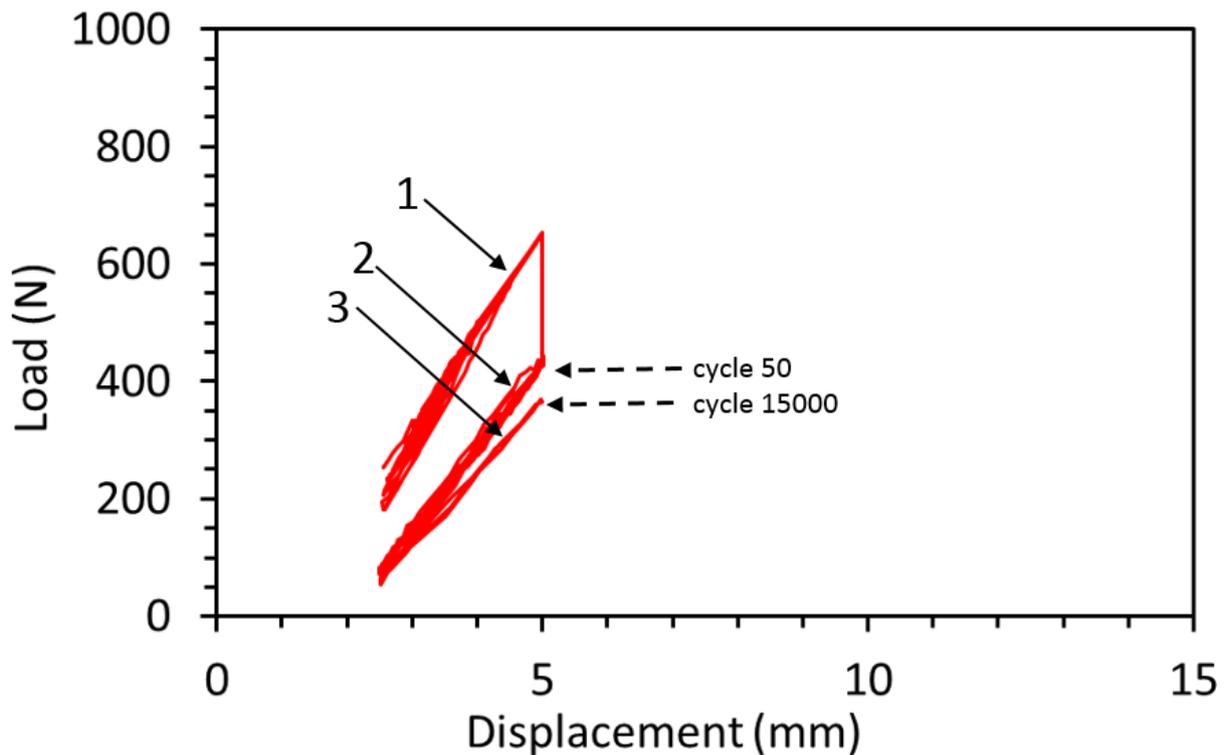
Figure 5.1 Load-displacement curves of [0]_{sp9} with ongoing fatigue cycles until failure

The first results belong to $[0]_{15s}$ UD curved composite laminates. The lay-up details are explained in the experimental method and material part. Two fatigue loading test results conducted under displacement control are presented in this section. The specimens show different behavior under fatigue loading than static loading case. The specimens carry higher loads for lower displacement values so that fatigue loading tests for $[0]$ UD curved composite laminates are conducted under low displacement values. First fatigue test is belong to $[0]_{sp9}$ which is conducted with 5 mm maximum displacement at R-ratio of 0.5. **Figure 5.1** presents the load-displacement plot of the fatigue cycles until failure of $[0]_{sp9}$. The plot presents only the part of the cycles for simplicity. Although the maximum displacement is 5 mm, the specimen is under high stress and first stiffness reduction is experienced after 50 cycles. The maximum load drops to 60% of the initial maximum load at 5 mm displacement. The second stiffness reduction is observed in the 15000th cycle leading to the final failure of the specimen. This stiffness reduction only causes 15% of load capacity loss of the specimen. Initial slopes and slopes after load drops are marked and matched with the normal camera images.

loading. Fatigue loading cycles on the plot represents the results of [0]_sp9 and they are designated with red lines. Static loading results belong to [0]_sp2 and are represented with red dashed line. Static and fatigue load-displacement curves behave similar. However, as can be seen from the plot, there is a slight difference at the initial slope of static and fatigue loading curves. Since the slope is higher under fatigue loading, at 5 mm displacement [0]_sp2 carries 600 N load whereas [0]_sp2 carries only around 400 N. In two load cases, two load drops are observed. The first load drop is relatively greater than the second load drop under static and fatigue loading. Under fatigue loading, the load drops 400 N after loading cycles with constant maximum displacement of 5 mm. Under static loading, increasing displacement causes load drop as well which is equal to the first load drop level of fatigue loading. Under fatigue loading, after the first load drop, the remaining slope is almost the same with the initial slope of the static test specimen. After the first failure, static loading curve experience a small load drop corresponding to crack propagation, however, the slope of the curve remains constant. Then, [0]_sp9 experience the final failure and the specimen lose almost all its stiffness. However, under fatigue loading the specimen experience small load drop leading to the failure of the specimens. The final slope of the load-displacement curve of the fatigue loading is higher than the remaining slope of the static loading specimen after failure. Table 6.1 presents the slopes of [0]_sp9 and [0]_sp2 until failure. Under fatigue loading, the slopes of the curves are greater than the slope of the static loading specimen from the initial state until failure.

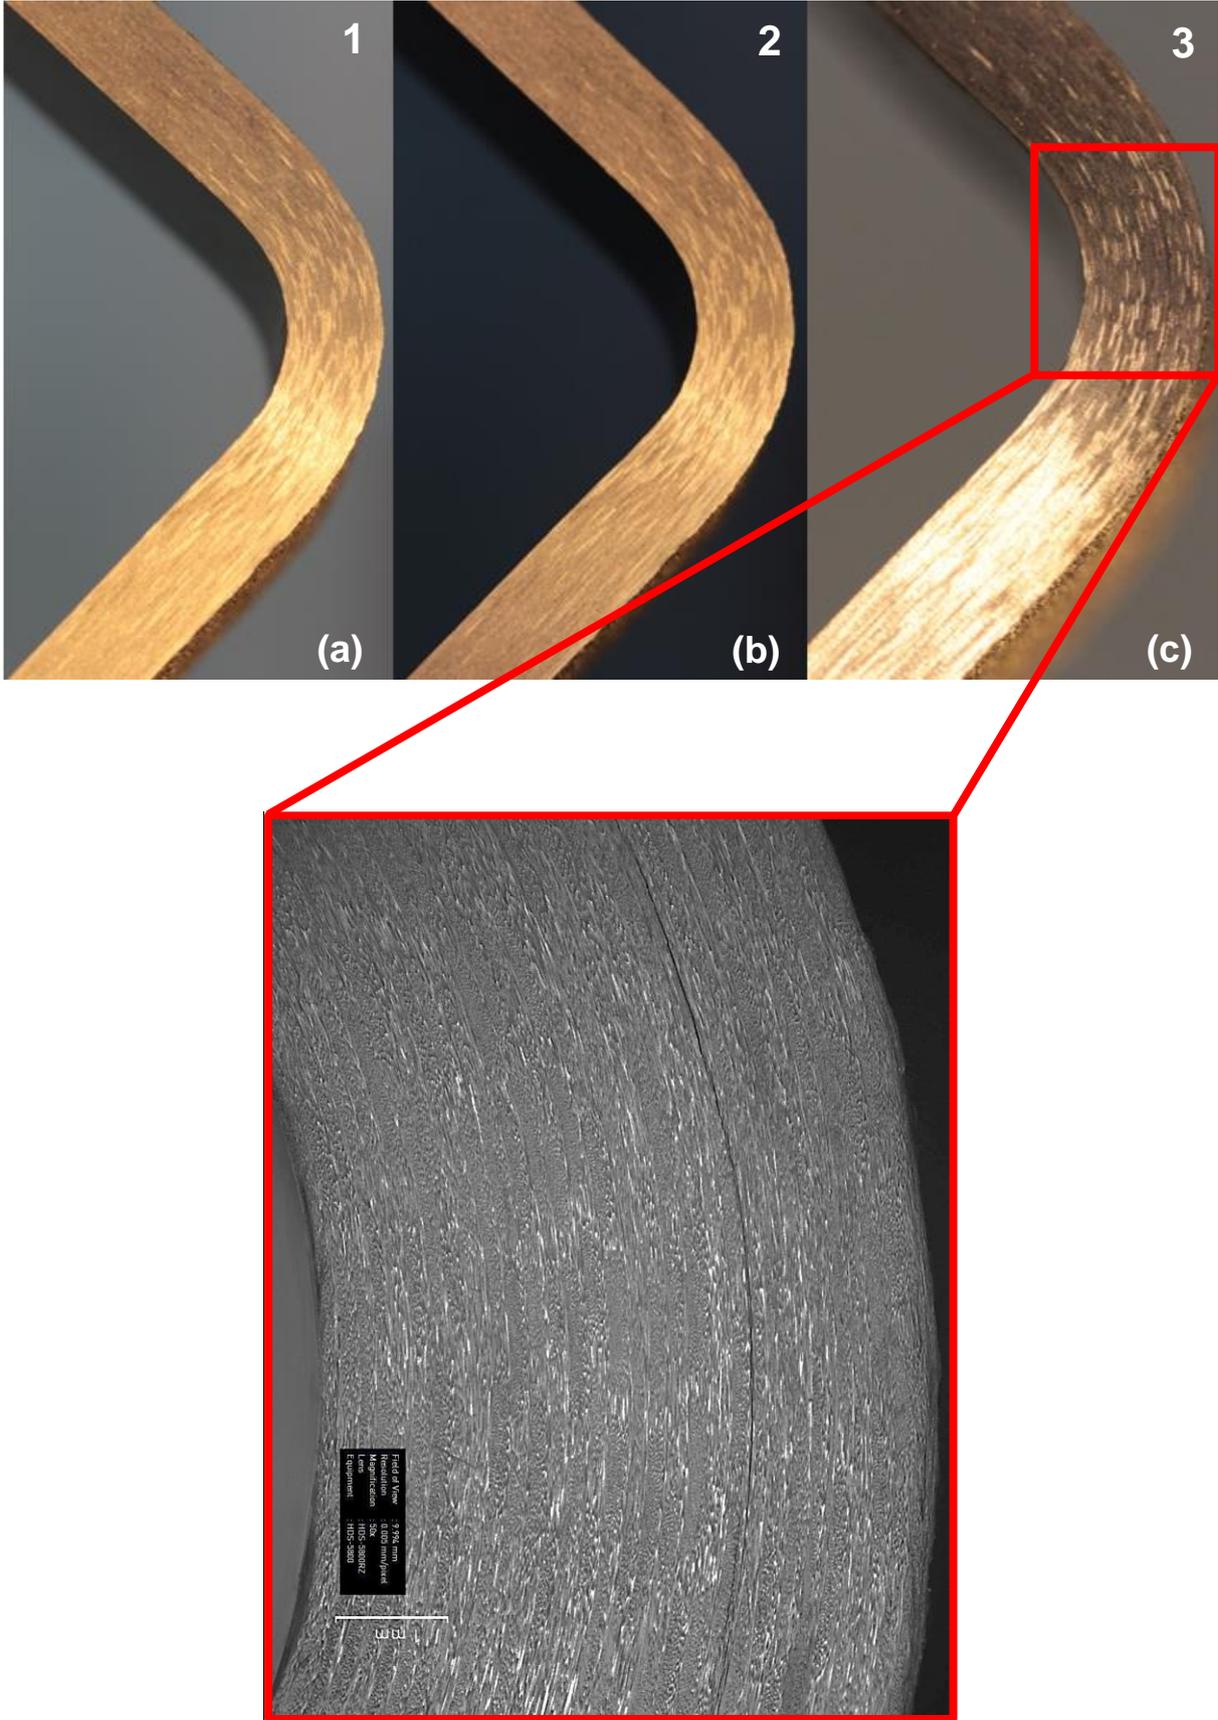
Figure 5.2 The images of [0]_sp9 under fatigue loading (a) Initial state; (b)After first load drop; (c) After failure; (d) The micrograph after failure

The images taken after the load drops are presented in **Figure 5.2**. **Figure 5.2a** shows the initial form of the specimen without any damage corresponding to the first slope on the plot. The first load drop occurs suddenly with cracking sound. However, as shown in **Figure 5.2b**, after the first load drop there is no cracks or delaminations are formed in the edges of the specimen. After the first load drops, fatigue loading with the same displacement value is conducted on [0] UD curved composite specimen and after 1000 cycle, second load drop is observed with small delamination occurred in 67% of the thickness at the curved region (**Figure 5.2c**). This delamination corresponds to the final failure of the specimen. **Figure 5.2d** presents the micrograph of the same specimen. The delamination leading to the failure is thin and unclear so that it is marked on the micrograph. It can be seen easily that there is no damage sign except the delamination occurred at 0.67t of the thickness.

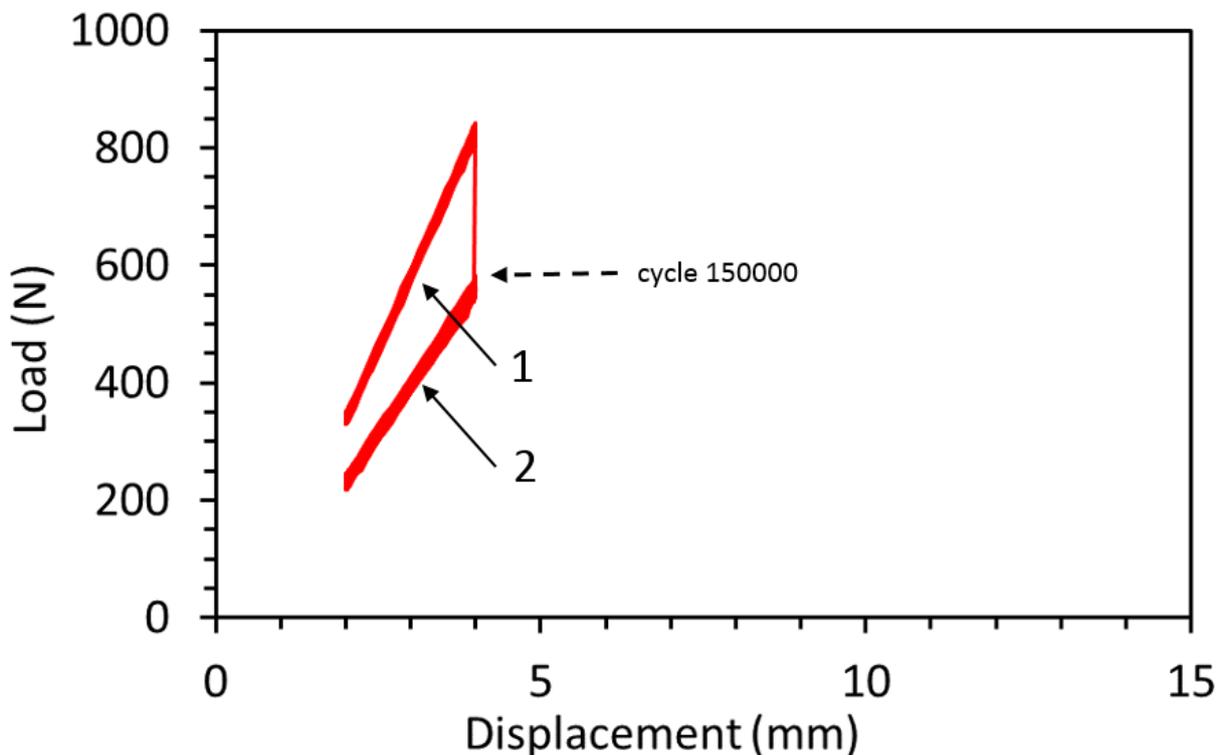
Figure 5.3 Load-displacement curves of [0]_sp8 with ongoing fatigue cycles

In order to understand the failure mechanism after the first load drop without any delamination observed, another fatigue test is conducted using [0] UD curved composite laminate with [0]_sp8. **Figure 5.3** presents the load displacement plot of the [0]_sp8 with ongoing cycles until the first stiffness degradation. 4 mm opening corresponds to over 800 N load so it is applied as maximum displacement at R-ratio of 0.5. The first slope corresponds to the initial stiffness of the material. Until the first load drop, the material preserve the initial stiffness so that the load-displacement plot includes only the last cycles of the initial slope and the first cycles of the remaining stiffness. The maximum load applied to the specimen is 850 N at 4 mm displacement. After 150000 cycles, [0] UD curved composite laminate experience the stiffness reduction. The maximum load at 5 mm displacement drops to its 65% after the first damage occurred. The load drop occurred after the first damage on specimen 8 is consistent with the first failure of specimen 9.

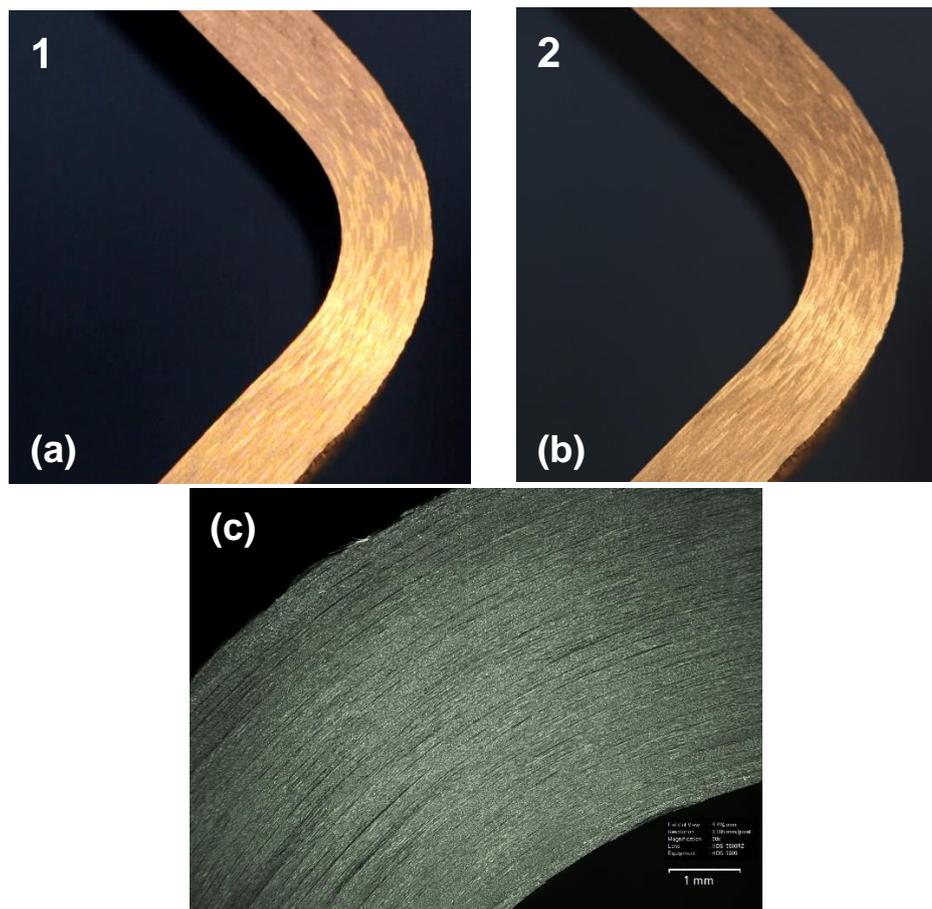
Figure 5.4 The images of [0]_{sp8} under fatigue loading (a) Initial state; (b) After first load drop; (c) The micrograph after the first load drop

Figure 5.4a present the specimen without any damage corresponding to the initial slope on the load-displacement plot. **Figure 5.4b** is taken after the first load drop. As can be seen from the figure, there is no crack or delamination that can be seen from the lateral surface of the specimen. In order to investigate the source of the stiffness degradation, micrographs are taken (**Figure 5.4c**). As can be seen from the micrograph, there is no sign of any crack or delamination formed in the edges of the laminates. The marks on the surface correspond to the epoxy. Nondestructive testing is required to observe the interior damages. Through-transmission ultrasonic testing (TTU) is conducted on specimen 8 after the first stiffness degradation without any edge

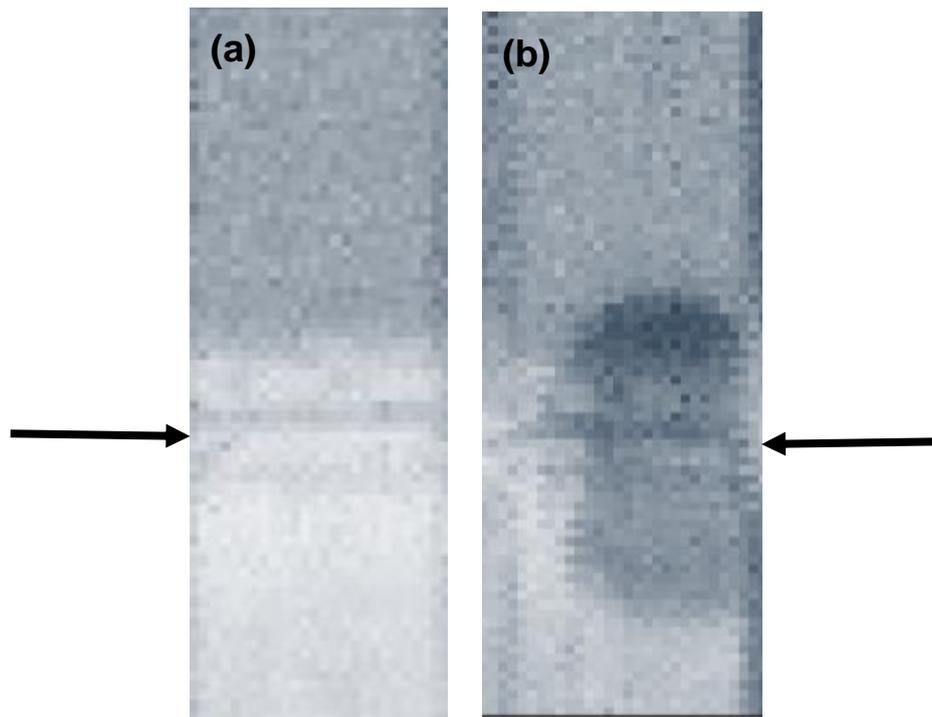
Figure 5.5 TTU test results (a) Initial state; (b) After first load drop

delaminations. The details of NDT method is explained in Methodology chapter. Figure xx shows the results of TTU testing of [0]_{sp8}. **Figure 5.5a** presents the result of the initial state of the specimen as reference image and **Figure 5.5b** present the result of the specimen after the stiffness degradation. The images shows the top view of the specimen and the arrow marks the radius. The color differences in **Figure 5.5b** correspond to defects occurred in the specimen. It is clear that in the curved region interior delamination is formed. Delamination is arrested in the curved region and cannot proceed until the edges of the specimen. This interior damage explains the stiffness degradation occurred under fatigue loading.

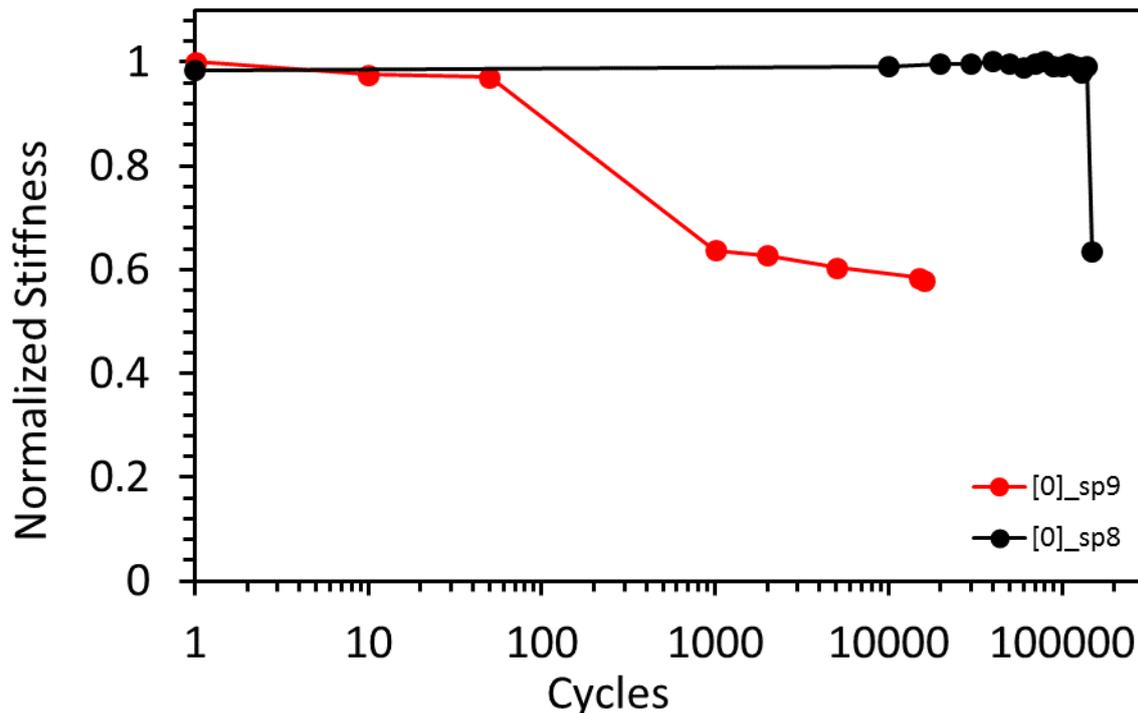
Figure 5.6 Normalized stiffness degradation with ongoing cycles of [0]_sp9 and [0]_sp8

In **Table 5.1**, the slopes varying with the ongoing cycles are presented for both [0] UD specimens. The slopes corresponding to the stiffness of the materials are similar. Slight differences may be due to the difference in the loading rate. In order to investigate the stiffness reduction of [0] UD laminates until failure, the slope of the ongoing cycle for both fatigue loading specimens are calculated. The normalized stiffness values of [0]_sp9 until failure and [0]_sp8 until first failure are presented in **Figure 5.6**. As can be seen from the plot, [0]_sp9 experience the first load drop earlier than [0]_sp8. Although the fatigue resistance of specimens are different, the stiffness reduces to the same level, 60%, after the first load drop. It is observed that, the stiffness reduction which corresponds to the first damage is very sharp in both specimens. However, after first load drop, stiffness degrades gradually until failure which corresponds to gradual damage progression. However, failure on the lateral surface occurs sudden which may be caused by interior delaminations. After failure [0]_sp9 preserves 50% of its initial stiffness.

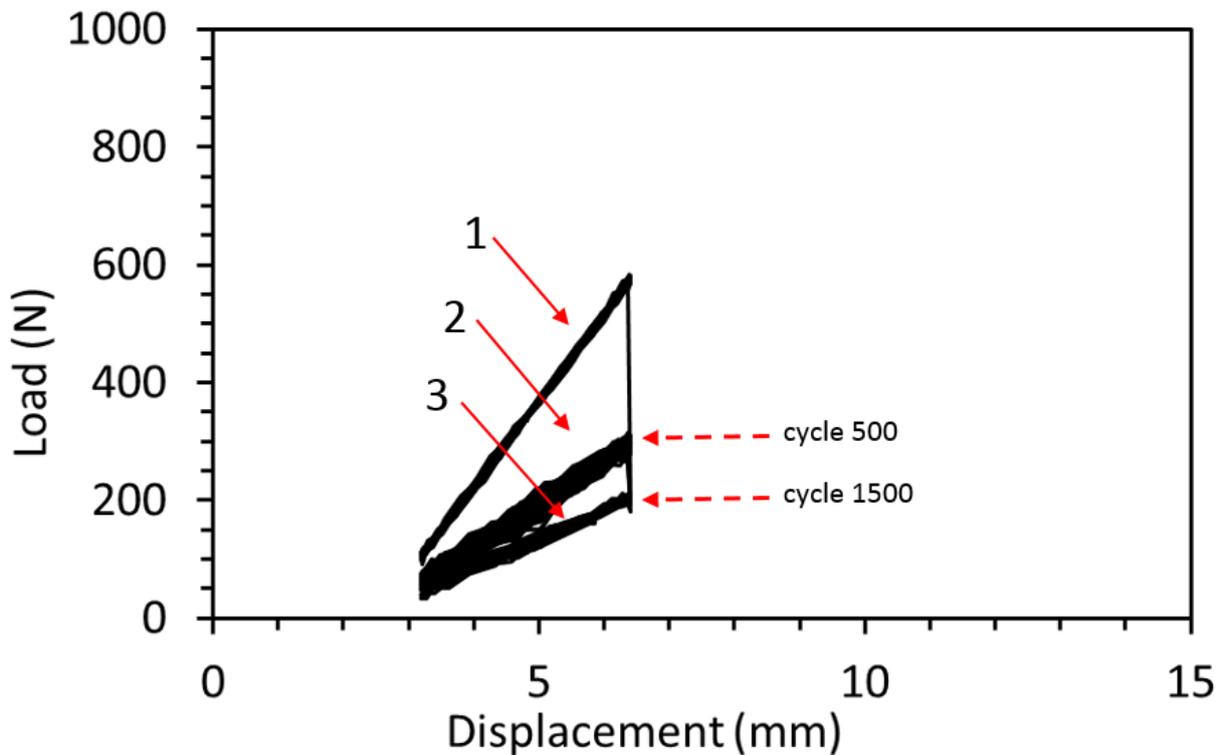
Figure 5.7 Load-displacement curves of [0/90]_{sp8} with ongoing fatigue cycles until failure

Cross-plyed specimens carry consistent load values with static loading case. The average ultimate strength of cross-plyed laminates are decided as 650 N. Fatigue loading experiments are conducted at high stress states. **Figure 5.7** presents the load-displacement plot of [0/90]_sp8 under fatigue loading until failure. The experiment is conducted under displacement control with maximum displacement of 6.5 mm at an R-ratio of 0.5. The corresponding load value for 6.5 mm is 600 N which is 90% of the average ultimate strength of cross-plyed laminates. The load-displacement plot shows all fatigue cycles until failure. The initial slope corresponds to the initial stiffness of the material. After 500 cycles, the first stiffness degradation is observed. The maximum load at 6.5 mm displacement drops to 300 N which corresponds to 50% of the initial maximum load. After the first load drop, it is observed that the load at minimum displacement value drops slightly. Although the stiffness value of the laminate degrades, cross-plyed laminates preserve load carrying capacity with lower slope. Fatigue loading is conducted with the same maximum displacement value after the first load drop and the cross-plyed specimen experience the second stiffness degradation in the 1500th fatigue cycle. The maximum load at maximum displacement drops to 200 N which corresponds to 65% of the remaining maximum load value. This load drop leads to final failure of the specimen and the maximum load capacity is only 35% of the initial maximum load value. After the second load drop, load value corresponding to the minimum displacement remains constant. The slope of the load-displacement plot corresponding to the stiffness of the material decreases which is

relatively less than the degradation after first load drop. The initial slope and the slopes after load drops are marked which correspond to the damage observed in the normal camera images.

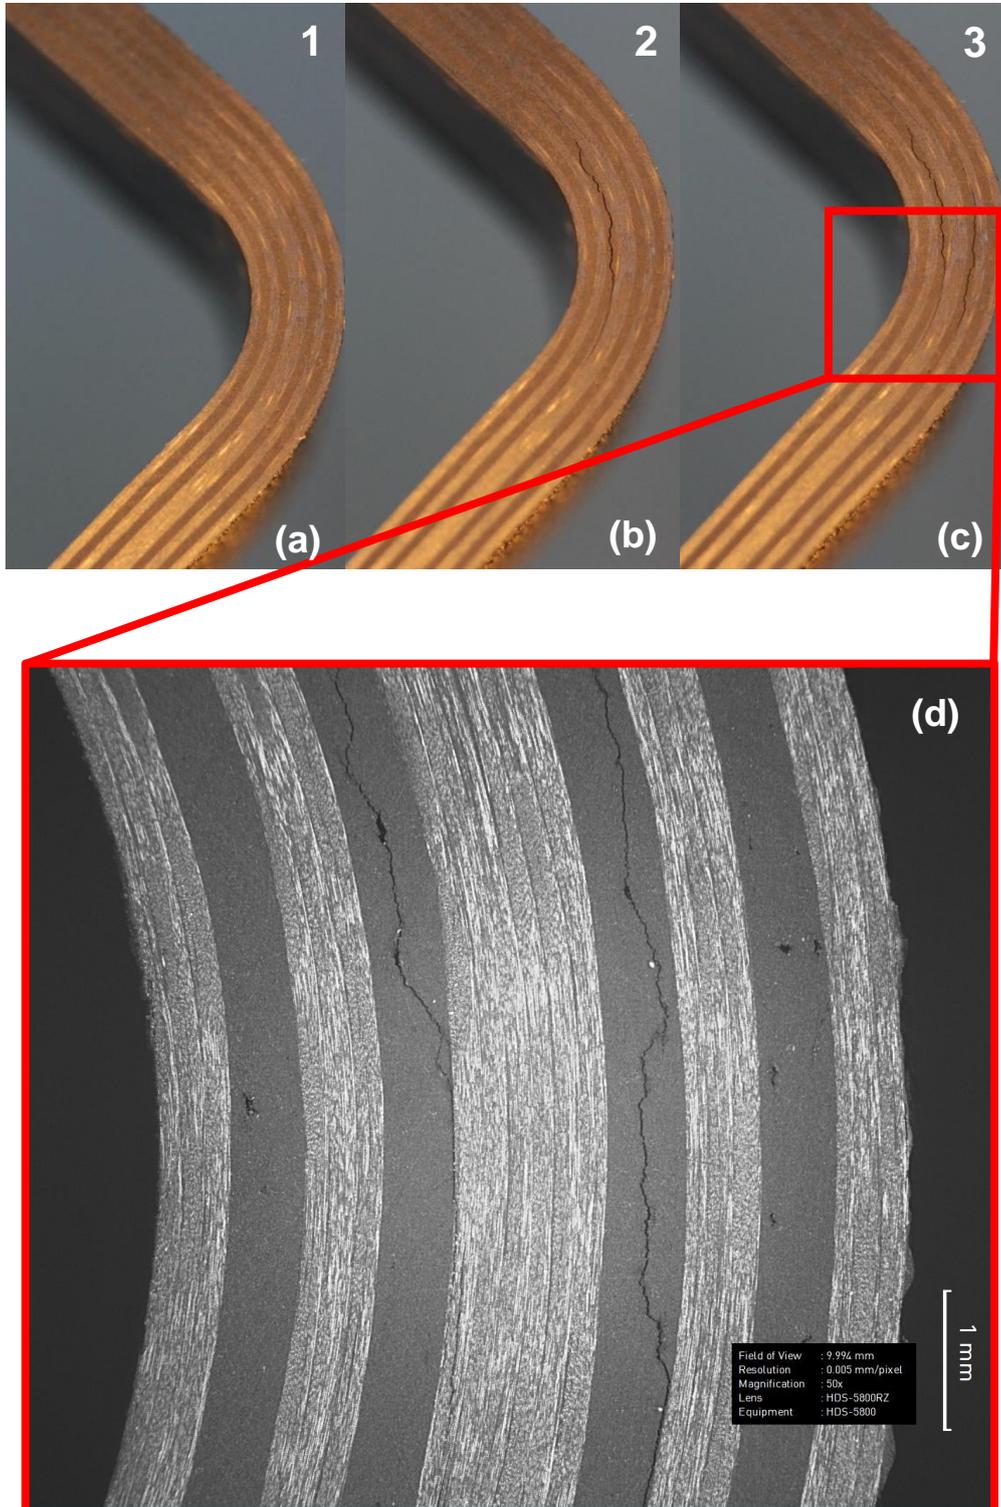
Figure 5.8 The images of [0/90]_{sp8} (a)Initial state; (b)After first load drop; (c)After failure; (d)The micrograph taken after failure

The evolution of the damage under fatigue failure on [0/90]_{sp8} is presented in **Figure 5.8**. The images are taken after every load drop using DSLR camera. **Figure 5.8a** shows the initial state of the specimen without any damage. This image corresponds to the initial slope on load-displacement curve of the specimen. **Figure 5.8b** presents the initial crack occurred in the second off-axis ply corresponding to the first load drop after 500 cycle. Since the first damage forms in the second 90° ply, high rate of stiffness loss is observed after the first load drop. The images are taken using normal camera so that the initiation and progression of the damage cannot be caught. However, as can be seen from **Figure 5.8b**, the failure pattern includes matrix cracking through the curved region and progressed delaminations through the arm. Matrix cracks initiate first and lead to the delaminations. Matrix crack proceed lead to delamination through the interface of the adjacent 0° ply to the upper arm. Matrix cracks continue as delamination through the lower arm. Delamination starts at the interface of the two plies and proceeds through the 0° ply. Delaminations do not progress through the arms, the crack tips are marked with the arrows. **Figure 5.8c** presents the failure pattern leading to the final failure of the specimen occurred in 1500th cycle. With the ongoing cycles, it is observed that the first damage occurred in the second off-axis ply remains constant. It is observed that damage is formed in the third off-axis ply corresponding to the second load drop and final failure. Matrix cracks are formed at

the curved region and they slightly proceed to the arms through the interface with the adjacent 0° ply. Both matrix cracking and delamination occurred in the third off-axis ply is smaller than the first damage. **Figure 5.8d** presents the micrograph of the lateral view of the specimen. The matrix cracks delaminations proceeding through the lower arm are seen easily.

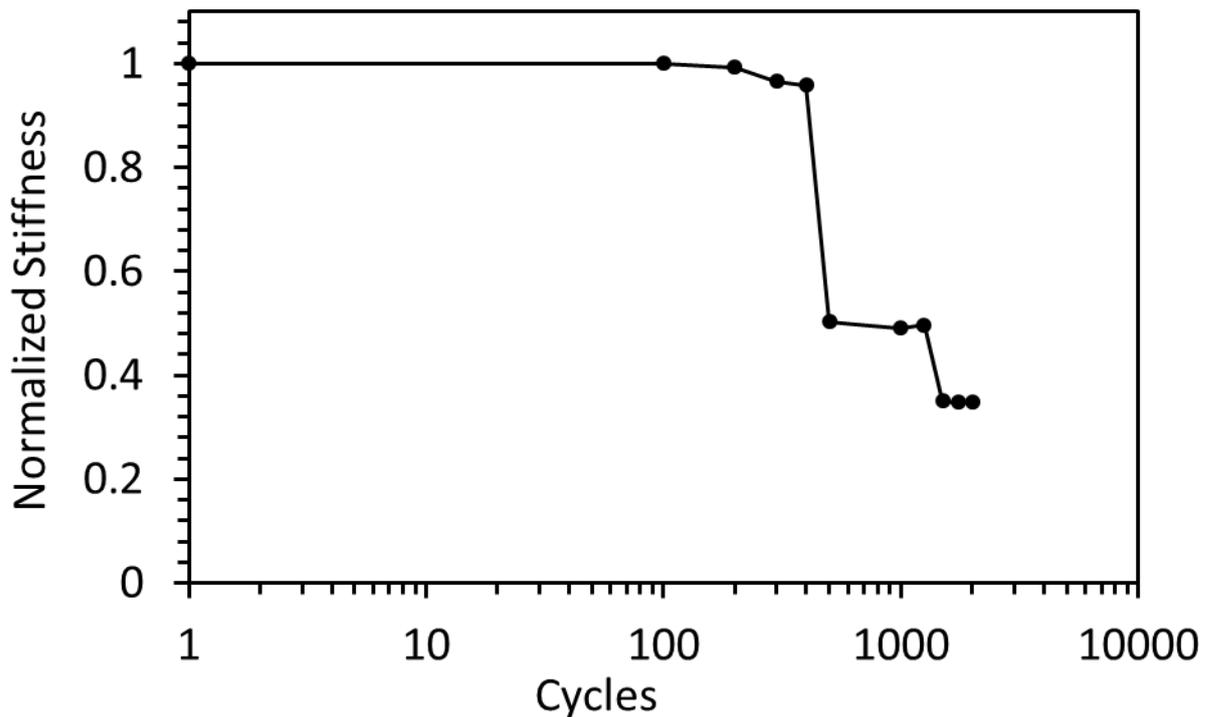
In order to investigate the stiffness reduction of cross-plyed laminates under fatigue loading until failure, the slope of the ongoing cycles are calculated for [0/90]_{sp8}. The normalized stiffness values of [0/90]_{sp8} until failure are presented in **Figure 5.9** Figure 5.6. It is observed that, until damage initiation stiffness value remains constant with ongoing cycles. Then, stiffness degrades sharply which corresponds to sudden damage initiation not gradual damage progression. After the first load drop, the stiffness value is 48% of its initial value and after failure the only 32% of the maximum stiffness is preserved. The results are consistent with the results of load-displacement curve.

Figure 5.9 Normalized stiffness degradation with ongoing cycles of [0/90]_{sp8}

| Figure 5.9 Normalized stiffness degradation with ongoing cycles of [0/90]_sp8..... | 65 |

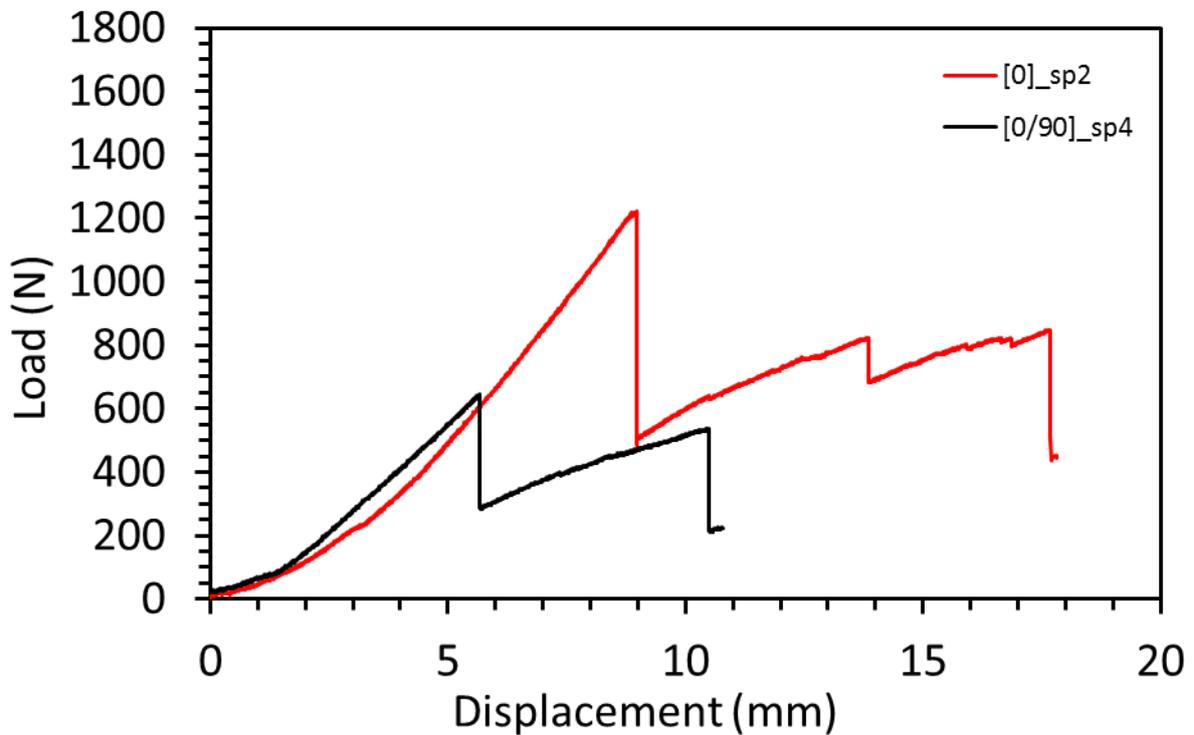
In this section, the effect of the lay-up orientation on failure mechanism under static bending moment loading is discussed. The results of [0]_{sp2} from [0] UD laminates and [0/90]_{sp4} from cross-plyed laminates are compared as average results. According to the results, a dynamic delamination is occurred in both cases so that the included off-axis plies do not change the dynamic failure however, they affect the load carrying capacity. Figure 6.1 presents the load-displacement curves of [0]_{sp2} and [0/90]_{sp4} under static loading until failure. As can be seen from the plot, the initial slope of [0] UD laminate is slightly greater than the cross-plyed laminate. [0] UD laminate can carry up to 1200 N, whereas the maximum load cross-plyed laminate is 650 N. The difference between this load carrying capacity is due to the difference between the longitudinal modulus of the laminates. The greater longitudinal modulus provides strength to the laminates in the longitudinal direction and as presented in **Table 3.4** the longitudinal modulus of [0] UD laminates are higher than the cross-plyed laminates. After the first failure the load carrying capacities are different as well. [0] UD laminates lose most of its load carrying capacity, the slope of the load-displacement curve degrades. The little steps are observed in the load-displacement curves after the first failure then second load drop occurs leading to the final failure. In contrast, cross-plyed laminates carry load after first failure. Although the slope of the load-displacement curve slightly

decreases, the specimen carry load to the level which is close to the maximum load value then second load drop occurs leading to the final failure.

Figure 6.1 Load-displacement comparison of [0]_sp2 and [0/90]_sp4 under static loading

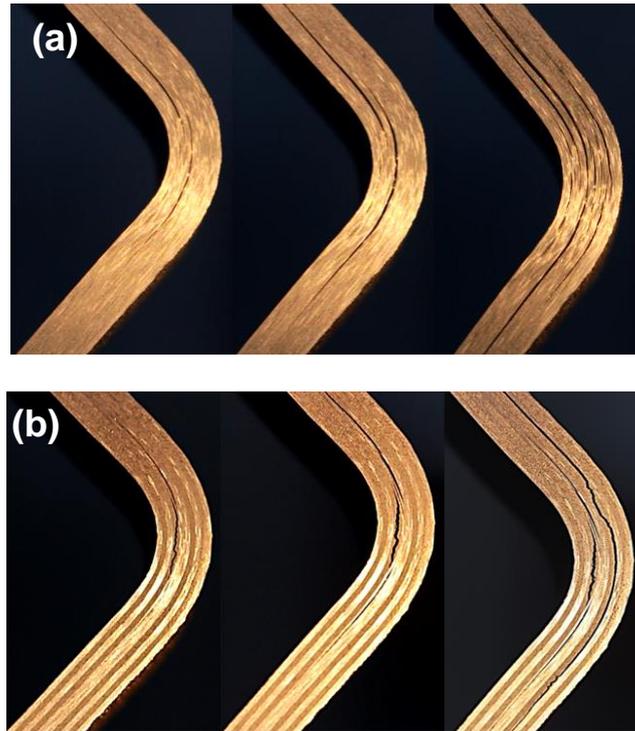
Figure 6.2 The damage evolution under static loading (a)[0]_{sp2}; (b)[0/90]_{sp4}

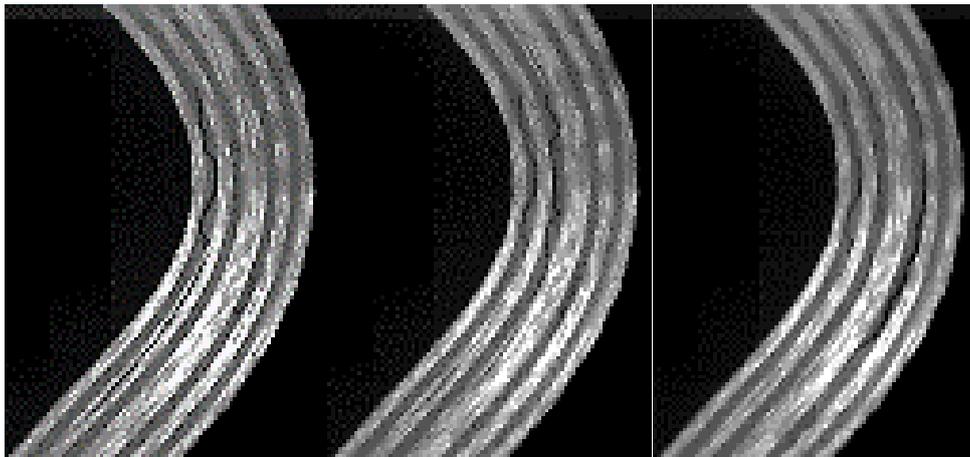
Figure 6.3 High speed camera images of [0/90]_{sp2}

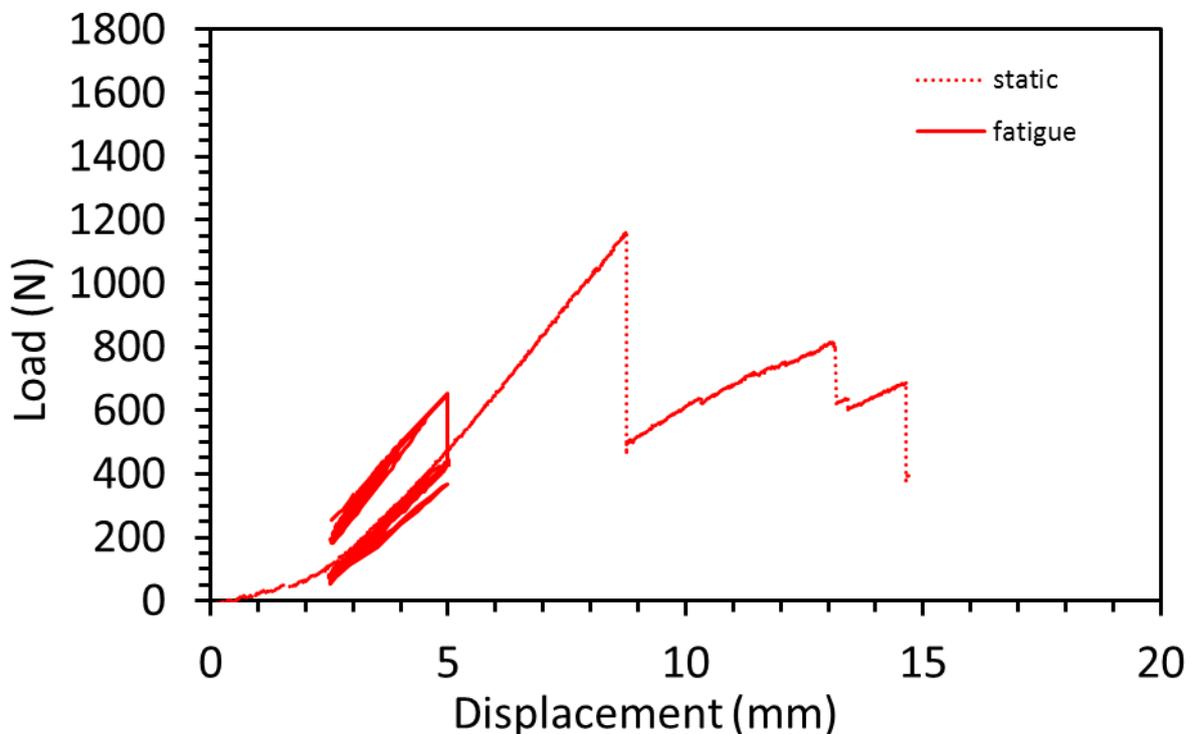
In this section, the static and fatigue loading results of [0] UD curved composite laminates are compared. The load-displacement plots are compared; the slopes and load drops are discussed. The failure pattern of the specimens under static and fatigue loading are compared using DSLR camera images. **Figure 6.4** presents the load-displacement plot of [0] UD curved composite laminates under static and fatigue

Figure 6.4 Load-displacement curves of [0]_sp2 and [0]_sp9 until failure

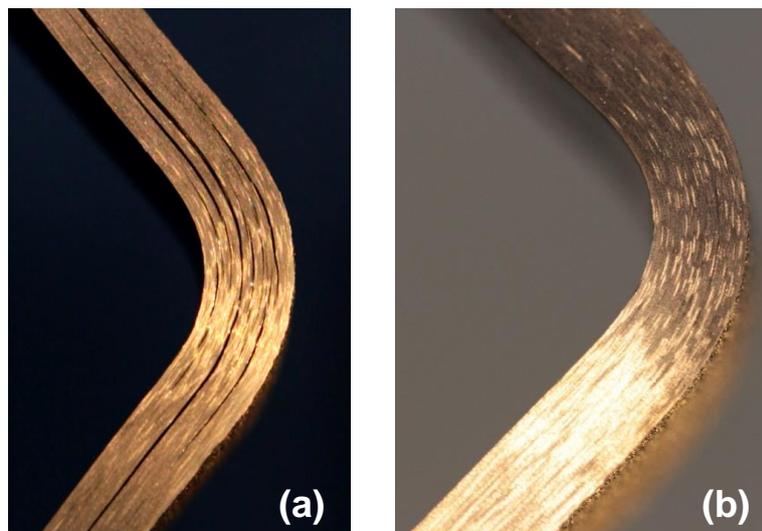
The difference in the failure mechanisms are presented in **Figure 6.5**. Both images represents the final failure of [0] UD curved composite laminates; **Figure 6.5a** shows the static failure and **Figure 6.5b** presents the failure occurred after fatigue cycles. The failure mechanisms are obviously different than each other. In **Figure 6.5a**, multiple delaminations on [0]_sp2 can be seen easily which occur under static loading. **Figure 6.5b** shows the final failure of [0]_sp9 under fatigue loading. The delamination corresponding to the first load drop cannot be seen from the lateral view of the specimen. However, under static loading first load drop is in combination with delamination through the specimen length at 0.35t of the specimen. With another fatigue loading experiment, it is observed that, the load drop on the load-displacement plot corresponds to interior delamination. Under fatigue loading the first damage occurs inside and it initiates from the mid-point of the curvature. As can be seen from **Figure 6.5a**, the second major delamination occurs at 0.75t in combination with small delaminations through the thickness at the curved region which lead to the final failure of the specimen under static loading. Although the failure comes with the multiple and arm-length delaminations under static loading, under fatigue loading the only failure pattern observed from the lateral surface of the specimen is an arrested and thin delamination at the 0.75t of the curved region of the specimen. The second delamination corresponding to the final failure occurred under both static and fatigue loadings are at the same location. However, the damage progression under fatigue loading totally differs from the fatigue failure.

**Figure 6.5** (a) Static failure; (b) Fatigue failure

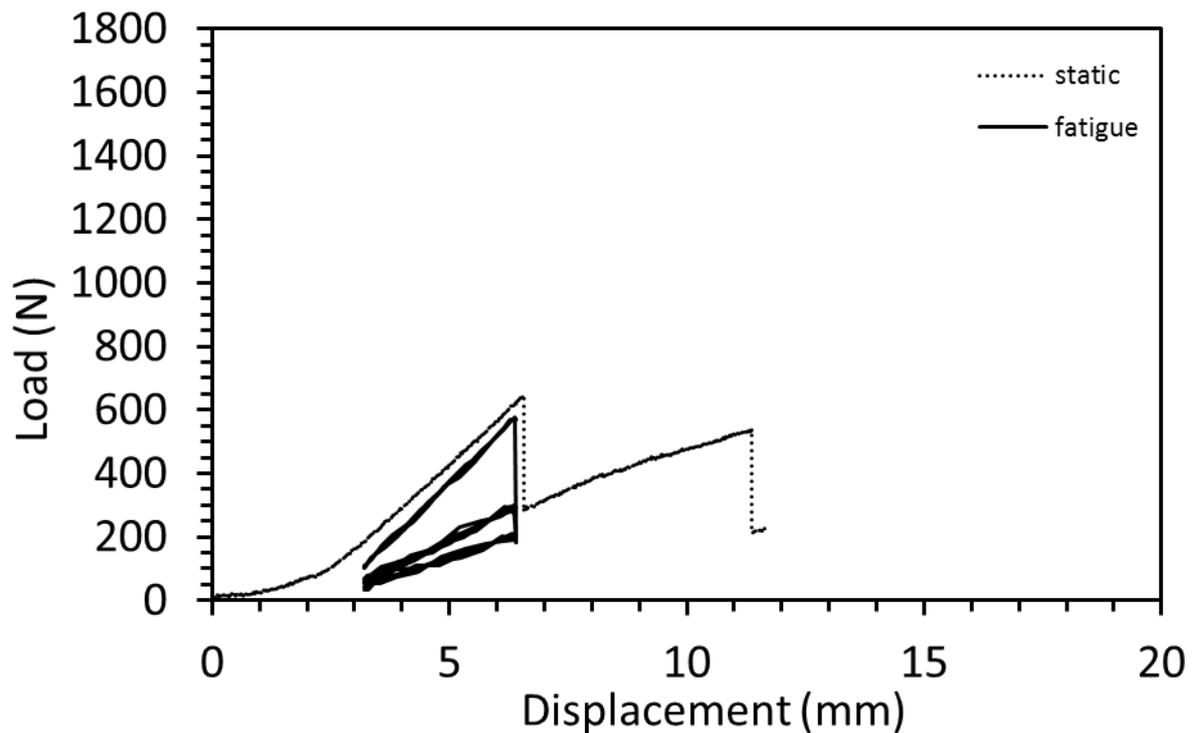
In this section, the static and fatigue loading results of $[0_3/90_3/0_3/90_3/0_3]_s$ cross-plyed curved composite laminates are compared. The load-displacement plots are compared; the slopes and load drops are discussed. The failure pattern of the specimens under static and fatigue loading are compared using DSLR camera images. In order to compare the results of static and fatigue loading appropriately, $[0/90]_{sp4}$ from static results and $[0/90]_{sp8}$ from fatigue results are chosen since both specimens have damage on the same plies. **Figure 6.6** presents the load-displacement plot of cross-plyed curved composite laminates under static and fatigue loading. Fatigue loading cycles on the plot representing the results of $[0/90]_{sp8}$ are designated with black lines. Static loading results belonging to $[0/90]_{sp4}$ are represented with black dashed line. The load-displacement curves of the static and fatigue loadings behave similar. The initial slope of the load-displacement curves of both static and fatigue loading cases are almost the same. It can be easily seen that, the stress state is 90% of the peak stress of the static loading. After low number of fatigue cycles, the first stiffness degradation occurs. Under static loading, around the same displacement value, the specimen experience the first failure corresponds to the first load drop. As can be seen from the graph, the maximum load at maximum displacement level after the first load drop under fatigue loading is equal to where the peak load drops after first failure under static loading. The remaining stiffness of the fatigue loading specimen is the same with the remaining stiffness of the static loading specimen as the slope of the curves are equal after the first failures. Under static loading, $[0/90]_{sp4}$ carry load with increasing displacement until almost the peak load value then experience the second load drop. $[0/90]_{sp8}$ resists to fatigue cycles with remaining stiffness then the second load drop occurs. As the first load drop, the load value is the same under static and fatigue loading where the remaining maximum load drops after final failure. The slopes of static and fatigue curves are the second load drop corresponding to the remaining stiffness value after the final failure of both specimens. The corresponding slopes calculated from the load-displacement curves of $[0/90]_{sp4}$ under static loading and $[0/90]_{sp8}$ under fatigue loading are presented from the initial state until failure in **Table 6.2**. As can be seen from the table, although only slight difference is observed in the initial slopes, the slopes corresponding to the stiffness values after each load drops are similar.

Figure 6.6 Load-displacement curves of [0/90]_sp4 and [0/90]_sp8 until failure
