MASTER THESIS

Experimental Investigation of Fatigue Behavior of Curved Composite Laminates

Universitat Politècnica de Catalunya
Master in Aerospace Science & Technology
July 2016

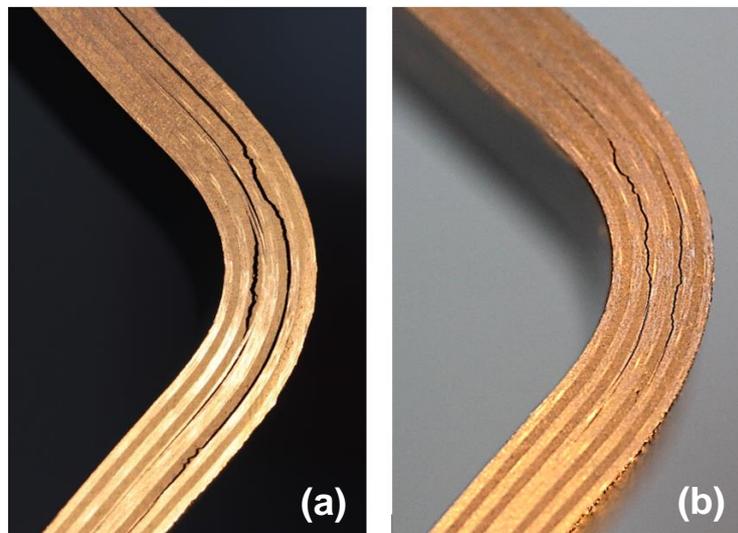
The difference in the failure mechanisms are presented in **Figure 6.7**. Both images represents the final failure of cross-plyed curved composite laminates; **Figure 6.7a** shows the static failure of [0/90]_sp4 and **Figure 6.7b** presents the failure occurred after fatigue cycles on [0/90]_sp8. In the images representing the failure mechanisms of static and fatigue loading show similarities. In both cases, the damage occurred in the second off-axis ply corresponds to the first load drop and the damage occurred in the third off-axis ply corresponds to the second load drop leading to the failure of the specimens. Under static loading, matrix cracks initiate in the second 90° ply at the curved region and proceed as delaminations through the adjacent 0° ply. The crack tip on the upper arm can be seen, however, the delamination progress through the lower arm. Under fatigue loading, similar matrix cracks are observed at the curved region corresponding to the first load drop. Matrix cracks form through the off-axis ply and the length is greater than the static failure. Matrix cracks lead to the delaminations proceeding through the adjacent 0° ply as static failure. However, both delaminations stop after proceeding short distance in contrast of the delaminations occurred under

static loading. The second delamination occurred in the third 90° ply (**Figure 6.7a**) is formed under static loading and matrix cracks initiated at the upper curved region of the specimen and in both arms, matrix cracks lead to delamination proceeding through the interface with the adjacent 0° ply which progress until the end of both arms. However, the biggest difference between the static failure and the damage occurred under fatigue loading leading to the final failure of [0/90]_sp8 is the crack length. The matrix cracks initiate at the curved part and lead to delamination, however, delaminations are arrested in the curved region of the fatigue loading specimen. The progress of the delaminations are similar with the behavior of the first delaminations under fatigue loading which is tend to be proceeding through the adjacent 0° ply to the both arms.

Figure 6.7 The final failure pattern (a) [0/90]_sp4; (b) [0/90]_sp8

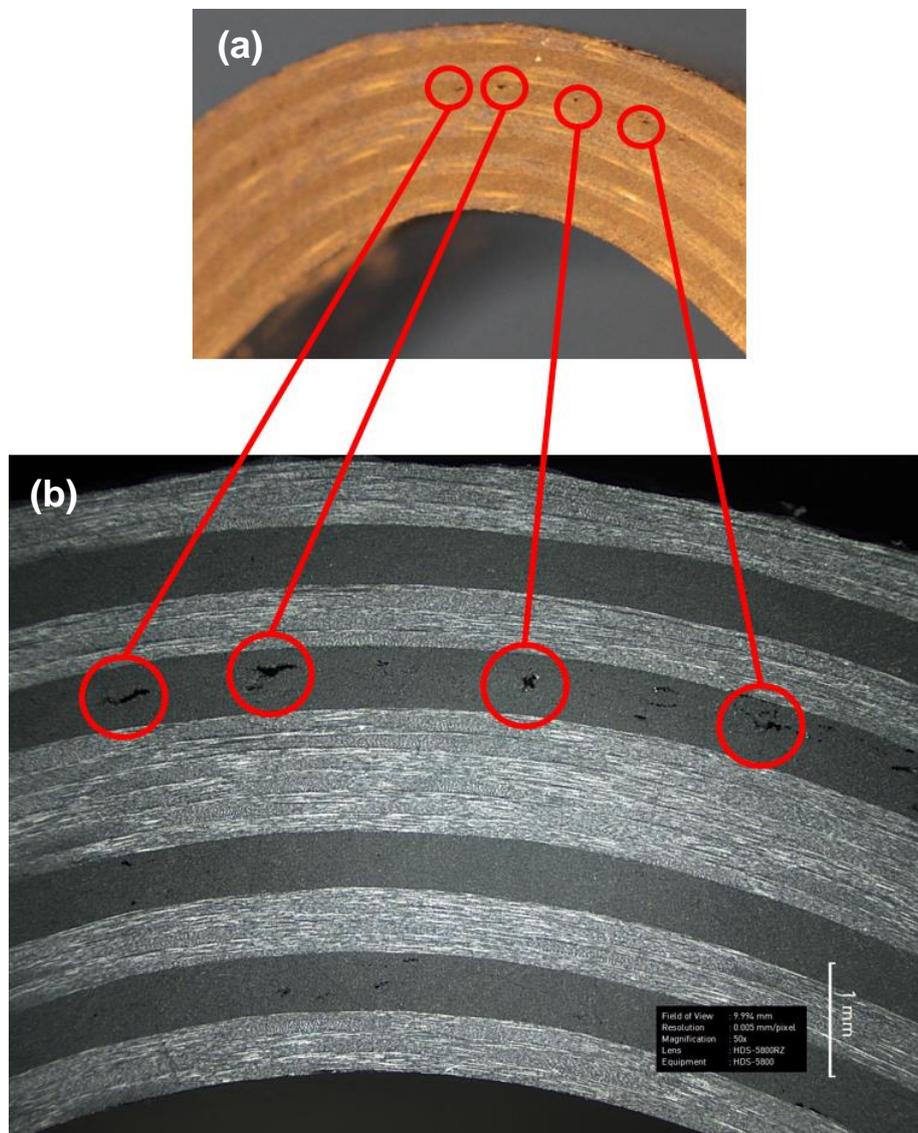
Figure 6.8a presents the initial state of [0/90]_{sp7} of cross-ply laminates before fatigue loading experiment. The image is taken using DSLR camera and the defects formed as voids can be seen on the third off-axis plies at the curved region. In order to investigate the defects, the micrograph of the curved region is taken (**Figure 6.8b**). As can be seen from the micrograph the voids are present in the third off-axis ply at the curved region. The critical size voids seen in the normal camera image are matched with the voids seen in the micrograph.

Figure 6.8 The initial state of [0/90]_{sp7} (a) DSLR camera image; (b) Micrograph of curved region

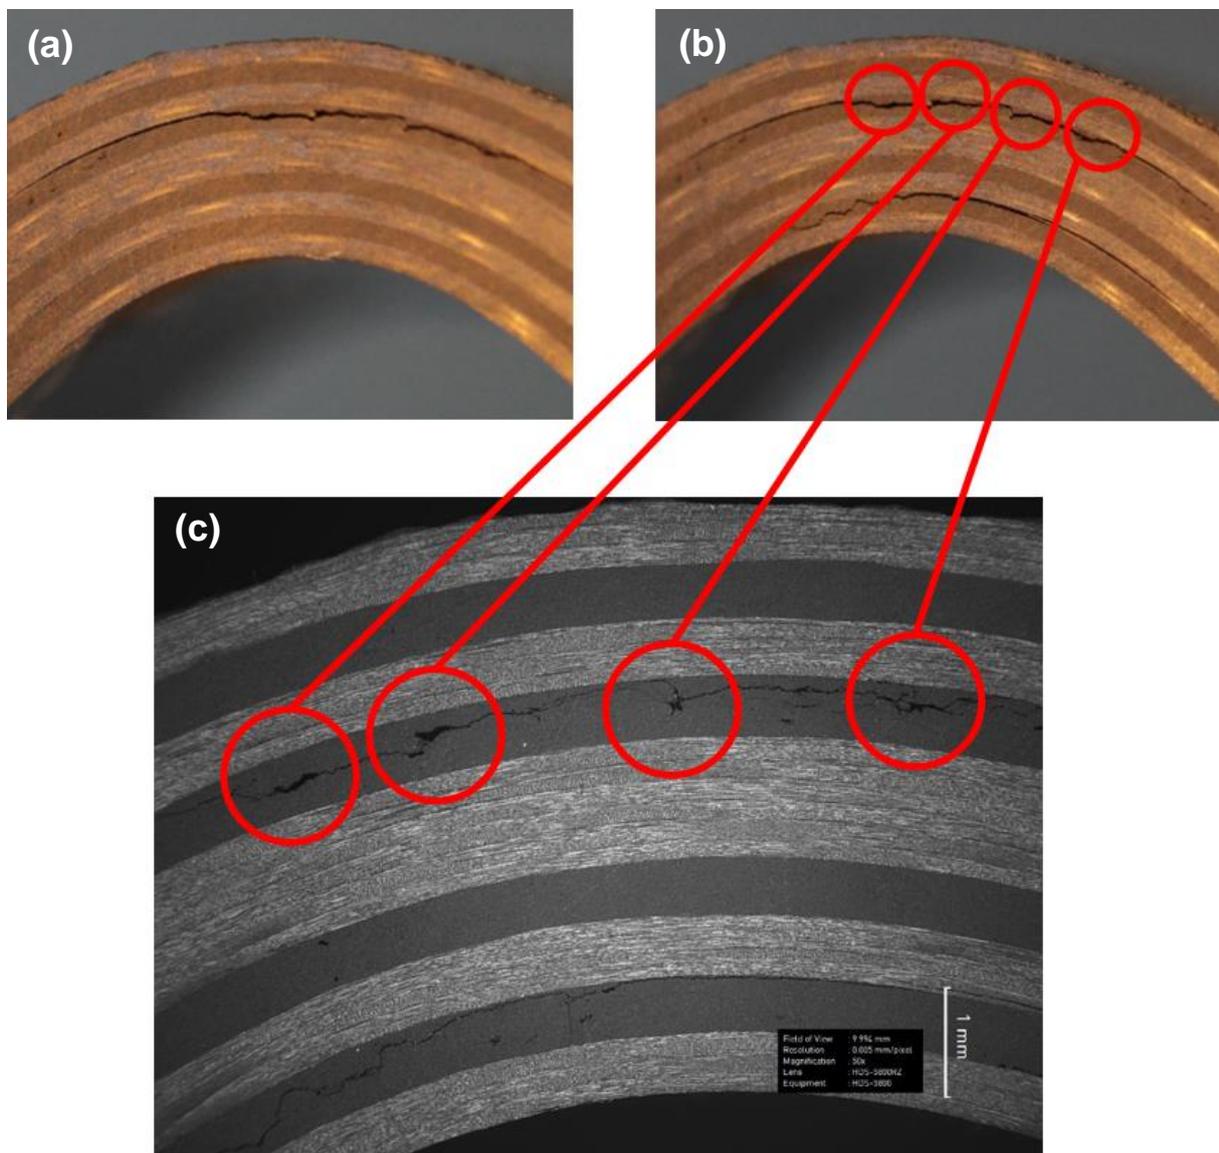
The DSLR camera image after the first failure of [0/90]_{sp7} occurred under fatigue loading corresponding to the first load drop is presented in **Figure 6.9a**. As can be seen from the figure, the failure initiates not in the highest tensile stress location but in the third 90° ply. From the normal camera image, it is observed that the matrix cracks pass through the voids. **Figure 6.9b** shows the final failure of the specimen occurred after fatigue cycles. The second damage corresponding to the final failure occurs at the interior off-axis ply where the tensile stress is maximum as expected. Figure 6.9c presents the micrograph of the curved region of [0/90]_{sp7} after failure. The damage in the third off-axis ply corresponding to the first load drop occurs due to the void presence in the critical location, although the higher tensile stress is in the interior off-axis ply. The matrix cracks initiated from the voids which is seen in the normal camera image are matched with the micrograph of the curvature.

Figure 6.9 [0/90]_{sp7} (a) DSLR camera image after first load drop; (b) DSLR camera image after failure; (c) Micrograph taken after failure

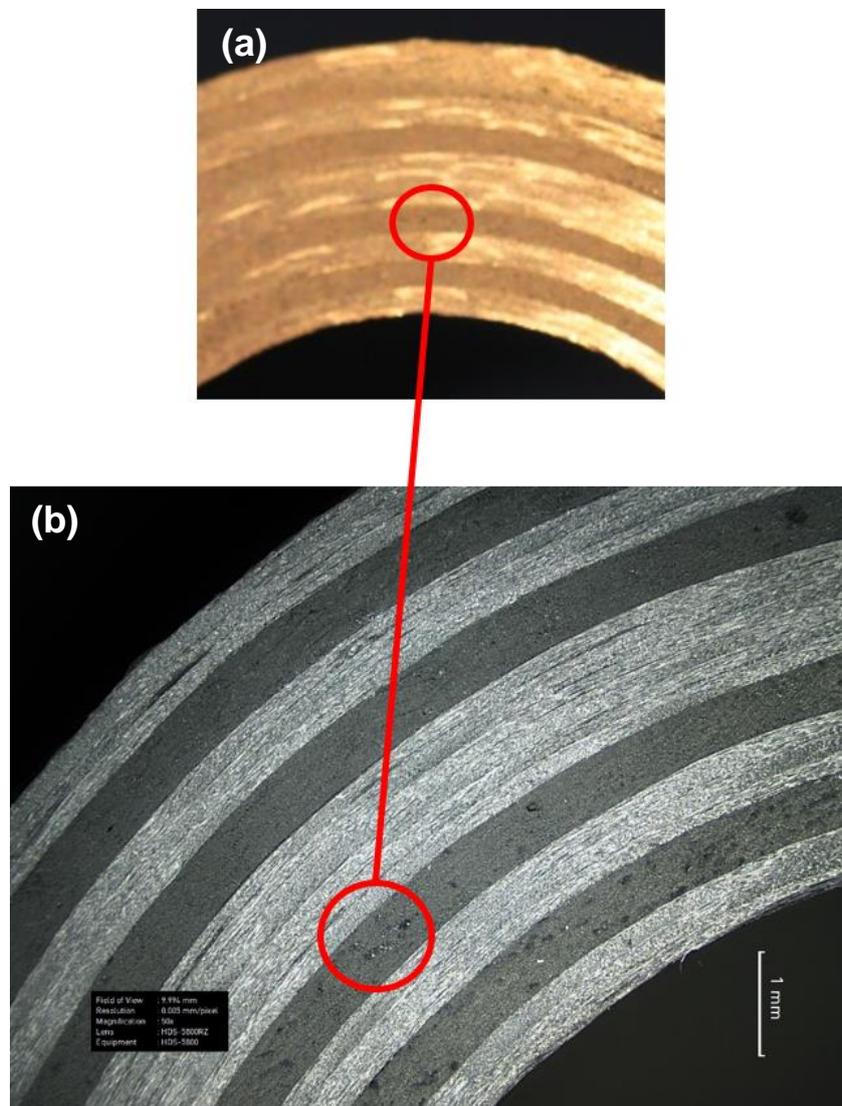
The same unexpected behavior is observed not only under fatigue loading but also under static loading. Under static loading, the failure occurred in [0/90]_{sp4} is different than expected. In order to investigate this damage behavior, the initial state of the specimen is investigated using normal camera images and micrographs. **Figure 6.10a** represents the initial state of [0/90]_{sp4} of cross-ply laminates before the static loading experiment. The image is taken using DSLR camera. If the normal camera image is investigated in detail, the void can be seen in the second off-axis ply. The void exists at the critical curved region and it is marked with the red circle. In order to investigate the location and size of the void, the micrographs are taken before the static loading experiment (**Figure 6.10b**). As can be seen from the micrograph, in the interior off-axis ply, many defects are observed which are occurred only at the surface. In the second 90° ply, the defects formed as voids can be seen easily. The void seen in the normal camera image is matched with the one in the micrograph and the other voids are marked with red circle.

Figure 6.10 The initial state of [0/90]_{sp4} (a) DSLR camera image; (b) Micrograph of curved region

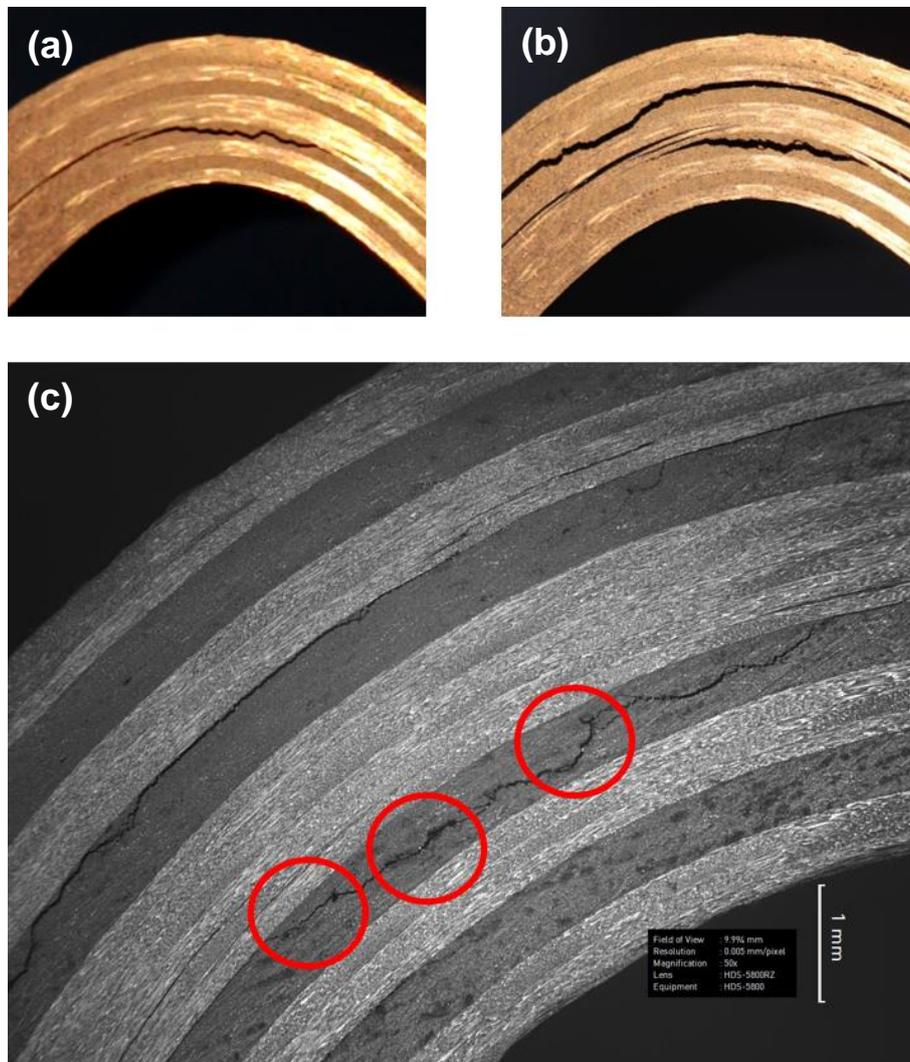
The DSLR camera image after the first failure of [0/90]_{sp4} occurred under static loading corresponding to the first load drop is presented in **Figure 6.11a**. As can be seen from the figure, the failure initiates not in the highest tensile stress location but in the third 90° ply. The void size is small so that it is impossible to understand from the normal camera images whether the matrix initiation is caused by these voids. **Figure 6.11b** shows the final failure of the specimen occurred after fatigue cycles. The second damage corresponding to the final failure occurs at the third off-axis ply, since after the first failure the remaining thickness carries load and the highest stress occurs at that location causing the failure. **Figure 6.11c** presents the micrograph of the curved region of [0/90]_{sp4} after failure. The damage in the second off-axis ply corresponding to the first load drop occurs due to the void presence in the critical location, although the higher tensile stress is in the interior off-axis ply. It can be easily seen that the matrix cracks initiate from the voids which cannot be observed in the normal camera image. The voids leading to matrix cracking are marked with red circles. The voids leading to matrix cracking are marked with red circles.

Figure 6.11 [0/90]_{sp4} (a) DSLR camera image after first load drop; (b) DSLR camera image after failure; (c) Micrograph taken after failure
