A Sensor Fault Detection Methodology applied to Piezoelectric Active Systems in Structural Health Monitoring Applications

Abstract Damage detection is the basis of the damage identification task in Structural Health Monitoring. A good damage detection process can ensure the adequate work of a SHM System because allows to know early information about the presence of a damage in a structure under evaluation. However this process is based on the premise that all sensors are well installed and they are working properly, however, it is not true all the time. Problems such as debonding, cuts and the use of the sensors under different environmental and operational conditions result in changes in the vibrational response and a bad functioning in the SHM system. As a contribution to evaluate the state of the sensors in a SHM system, this paper describes a methodology for sensor fault detection in a piezoelectric active system. The methodology involves the use of PCA for multivariate analysis and some damage indices as pattern recognition technique and is tested in a blade from a wind turbine where different scenarios are evaluated including sensor cuts and debonding.

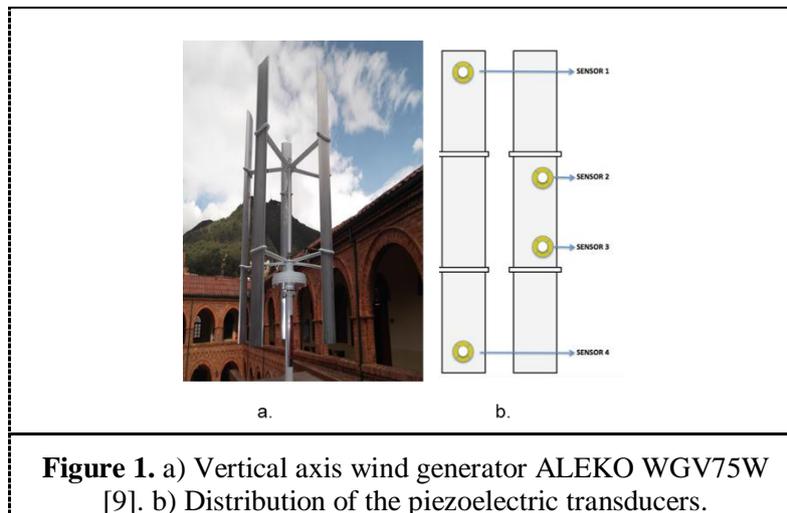
For the experimental setup a blade from a vertical axis wind generator ALEKO WGV75W was equipped with four piezoelectric sensors which were distributed over the two external faces, (see figure 1). The inspection process is performed by the PZTs working in different actuation phases as in [8], this active system uses each sensor acting as receiver and as actuator in the four different phases of the experiment. The excitation input was a 50 cycles and 100 KHz burst signal with 8 V of amplitude, data were collected at a 20 MHz sample rate, and organized by sensor actuation phases as in [10]. The signal generation and acquisition program were developed in MatLab®.

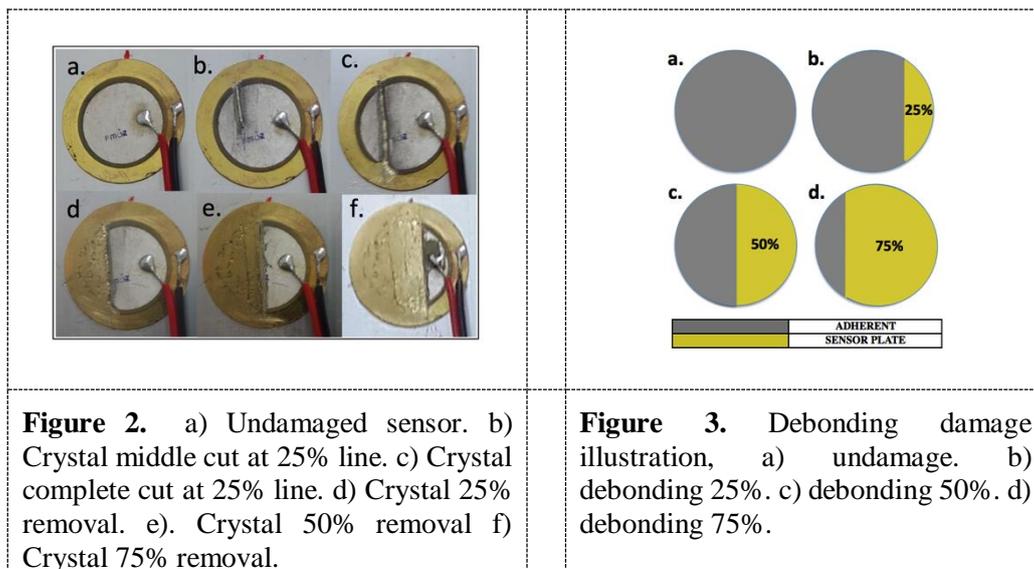
Eight damages were induced over one sensor, they are described in Table 1 and their appearance is shown in figure 2. Five of the eight damages are related to the piezoelectric crystal with cuts and removal of a certain area, the other three are related to the debonding of the metal plate of the sensor. Both, crystal removing and debonding damages are supposed to be critical in the actuation mode, since these can change the signal applied to the structure. In the same way, in the data acquisition, these damages can affect the data reliability since the mechanical transduction to the electrical field which is going to be corrupted for the cracks in the crystal and to the incomplete energy received (case of debonding).

Those damage were physically induced in the sensor 1, the other piezoelectric transducers and the wind blade structure were in a healthy state. Figure 3 presents a description of the percentage of debonding.

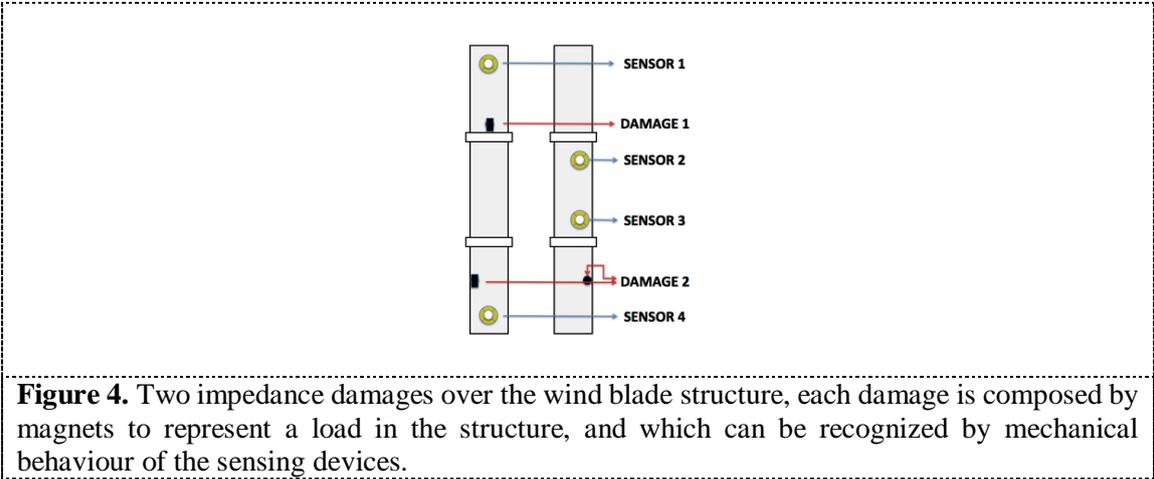
To show the influence of the damaged sensors in the damage detection process, 2 simulated damages which consists of magnets attached to the structure in order to change the mechanical impedance were introduced as in Figure 4.

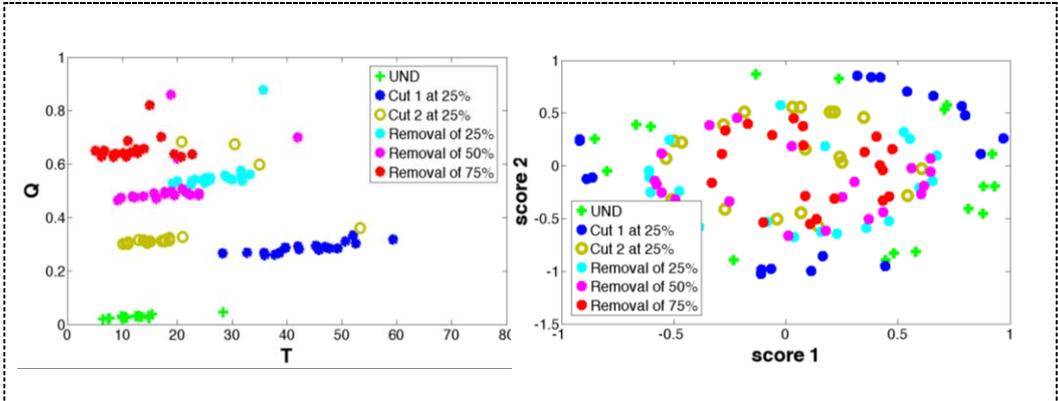
As first outcome, Figure 5 shows the score and damage index plots using data from undamaged sensor, crystal cuts and removals were organized to evidence if each sensor fault could to be recognized by comparing with the baseline. By a simple comparison, can be concluded that in this case, score plot with just two components is not able to discern the presence of faults, however the use of the damage indices allow to determine the presence of all damages and some differences between them. Similar results are obtained in each actuation phase.

Figure 5. T-Q PCA indices and Scores 1-2 for the 5 damages induced over the piezoelectric crystal. (actuation phase 2)

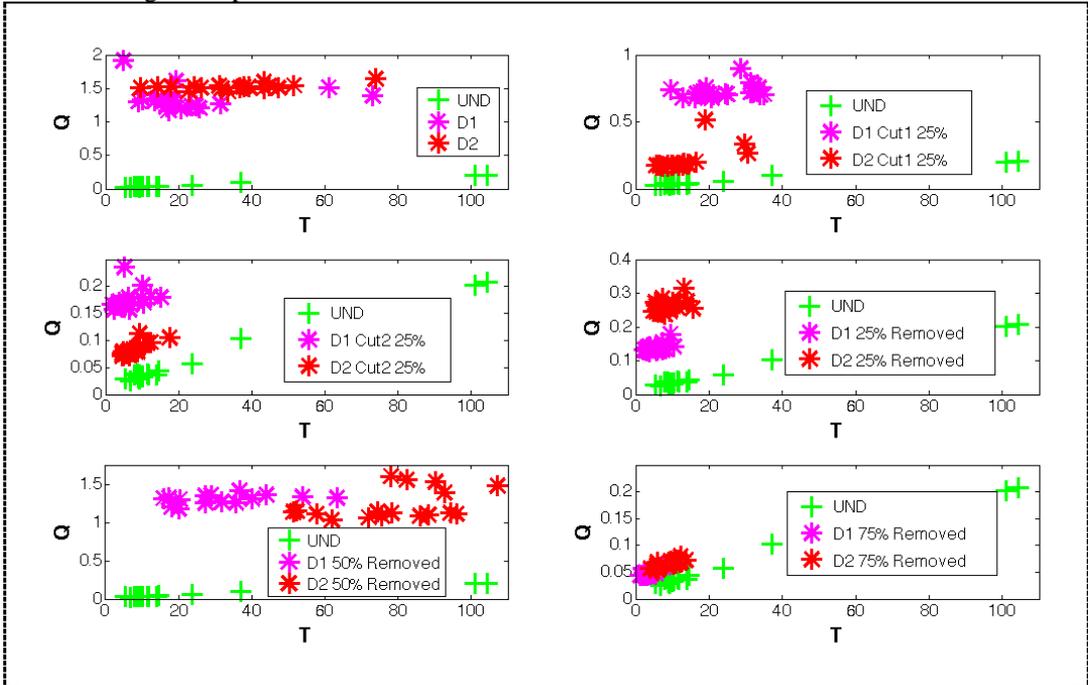
Damages over the sensing system maybe critical, but in some cases it is not possible to replace or repair the sensors immediately. Considering this situation, the second test was performed by including simulated damages to the structure when one of the sensor is known as with a fault. Figure 6 shows the results in the use of the damage indices, as it is shown both damages can be separated from undamaged, however it is necessary to highlight that baselines were built with the sensor in the different fault conditions, this result allow to confirm that the pattern recognition approach allows to determine the presence of damages in spite of the faults in a sensor.

Figure 6. T-Q PCA indices for the 2 impedance damages over the structure in a. undamaged sensors b. fault the damages are measured from the 5 faults induced over the piezoelectric crystal (actuation phase 1)

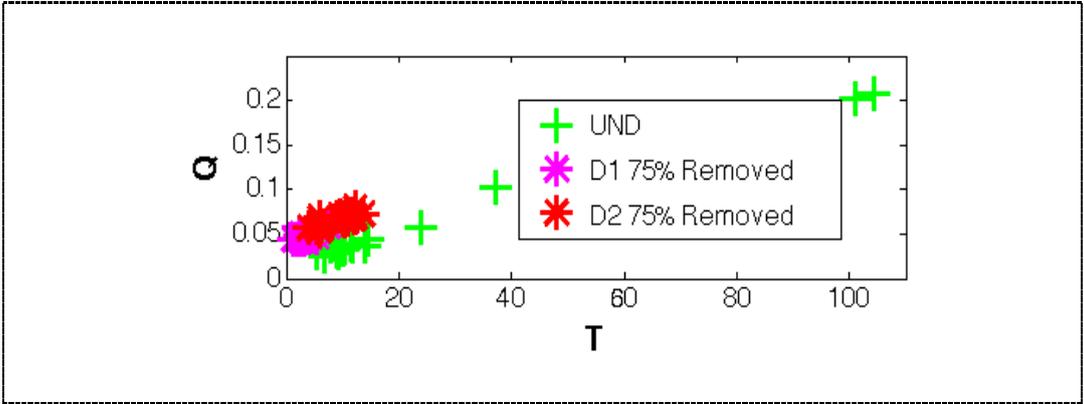
Evaluating the rest of the actuation phases, similar results are obtained, although for the Phase 1 which includes the fault sensor at 75% crystal removal case, the damages seem to be close enough from each other, is the only case where they behave like this (figure 7).

Figure 7. T-Q PCA indices for the 2 impedance damages over the structure, damages are measured from the 75% crystal over the piezoelectric.

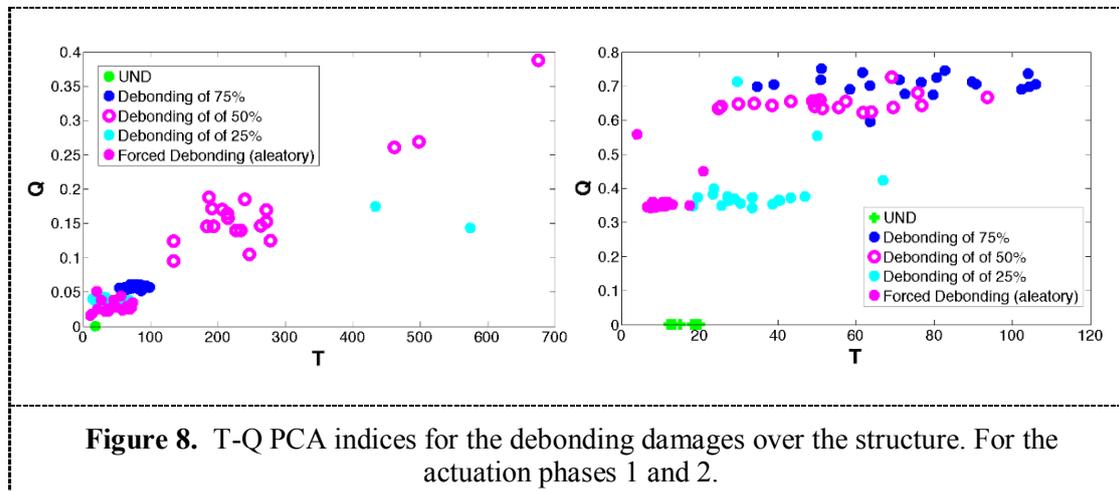
As third experimental validation, the detection of debonding was performed. Figure 8 presents the results when an incremental debonding is studied in two actuation phases. As it is possible to observe, the undamaged state is separated from the different faults.

Figure 8. T-Q PCA indices for the debonding damages over the structure. For the actuation phases 1 and 2.
