On the robustness to corrosion in the life-cycle assessment of an existing reinforced concrete bridge

Eduardo S. Cavaco^{a,b}, Luis A. C. Neves^{a,c}, Joan R. Casas^{d,*}

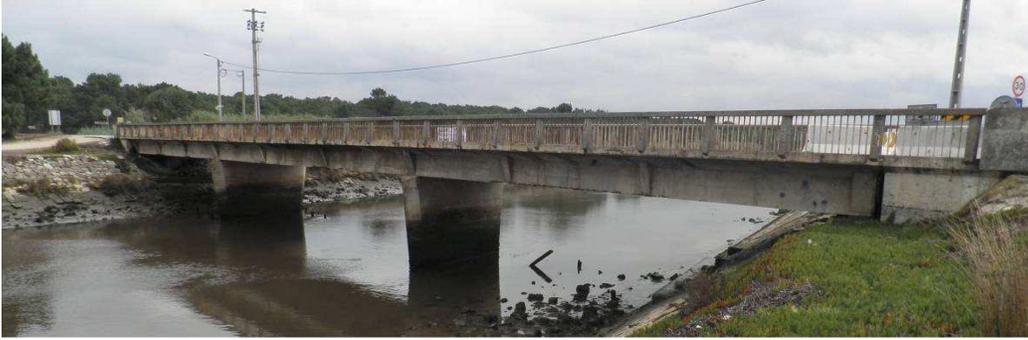
Figure 2: Tercenas bridge lateral view.

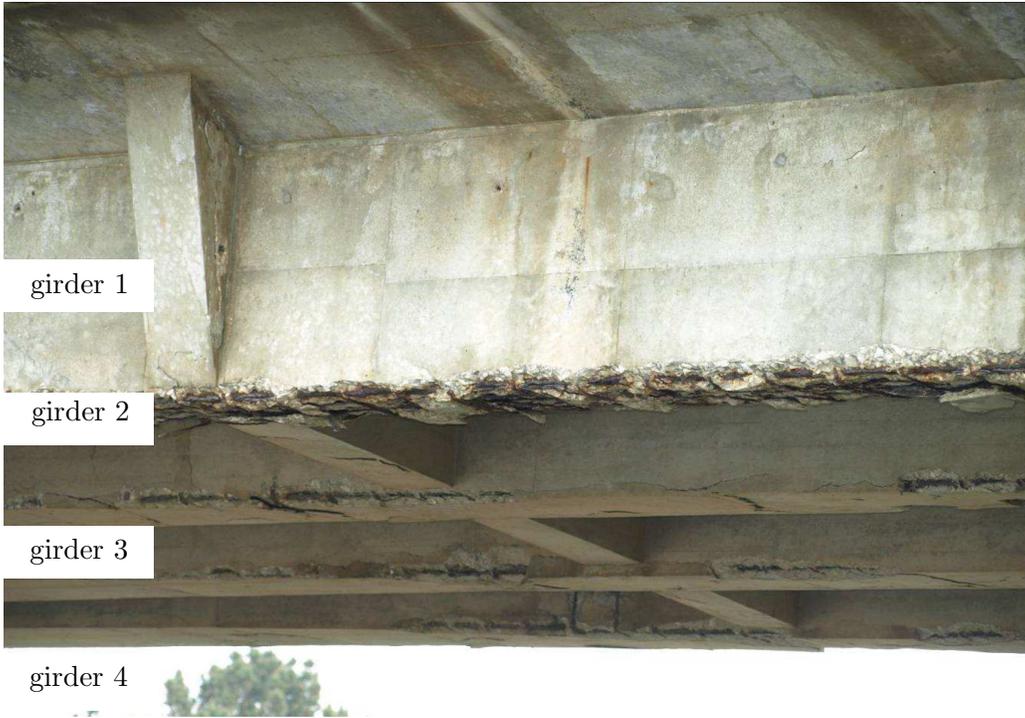
Figure 4: Corrosion affecting girders 1 to 4.

safety. In March 2011, Jacinto (2011) carried out a detailed visual inspection of Tercenas bridge, having found the most concerning pathology to be the generalized corrosion of the bottom reinforcement of deck girders. Although no chemical tests were performed, probably corrosion was due to chloride contamination due to the bridge proximity to the coast. Figure 4 shows a photo taken from the west-side of the bridge. It is possible to observe generalized corrosion in all girders, and concrete cover cracking and spalling, in some cases. Figure 4 and Figure 5 also show corrosion on girder 1 to be more advanced than that observed in the remaining girders.

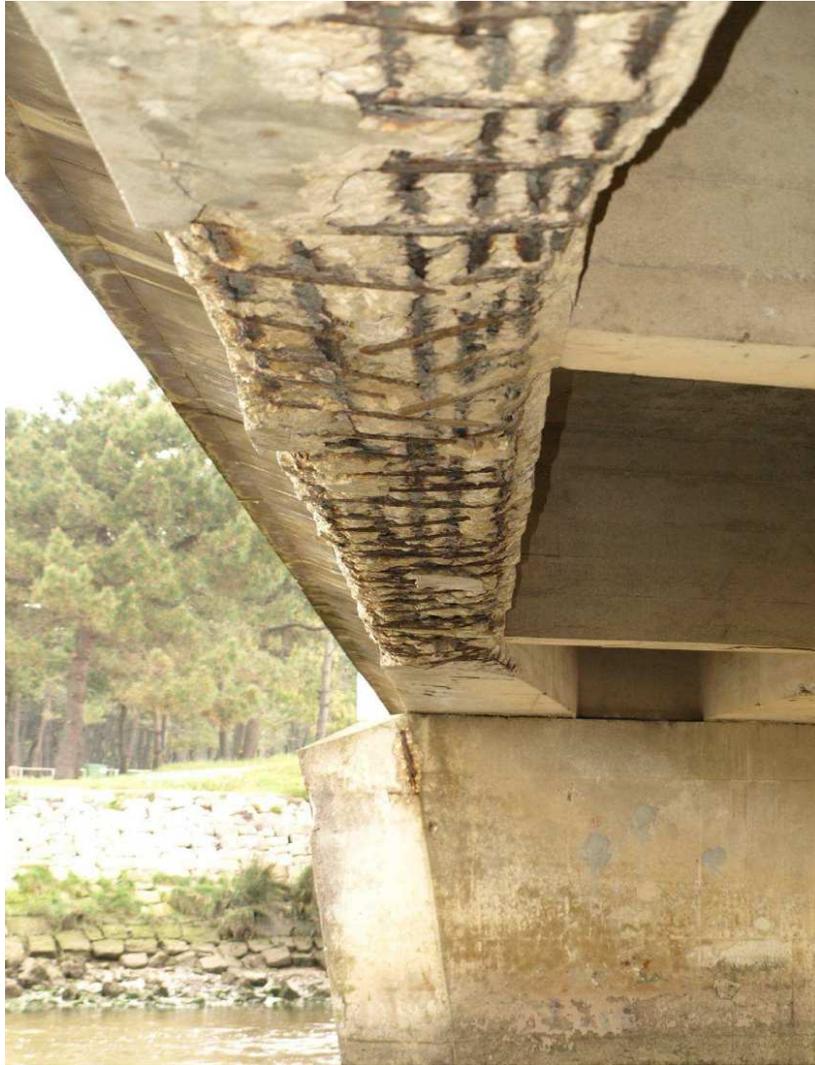
Figure 5: Exposed reinforcement on Girder 1.

The effect of concrete cracking and spalling in the tension zones was indirectly considered by assuming a zero tensile strength material. In the compression zones the effect was not addressed as here concrete was found to be in good conditions. In the length of positive bending moments concrete under compression was intact due to pavement protection, and in the length of negative bending moments, near the supports, concrete was found to be not cracked and the cross sections exhibited over width, as shown in Figure 5.
