## DETAILED DESIGN AND CONSTRUCTION OF THE ST. LOUIS PARK ICE RINK

Craig G. Huntington\*, and Jeffrey A. Carpenter†

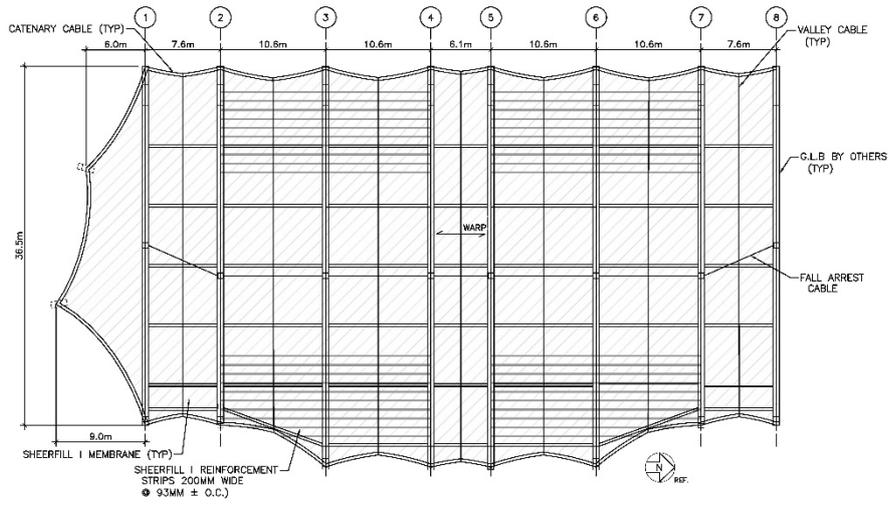
Figure 1: Roof plan

The structure is the cover of a new ice skating rink, owned by the City of St. Louis Park, MN. It has a PTFE-coated fiberglass fabric roof, supported on glu-laminated timber arches. The cover is 73m x 41m in plan, and supported by eight parallel arches bearing on concrete piers (Figures 1-3). The roof has a plan area of approximately 2,500 m<sup>2</sup>.

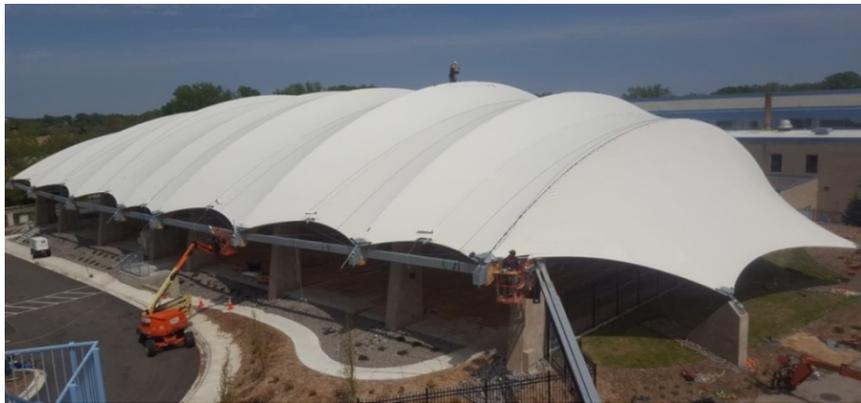
Figure 2: The roof structure nearing completion

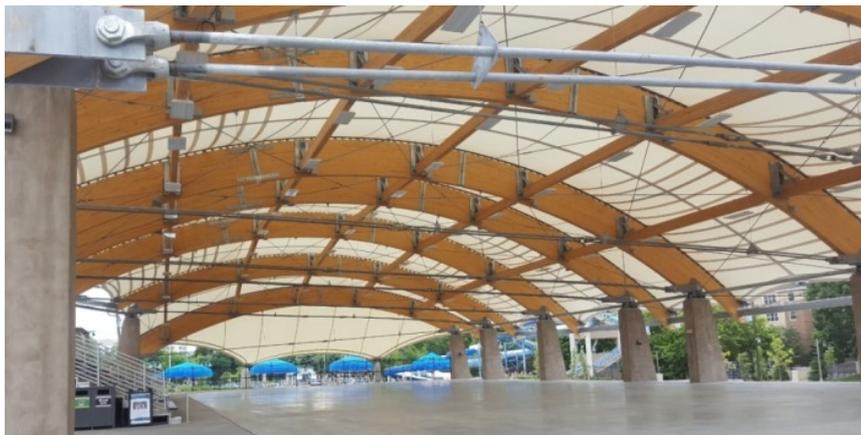
Figure 3: Interior view, looking south, showing glu-lam arches, fabric reinforcement

Patterning of the membrane was carried out in a special way to utilize stronger goods in areas of high stress, in order to minimize reinforcement strips and maximize capacity (see Figures 1, 3, 11 for fabric reinforcements). Rolled goods were tested both at the supplier and in Birdair's quality lab to determine the actual strength of each roll. Rolls were then grouped by strength and by biaxial test results (compensations) to determine the most efficient layout of the material. Rolls with specific strengths and compensations were grouped together with similarly stressed areas within the assembly (i.e. higher strength goods with similar compensations were paired with the higher stressed areas and so on). Birdair was also careful to use reinforcing strips from the same rolled goods as the main membrane for more efficiency and integrity during fabrication and erection.

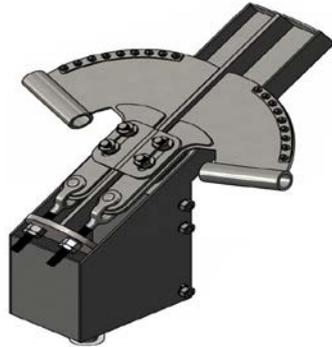
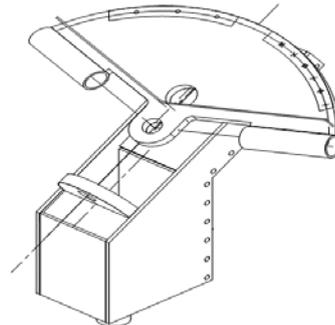
Figure 4: Blackwell membrane plate & drain scupper      Figure 5: Membrane plate & scupper as constructed

By making this one large panel we reduced 28 corner pulls down to 4; and those 4 are over the full length and width of the large panel, giving much more leeway to stretch prior to achieving the final shape with valley and catenary cables. The membrane plates at the ends of the intermediate arches were changed from two plates to one in this scheme (Figures 4 & 5).

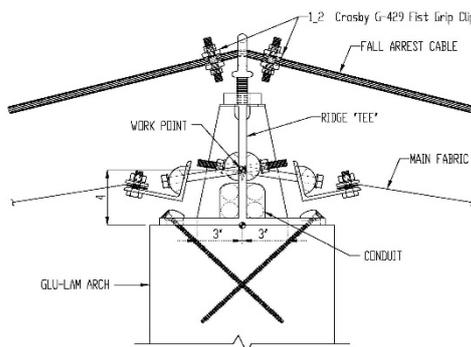
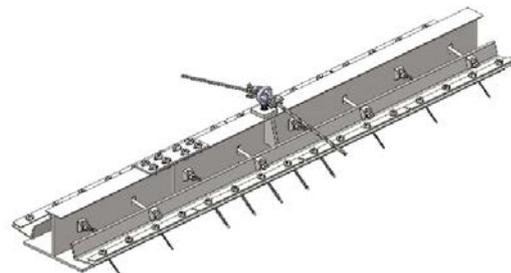
Figure 6: Blackwell top of arch detail (section & isometric)

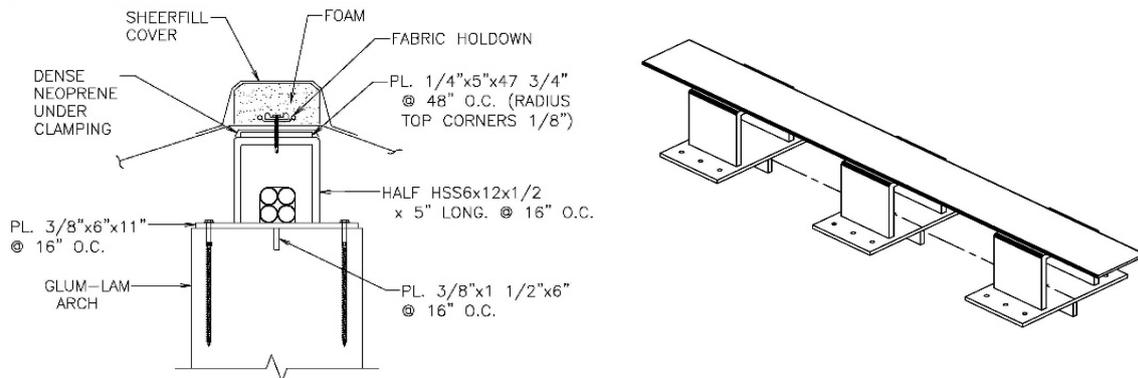
Figure 7: Top of arch detail as constructed (section & isometric)

Inverted U-shaped steel standoffs were provided atop each arch to accommodate the passage of electrical conduits between the arch tops and the membrane above (Figure 7). Analysis assumed complete membrane failure in alternate bays, resulting in large horizontal forces perpendicular to each supporting arch. Aluminum extrusions secure the membrane to the tops of the standoffs, and vertical steel shear tabs are welded to the standoff baseplates and fitted into slots cut into the top of each arch. These transmit the differential horizontal forces to the arches without using fasteners loaded in shear perpendicular to the grain of the timber.

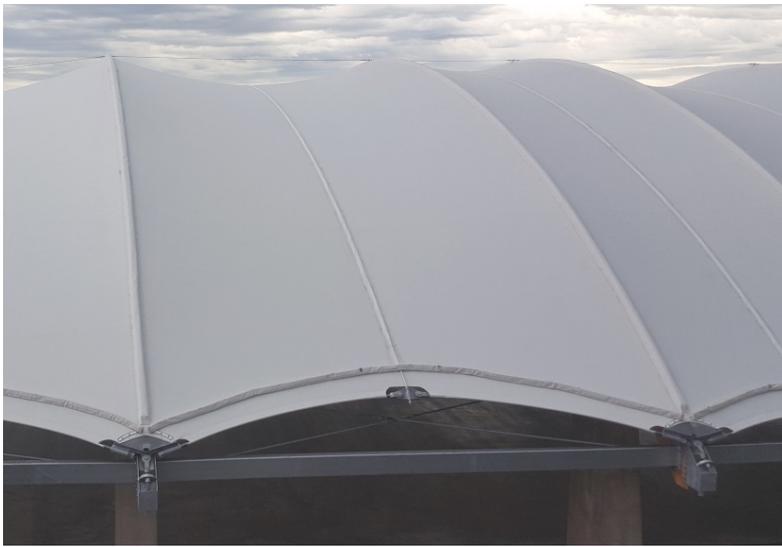
Figure 9: Diverter detail at membrane edge

The design incorporates foam-filled fabric water diverters around the perimeter of the membrane to control water runoff (Figure 9). The diverters are positioned to assure positive slope to drainage holes in the membrane plates at the ends of each arch, where the water is gathered into scuppers and diverted to pipes passing to grade. Detailing of a transition closure at the intersection of the diverters and valley cable closures was done in the shop for efficiency, and provides continuous water flow over the intersection.

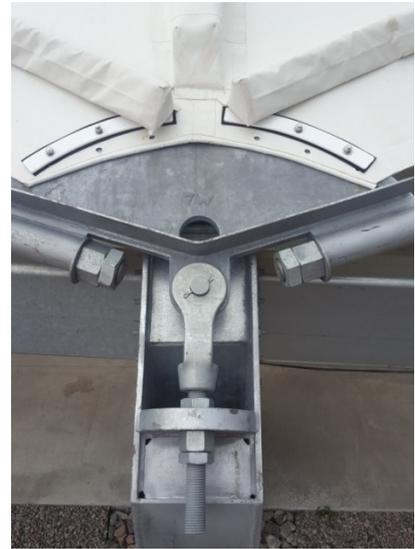
Figure 10: Typical "floating" membrane plate

Membrane plates at interior column Lines 2-7 and the two south piers provide adjustable anchorage for the membrane corners, with sleeved catenary cable terminations to each side (Figure 10). Water diverters to each side of the glu-lam arch terminate on the fabric just above the membrane plate, and the water that then passes onto the membrane plate is gathered by upstanding gutter plates and directed through a drain hole into a steel scupper assembly that is in turn bolted to the end of the glu-lam arch.

A rod and clevis mechanism provides adjustable anchorage of the membrane plate to a fixed plate welded to the scupper assembly. The design criteria assumed complete failure of the membrane to one side of each arch. This introduces large transverse forces to the membrane plates, which are secured against lateral displacement by guide plate assemblies that are in turn anchored to the glu-lams by pairs of 25mm diameter bolts that are drilled through the full depth of the glu-lams.

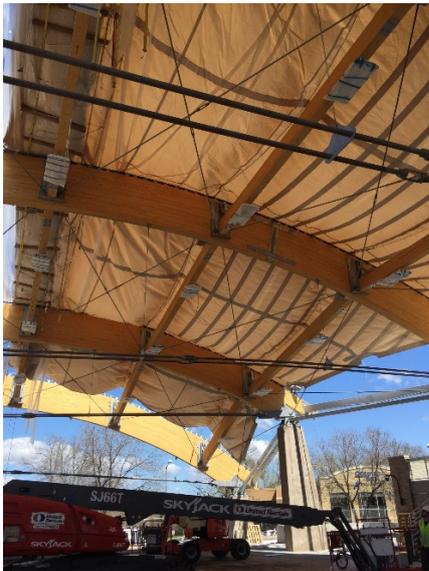
Figure 11: Fabric reinforcements during erection

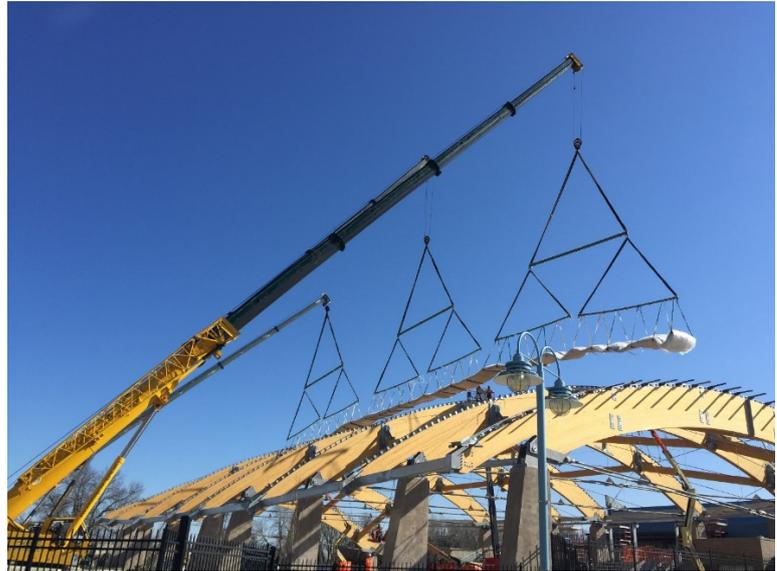
Figure 12: Three cranes with spreader bars placing fabric

As previously mentioned, the initial spreading and securing of the large fabric panel made for a long hard day. Three cranes were used with spreader beams to position the fabric at the ridge (Figure 12). Next, the membrane was unfurled along the direction of the arches, cables were roughly installed, and everything was secured for the night with ropes, come-

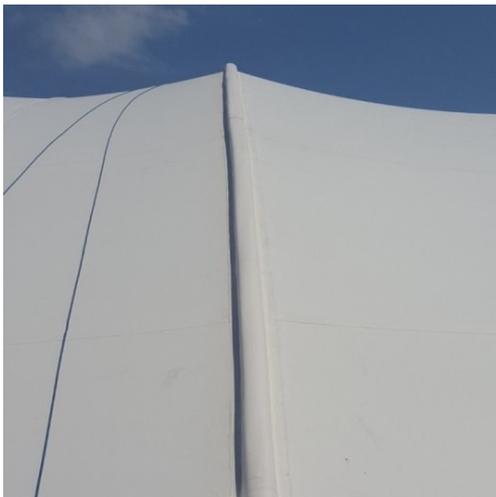
Figure 13: Fabric closure at arch top

Diverters and Closures present a challenge on jobs of any size and complexity because they are done near the end of the job, they have relatively little to no tension in them. The ridge closures were specially patterned due to the ribbed-look condition atop the arches and this proved effective in getting the closures looking nice (Figure 13). Valley closure-to-diverter details were prepared in the shop, so this was not something the field team needed to spend as much time on (Figure 14). The diverters themselves are challenging to install on any job because the foam needs to be relatively tight in the diverter cuff to make them look nice, which creates difficult in sliding the foam into the cuff. However, the end result is functional and aesthetically pleasing.

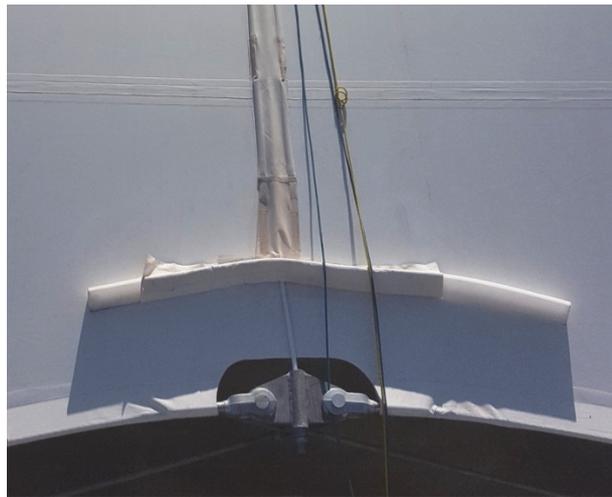
Figure 14: Valley closure / diverter intersection
