Article

Monitoring of Processing Conditions of an Ultrasonic Vibration-Assisted Ball-Burnishing Process

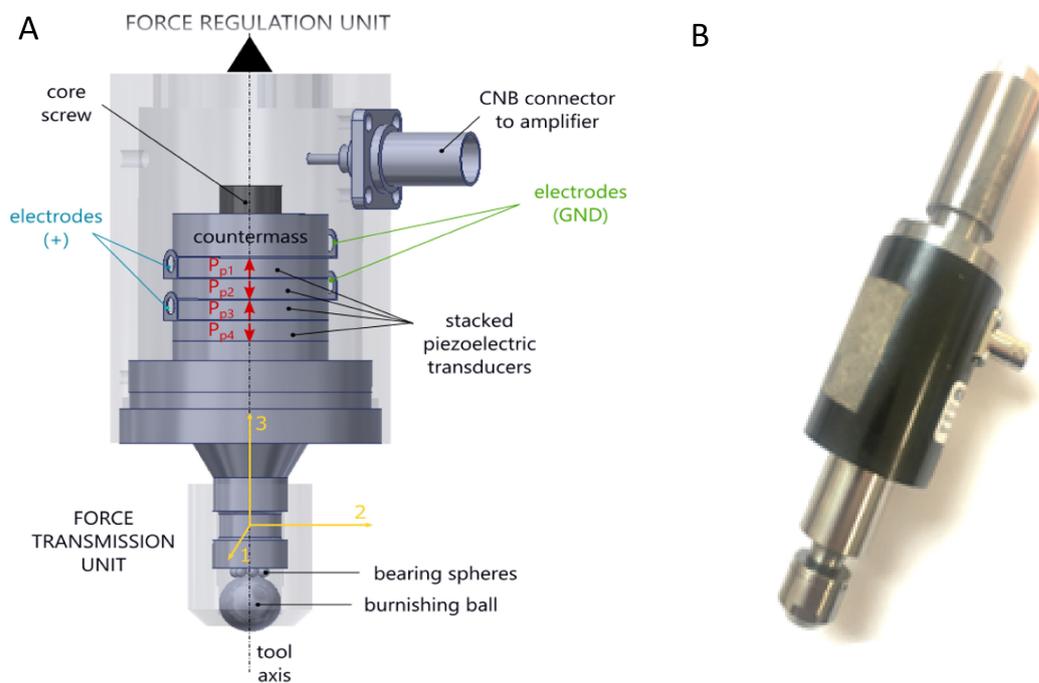
Figure 1. Ultrasonic vibration-assisted ball-burnishing (UVABB) tool equipped with a 1D linear displacement system through piezoelectric stack designed by Jerez-Mesa et al. (2018) [20]. (A) General scheme of the piezoelectric system; (B) Real image of the prototype used for vibration monitoring.

The ultrasonic-vibration-assisted ball-burnishing (UVABB) process has been extensively reported by Jerez-Mesa et al. (2018) [20]. This tool works so that vibrations are introduced through a sonotrode at whose tip the burnishing ball is installed, and whose length changes as an effect of thickness variation of a piezoelectric stack subjected to a difference of potential [21]. This tool is used for the monitoring and sensor installation during the works reflected in this paper. Figure 1 shows the design referred to. Its characterization lead to the conclusion that the working conditions (precharge or feed velocity during the process) are not influenced by the active resonant frequency of 40 kHz. For that reason,

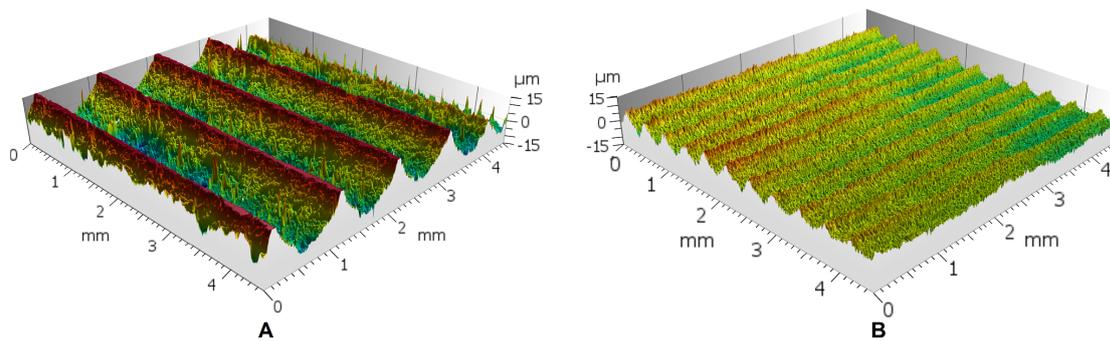
Figure 2. Surface texture modification through UVABB with the prototype object of study—after results obtained previously by Jerez-Mesa et al. (2018). (A) Before UVABB; (B) After UVABB [9].

In this paper, a prototype whose effectiveness has been confirmed in previous experiments on a similar carbon steel alloy (Figure 2) is the object of study [9]. Therefore, the monitorization that is featured in this paper is fundamental to know in-depth the phenomena occurring during the UVABB process that could affect the results. Furthermore, it is also its aim to understand whether the interaction of the burnishing ball with the original surface could lead to secondary excitations and cause tool malfunctions. Therefore, the knowledge generated here is of utter importance for industries (i.e., transportation, biomedical, etc.) interested in incorporating the UVABB in their production lines. Currently, the authors have not found previous bibliographical references dealing with this kind of monitoring and modal study of a process where so many excitation sources are present.

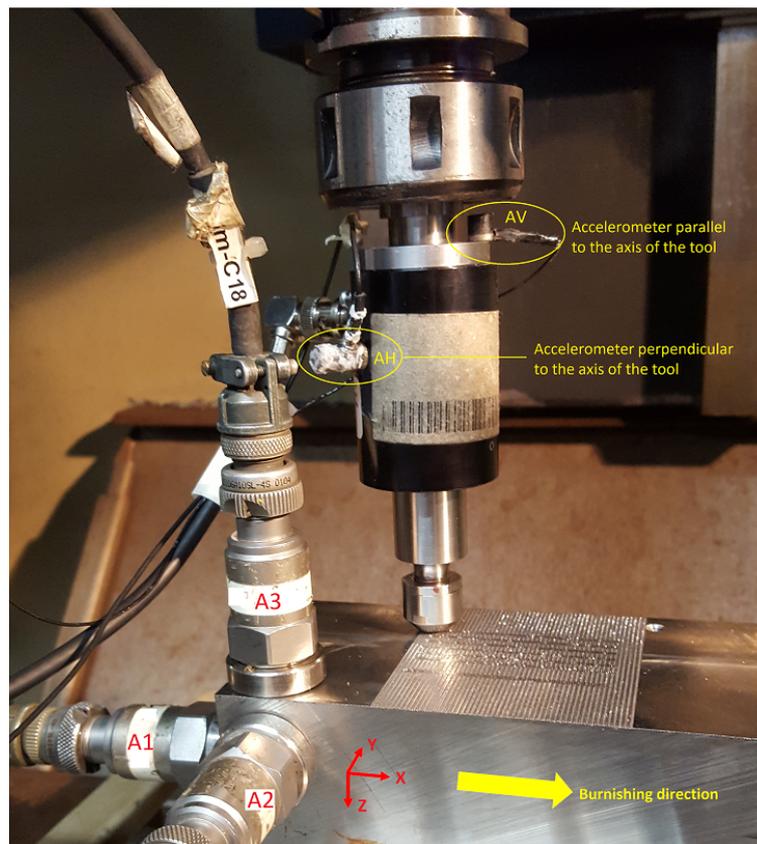
Figure 3. Experimental setup of accelerometers on the workpiece (A1, A2, and A3) and on the tool (AV and AH).

To monitor the vibrations, 5 accelerometers (Table 1) were installed: 2 on the tool and 3 on the workpiece. The overall setup is shown in Figure 3.

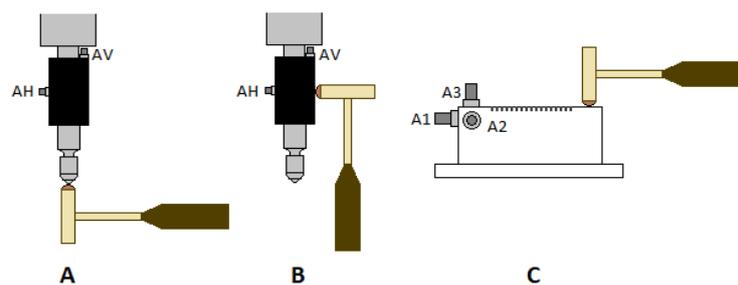
Figure 4. Schemes showing all types of performed impacts. (A) Vertically on the tool; (B) Horizontally on the tool; (C) Vertically on the workpiece attached to the dynamometric table.

Both the workpiece and the tool were impacted in different directions, as is shown in Figure 4. In addition, each test was undertaken under various circumstances, as is reflected in Table 3. It is obvious that vertical impacts on the tool can only be performed if it is not loaded on the workpiece's surface, whereas the setup enables the test operator to perform the tests under different loading conditions. Like that, it can be quantified how the natural frequency changes with regards to the overall system rigidity.

The natural frequencies found for the UVABB tool, and resulting from processing the signal registered by accelerometers AH and AV (Figure 4A,B), are presented in Table 4. Values not included in the table are missing due to the fact that they were not excited during the tests. These values evidence that, by changing the load exerted on the workpiece surface changes the rigidity of the system and, therefore, its natural frequencies. However, it can also be seen that these values are not sensitive to piezoelectric excitation, i.e., there is no modal change during a UVABB process compared to an NVABB operation. All values were deduced from the frequency response functions (FRF) and Bode diagrams to confirm coherence between the input signal generated by the hammer and the corresponding FRF. Figure 5 shows one as an example.

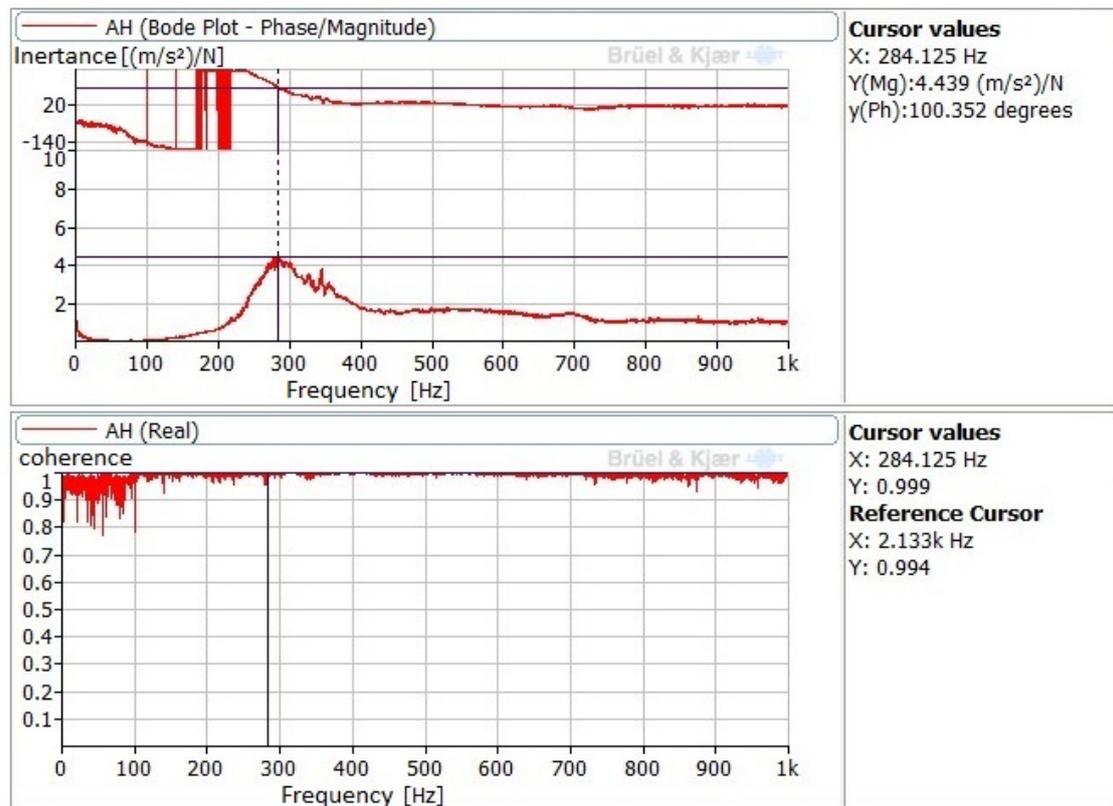
Figure 5. Frequency response functions (FRF) and Bode diagram obtained by AH accelerometer after impact test on the UVABB tool: unloaded and vibrations ON.

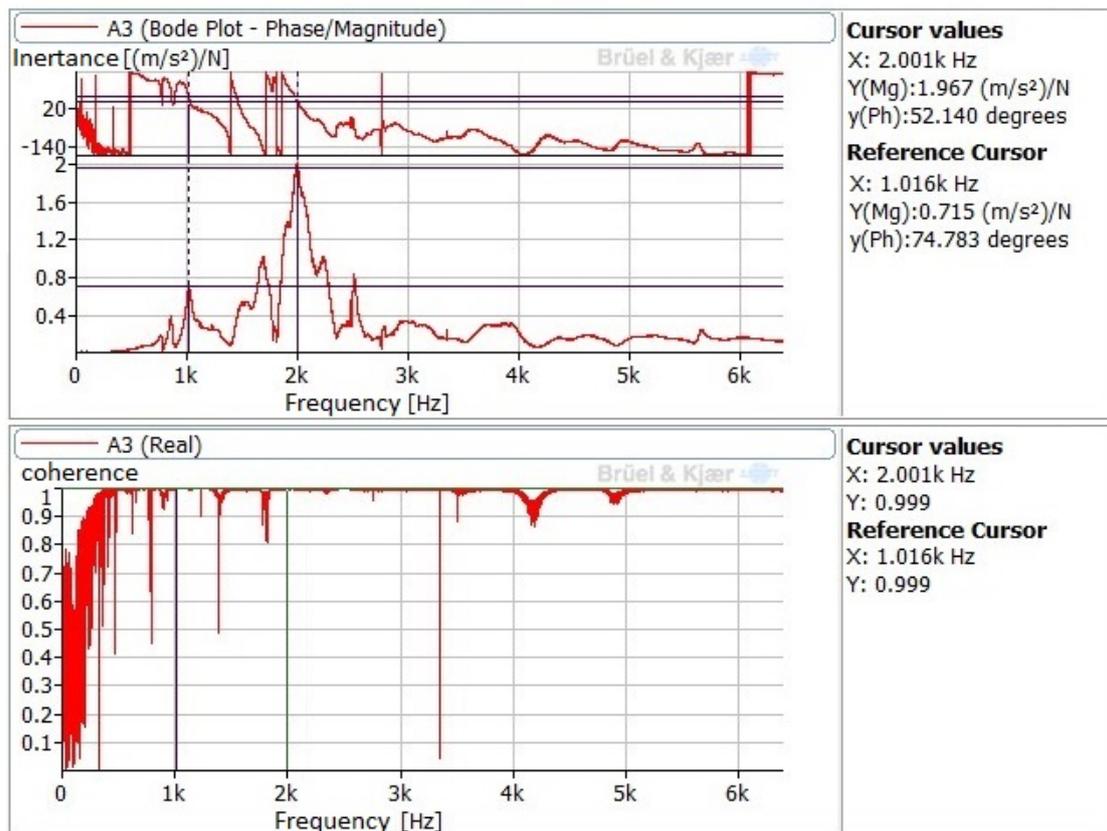
Figure 6. FRF and Bode diagram obtained by A3 accelerometer (vertical direction) after impact test on the unloaded workpiece.

On the other hand, natural frequencies measured on the workpiece are presented in Table 5. These are the result of processing signals acquired by accelerometers A1, A2, and A3 installed on the workpiece's surface (Figure 4C), such as the FDF and Bode diagram shown in Figure 6. Once again, the results demonstrate the invariability of natural frequencies of the mechanical system composed by the machine–tool–workpiece triplet, regardless of the preload level or the situation of the piezoelectricity in terms of excitation.

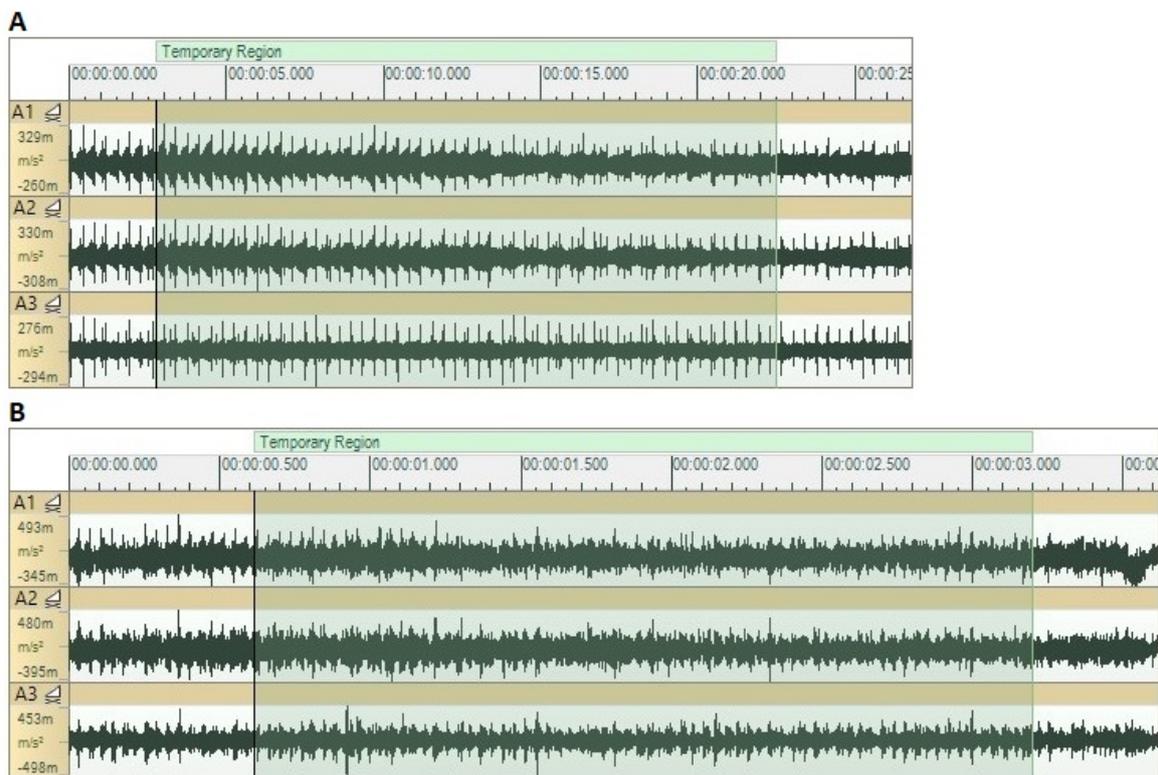
Figure 7. Signals measured on the workpiece during the UVABB process with a 250-N nominal preload in all three spatial directions. (A) 90 mm/min; (B) 900 mm/min.

The signals acquired on the workpiece through accelerometers A1, A2, and A3 in the time domain for both tested feed velocities evidenced the presence of periodic impacts that derive in a similar time behavior in all three spatial directions (Figure 7). However, the signal corresponding to the 900 mm/min test presents more random components, so the periodicity of those impacts is more difficult to determine.

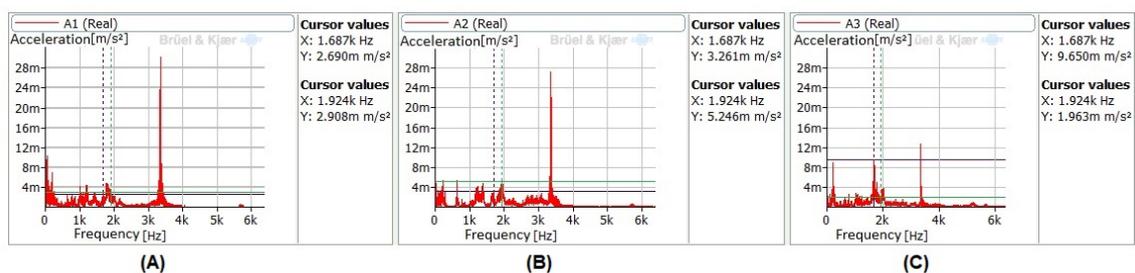
Figure 8. Signals showing natural frequencies of the workpiece being burnished at 900 mm/min, 400 N, 3 passes, and vibrations ON. (A) Accelerometer A1; (B) Accelerometer A2; (C) Accelerometer A3.

The spectral analysis of those time signals can be associated to the functioning of the milling machine and are present since it is turned on. Its amplitudes are higher in both longitudinal directions X and Y (accelerometers A1 and A2), with values that almost double the signal recorded in the vertical direction Z (accelerometer A3), as can be seen in Figure 8. It can also be appreciated that the natural frequencies are indeed excited between 1000 and 2000 Hz, as was already shown in Table 5.

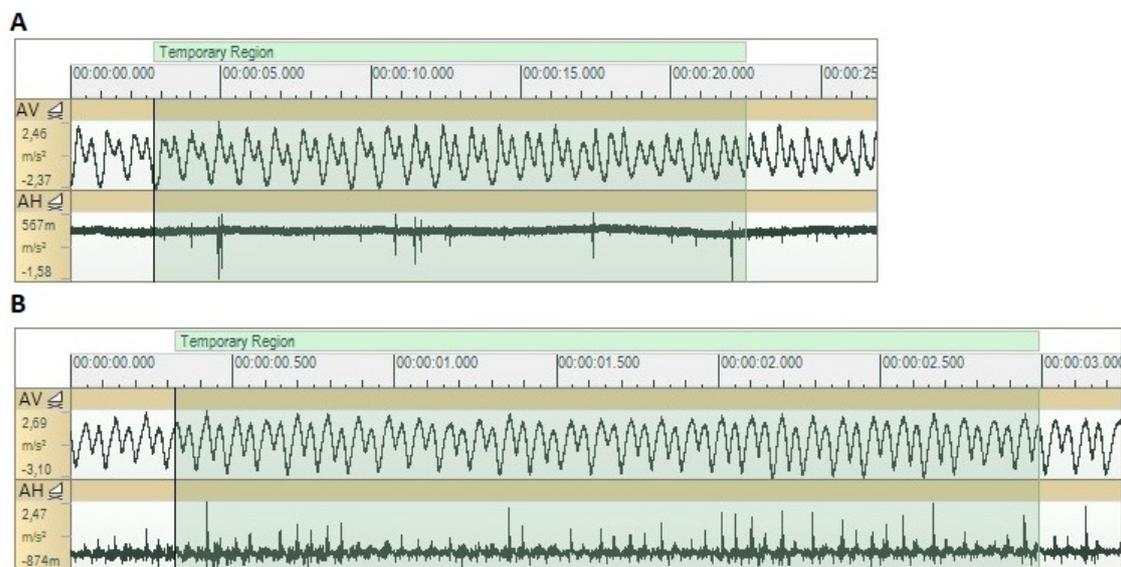
Figure 9. Signals measured on the UVABB tool along its vertical and transverse directions, during tests with vibrations ON. (A) 90 mm/min, 250 N, 1 pass. (B) 900 mm/min, 400 N, 3 passes.

The vibratory signals acquired on the tool are very different from the ones acquired on the workpiece, these are presented above. Indeed, the signals acquired along the vertical direction of the tool (accelerometer AV) is highly periodic and remains the same regardless of the testing conditions, unlike the signals recorded along the horizontal direction (accelerometer AH) that evidence different behavior depending on the feed velocity of the test (Figure 9). Tests performed with a 900 mm/min feed velocity show that their periodicity fits more exactly with the periodic repetition of its vertical signal's correspondents.

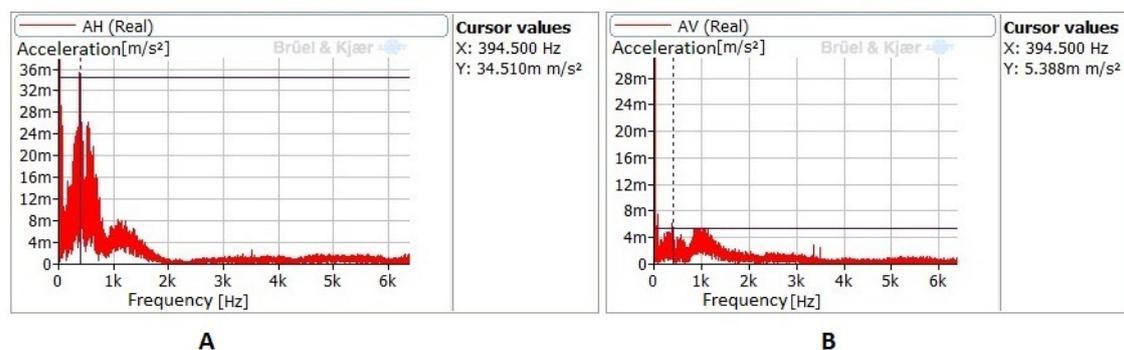
Figure 10. UVABB tool excitation signals measured on the longitudinal and radial directions. 900 mm/min, 400 N, 1 pass, vibrations OFF. (A) AH sensor; (B) AV sensor.

The spectral analysis of the same signals measured on the tool show that its natural frequencies, measured during the preliminary impact tests, are indeed excited during the process, and that excitation is higher when a 900-mm/min feed velocity is selected to perform the process. For instance, Figure 10 shows the spectrum obtained from the signals recorded by the AH and AV accelerometers, depicting those excitation zones around 394 Hz and 1000 Hz that constitute the natural frequencies of the system. Amplitudes are higher in the horizontal measurements than in the vertical ones.

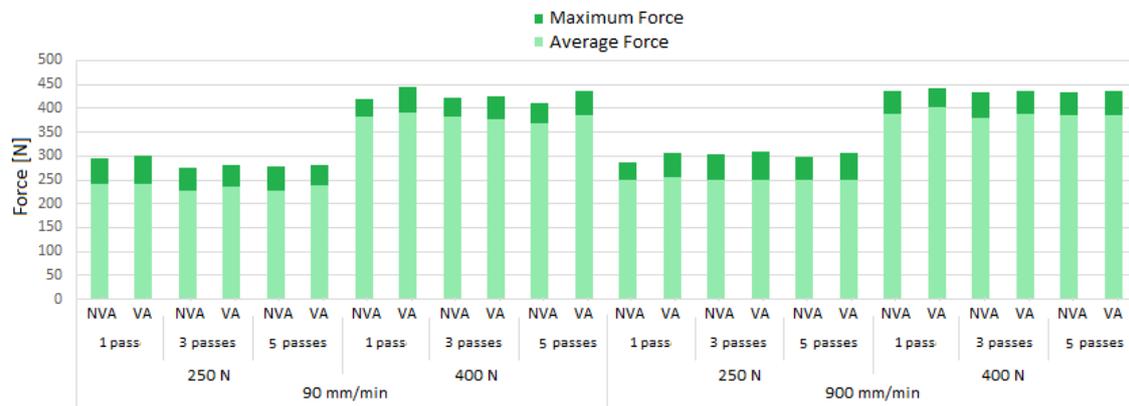
Figure 11. Average and maximum burnishing forces registered during all tests.

The acquisition and processing of the burnishing forces during all tests confirm that the average preloads that were exerted were around the nominal values of 250 and 400 N (Figure 11). The forces prove to be relatively stable, regardless of the testing conditions. This observation is more clear in the tests performed with the highest feed velocity. For 90 mm/min tests, the maximum force variation is 8%.

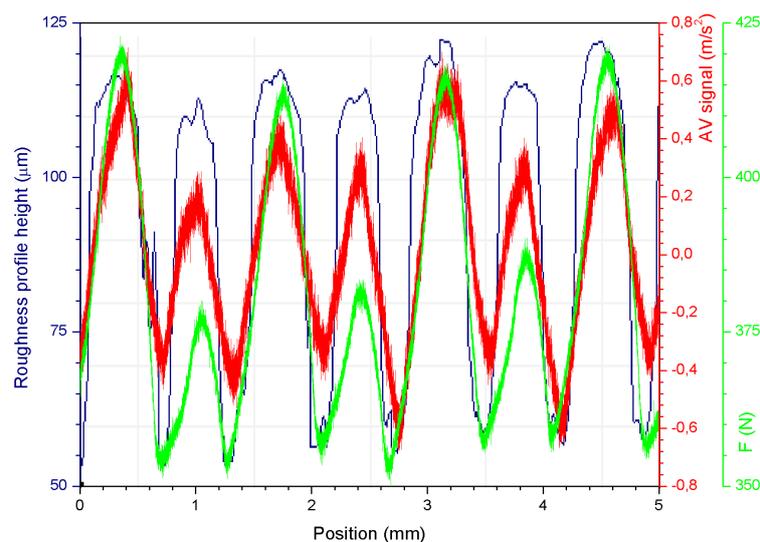
Figure 12. Vibratory signal acquired by the AV accelerometer (red), roughness profile (blue), and burnishing force (green) variation registered during the VABB process—90 mm/min, 400 N, and 5 passes—.

This variation is quite natural during the application of this kind of ball-burnishing test, and does not negatively affect the results. As highlighted previously by Jerez-Mesa et al. (2018), the source of change could be attributed to the absorption of the surface irregularities by the spring inside the tool during the process [9]. However, until now, no physical explanation had been formally found to explain the fact. Here, a clear correspondence of the signal acquired by the vertical accelerometer of the tool (AV), the burnishing force variation, and the topological profile on which the ball rolls during the experiment, confirms the hypothesis exposed before (Figure 12). On the other hand, these points also allow the researchers to confirm that the low-frequency vibrations observed during the process have an intrinsic nature and depend mostly on the type of roughness that the original surface presents.
